STATUS QUO REPORT:

COGTA: WHITBY LODGE

DEPARTMENT OF PUBLIC WORKS

AUGUST 2013

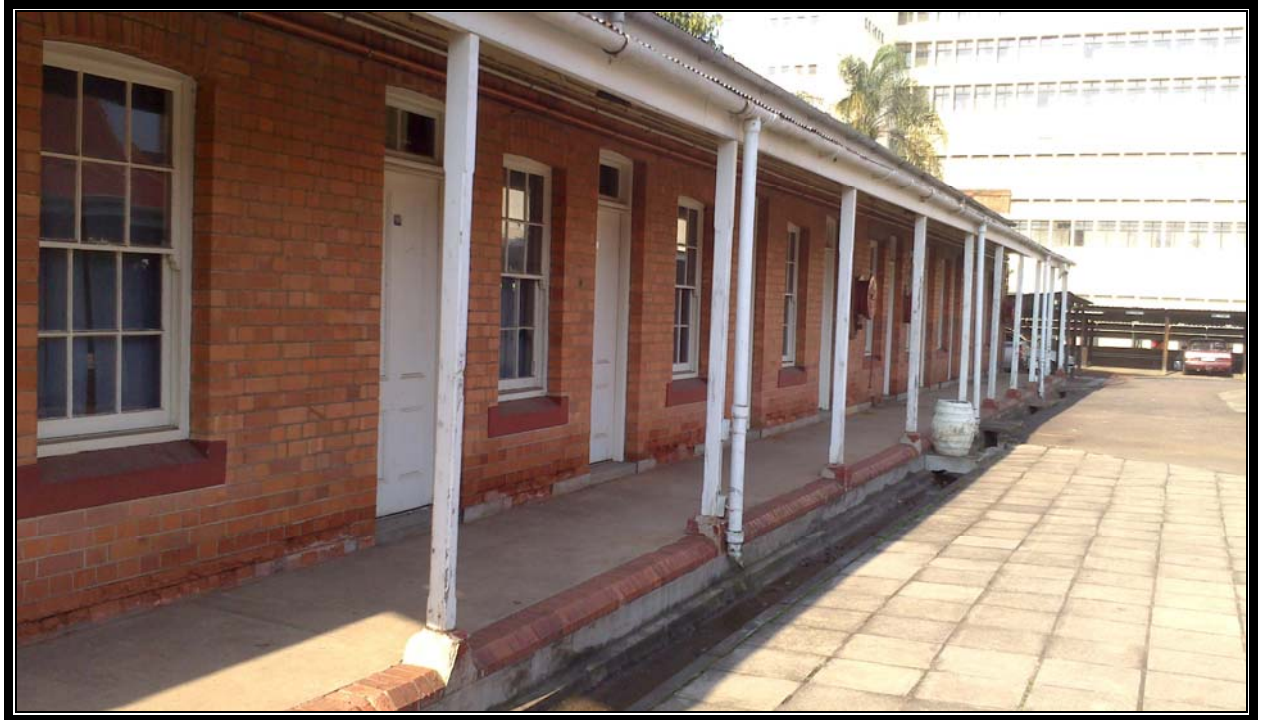
Photograph 1: External View of Larger Building

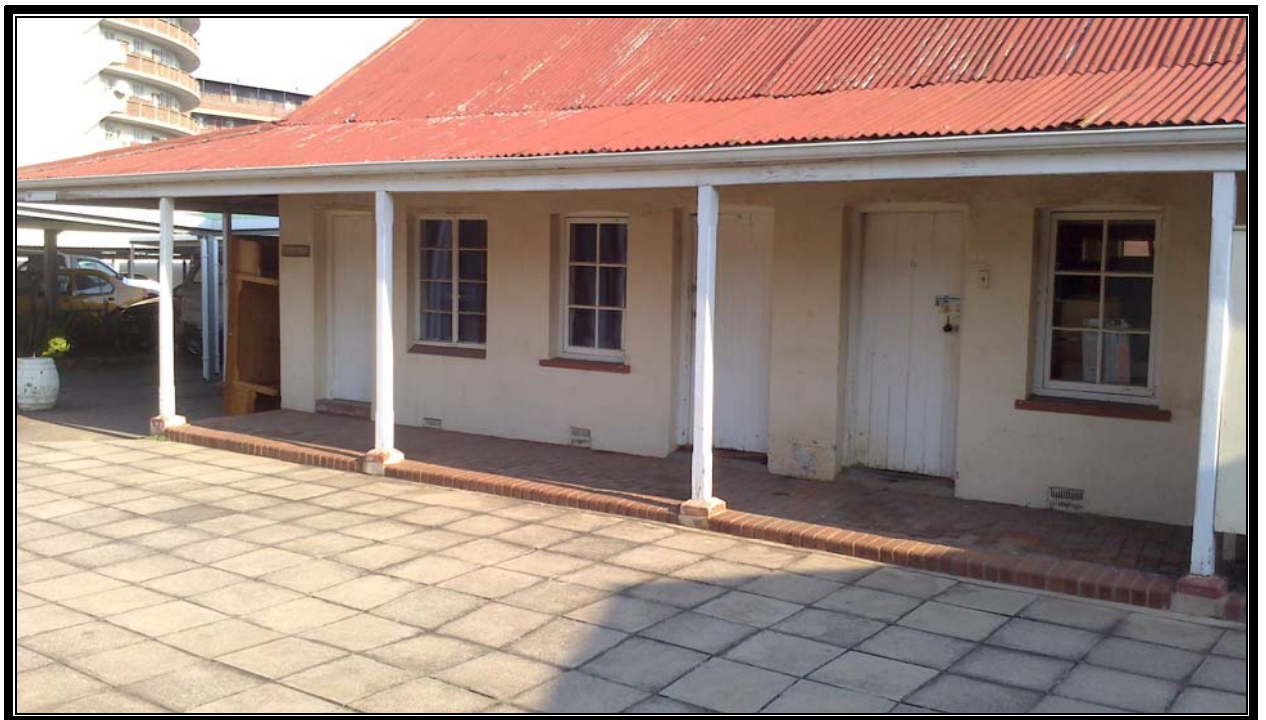
Photograph 2: External View of Smaller Building

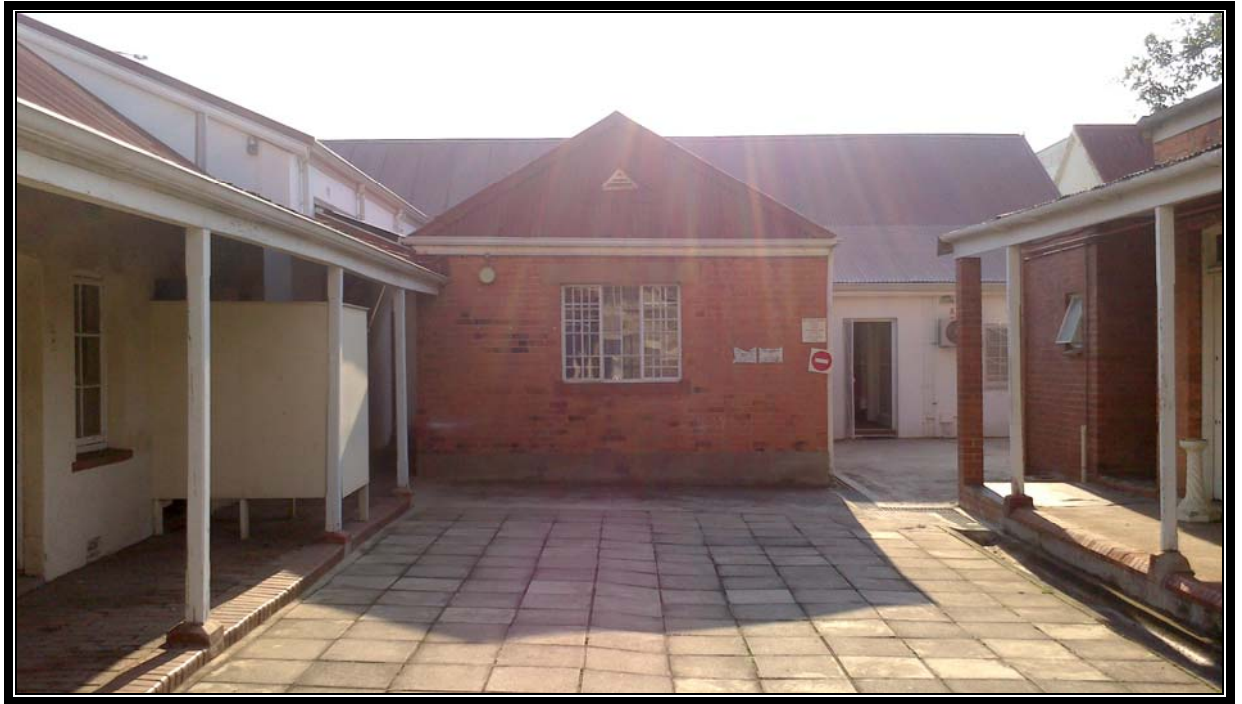
The paving is in poor condition, unsightly and has an inconsistent fall across its width.

Photograph 3: View of unsightly Courtyard between buildings

It is proposed that the existing concrete pavers be removed and that this area be finished with asphalt to match the surrounding surface finish.

Suitable "imported", compacted "fill" material will be utilised for this area to ensure that vehicular loads are adequately sustained.

Adequate fall of the asphalt towards the existing stormwater drain will be facilitated.

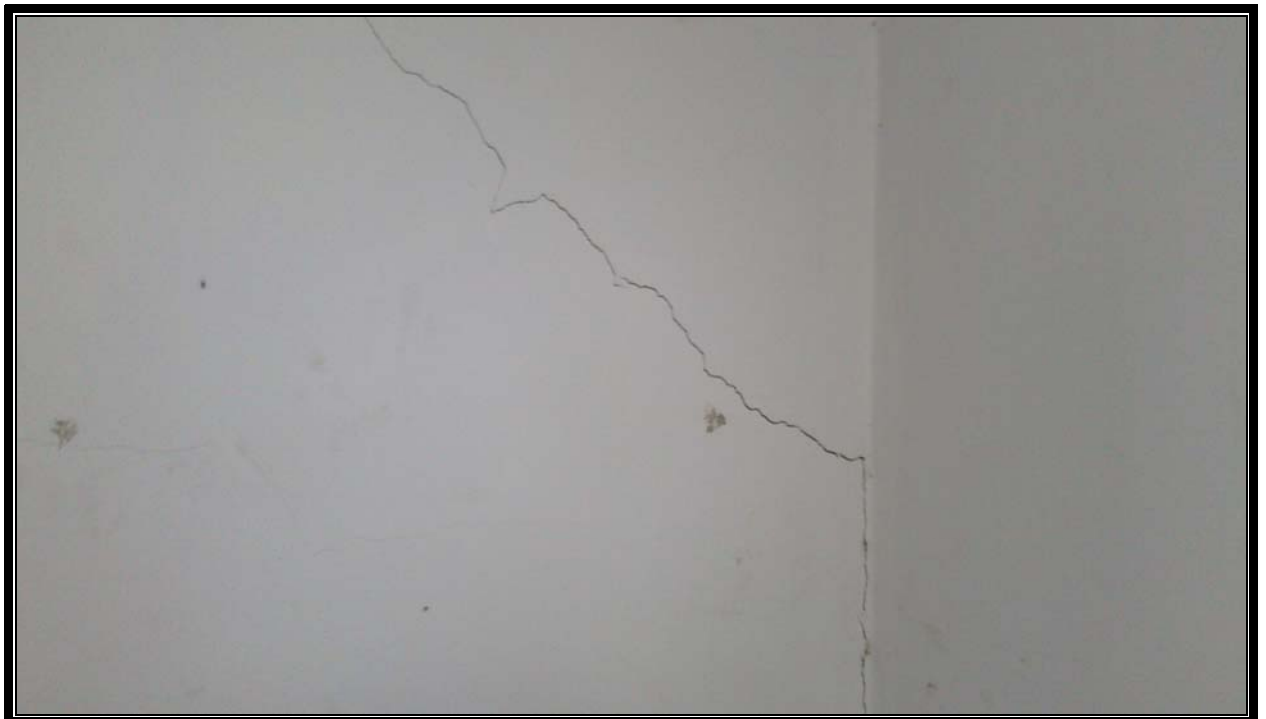
Site observations have revealed that cracking along the rear end walls of the larger building is present.

It is of the opinion that the cracking along the rear end walls of the building has resulted from foundation movements due to variations in moisture content of founding soils.

Photograph 4: View of Crack along rear Wall of Larger building

In order to remediate the rear end cracked walls of the larger building, it is proposed that “underpin” foundations be constructed to effectively increase founding depths at required locations and thereby minimise variations in soil moisture content.

Therefore it is recommended that the cracked brickwork be replaced approximately a year after the underpin foundations are completed.

Furthermore, aprons need to be constructed along the length of the rear walls to prevent storm-water from ponding close to the building foundations.

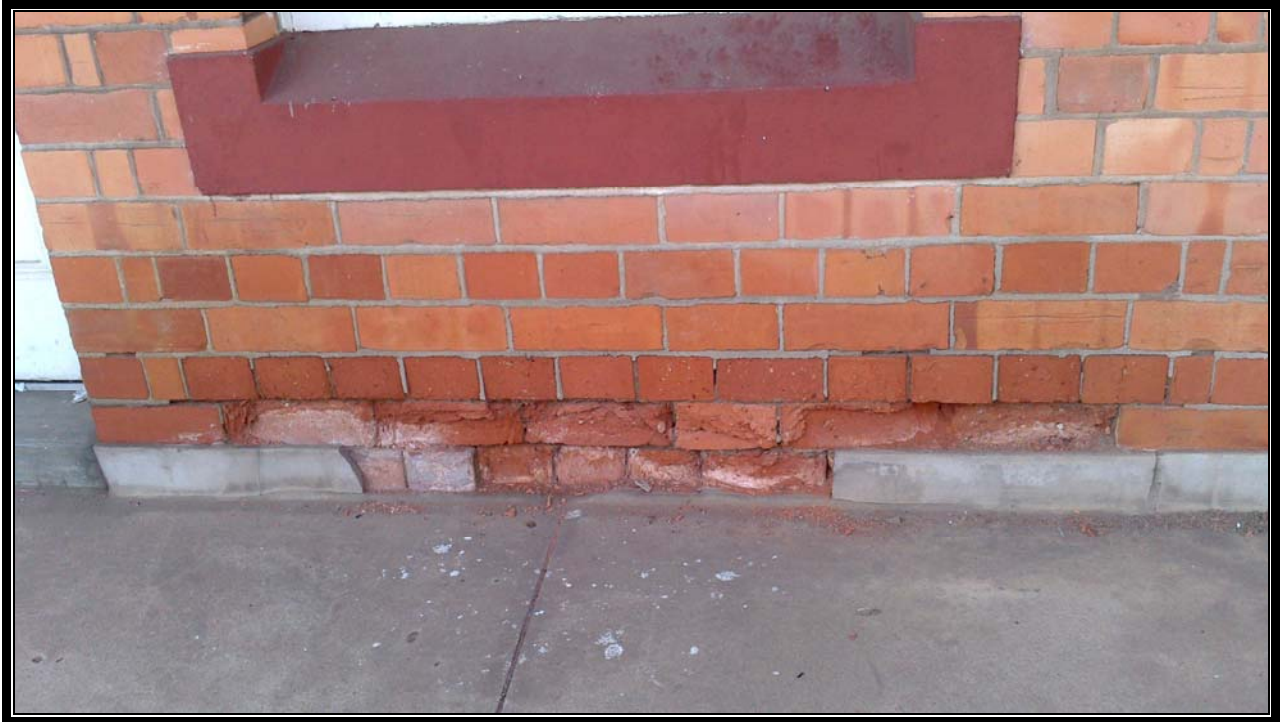
Along the length of the entrance walls, a band of brickwork immediately above the verandah floor slab (approximate height = 200mm) was also observed to be damaged.

Photograph 5: View of damaged brickwork along entrance wall of Larger building.

The damaged band of brickwork along the entrance walls to the larger building is to be carefully replaced in line with architectural and AMAFA recommendations, or, alternatively, a “plaster band” be created.

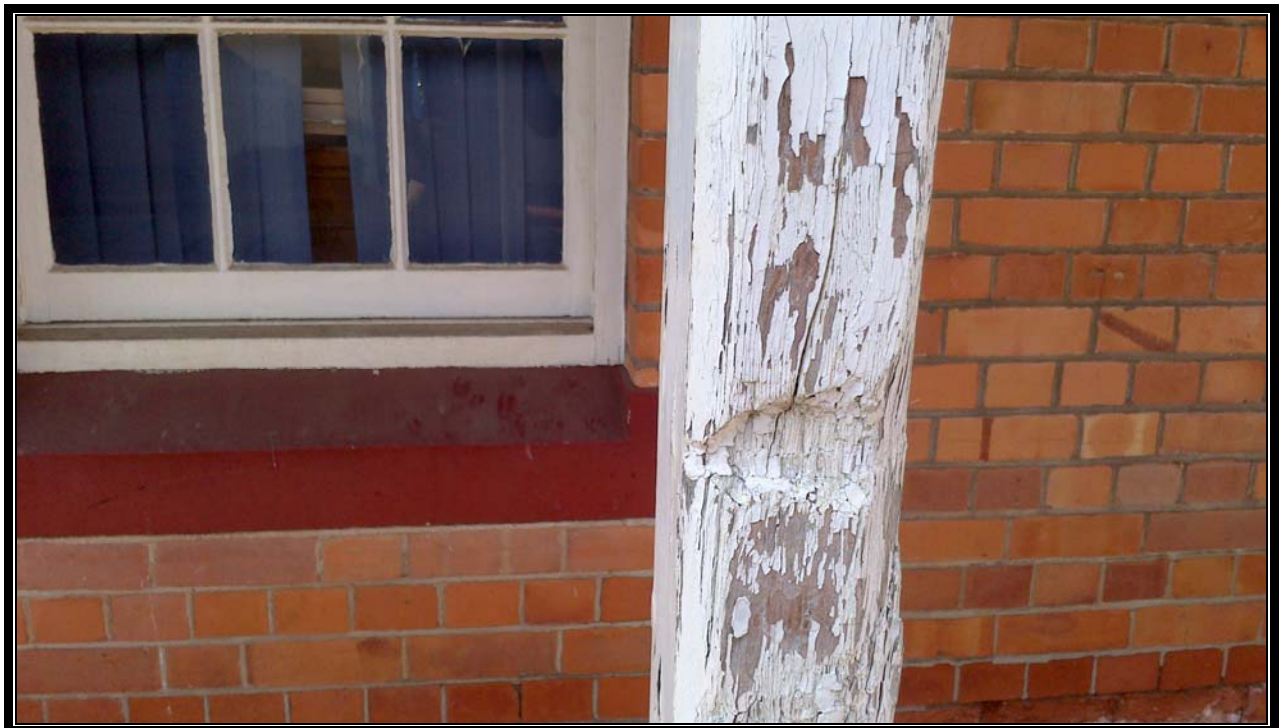
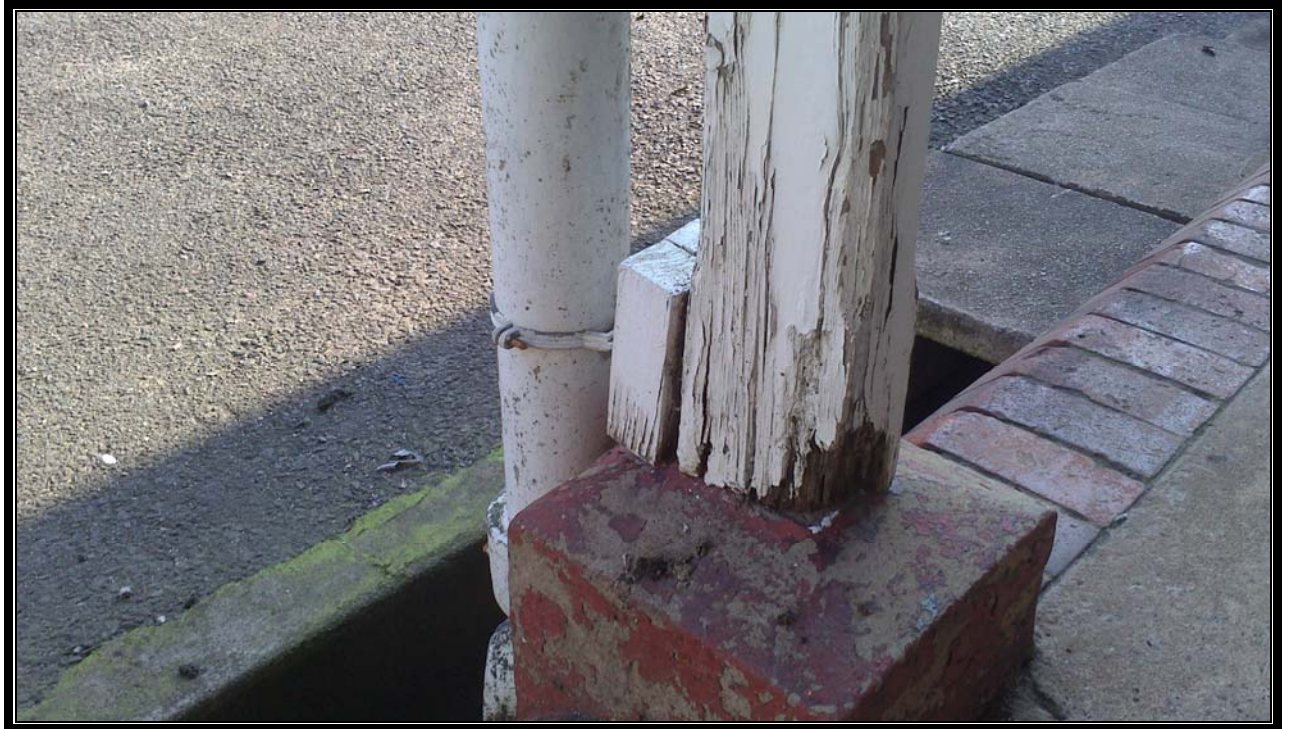
The vertical timber supports to the Verandah Eaves beam has undergone severe deterioration, particularly, along the lower portions of the post height.

The posts are in a poor structural condition.

Photograph 6: View of damaged verandah post

Photograph 7: View of damaged and deteriorated verandah post

It is proposed that the existing deteriorated timber posts be removed and suitably replaced.

New hardwood posts will need to be installed to match the existing post profile and satisfy architectural requirements.

The removal of the Vertical posts will also result in the removal and adequate replacement of the eaves timber beam.

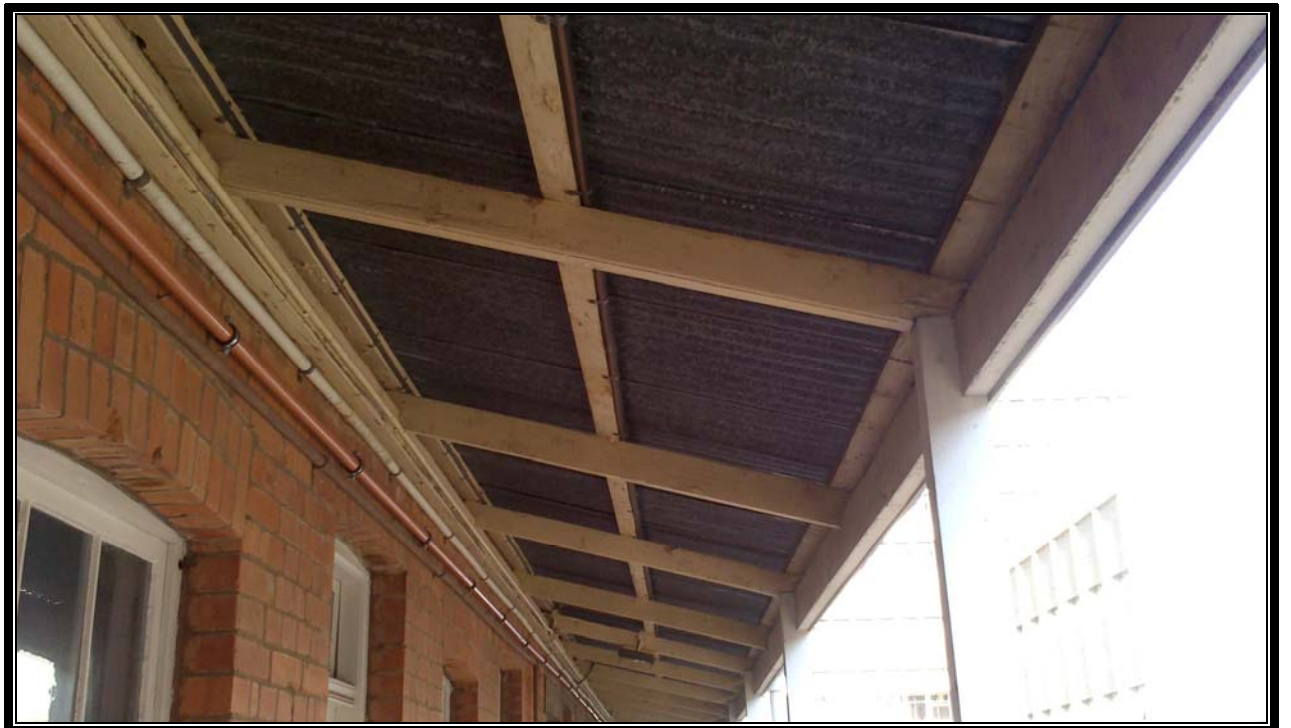
Roof sheeting was observed to be badly corroded and will require replacement.

Photograph 8: View of roof to verandah

Roof sheeting will need to be removed and replaced in line with architectural specifications. It is also anticipated that battens will most likely be required to be replaced.

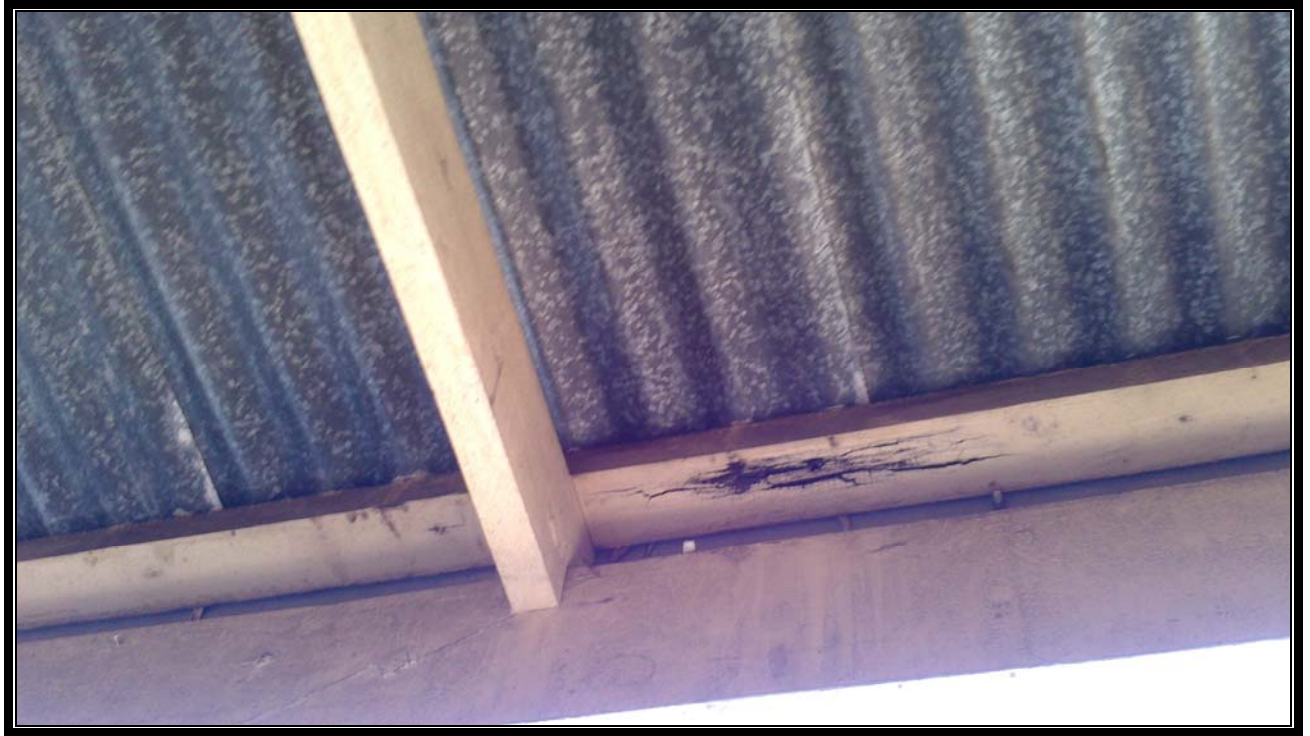
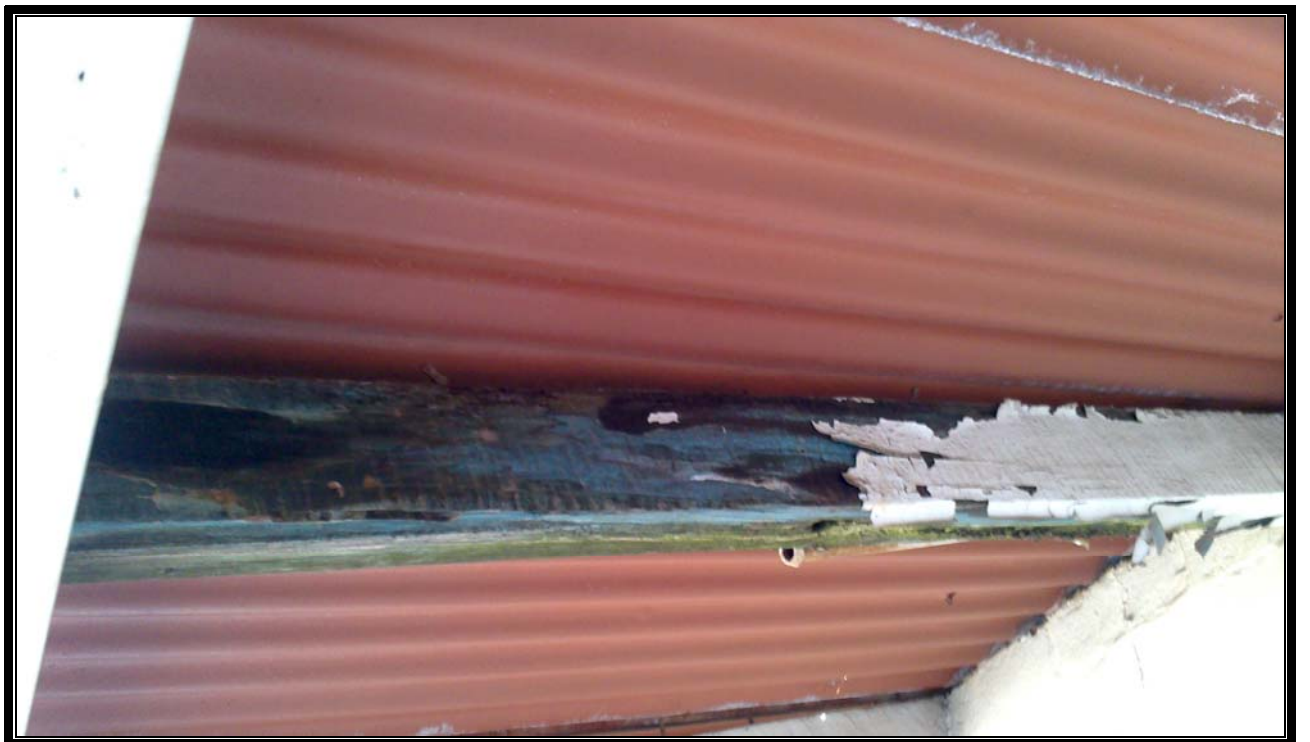
Observations made on the exposed sections of the roof members (verandahs) have indicated that certain section of the purlins, rafters and eaves beam have undergone deterioration and will need to be replaced.

Photograph 9: View of deteriorated verandah purlin.

Photograph 10: View of deteriorated verandah rafter

Judging by the visible deterioration on the exposed sections of the roof members, it is estimated that approximately 50% of the roofing members will need to be repaired and/or possibly replaced.

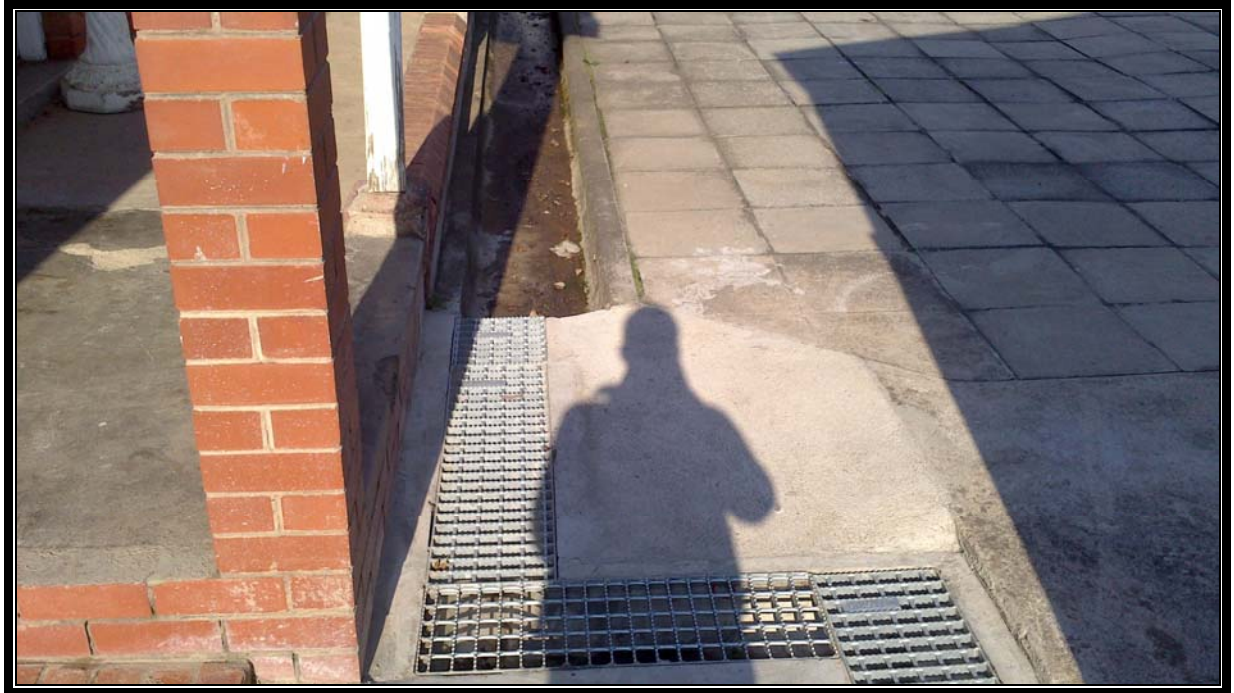
A small portion of the channel length has been covered with a steel grating and/or pre- cast concrete covers (to facilitate access over); however, the majority of the channel length is exposed and not covered.

Photograph 11: View of steel grating over portion of storm-water channel

It is proposed that suitable pre-cast concrete covers be used along the length of the existing channel to enable safe access over the v-drain and onto the verandah of the Larger building.

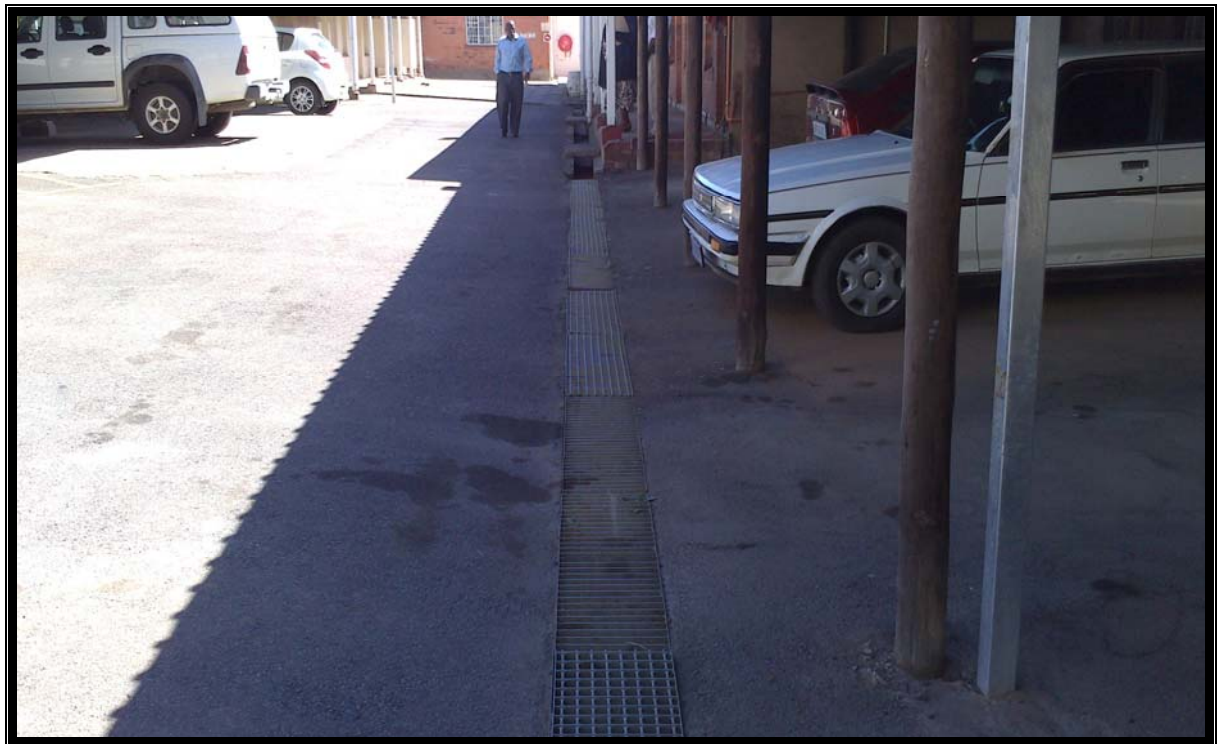
Observations have revealed that these stormwater channels (which covered with steel grating) are heavily silted up and/or blocked.

Photograph 12: View of channel (grating over) used to convey Stormwater away from Buildings. Channel observed to be blocked and requires cleaning.

It is therefore recommended that these stormwater channels which extend past the larger building undergo adequate cleaning to ensure that storm-water is effectively conveyed away from the buildings.
