Heritage impact assessment of ancillary sites with potential heritage on the Cornubia development, Mount Edgecombe

Prepared for: Tongaat Hulett Developments (Pty) Ltd
P O Box 22319
Glenashley
4022

archaic consulting

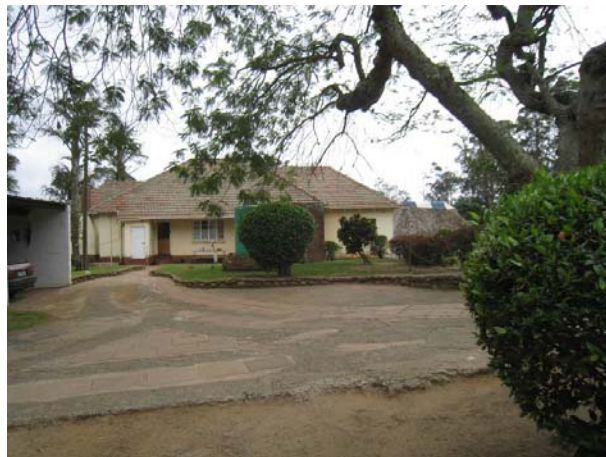
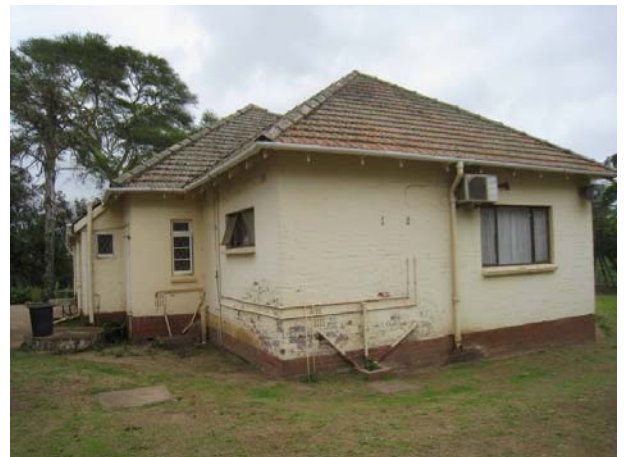
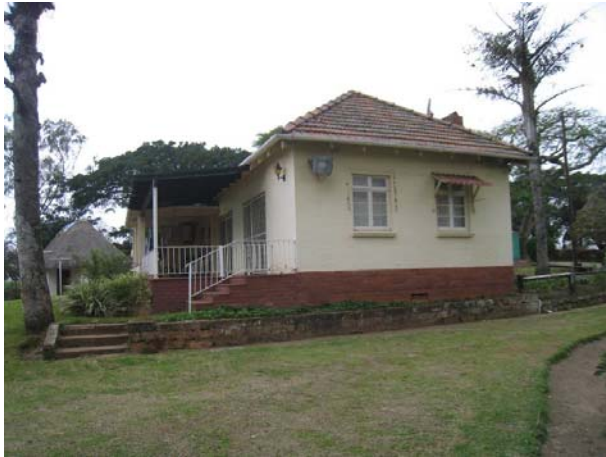
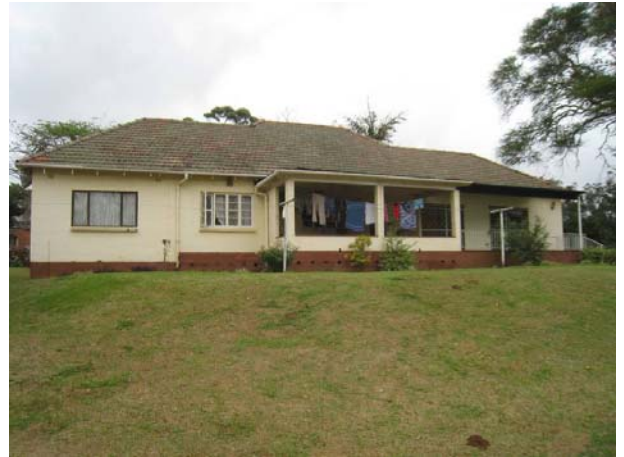
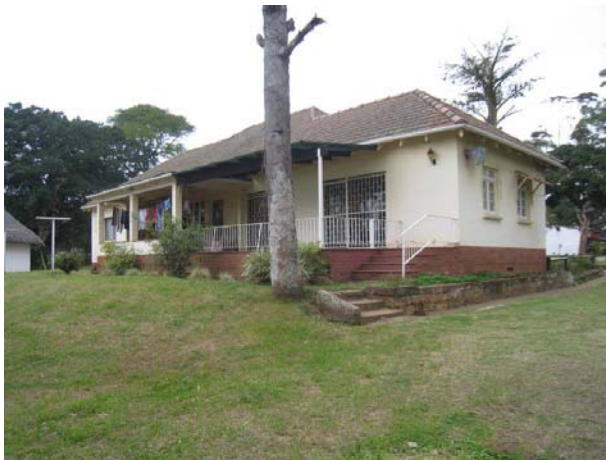
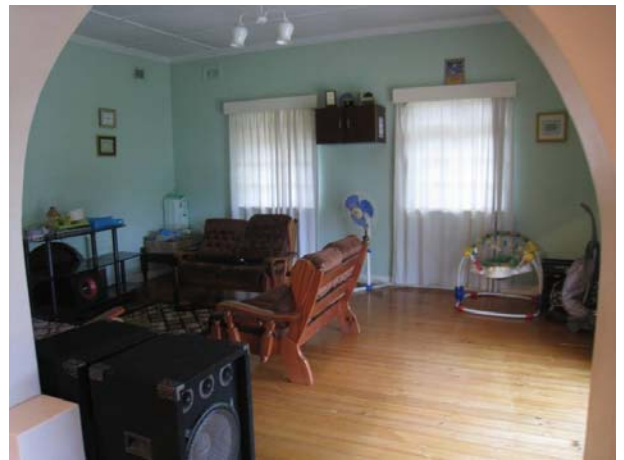
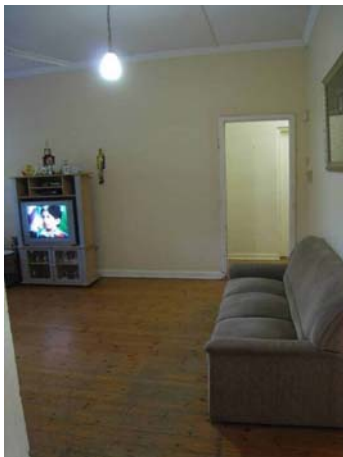
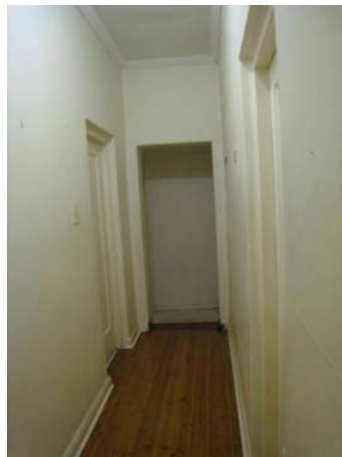
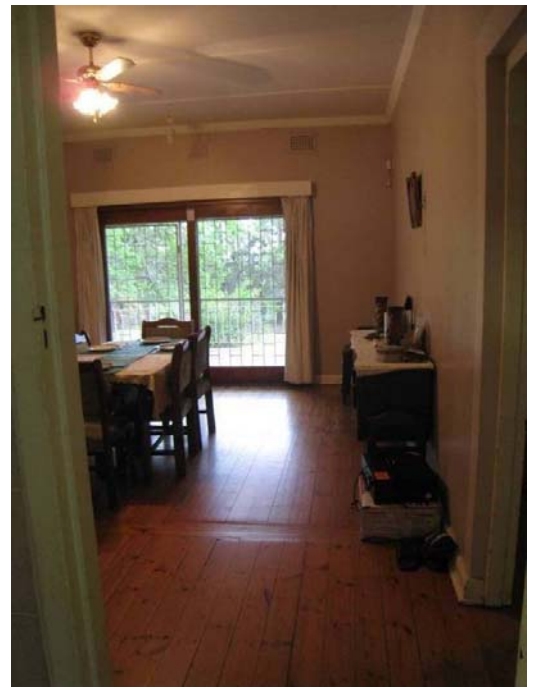
The main house faces north. It is of conventional construction, of brick and mortar under a hipped Marseilles tiled roof. To the north, a raised veranda has been more recently roofed with a shallow pitched corrugated sheeting 'afdak'. The walls have a facebrick dado base, with walls plastered and painted. The windows are steel and timber mixed. Internally, the house has suspended timber floors which are generally in good condition with a plasterboard ceiling.

It is a utilitarian, solid building, with few unique features. It is most likely over 60 years old, and thus protected in terms of the KwaZulu – Natal Provincial Heritage Resources Act no 4 of 2000.

Summary: This house is of good solid construction and is in good condition. However, it is a utilitarian structure similar to many others, and has few features which grant it merit. It is recommended that demolition be allowed, and that materials such as the suspended timber floors be delivered to Amafa for recycling in the Building Materials Bank.

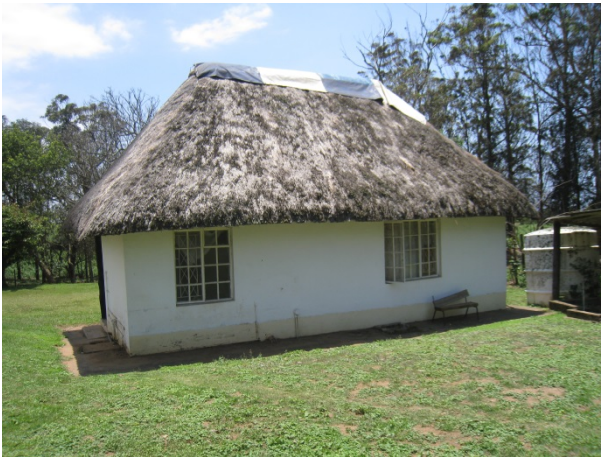
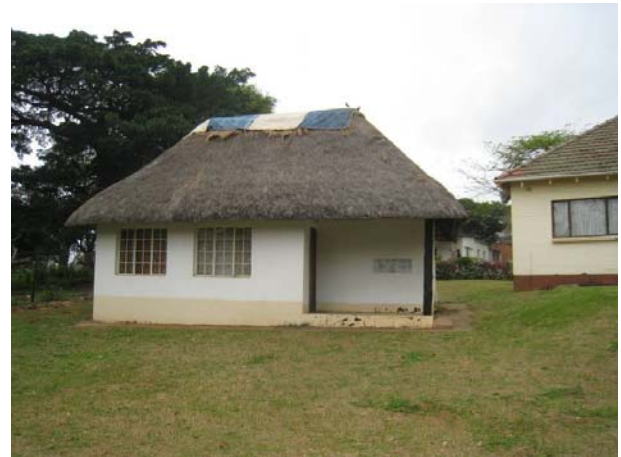
This rectangular cottage is located close to the main house, on the northern edge. It is of conventional construction, with steel windows and a thatched, hipped roof, which looks as though it is in need of repair. It has a small veranda to part of the north side which is supported in part by a gumpole post.

Summary: *This cottage is of good solid construction and is in reasonably good condition. However, it is a utilitarian structure similar to many others, and has few features which grant it merit. Demolition, should it be sought, is an option.*

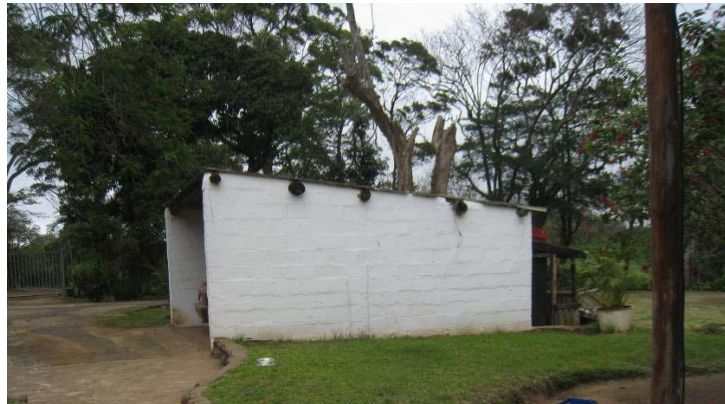
Fig 15: Garage building

This is a masonry constructed building being used as a garage with a monopitch sheeting roof set on gumpole rafters. It is utilitarian and has little merit.

Summary: *This building is in good condition. However, it is a utilitarian structure with few features which grant it merit. It is recommended that demolition be allowed.*

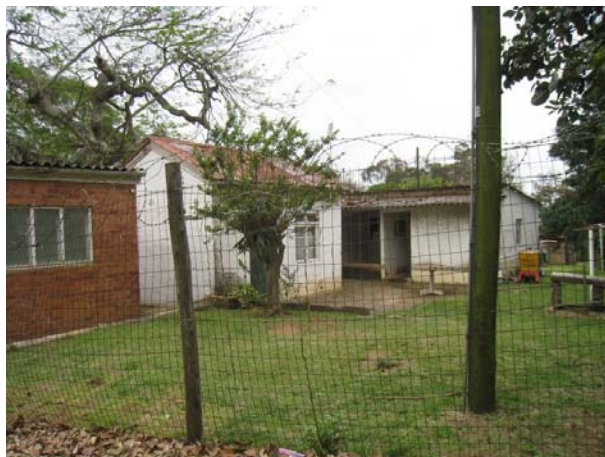
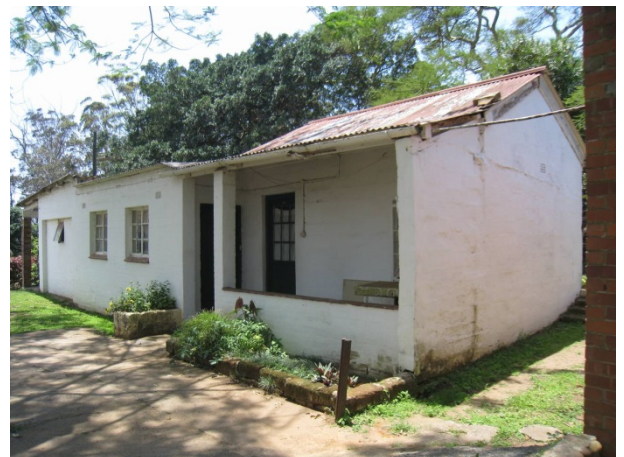
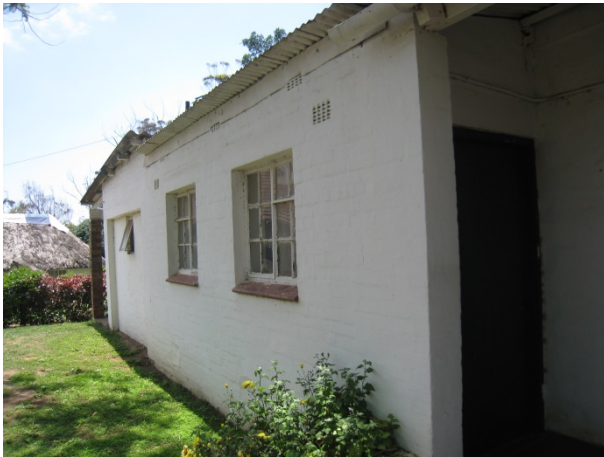
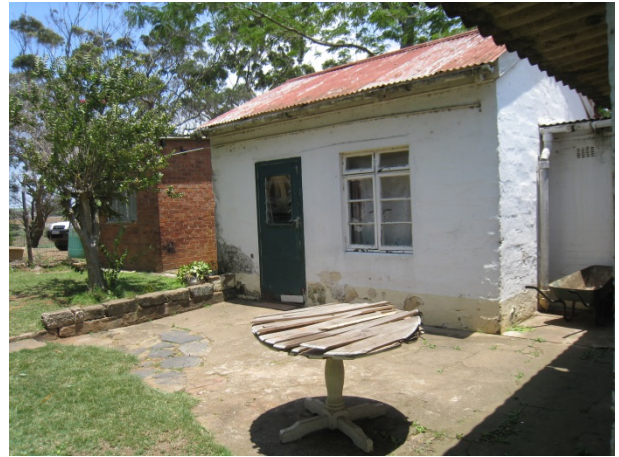
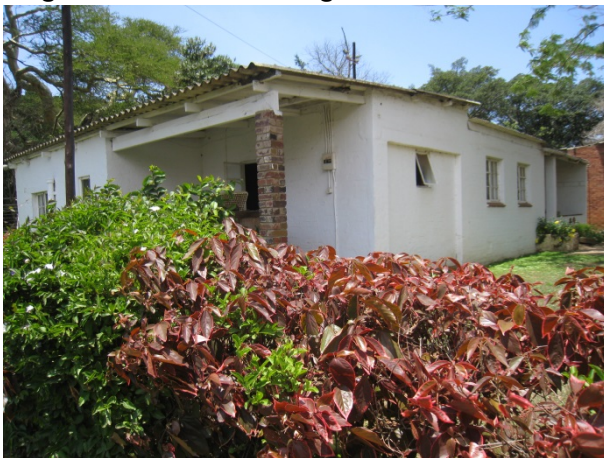
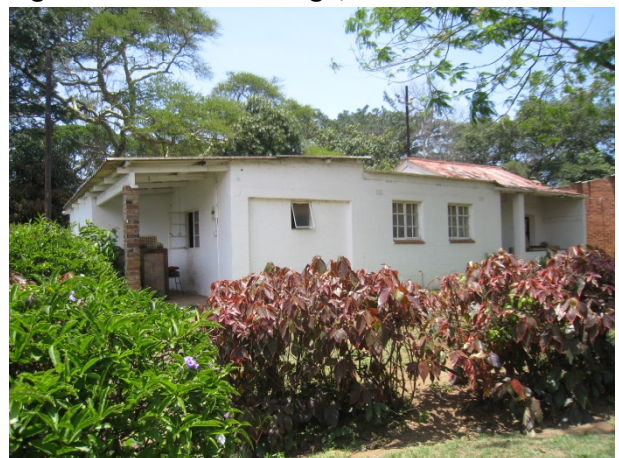
This is perhaps the most interesting building on the site. It is a small cottage, with entrance off the front veranda, and an extension to the north which runs backwards of the building. It is roofed with a saddle corrugated sheeting roof, with a veranda at a lower pitch. It is situated to the right of the main entrance gates, adjacent to a facebrick garage (building 5) of more recent construction.

Summary: *This house is of good solid construction and is in reasonably good condition. However, it is a utilitarian structure similar to many others, and has few features which grant it merit. It is recommended that demolition be allowed, and that any appropriate materials be delivered to Amafa for recycling in the Building Materials Bank.*

- **Building no 4 is a good example of a labourer's cottage (most likely indentured labour). It is of mixed construction and has had random subsequent accretions to the north.**
- **The main house itself is not a striking example of architecture of the late 1940s and 1950s: it is generally well kept, and intact, although there are areas in which new windows have been inserted, as well as the addition of the veranda to the north.**
- **It is not clear what the function of outbuilding 8 was, but it shows evidence of pre-war construction.**

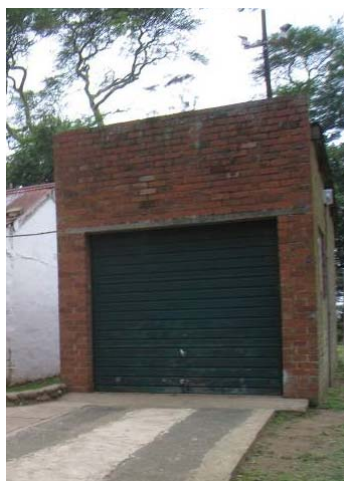
Fig 22: Building no 5, garage

This is a face-brick garage located next to building no 4 with mono-pitch corrugated sheeting roof and roller garage shutter. This is of conventional construction and has little or no merit from any point of view.

Summary: *This building is of solid construction and is in good condition. However, it is a utilitarian structure similar to many others, and has few features which grant it merit. It is recommended that demolition be allowed.*

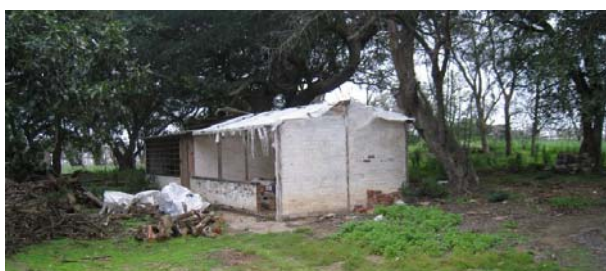
Fig 23: Building no 6, poultry pen

This is a poultry pen of mixed construction located outside the perimeter fence of the main complex comprising Site 1. This structure is of no heritage value and of limited interest from an architectural, scientific, historical or technical point of view.

Summary: *This building is utilitarian similar to many others, and has few features which grant it merit. It is recommended that demolition be allowed.*

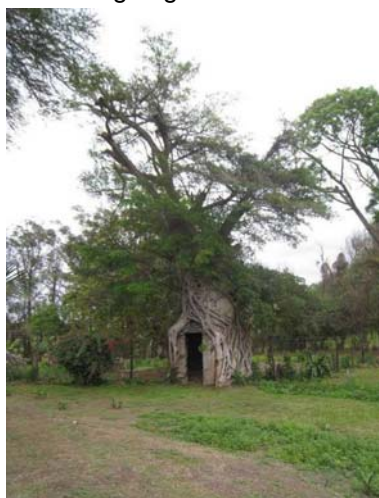
This building is an old outbuilding in the garden of the complex which has been enveloped with a large fig tree. It has little heritage value, rather an aesthetic nostalgia.

Fig 24: Outbuilding and fig tree

Summary: *This building is of picturesque value and few features which grant it cogent merit. It is recommended that demolition be allowed.*

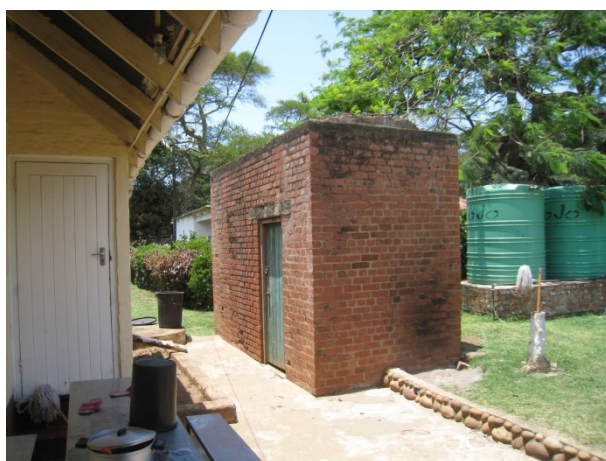
Fig 25: Outbuilding adjacent to main house

This structure is of uncertain use, but is constructed with mixed headers and stretchers, placing it as being most likely over the age of 60 years.

Summary: *This building is utilitarian and has few features which grant it cogent merit. It is recommended that demolition be allowed.*

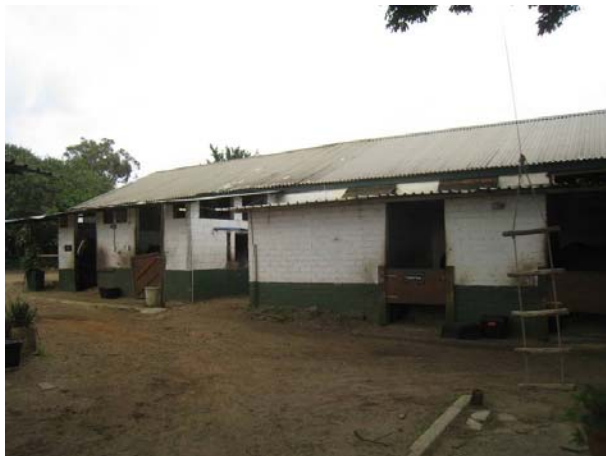
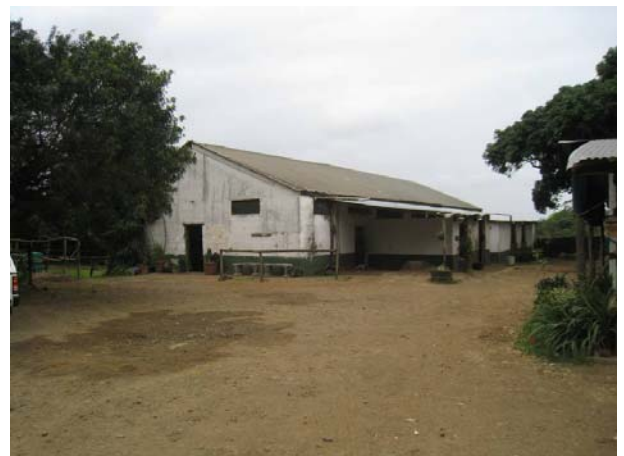
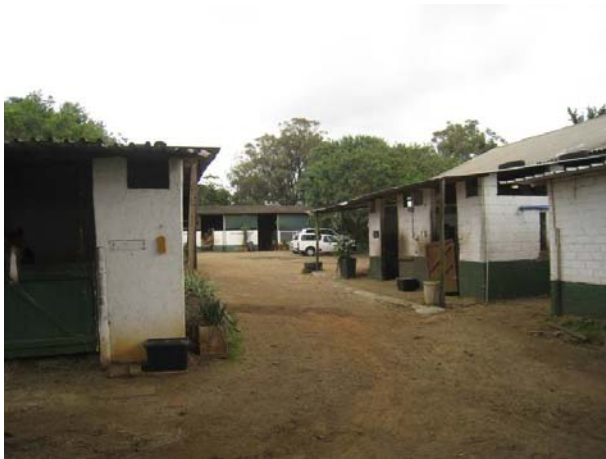
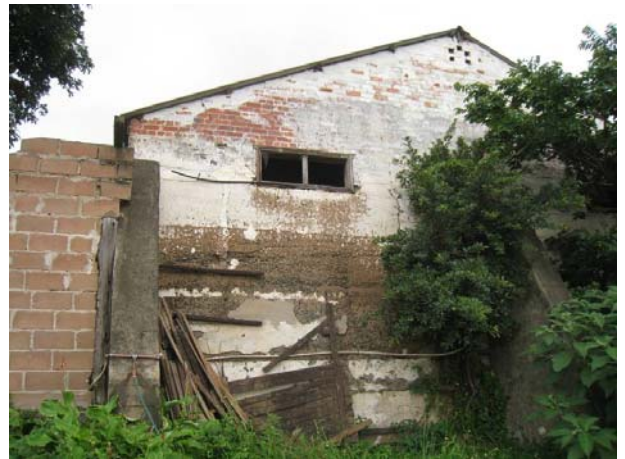
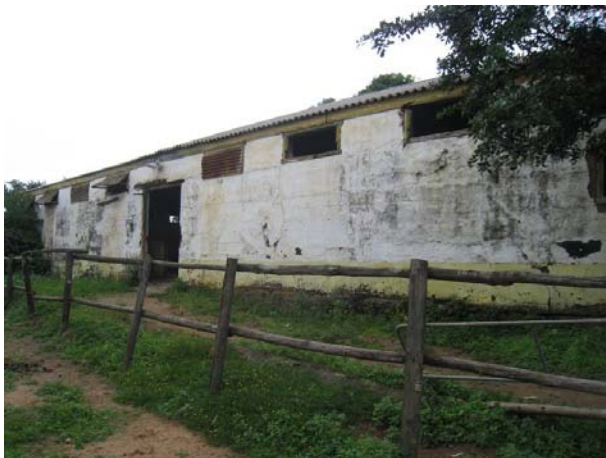
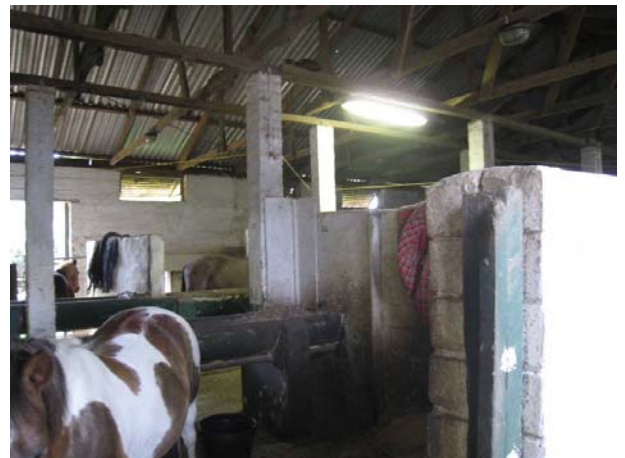
This is a large barn which houses a number of loose boxes. It is constructed out of mixed materials, largely masonry, with a corrugated sheeting double pitched roof. It has had many accretions over the years, which make it a ramshackle arrangement of space. It has additions to the south east and high level clerestory windows to the north- west.

Summary: *This building has elements of structures much older than at face value, and it is suspected that these elements formed the kernel of the structure evident in the 1953 aerial photograph. It is much altered. However, albeit of certain picturesque value, it has few features which grant it cogent merit. It is recommended that demolition be allowed.*

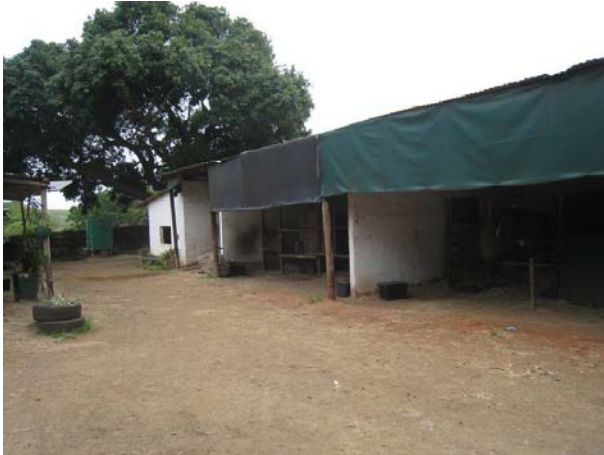
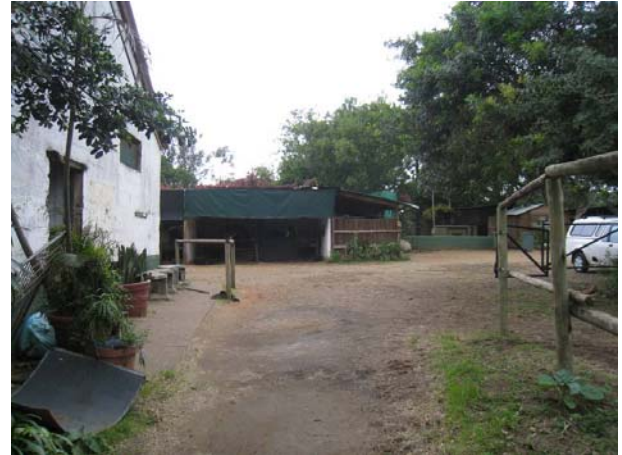
This building is another utilitarian structure of recent construction, of mixed materials. It has no value on any level.

Summary: *This building is of recent construction and has no heritage value. It is recommended that demolition be allowed.*

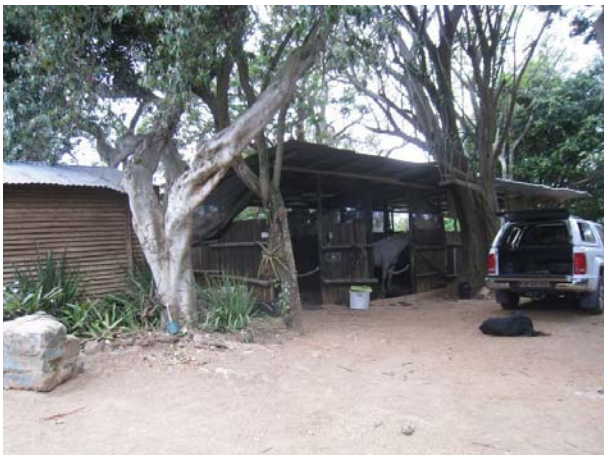
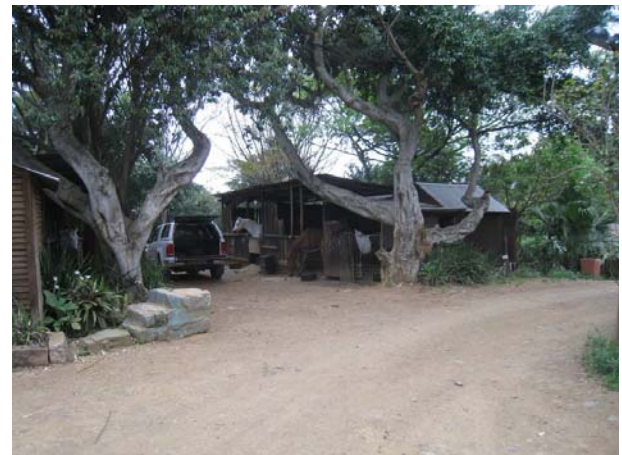
Figs 33 and 34: Building 3

These structures are prefabricated timber loose – boxes. They are insubstantial, ramshackle, of recent construction, and have no heritage or architectural value.

Summary: *This building is of recent construction and has no architectural or heritage value. It is recommended that demolition be allowed.*

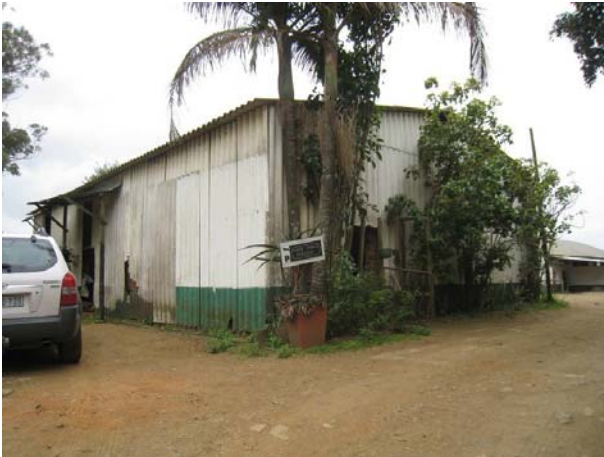
This is a wood – and – iron barn that is most likely over 60 years old, and dating back to the period of the Tongaat mules. It is not in good condition, and has very limited value in recycling.

Fig 35: Building 4, wood and iron barn

Summary: *This building is most likely over 60 years old, but is not in good condition, and has limited possibilities for recycling. It is recommended that demolition be allowed.*

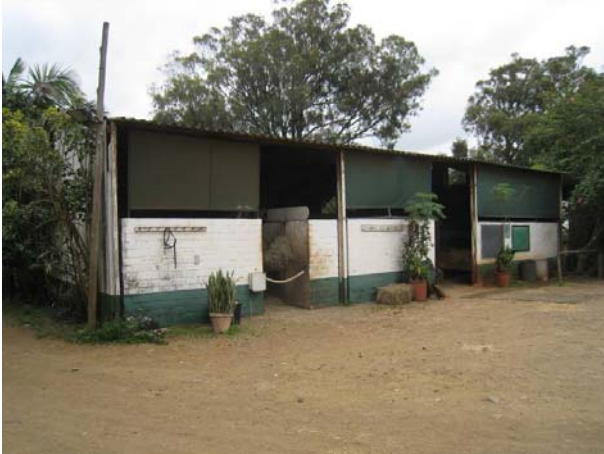
Fig 36: Stables

This building is of brick and mortar, with a corrugated sheeting mono-pitch roof. It also serves as stables. It has little architectural or historical merit.

Summary: *This building is utilitarian, of more recent construction, and has little heritage value. It is recommended that demolition be allowed.*

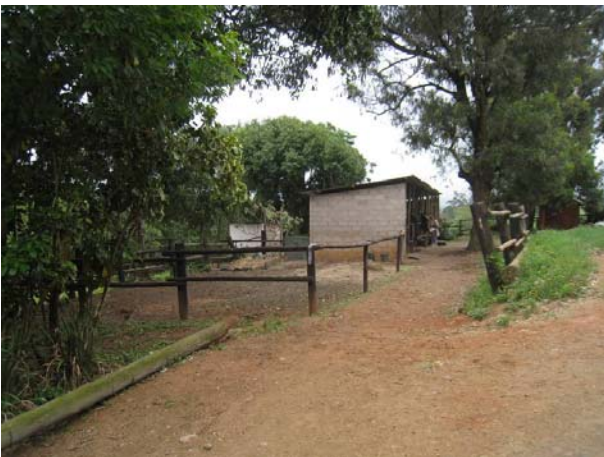
Fig 37: Loose boxes

This building is of block with a corrugated iron mono - pitch roof. It also serves as loose boxes.

Summary: *This building is of recent construction and has no architectural or heritage value. It is recommended that demolition be allowed.*

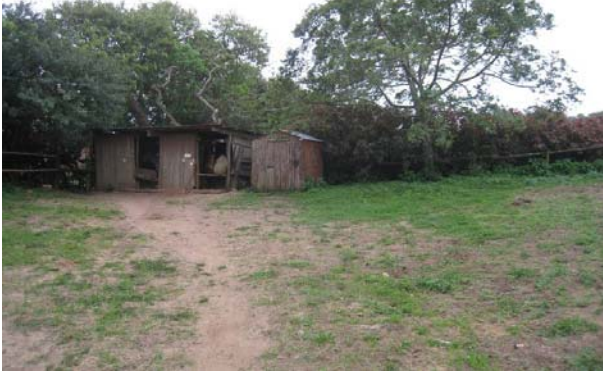
Fig 38: Loose boxes

This building is a ramshackle timber structure to the west of the main barn.

Summary: *This building is of recent construction and has no architectural or heritage value. It is recommended that demolition be allowed.*

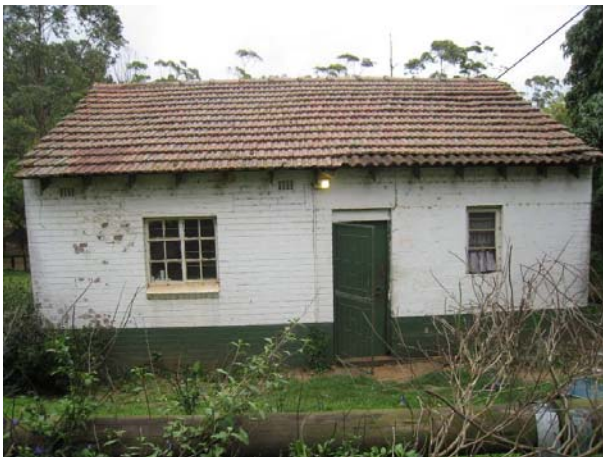
Fig 39: Labour quarters

This building is most likely over 60 years old: it has mixed header and stretcher courses, and a simple Marseilles tiled roof.

Summary: *This building is of picturesque value and few features which grant it cogent merit. It is recommended that demolition be allowed.*

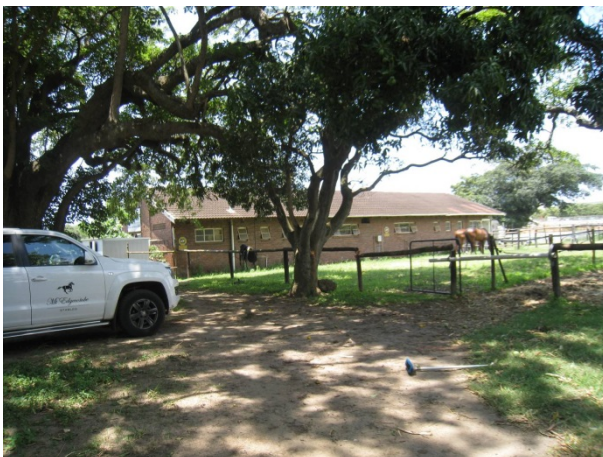
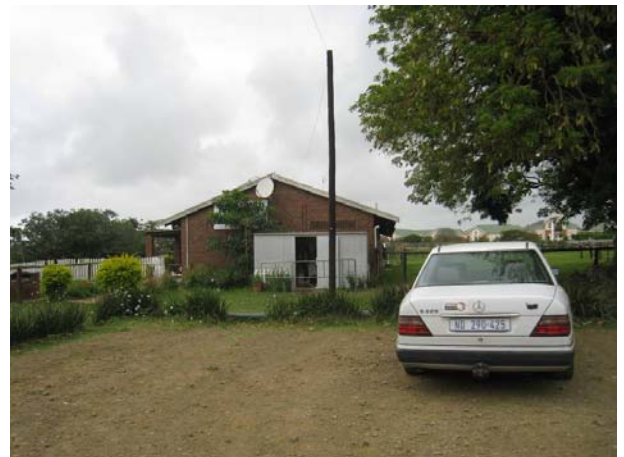
This is a long building comprising a tack shop and stables. It is of contemporary construction of face-brick under a double pitched roof.

Summary: This building is of recent construction and has no architectural or heritage value. It is recommended that demolition be allowed.

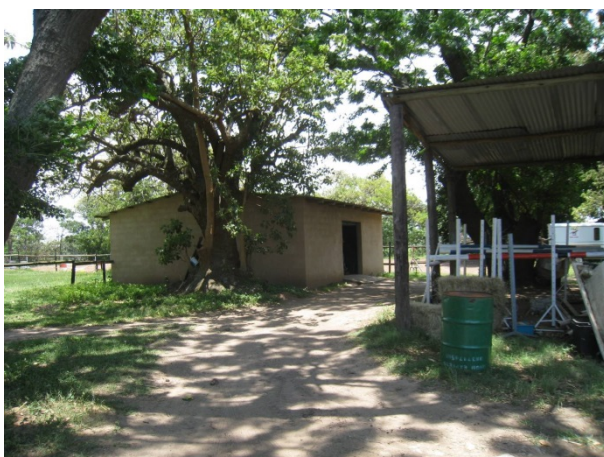
Fig 43: Building 2 from the south

Building 2 is a nondescript structure of plastered block with a double pitched corrugated sheeting roof.

Summary: *This building is of recent construction and has no architectural or heritage value. It is recommended that demolition be allowed.*
