**SUMMARY OF THE HERITAGE SITES DAMAGED ALONG  
THE TRANSNET NMPP**

**FOR KZN HERITAGE AND TRANSNET**

**DATE: 9 JULY 2010**

**Umlando: Archaeological Tourism and Resource  
Management**

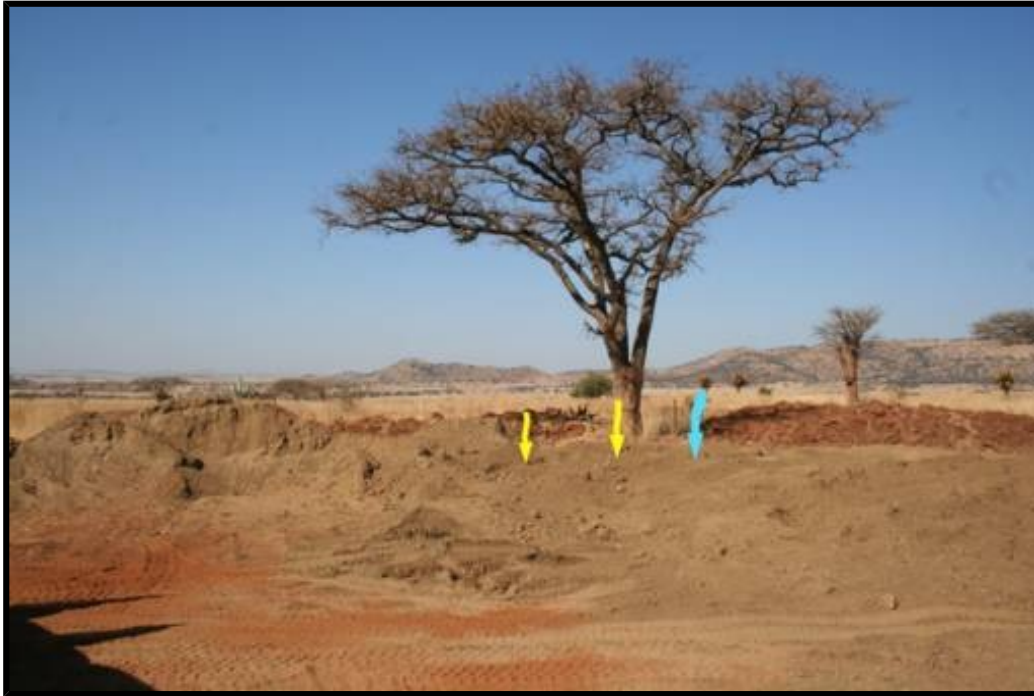
FIGURE 6: FEATURE 75 AT GLK066\_75 AFTER 2ND ROW CLEARANCE<sup>4</sup>

**Assessment of Damage:** The initial assessment suggested that the entire stone wall had been removed by RoW clearance and then topsoil was deposited on top of the site (fig. 6). The stone wall was originally ~10cm – 20cm above ground level and with a similar depth. The southern part of the kraal still exists and was used as a comparison.

<sup>4</sup> Yellow arrows indicate probably location of grave, blue arrow indicates location of the kraal.

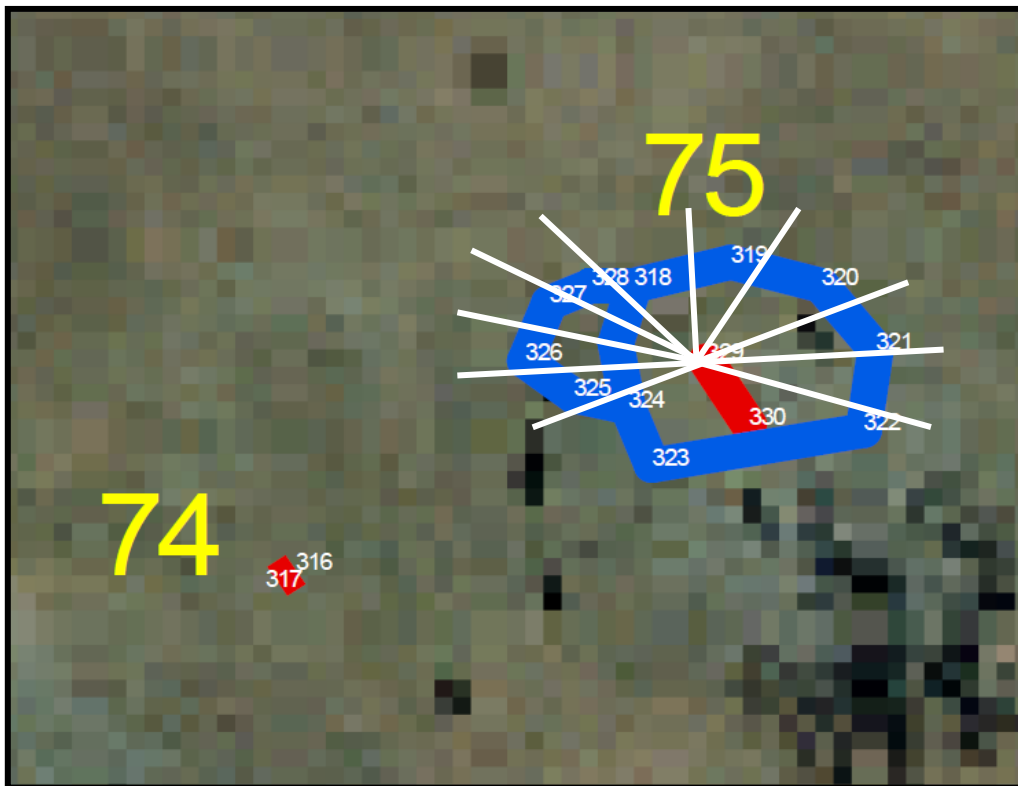
FIG. 7: EXCAVATION LINES AT GLK066\_75

I placed several excavation lines in a wheel spoke alignment from the middle of the kraal, for the assessment (fig. 7 - 8). The excavations used the site map (fig. 5) to determine where the walling would occur. The excavations went down to the original surface – visible by the layer of grass. If the stone wall existed, then the excavation lines would locate an *in situ* wall. If no walling was observed, then it implies that it has been removed by the RoW clearance.

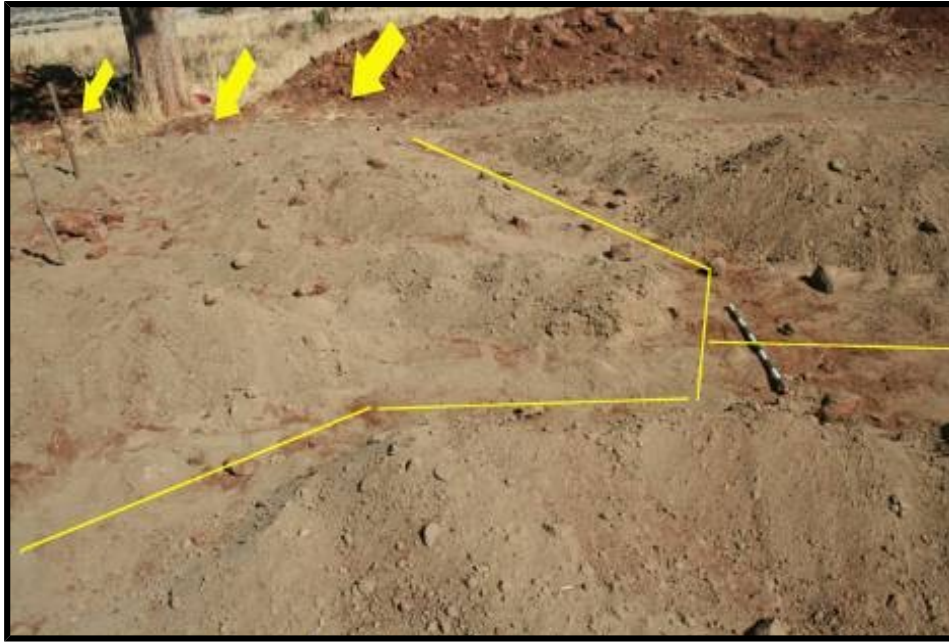
**FIG. 8a: EXCAVATION AT GLK066\_75<sup>5</sup>**

The excavations located parts of the primary wall. These remains were the basal stone layer. Most of the secondary wall has been cleared and I only located isolated stones. It appears that at least 75% of the site has been damaged in some manner. Figure 8b shows parts of the undamaged wall.

<sup>5</sup> Yellow line = location of stone wall; yellow arrow = undamaged stone wall

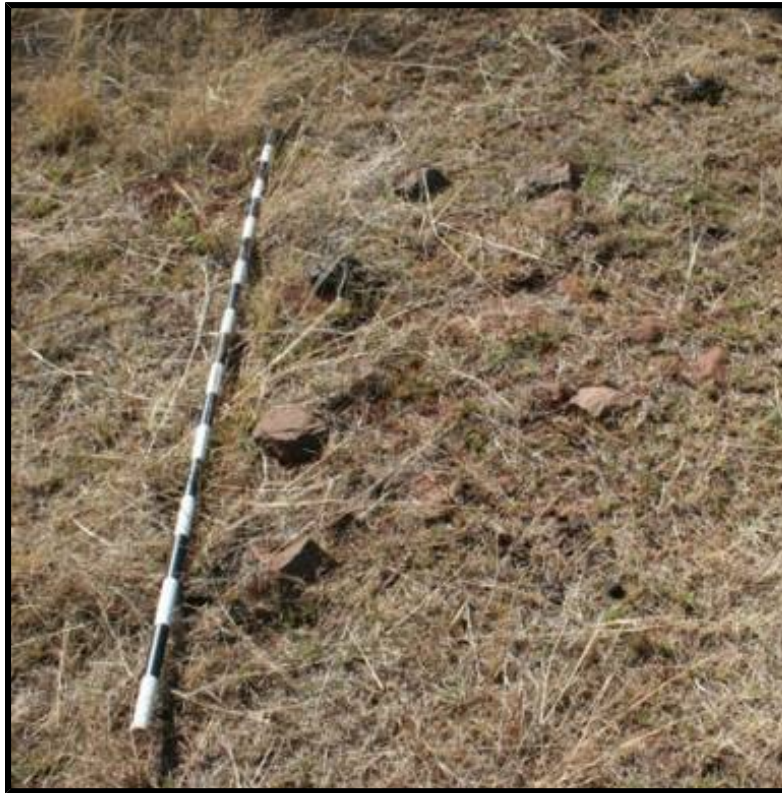
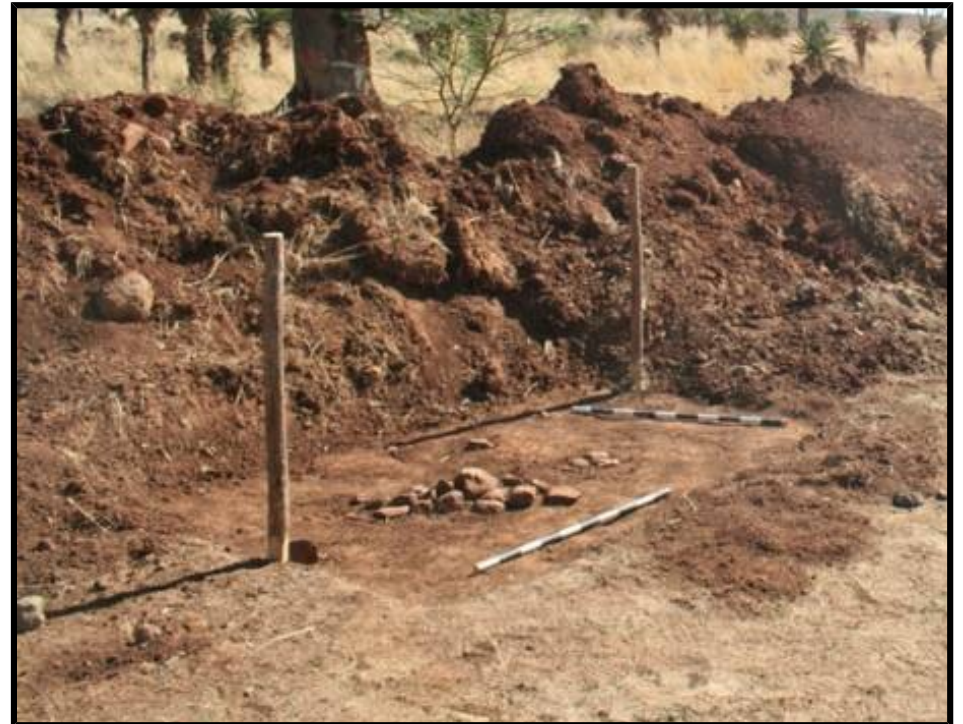
**FIG. 9: BEFORE AND AFTER PHOTOGRAPHS OF GRAVE AT GLK066\_74<sup>6</sup>**

The cairn at GLK066\_74 has been mostly removed and only a few *in situ* rocks remain. The cairn at GLK066\_75 has been partially affected, and minimally damaged.

<sup>6</sup> Note the change in the size of the stone cairn

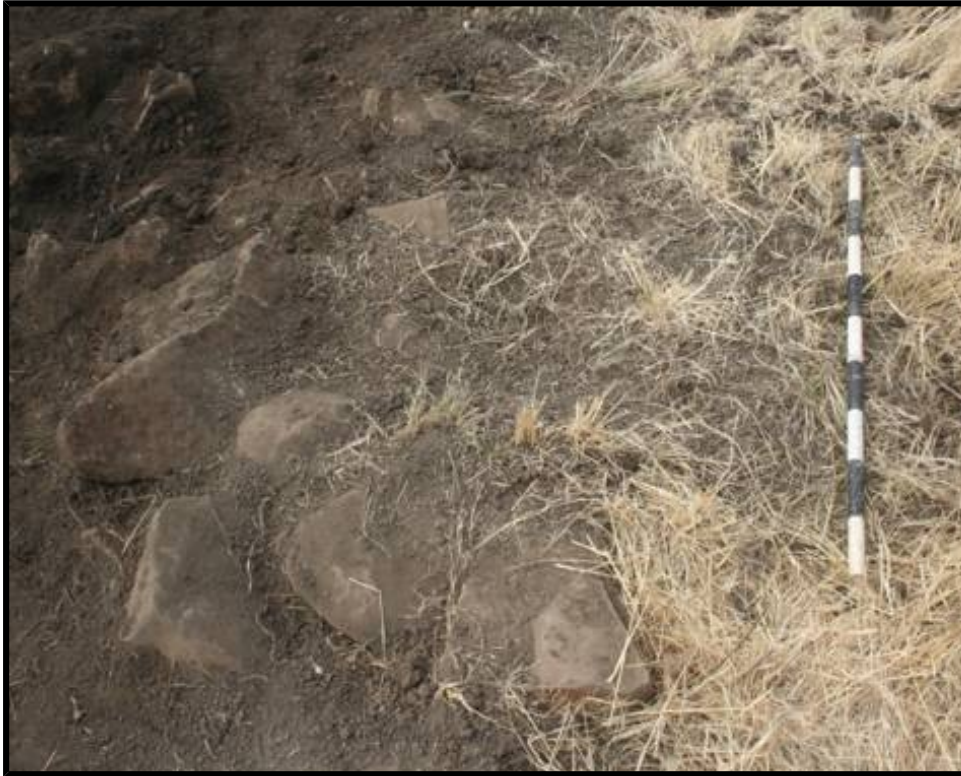
**FIG. 13: GLK118\_96 GRAVE AFTER CLEANING**

**Assessment of Damage:** The graves were technically not damaged and have been cleaned. The associated walling was also cleaned. There was however an infringement on the site and this forms part of the pattern of demarcated heritage sites being ignored by the contractor.

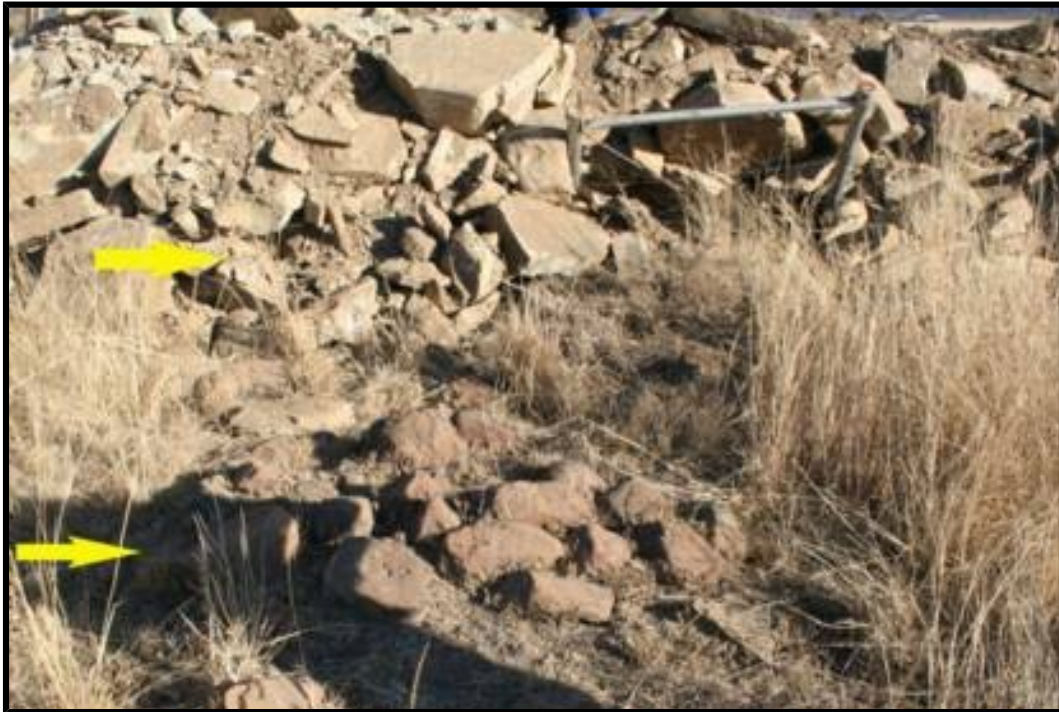
**FIG. 15: STOCK PILE OF ROCKS OVER ONE GRAVE AT GLK118A<sup>7</sup>**

**Assessment of Damage:** The graves were technically not damaged and have been cleaned. The associated walling was also cleaned. There was however an infringement on the site and this forms part of the pattern of demarcated heritage sites being ignored by the contractor.

<sup>7</sup> Top arrow indicates the covered grave

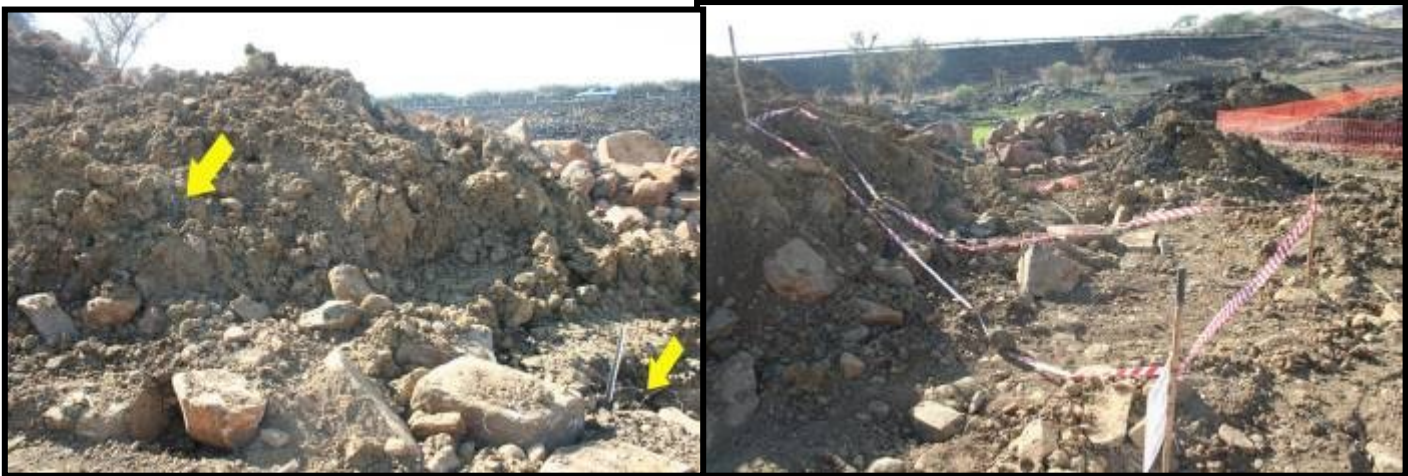
**FIG. 21: STOCKPILE OVER DEMARCATED FENCING**

The grave has been affected in several ways. The fenced off area has been ignored and damaged. The stone cairns are missing due to trenching spoil material being placed on top of it (fig. 21). Site instructions were given for the grave to be covered with protective material during blasting activity; however, I am not sure if this was undertaken. All work activity in the area of the grave had to cease until further notice as from June and a site directive for this was given from Transnet. This meant that the pipe could not be placed into the trench, nor could any backfilling occur.

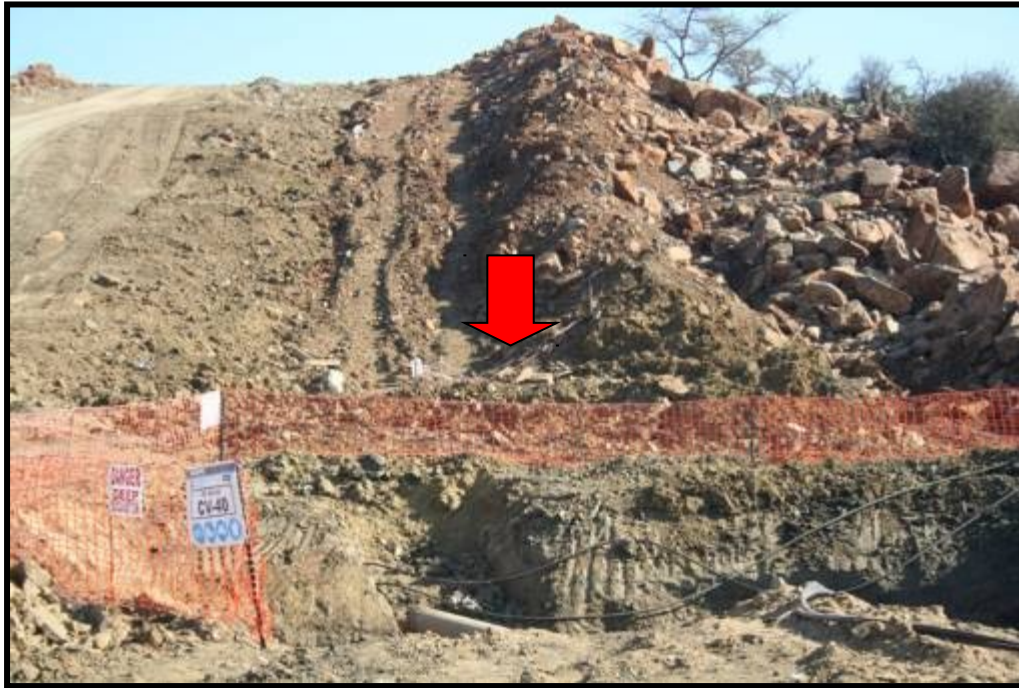
**FIG. 22: BACKFILLING AFTER THE AREA HAD BEEN CLOSED<sup>8</sup>**

**Occurrence of damage:** During trenching and later when the trench was backfilled.

<sup>8</sup> Red arrow indicate the location of the possible grave.

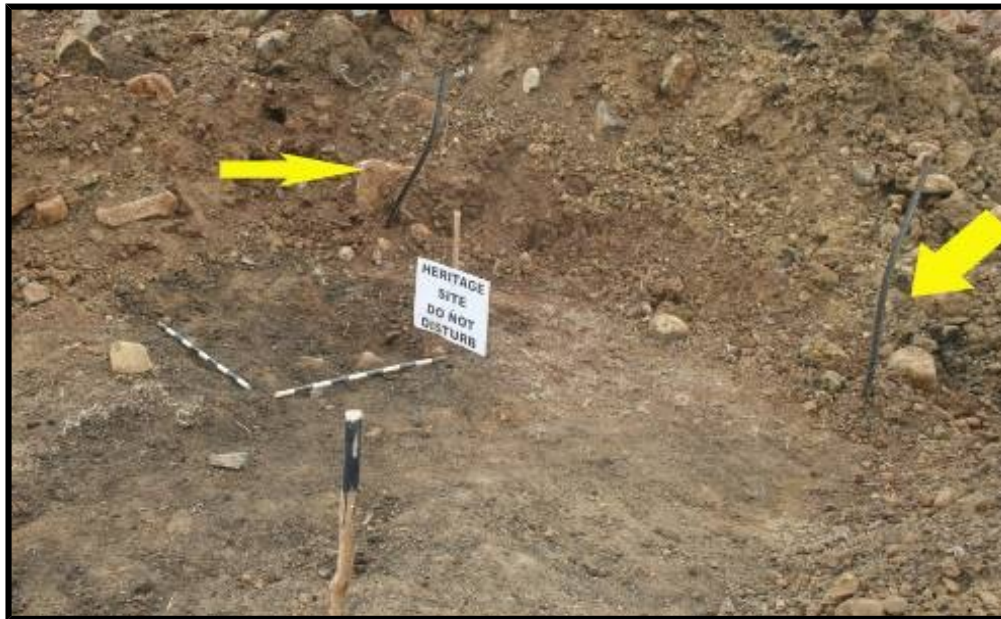
**FIG. 23: POSSIBLE GRAVE IS EXPOSED<sup>9</sup>**

The poles demarcating the outer edges of the grave have been removed by the trenching team. The demarcated area was cleaned of the stockpile and the original cairns were exposed (fig. 23). Some of the rocks are missing. I placed some stones to indicate the position of the possible grave (fig. 24).

<sup>9</sup> Yellow arrows indicate the original fencing poles

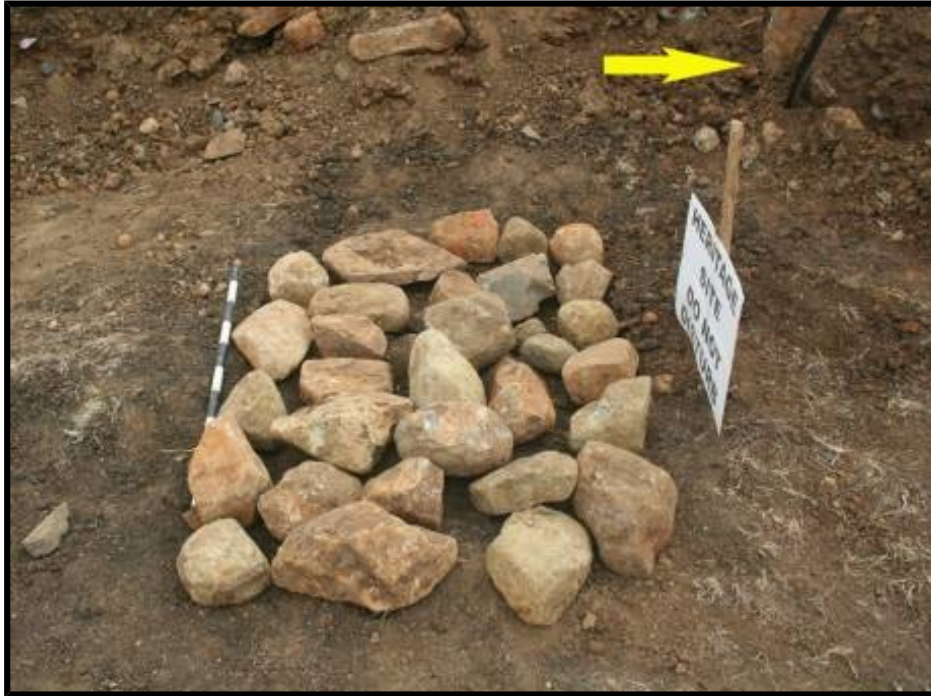
**FIG. 24: POSSIBLE GRAVE WITH STONES DEMARACTING THE AREA**

**Assessment of Damage:** The area was cleaned and the outline of the possible grave was demarcated. A few of the rocks from the cairn are missing.

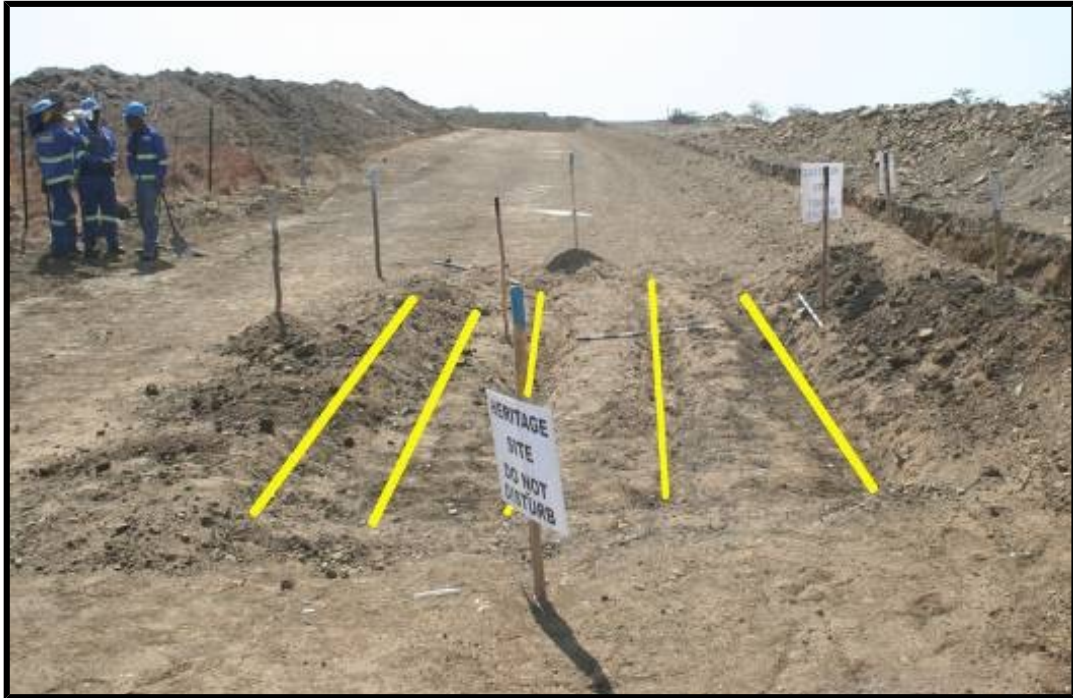
**FIGURE 28: POLES INDICATING THE EXTENT OF THE GRAVE AND THE  
EXCAVATION TRENCHES**

**Assessment of Damage:** The entire cairn has been removed and presumably the grave itself.

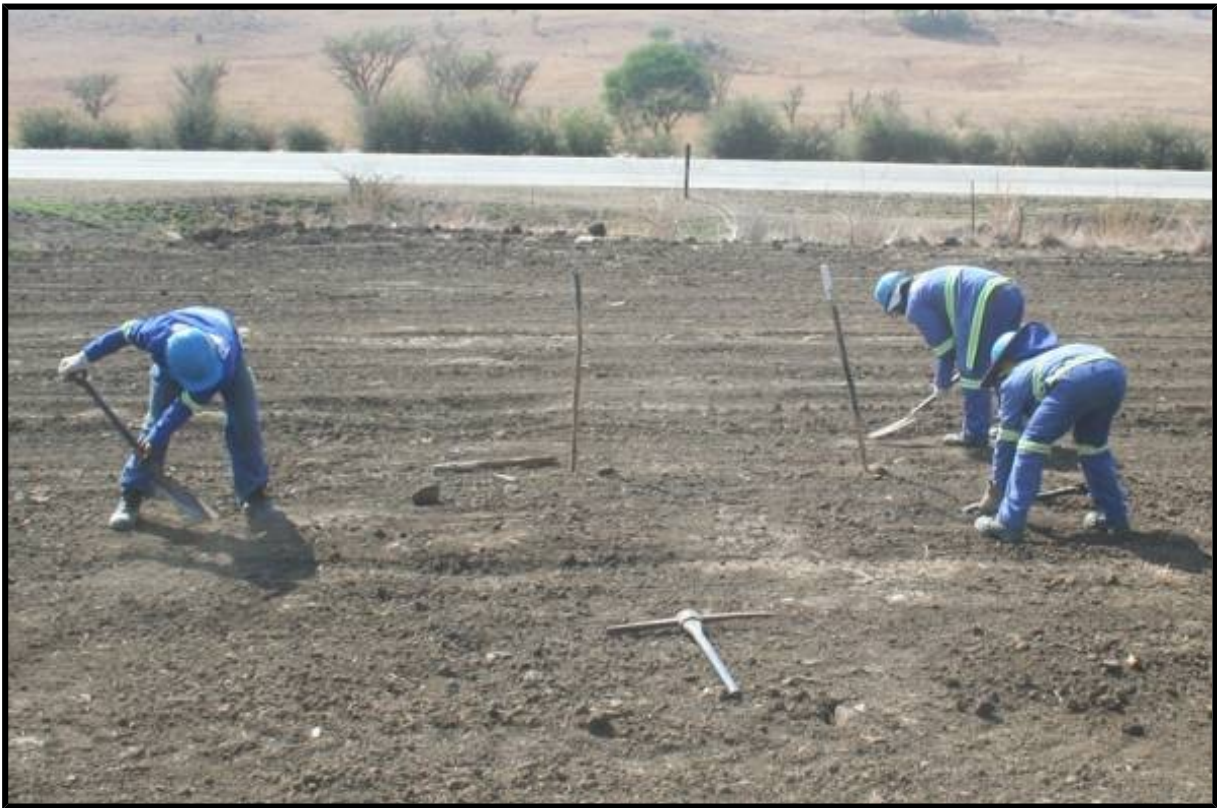
**FIGURE 31: CLEARED AREA WHERE THE GRAVE OCCURRED**

The stone cairns are missing due to additional construction activity. The excavations could not locate any concentration of stones, although two possible areas were noted (fig. 32). I believe that these two possible areas are the result of natural rock formations and not the graves. The area was fenced off after the excavations. The grave ~50m uphill was not damaged.

**Significance of site:** The site is of high significance  
**Significance of impact:** High negative  
**Previous mitigation:** Area was fenced off.  
**Occurrence of damage:** After RoW clearance.  
**Assessment of Damage:** The entire cairn has been removed and presumably the grave itself.

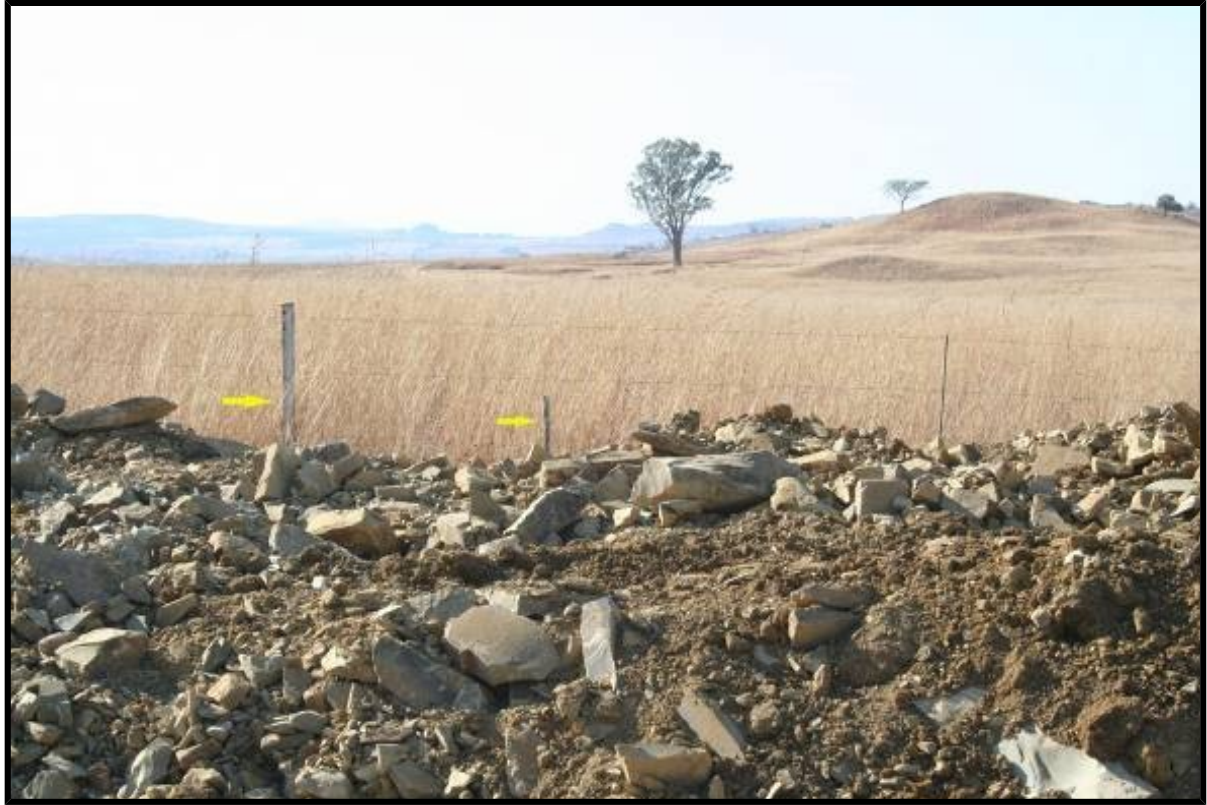
**FIGURE 37: TRENCHING SPOIL OVER GRAVES AT GLK063A GRAVE 16A**

**Assessment of Damage:** The graves are technically not damaged and they have been cleaned. There was however an infringement on the site and this forms part of the pattern of demarcated heritage sites being ignored by the contractor. The living descendents may claim that the ancestral spirit needs to be appeased.

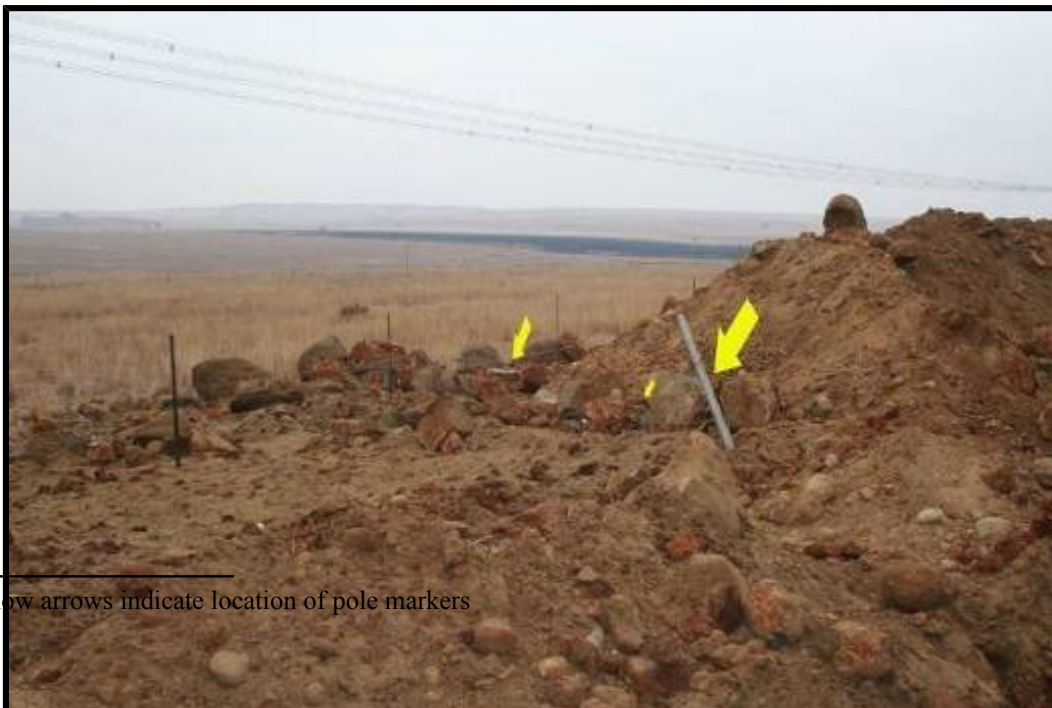
**FIGURE 7: ENGRAVINGS UNDER BLASTING AND TRENCH SPOIL AT GLK078  
ENGRAVINGS 20<sup>13</sup>**

Comment: There has been a disregard for site instructions regarding blasting in this area, as well as by the trenching team.

<sup>13</sup> Yellow arrows indicate location of pole markers

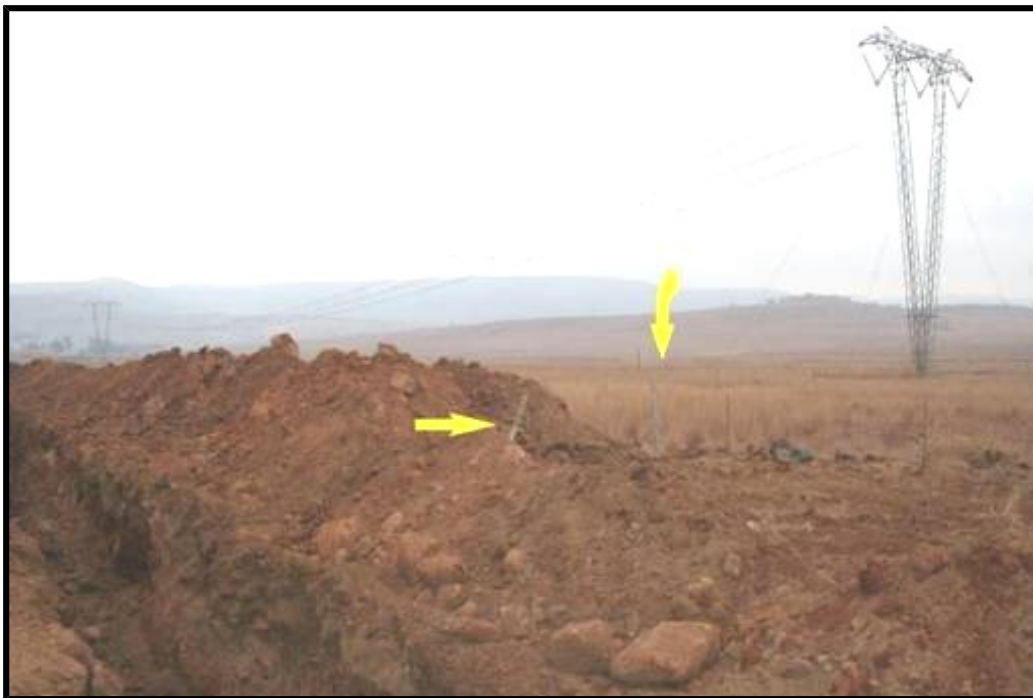
**FIGURE 8: ENGRAVINGS UNDER BLASTING AND TRENCH SPOIL AT GLK078 ENGRAVINGS 615<sup>14</sup>**

Comment: There has been a disregard for site instructions regarding blasting in this area, as well as by the trenching team.

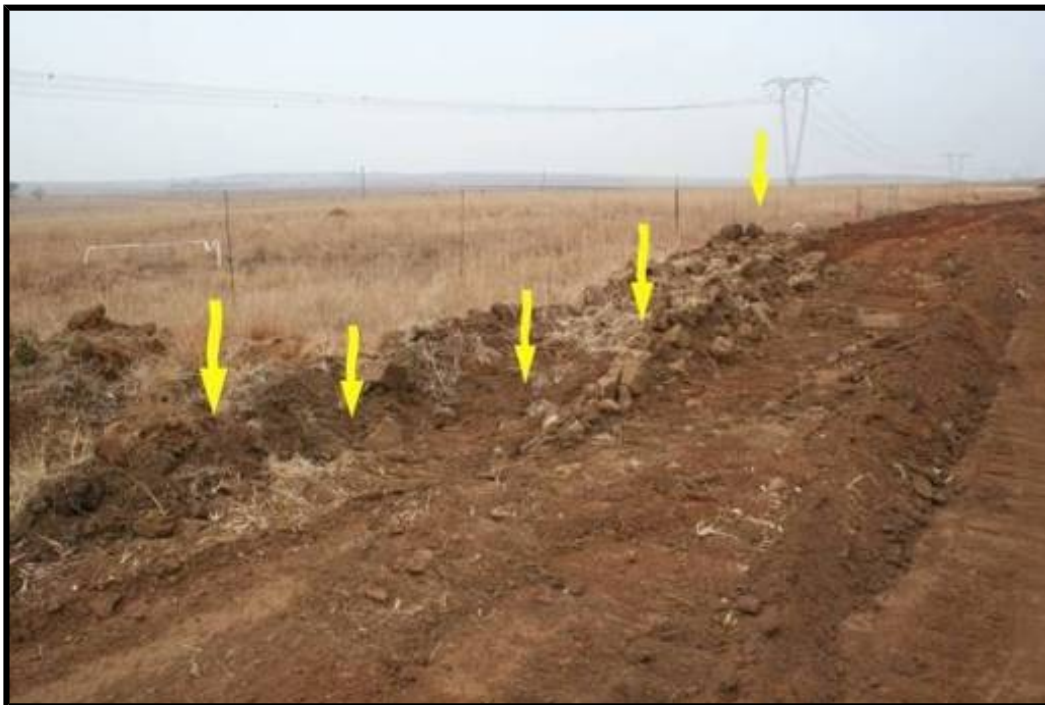
**FIGURE 9: DAMAGED KRAAL AT GLK078<sup>15</sup>**

The kraal wall has been slightly damaged by excavator driving over it (fig. 9).

Comment: The tracks over and through the edge of the kraal occurred within one week of our site visit.

<sup>15</sup> Yellow arrows indicate the damaged area of the kraal.

Proposed mitigation: Rocks related to the kraal need to be replaced by HIA.

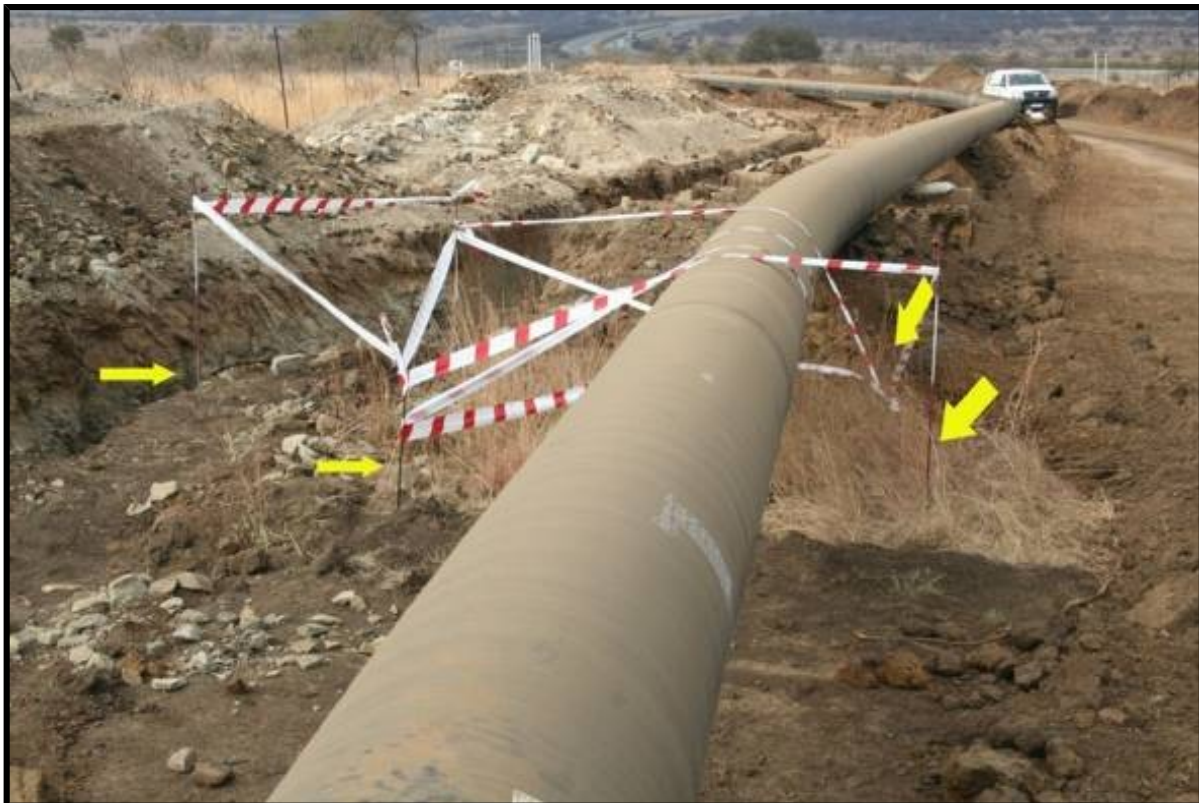
**FIGURE 11: EXAMPLE OF LOW NEGATIVE IMPACT**

Several grave sites have had low negative impacts. These consist of the pipeline being placed above the grave. The impact is thus not on the grave itself but on the heritage zone (fig. 12). All of these sites have been noted and no work may occur near the site unless an ECO or HIA is on site to monitor. The graves may not be affected in any manner. Instructions for the fencing of two graves were given; however, this was not followed through.
