Evaluation of existing built structures on:

Portion 662 of the Farm Olievenhoutpoort 196 IQ

Johannesburg, Gauteng

EVALUATION OF STRUCTURES

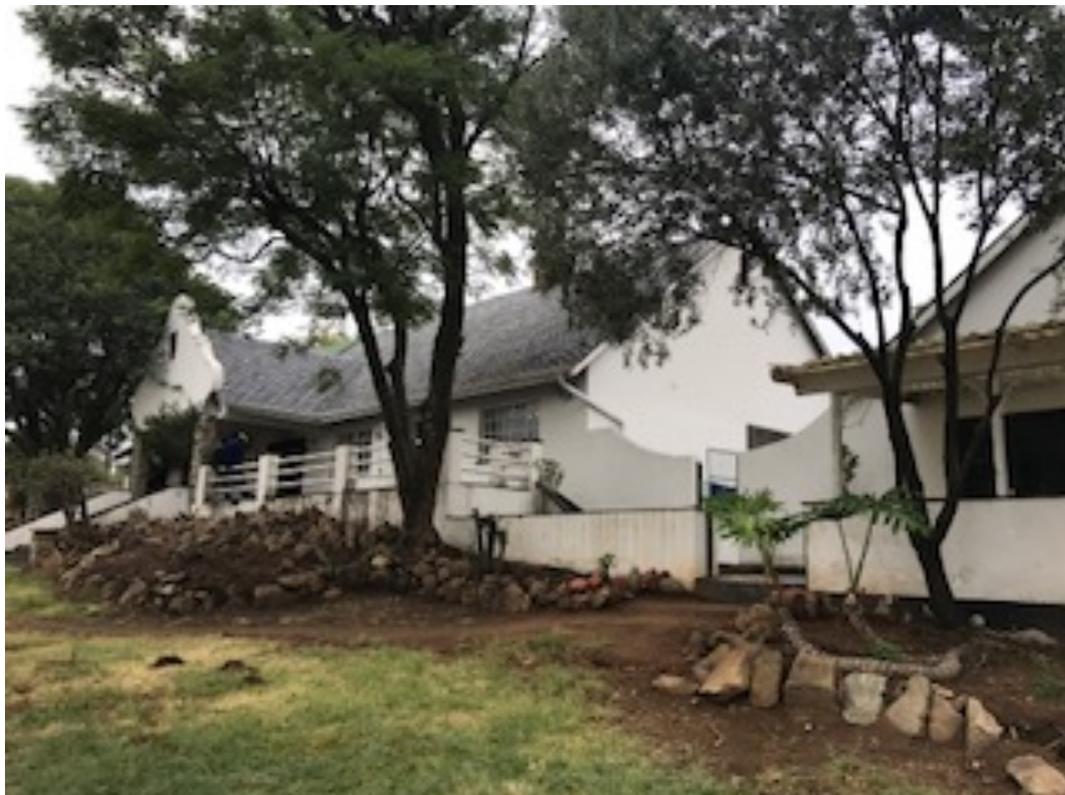
figure 4: entrance view of two adjacent residential buildings; gable over main entrance visible; photo by author

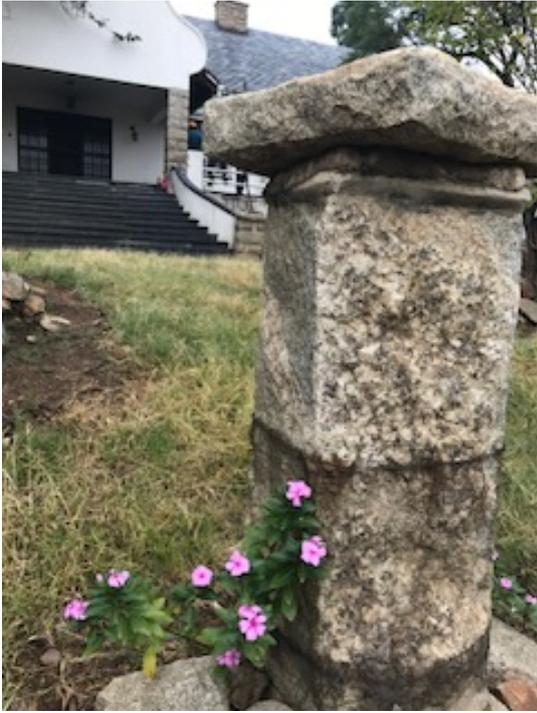
figure 5: granite type stone feature on centre line axis to main entrance; photo by author

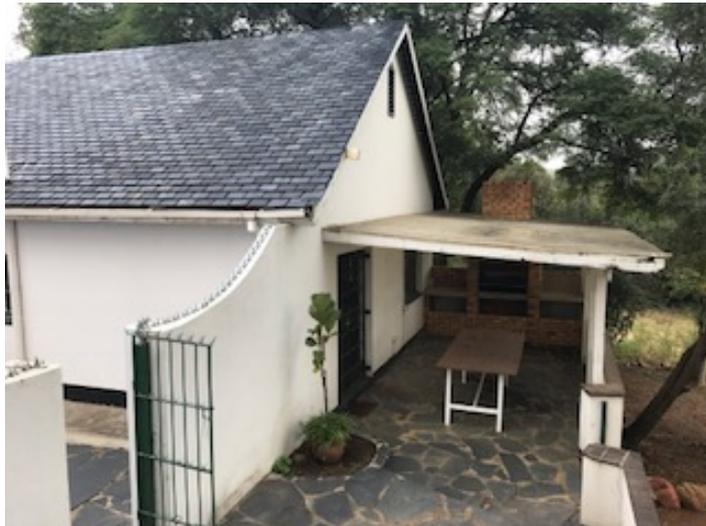
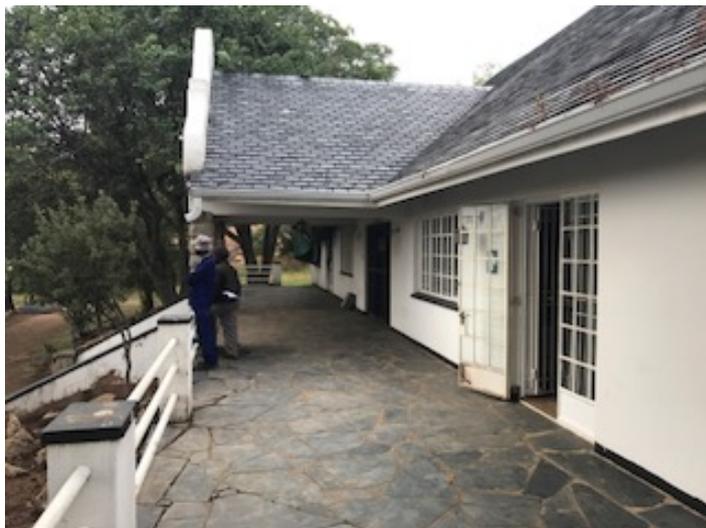
figure 6 & 7: views of main residence displaying slate tiled roofs and external area; steel windows and doors with cottage pane; slate finishes to balustrade walls and pillars as well as slate window sills; photo by author

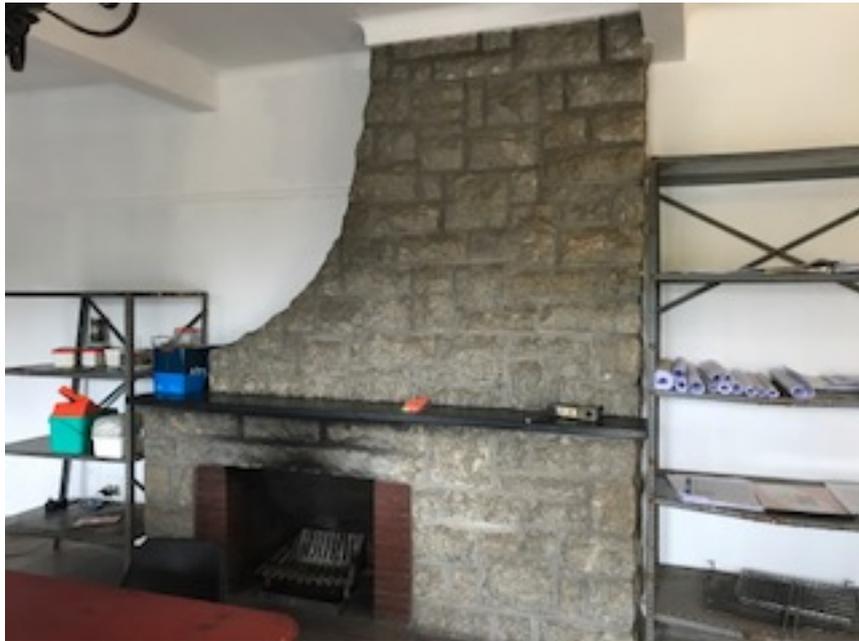
The style and format of the fire place feature (figure 8) is “rectangular dressed, random built in ashlar”.

figure 8: internal fire place of granite type stone, photo by author

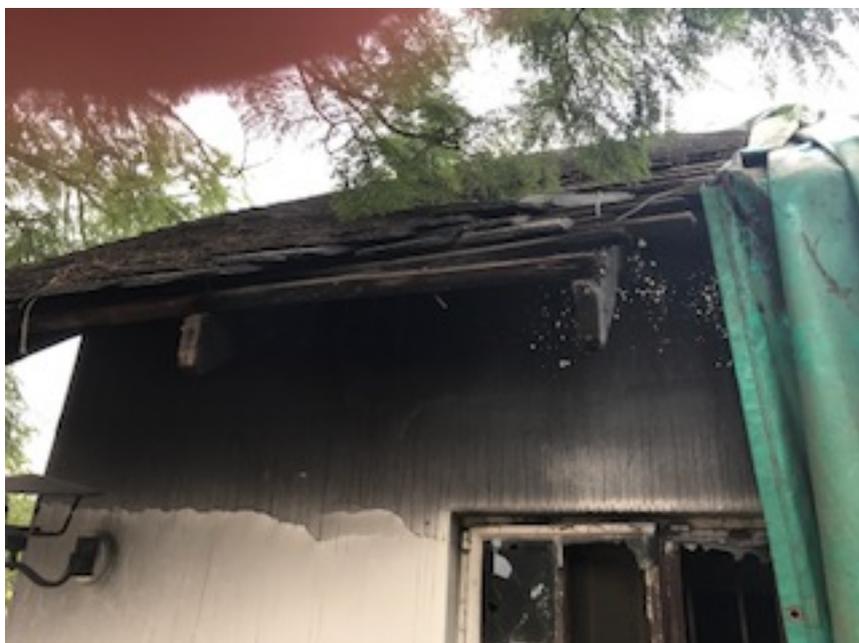
figure 9: ruin of part of main residence that displays evidence of fire damage, photo by author

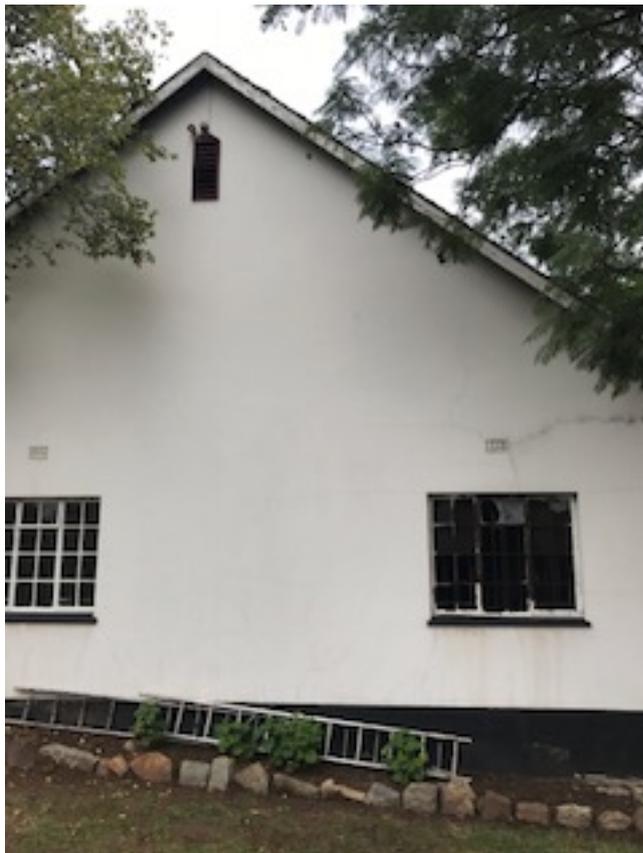
figure109: gable façade of main residence showing dark face brick plinth, arched gable ventilation opening and fixture, ventilation blocks from the 20th century and fire damage, photo by author

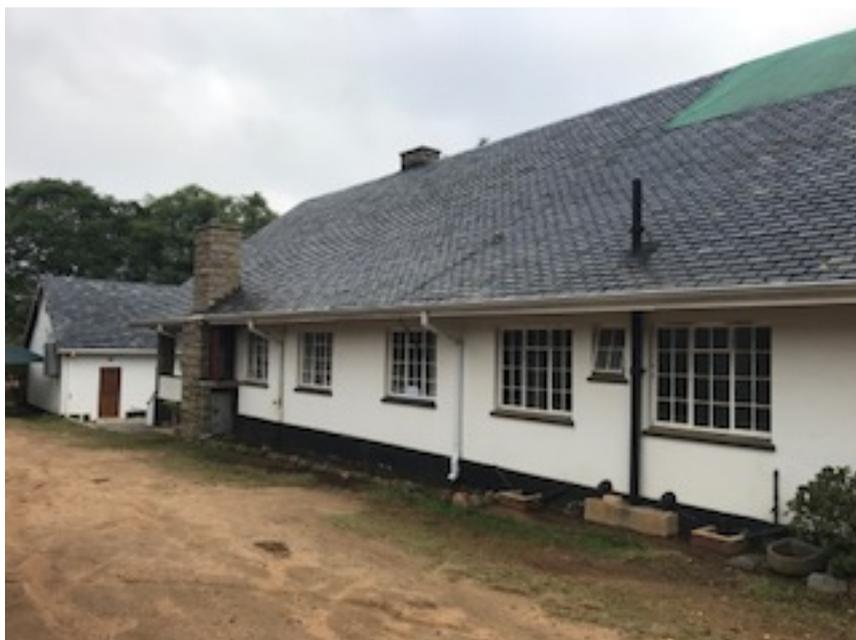
figure 11: façade of main residence with chimneys of granite type stone, photo by author

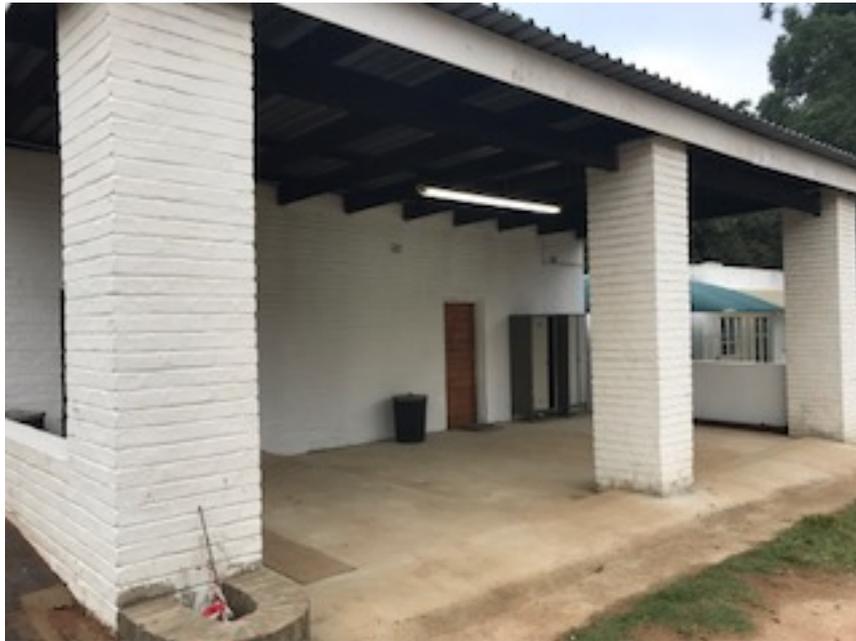
figure 12: service structure adjacent to the main residence, photo by author

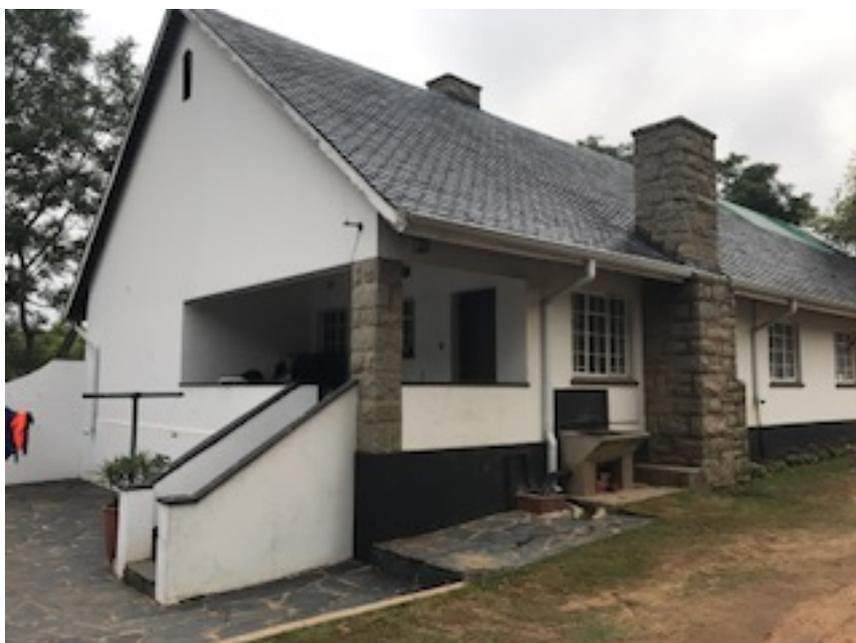
The style of the house and stone feature ensemble, as displayed on figure 13, is deemed to date from around circa 1950 to circa 1960.

figure 13: side view of main residence onto washing yard, with stone features, photo by author

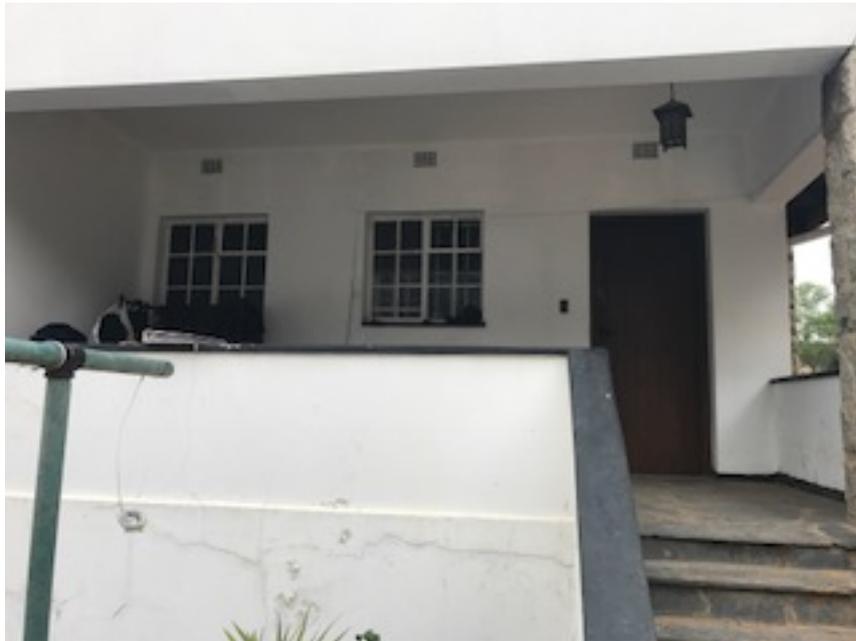
figure 14: side view of main residence onto washing yard, with stone features, photo by author

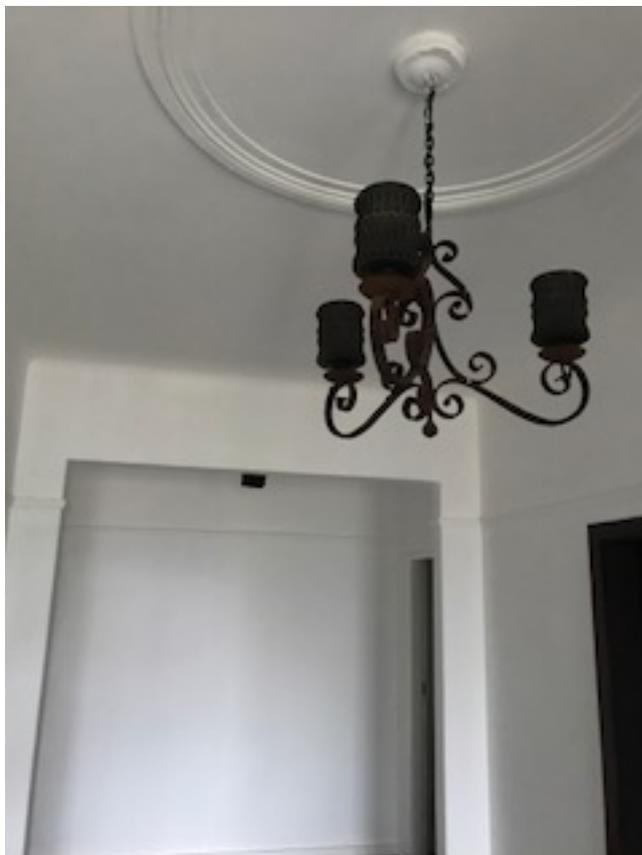
figure 15: internal view of wrought iron light fitting, ceiling feature and picture rails along internal walls, photo by author

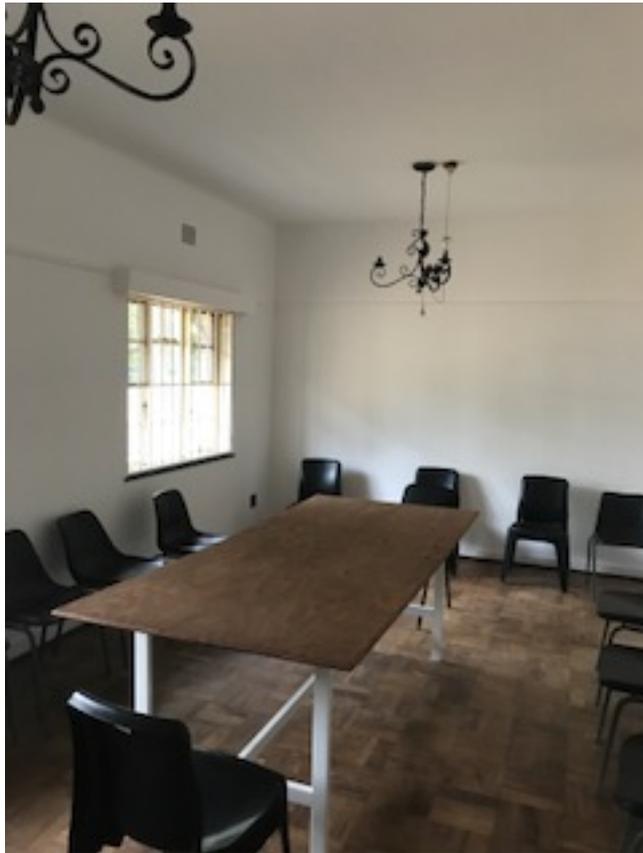
figure 16: internal view of wrought iron light fitting, parquet flooring, timber pelmets and picture rails along internal walls, photo by author

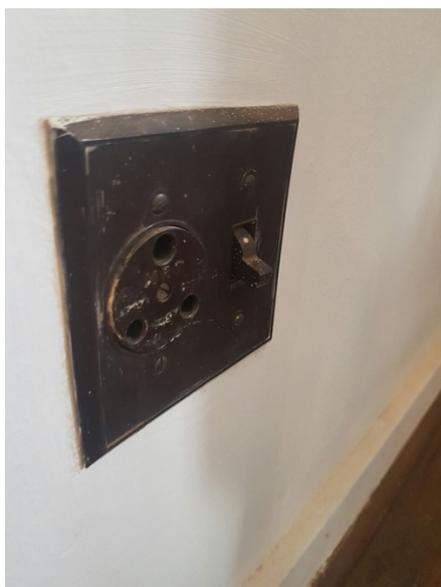
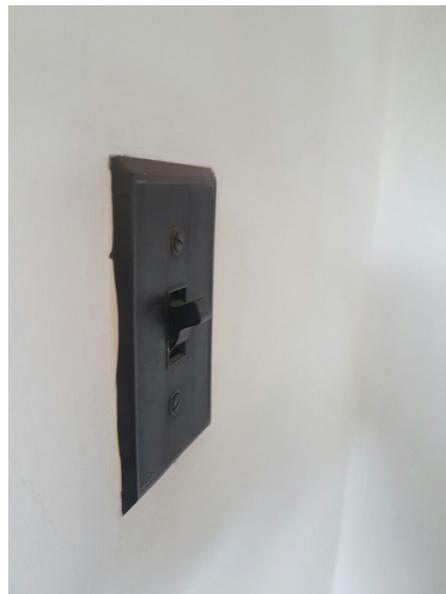
Bakelite light switches and plug covers (figures 17 a & b) occur throughout the house and are deemed to date from the early 1940’s to the early 1960’s.

figure 17 a & b: original plugs and light switches are bakelite, dating from approximately circa 1940's-1950's, photo by author

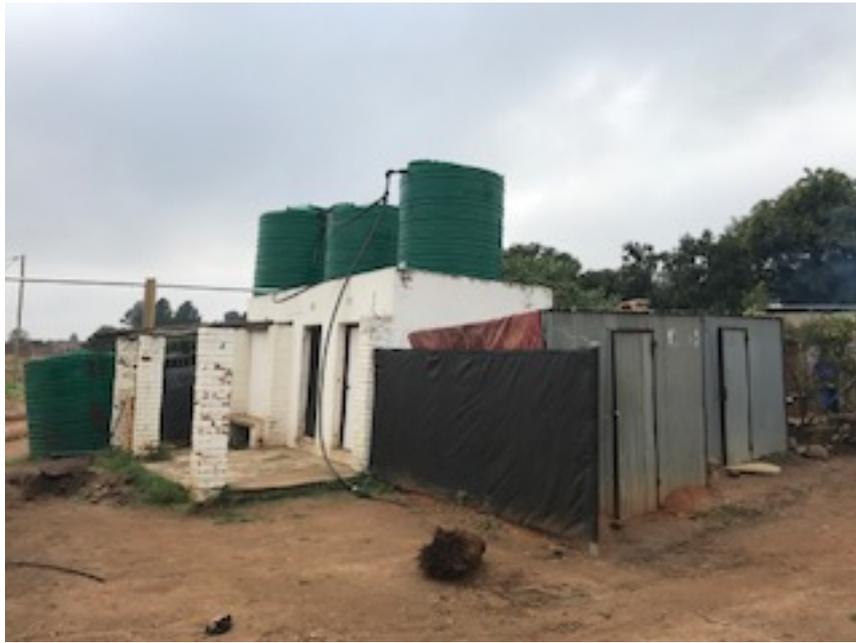
figure 18: service quarters with remnants of shaded 'stoep' area, photo by author

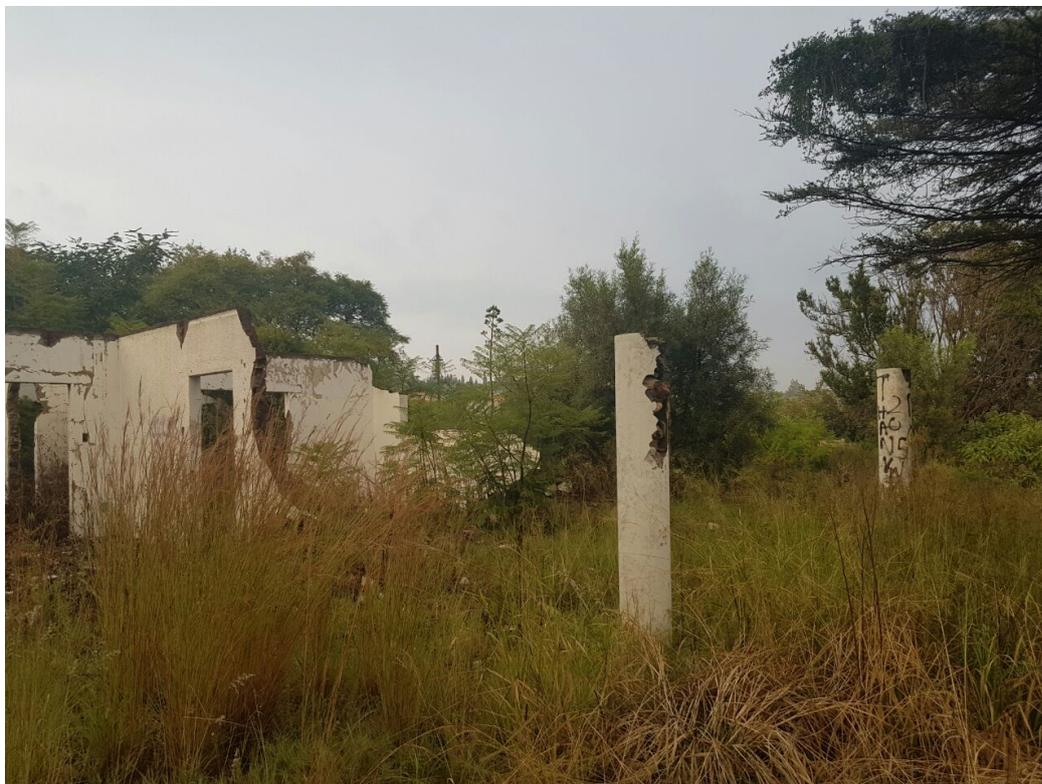
Along the northern boundary of the site, building ruins were recorded which are unidentifiable in terms of age and architectural style, due to deterioration.

figure 19: ruins of unidentifiable structures adjacent to the site boundary, photo by author

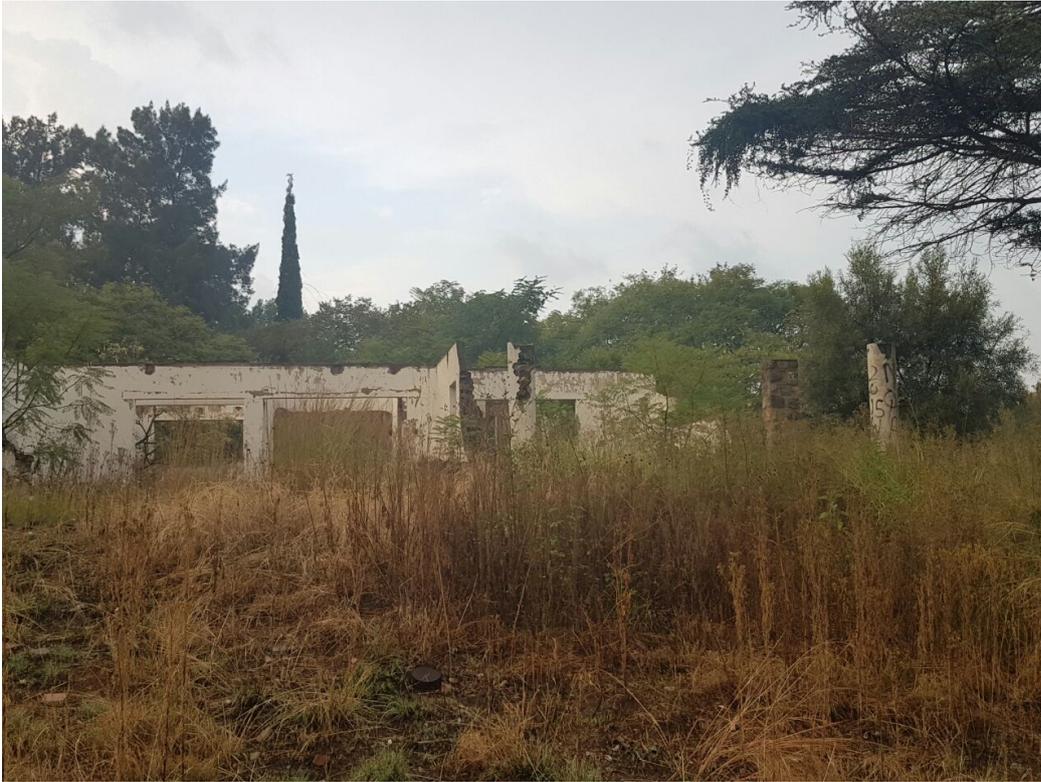
figure 20: ruins of unidentifiable structures adjacent to the site boundary, photo by author
