**Re – inspection and review of the farmstead situated on  
Portion 1 of the farm Bellevue 15321, Pietermaritzburg**

**archaic consulting**

# Re – inspection and review of the farmstead situated on Portion 1 of the farm Bellevue 15321, Pietermaritzburg

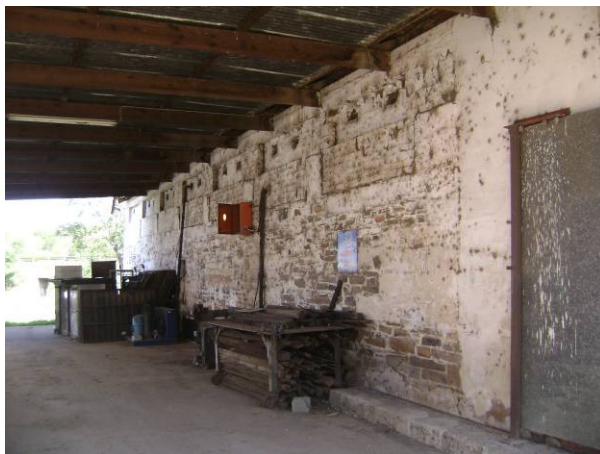
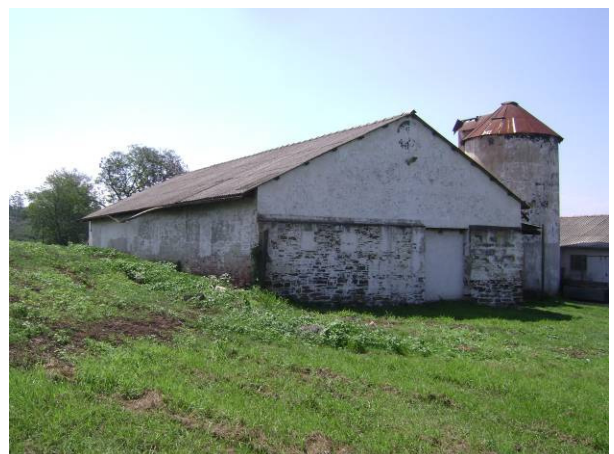
**Figs 3 and 4: The covered space between shale barns and Barn no 1 with a silo behind**

***RECOMMENDATIONS: Given the age and scale of the shale barns it is recommended that these structures, together with the silos be reused in the new development. Since the brick barn is likely of an age, and part of an architectural grouping, its contribution to the topophilia of the site indicates that it too, should be retained and reused.***

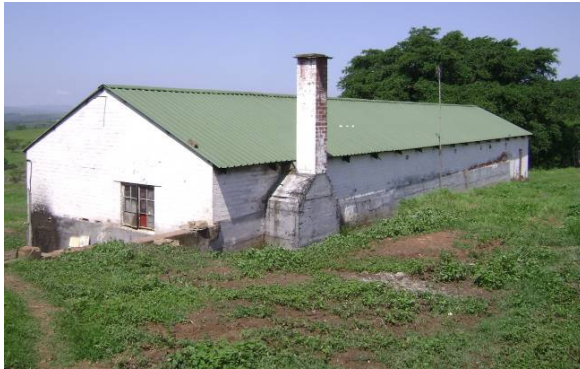
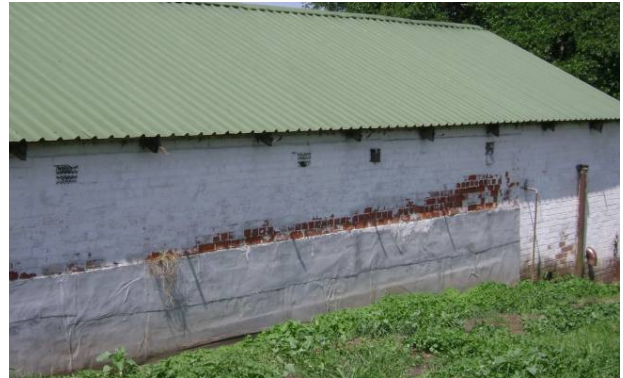
This structure is of painted brickwork in English bond under a corrugated sheeting roof. It is suspected that it dates to pre-1950. It forms part of a group together with the shale barns. It has certainly been extended to the north-west since its original construction.

Given the state of the brickwork in 2011 and its condition now, it is evident that a serious effort has to be made by the landowner in order to address the damp.

***Figs 5 and 6: Showing the old brick barn: the portion towards the trees is in English bond suggesting that this portion was pre- or immediately post- World War II.***

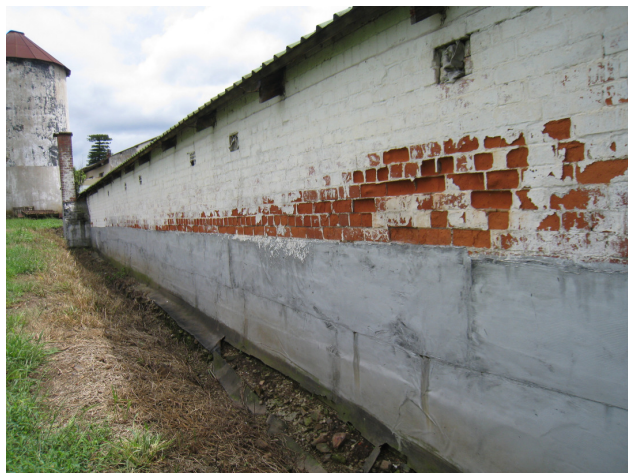
***Fig 7: Showing degraded brickwork on southern side of labour quarters***

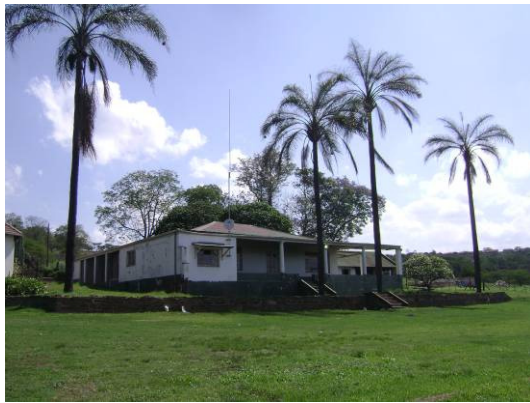
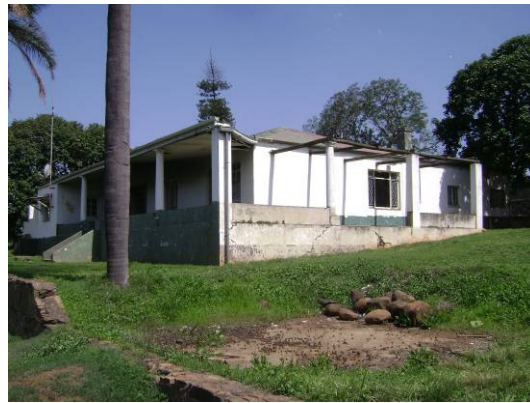
**Figs 8 and 9: The main house at Bellevue from the north-east and from the north-west**

**RECOMMENDATIONS:** *Given the dislocation from the farmstead, the lack of association with buildings of landmark, and its minimal architectural, social or historical merit, it is suggested that the demolition of this building and its ancillary structures could be considered an option.*

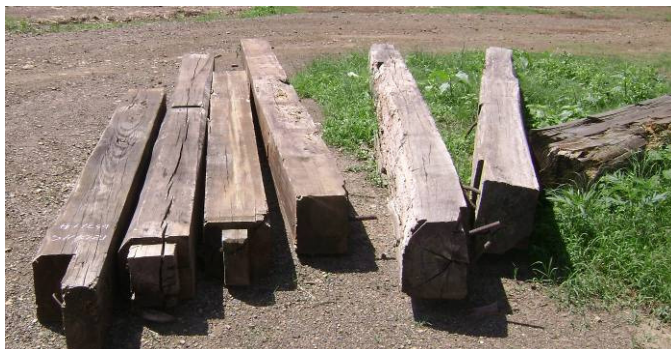
*There is a pile of substantial timber beams suspected to originate from the farmstead lying next to the barns. It is recommended that these be donated to the Amafa Materials Bank for reuse in historic structures in need.*
