Condition Report

Accession No.: JAG1994.7.13

Artist: Mancoba, Ernest Methuen

Title: Bantu Madonna/ African Madonna

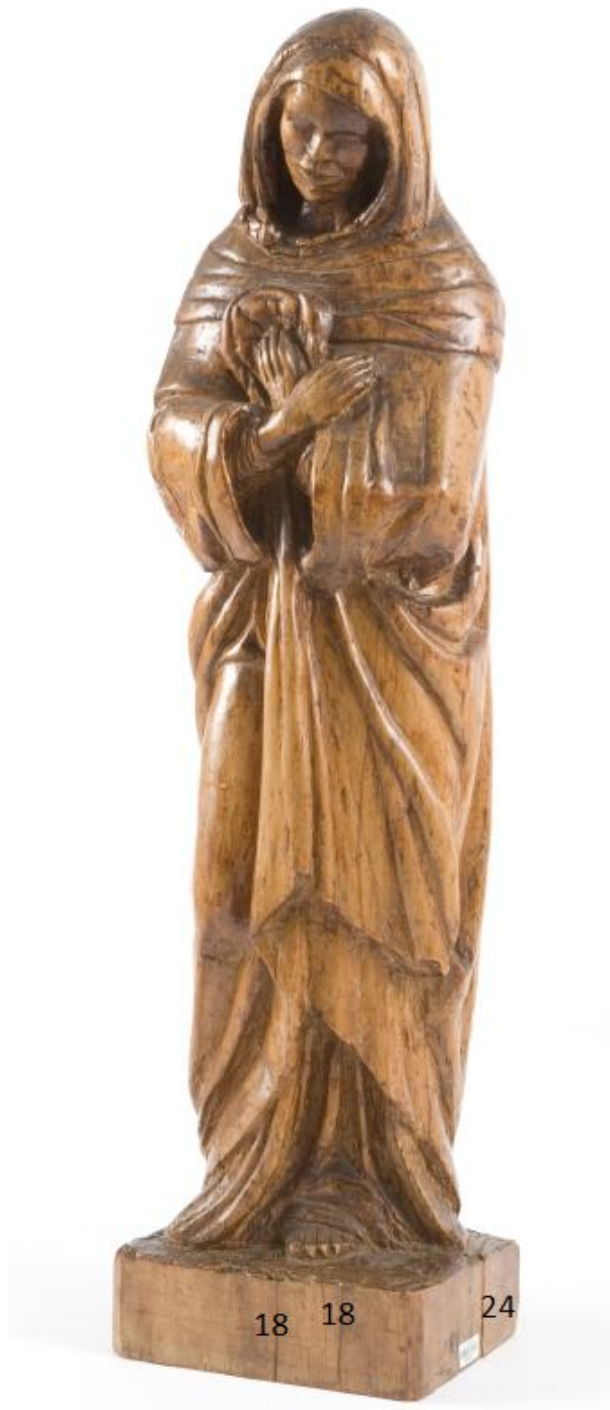
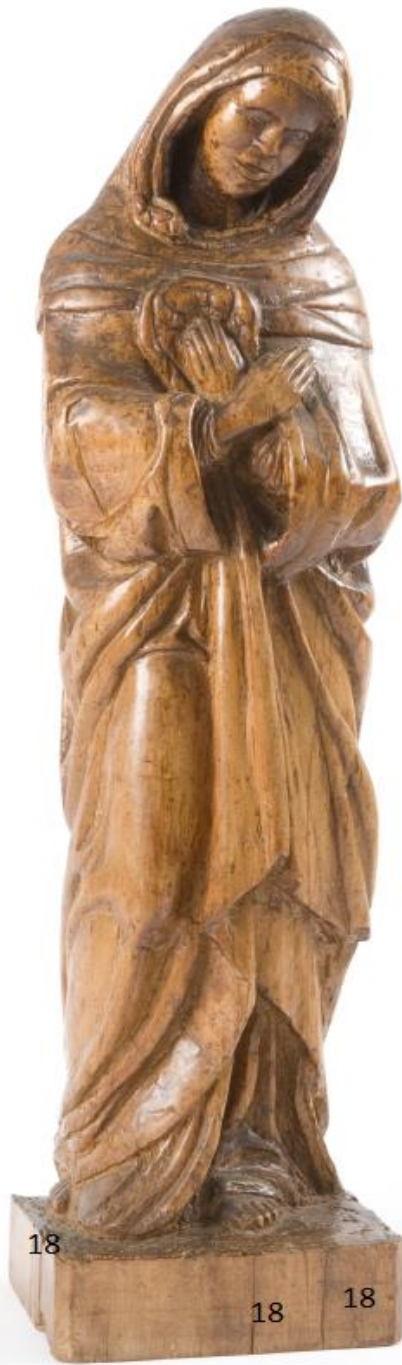
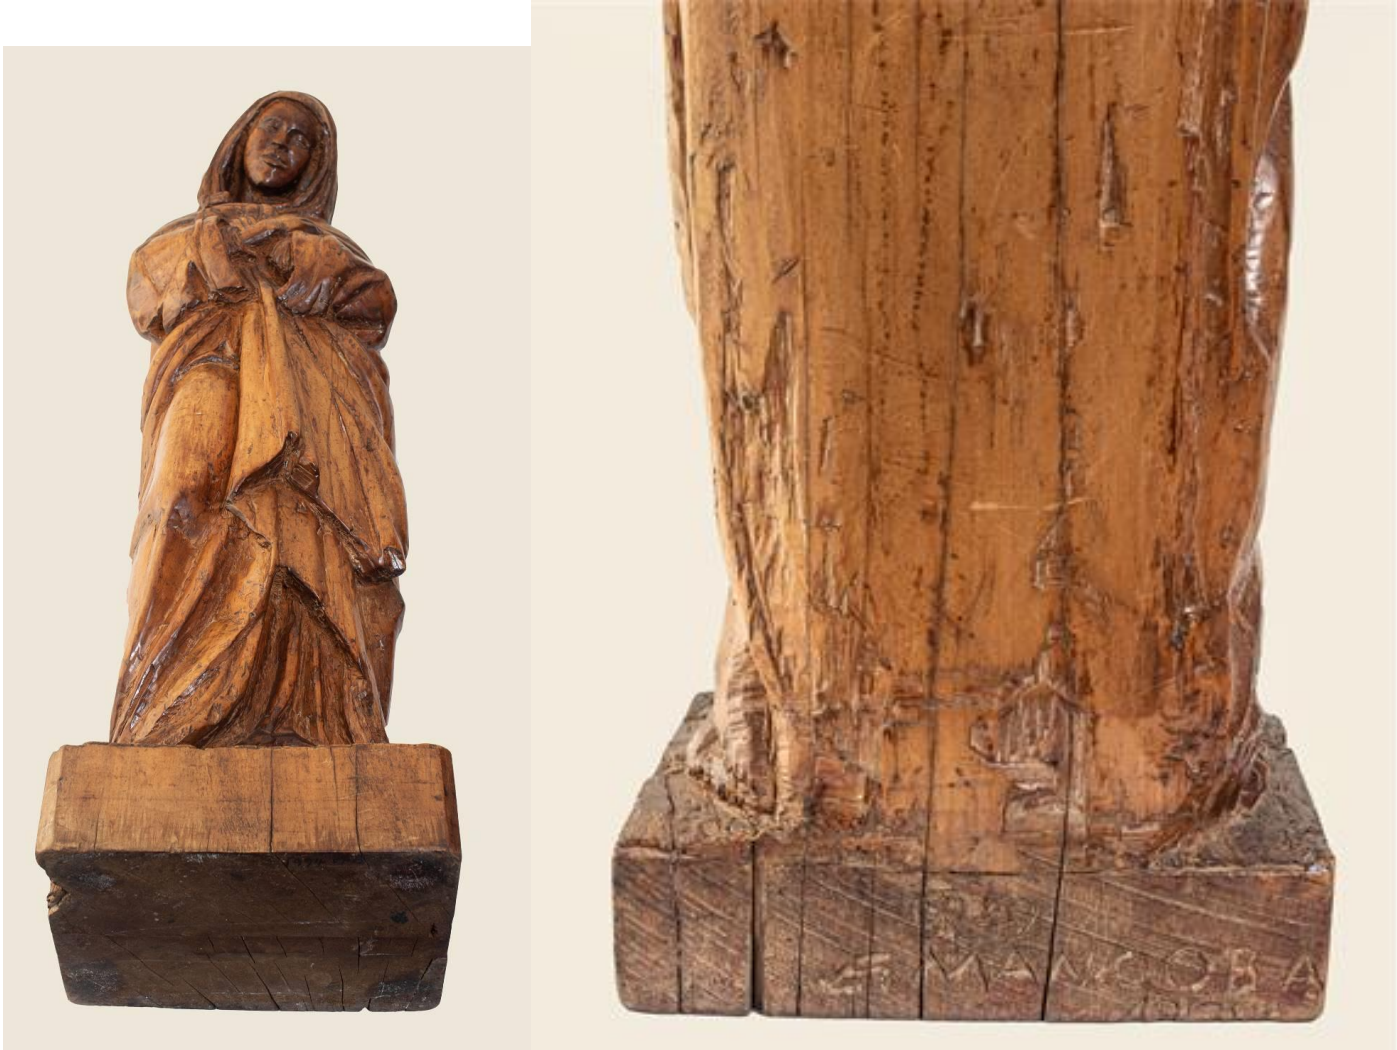
| <input type="checkbox"/> 1 deformation (warping, buckling, bending) | <input type="checkbox"/> 13 oxidisation / corrosion | <input checked="" type="checkbox"/> 24 visible join (glue, resin, grout, plaster, etc) (on base) |
| <input type="checkbox"/> 2 hole | <input checked="" type="checkbox"/> 14 microfractures (on base, throughout) | <input type="checkbox"/> 25 patch |
| <input checked="" type="checkbox"/> 6 scratch (on rear, minor) | <input checked="" type="checkbox"/> 18 splitting (on base) | <input type="checkbox"/> 29 foreign material / dirt deposit |

41 crack / split (see on images)
