Condition Report

Accession No.: JAG1994.7.13

Artist: Mancoba, Ernest Methuen

Title: Bantu Madonna

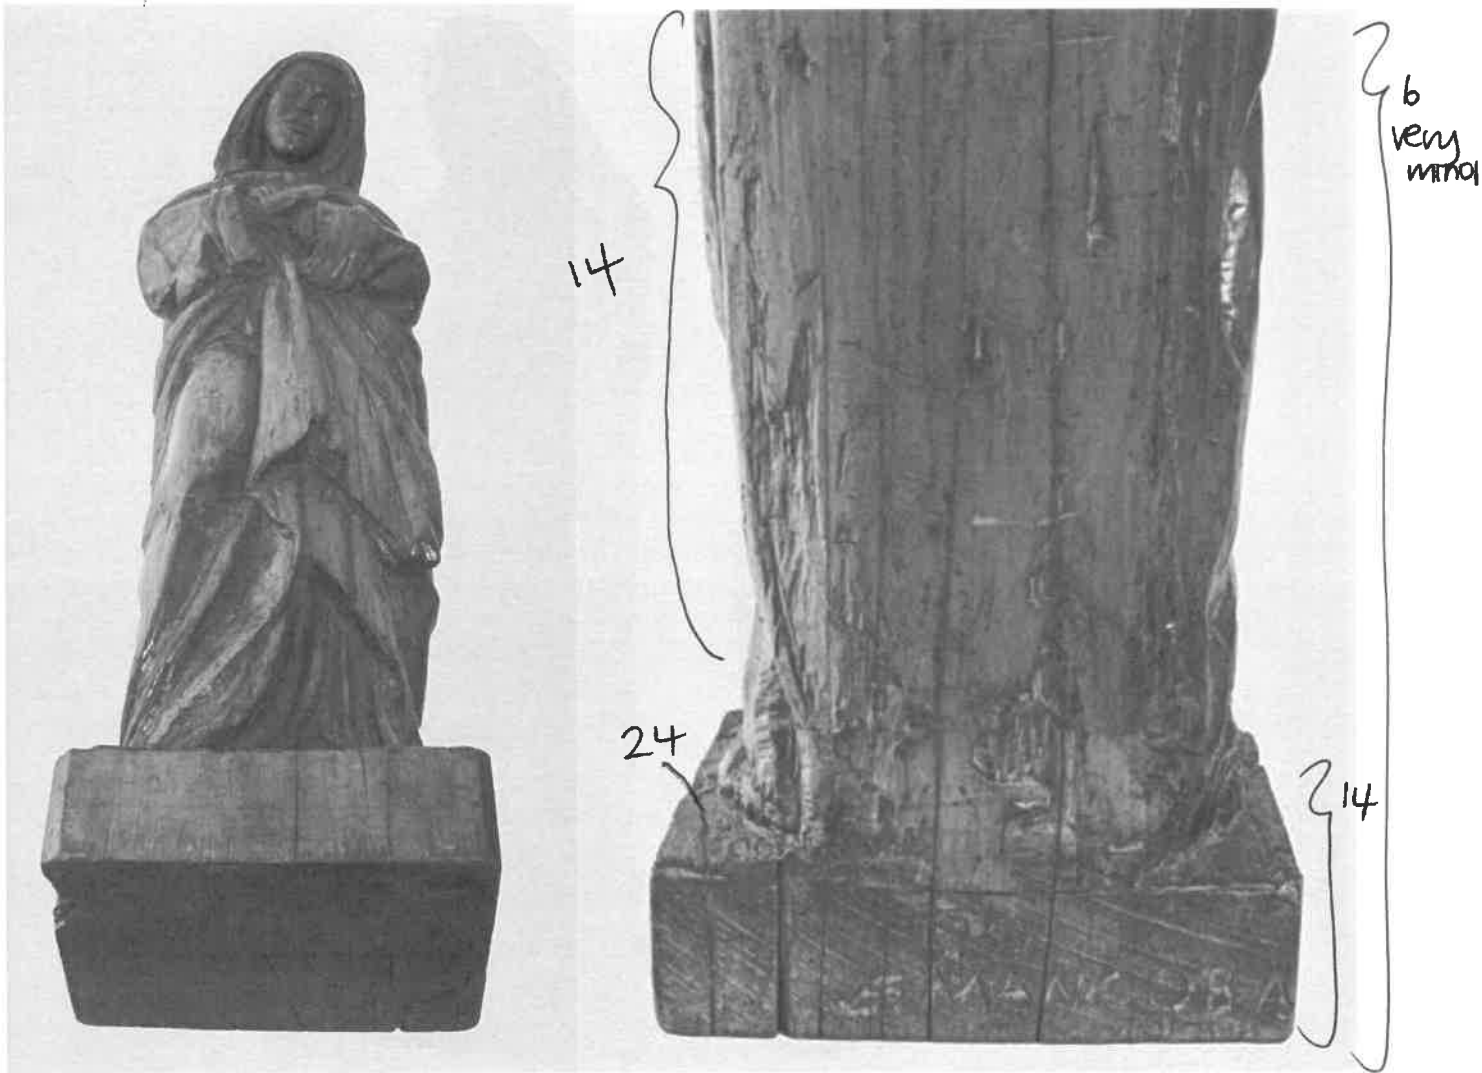
REAR and INSCRIPTION

Inscription, carved: 'E. MANCOBA / 19... (unclear)'
