**REPORT ON THE WOODEN BRIDGE,
MILNERTON LAGOON,
FOR THE MILNERTON MUNICIPALITY**

SEPTEMBER 1994

**WATERMEYER PRESTEDGE RETIEF
UNION CASTLE HOUSE
PIERHEAD
VICTORIA & ALFRED WATERFRONT
CAPE TOWN 8001
TEL: 4183830**

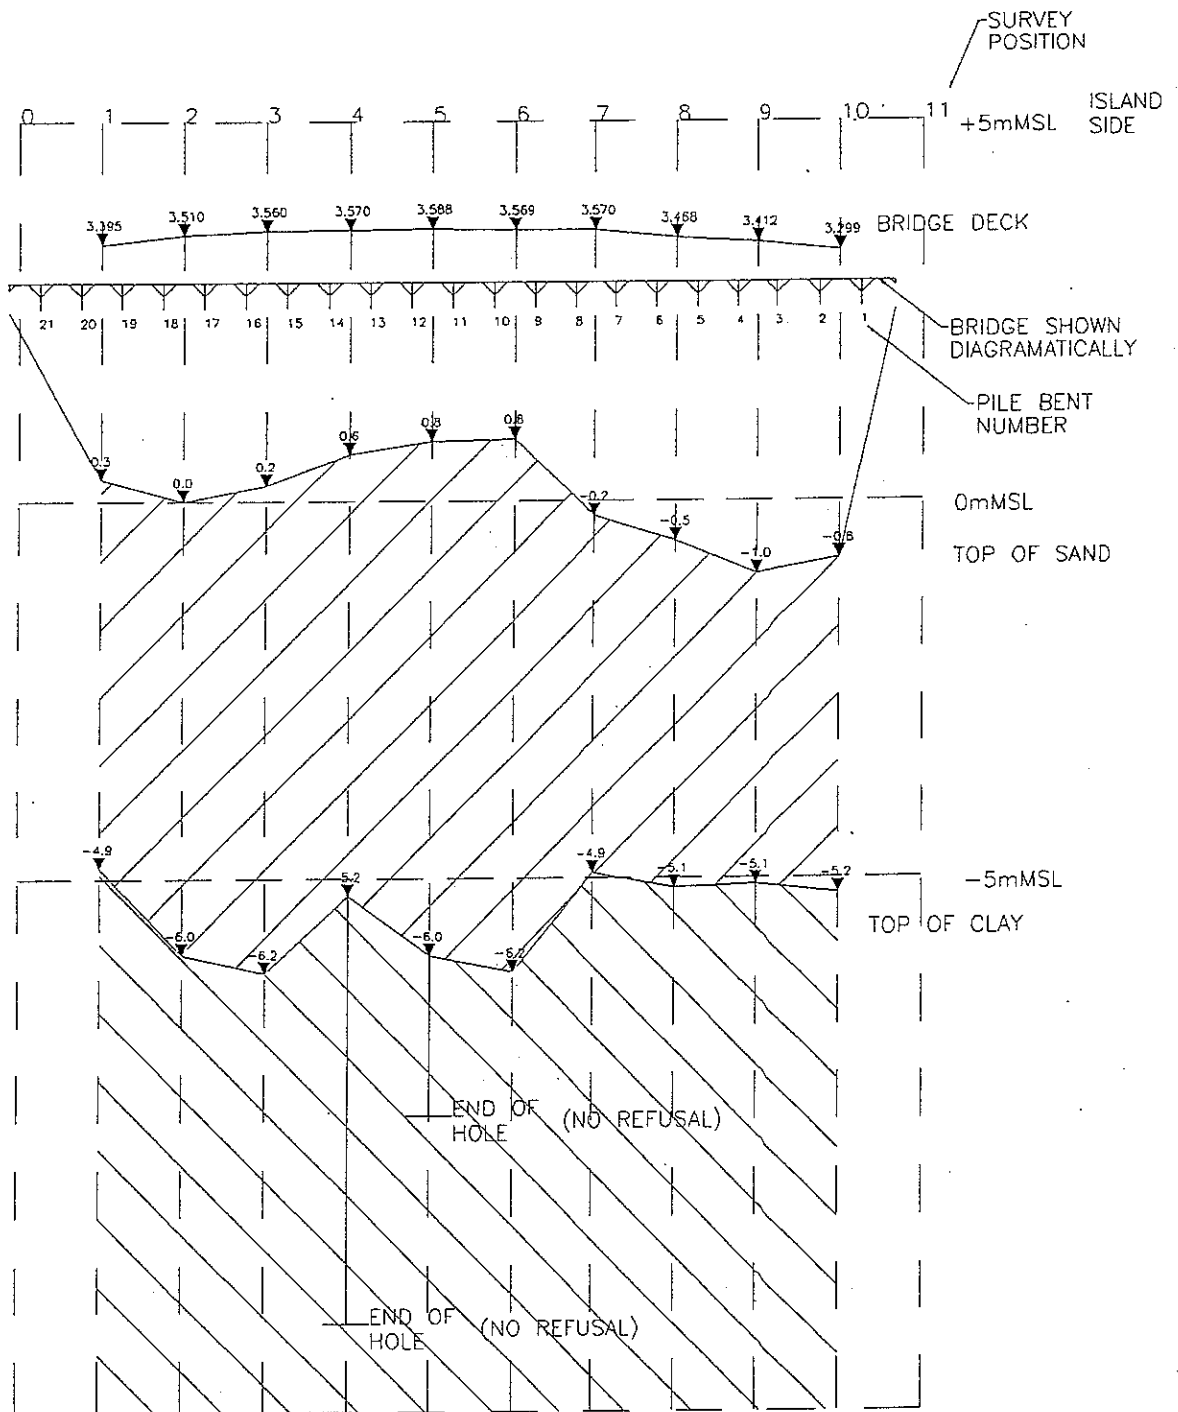
Drawn	CSS	Project	MILNERTON WOODEN BRIDGE INSPECTION	Figure No.
Checked		Title	RIVER BED AND SOIL PROFILE AT BRIDGE	4
Date	AUG 94			
Ref.

The probes indicate that the riverbed at the bridge comprises a sand horizon, varying in thickness from 4 m to 7 m overlaying a clay layer of unknown thickness. At the level taken to be the top of clay there was a marked reduction in the rate at which the probe sank into the soil. At two positions the probe was sunk further (2,0 and 5,5 m) into the clay layer without encountering bedrock. The results of the survey are given in Figure 4.

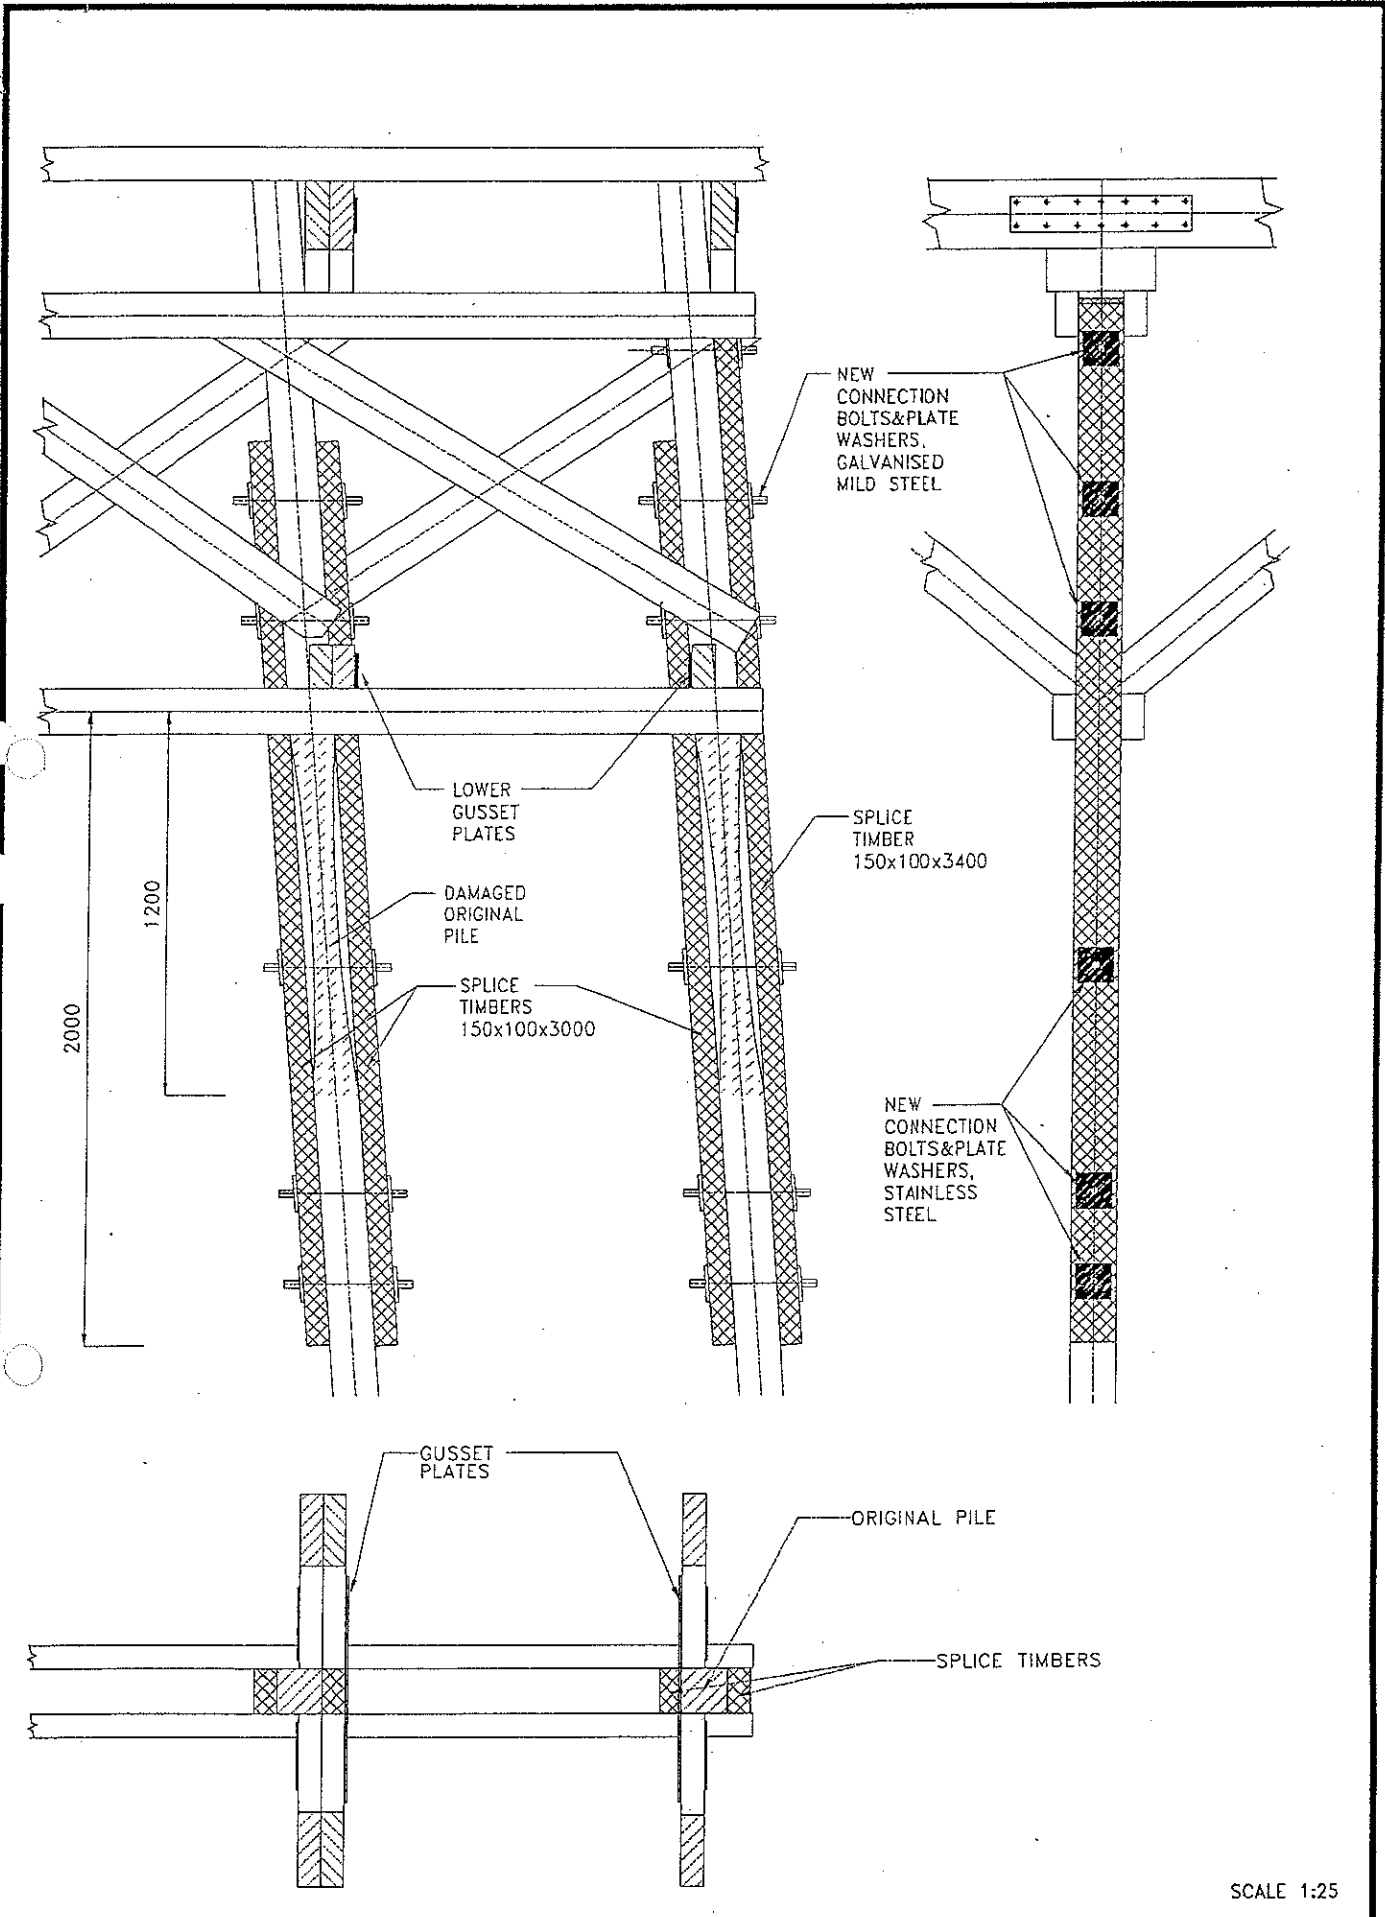
Drawn	CSS	Project	MILNERTON WOODEN BRIDGE INSPECTION	Figure No.
Checked		Title	PILE SPLICE	5
Date	AUG 94			
Ref.

It is recommended that the piles should be strengthened over the tidal zone. The most appropriate form of strengthening for reasons of aesthetics and ease of construction is to splice extra timber across the weakened area. The splice should consist of two half size timbers (ie. 150 x 100 mm section), one on the upstream face and one on the downstream. The splice timbers should be connected by drilling and bolting as illustrated in Figure 5. In order to make the splice less obtrusive the outermost splice timber is shown extended to the underside of the deck bearers. Some piles already have splices, presumably done during the original construction.

The lower connections will have to be constructed by divers and will require excavation around the piles situated in the sand bar and the eastern channel. Removal of one of the lower horizontals will be necessary at each pile bent to enable insertion of the splice timbers.

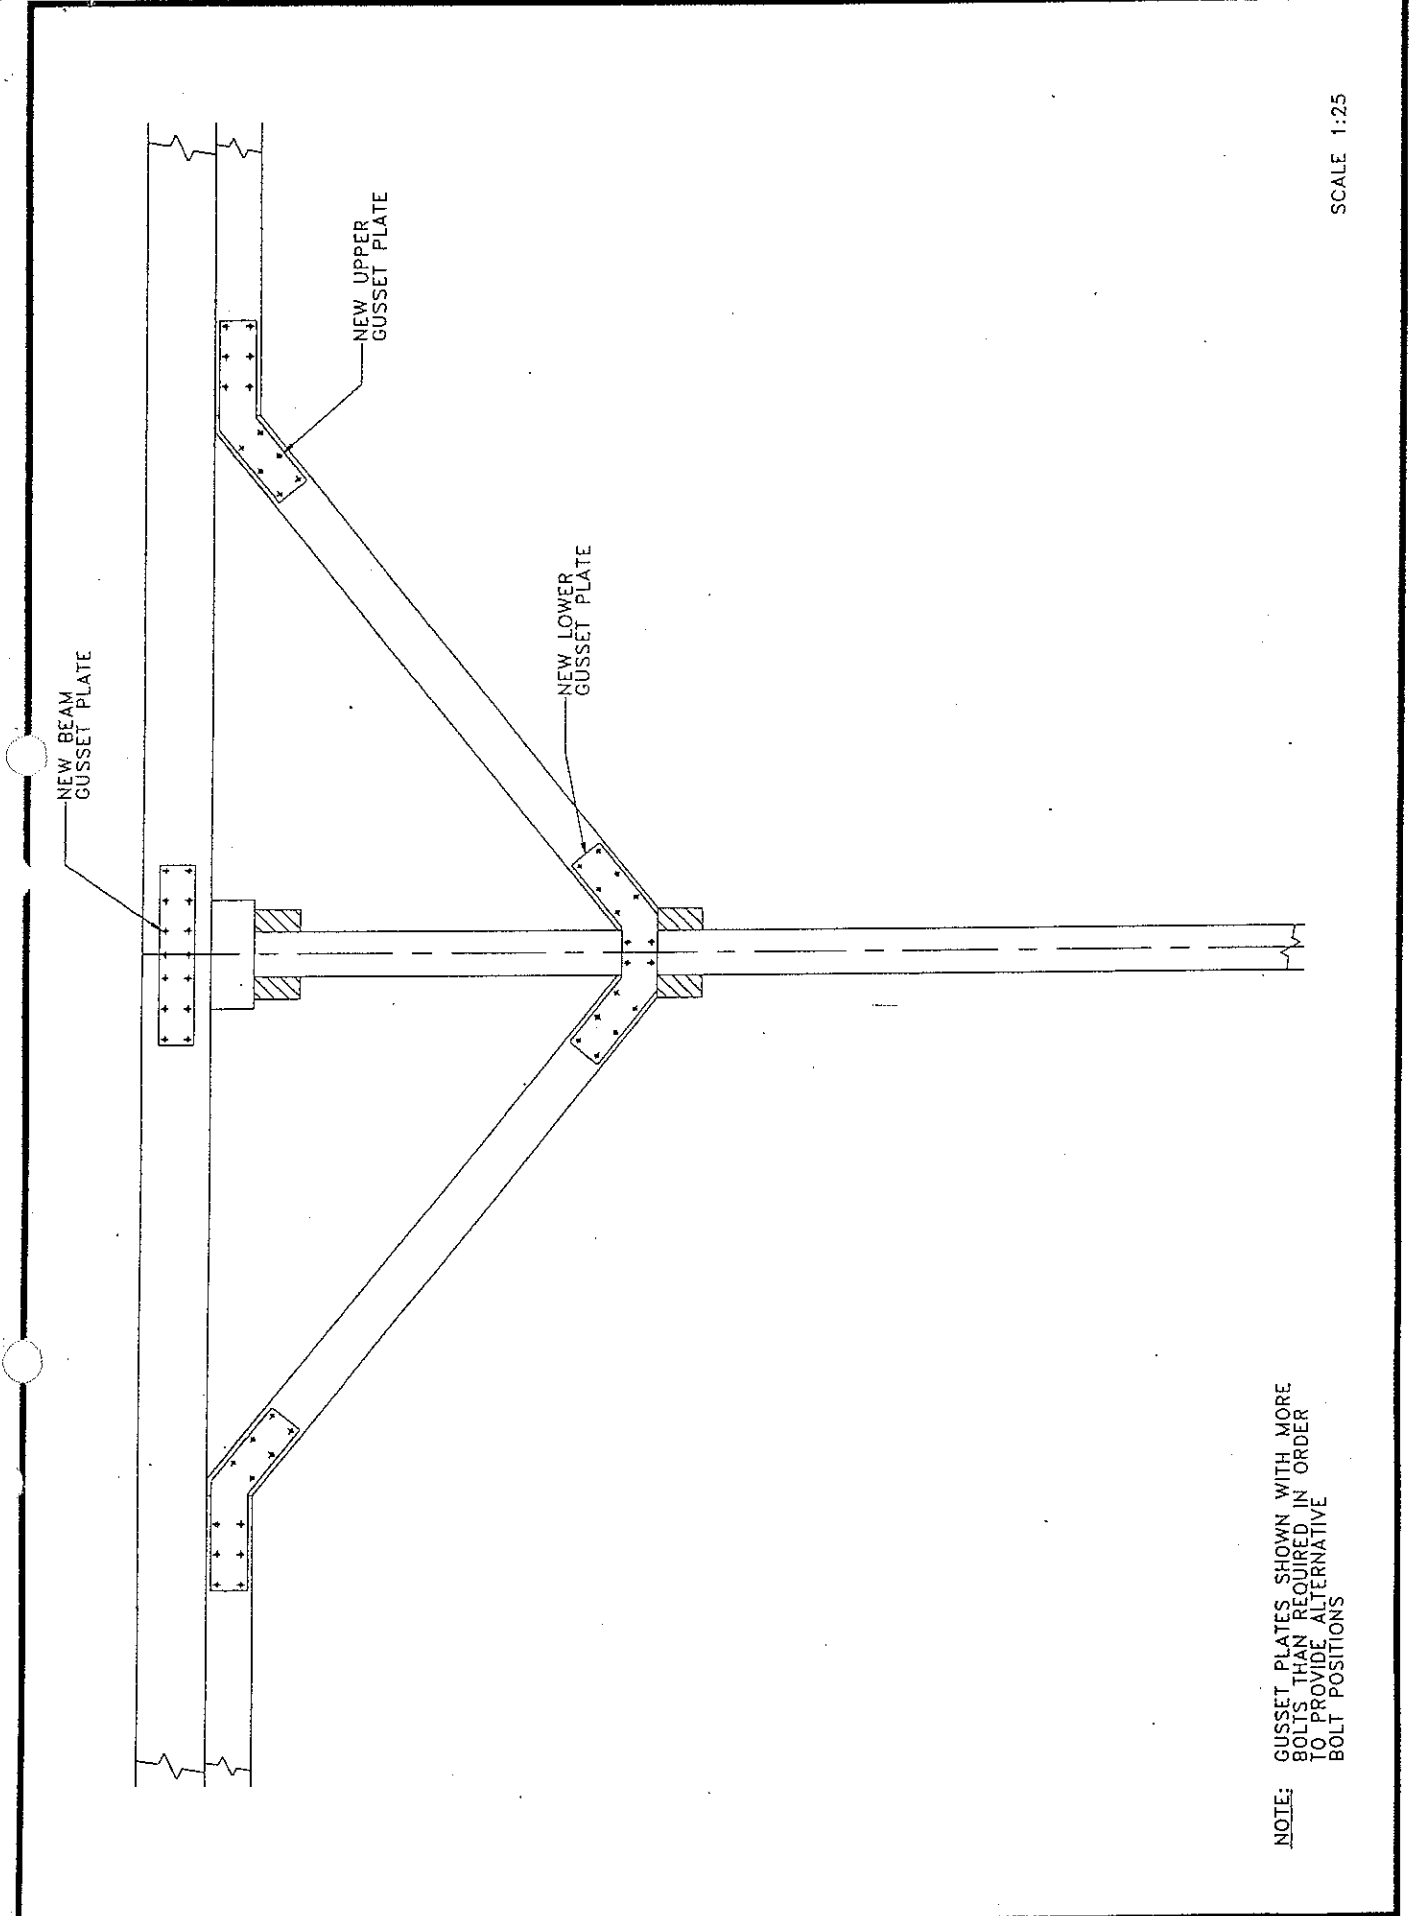
Drawn	CSS	Project	MILNERTON WOODEN BRIDGE INSPECTION	Figure No.
Checked		Title	NEW GUSSET PLATES	6
Date	AUG 94			
Ref.

Figure 6 illustrates the recommended revised replacement gusset plates. It is considered that plates larger than the originals be used with bolt positions that straddle the old bolt holes in order to avoid splits, oversize holes and old bolts that are difficult to extract.

In time all gusset plates will require replacement. Initially missing plates and all the lower gusset plates will have to be replaced, concurrently with pile splicing. Sequencing of the remedial works is discussed further in section 5.5 below.
