## BO-KAAP MUSEUM

ERF 115963, 71 WALE STREET, CAPE TOWN

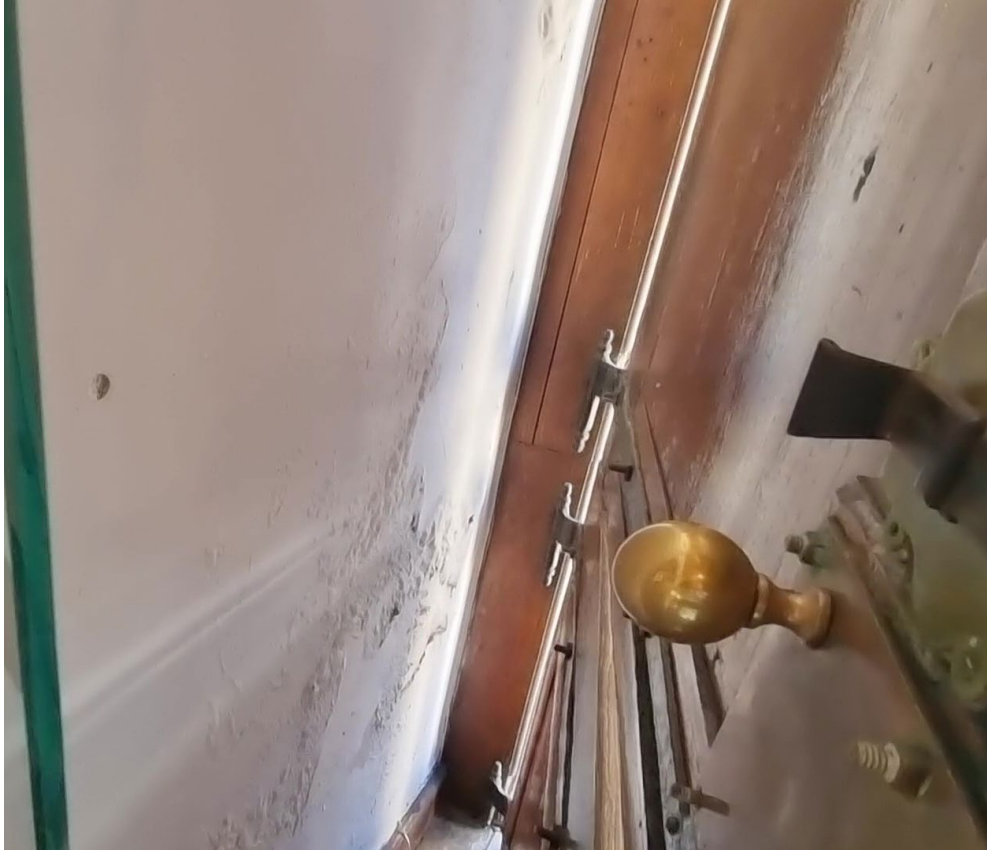
*Figure 8: Image shows noticeable damp damage behind front entrance door.*

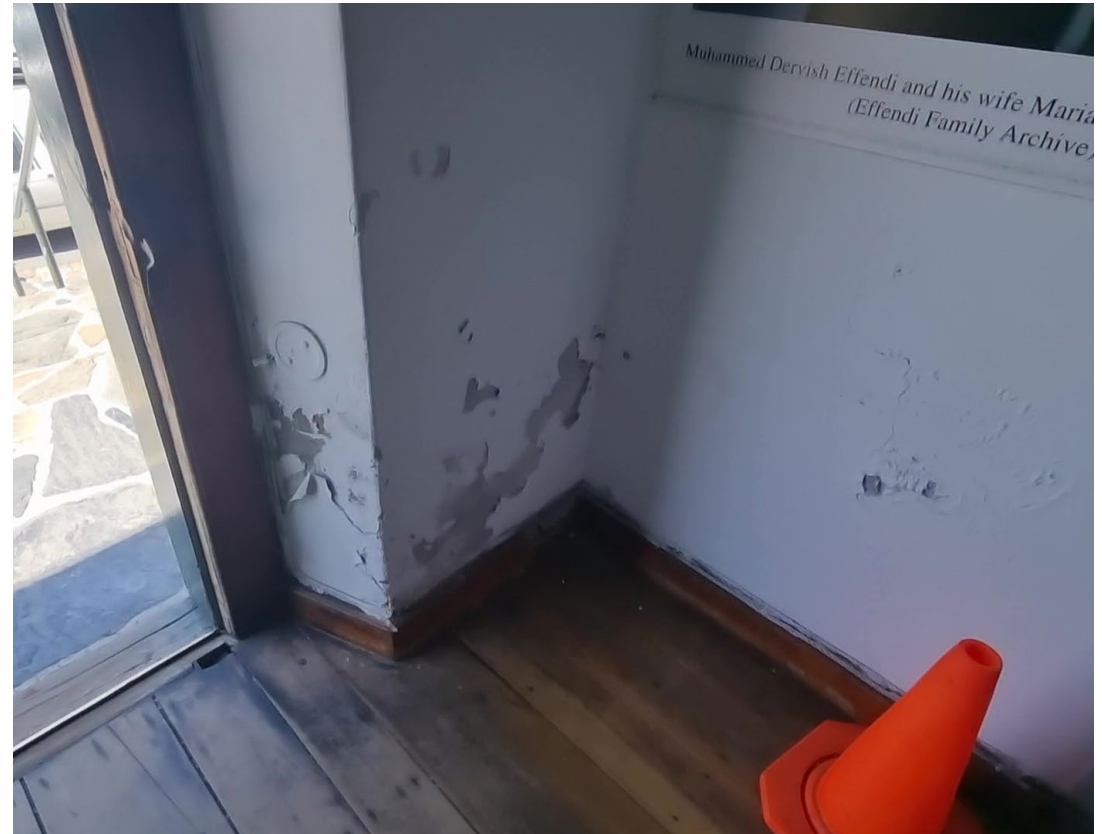
*Figure 9: Image shows noticeable damp damage next to front entrance door.*

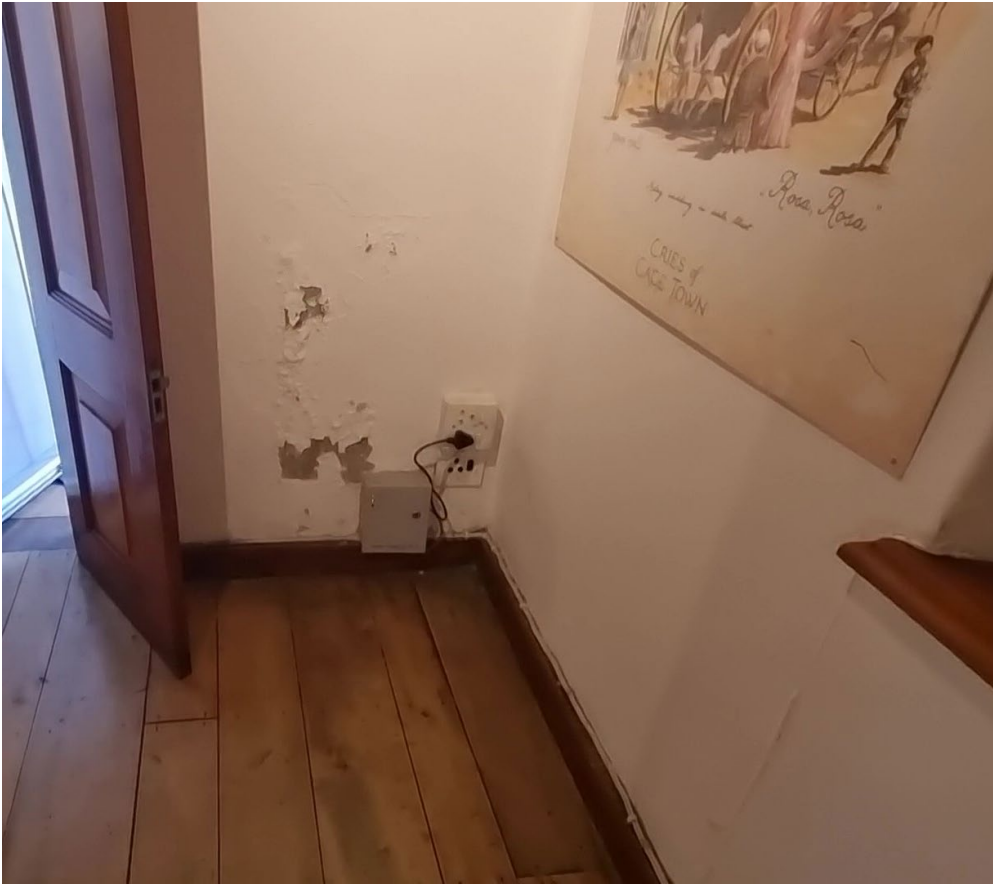
Figure 10: Image shows water damage to a wall in the East-Room (Exhibition room 3).

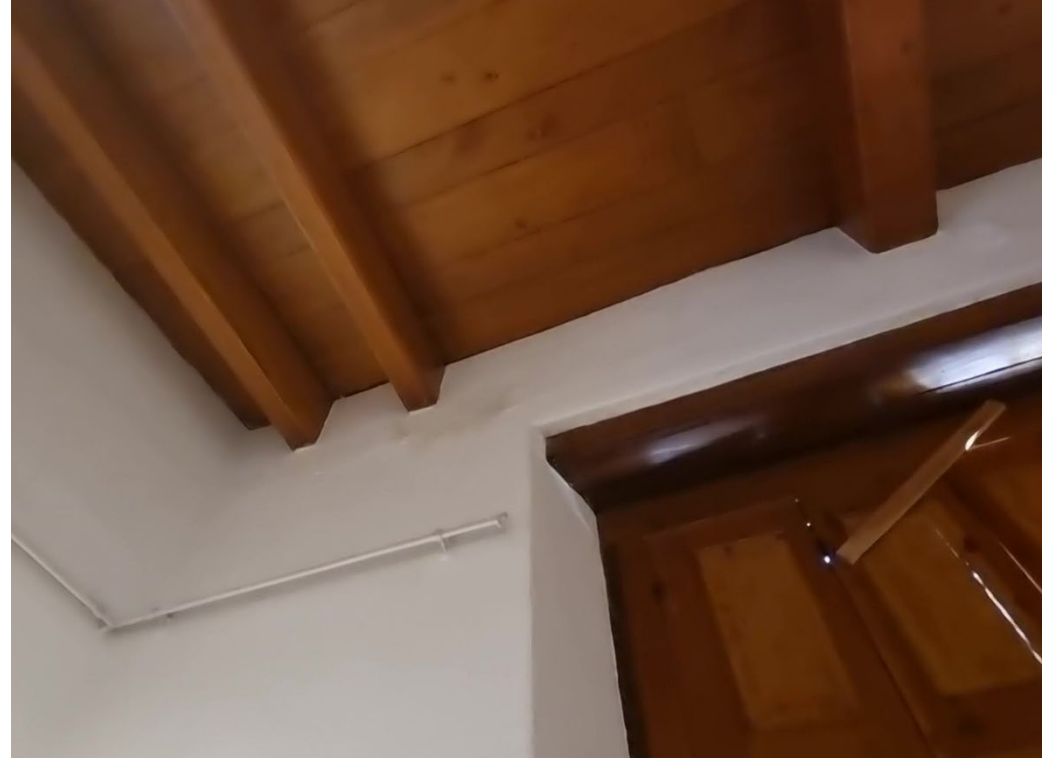
Figure 11: Image shows water damage to the underside of the ceiling.

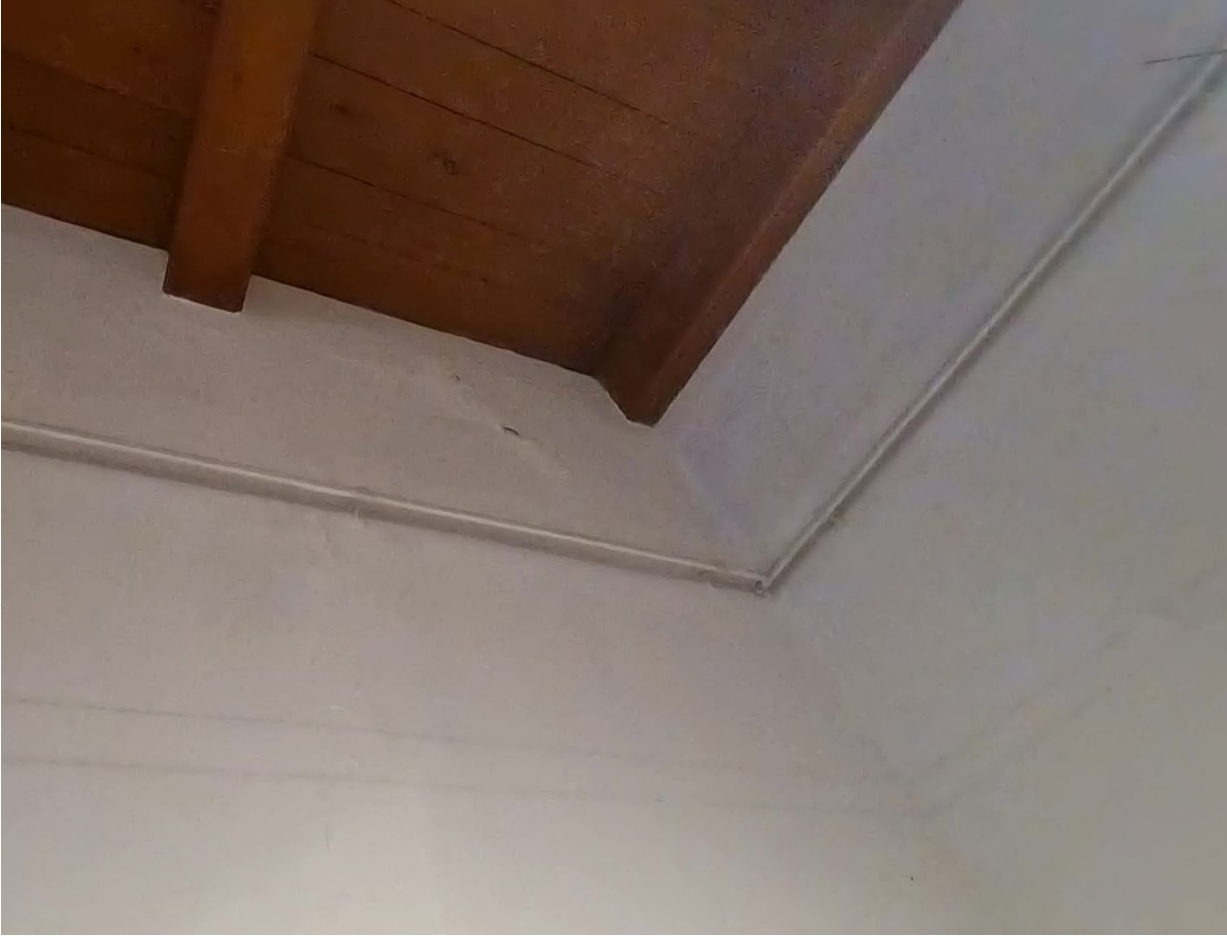
*Figure 12: Image shows water damage to the walls and ceiling.*

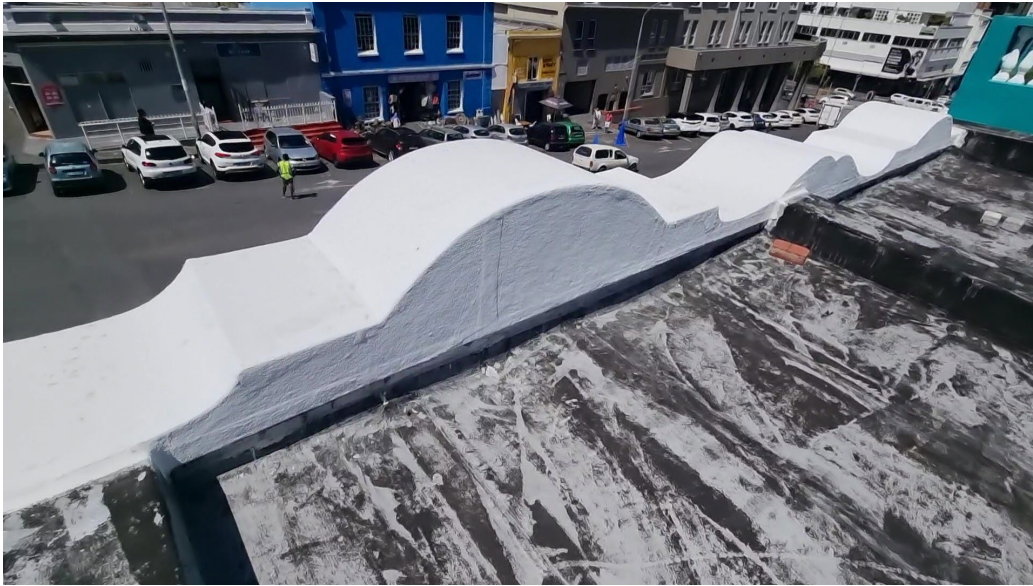
*Figure 13: Image shows the gable end parapet waterproofing seem to be in good condition.*

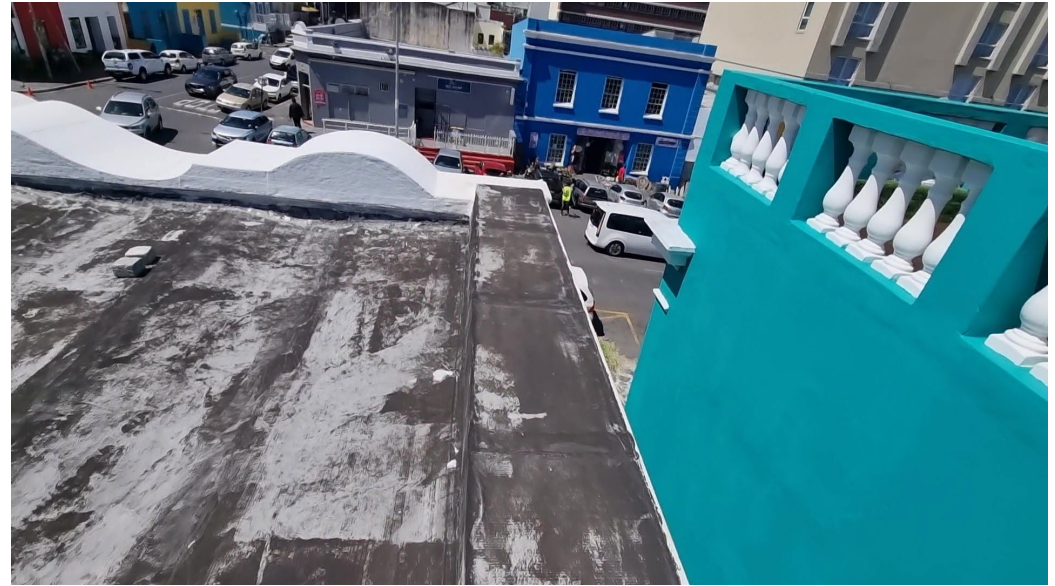
*Figure 14: Image shows the waterproofing membrane over parapet to extend down over external wall.*

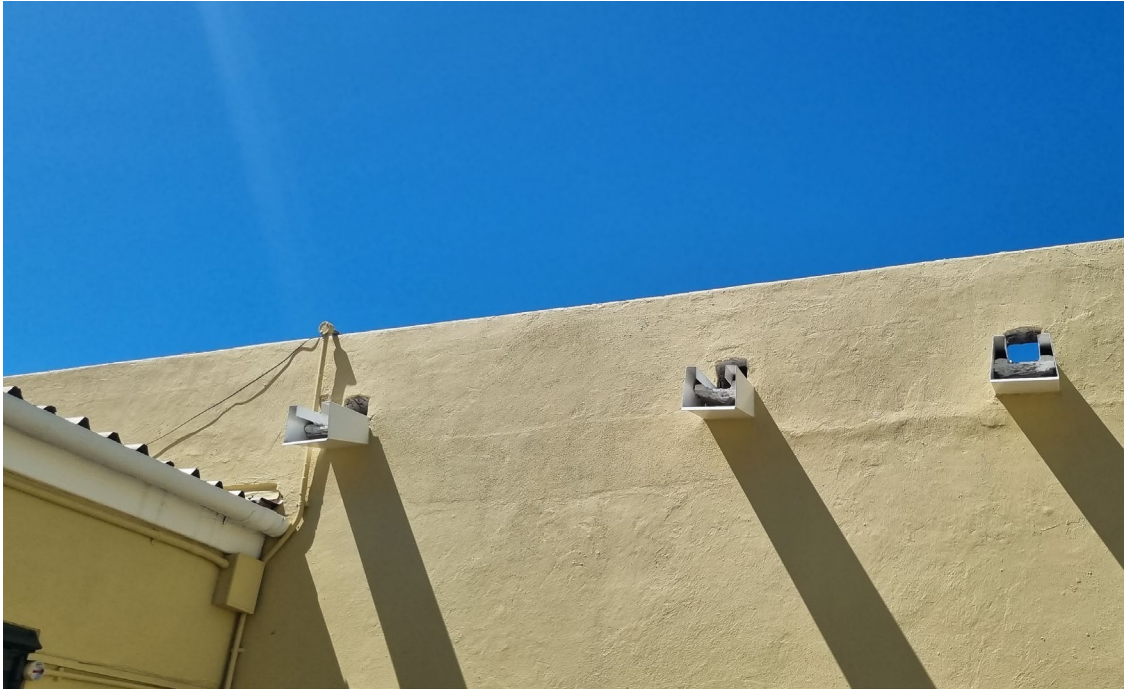
Figure 17: Image shows the water outlets to roof in clean and good condition. Discuss the option of hopper boxes and downpipes.

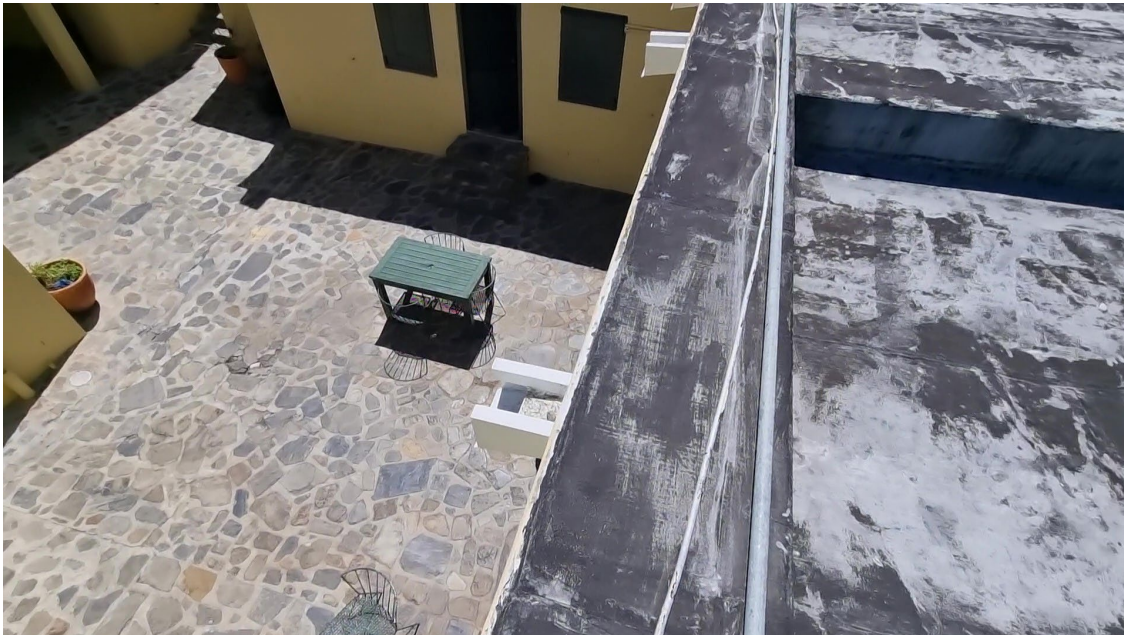
Figure 18: Image shows the waterproofing membrane over parapet to extend down over external wall.

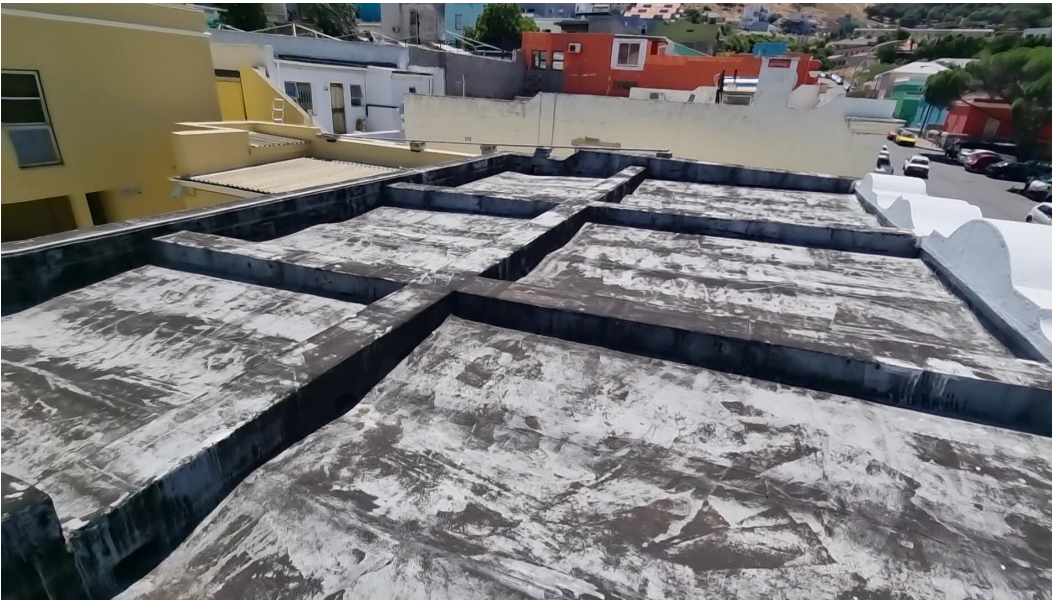
*Figure 20: Image shows an overall view of roof indicating wear and exposed torch on membrane.*

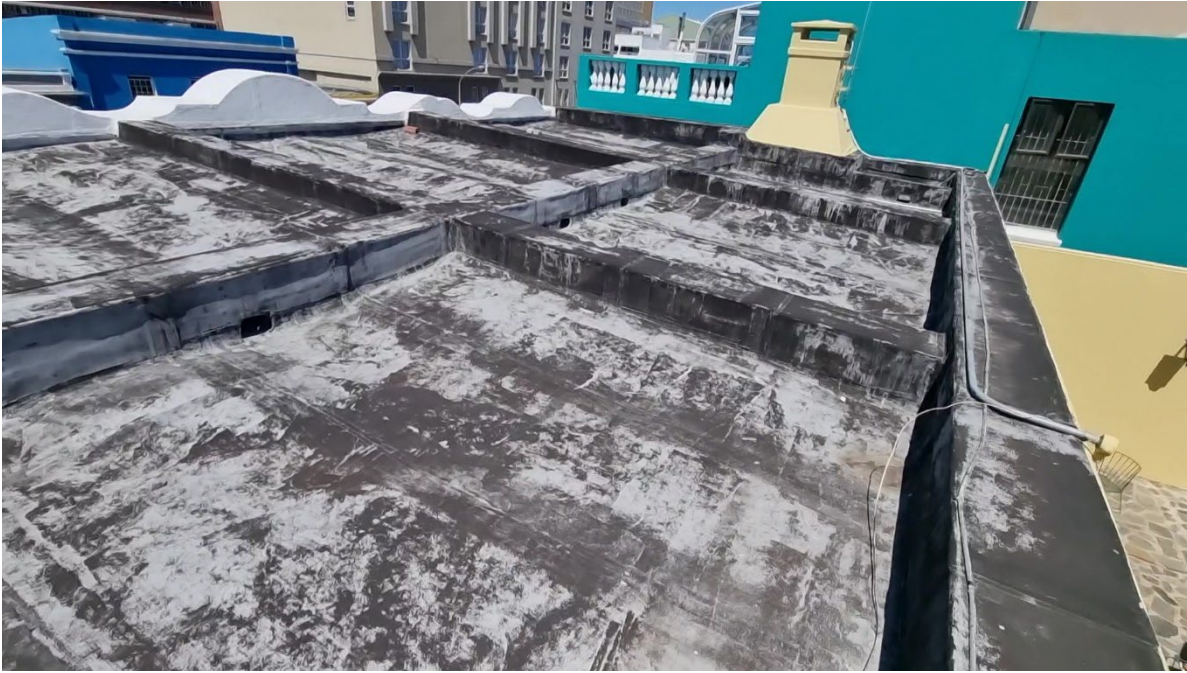
Figure 21: Image shows an overall view of roof indicating wear and exposed torch on membrane.

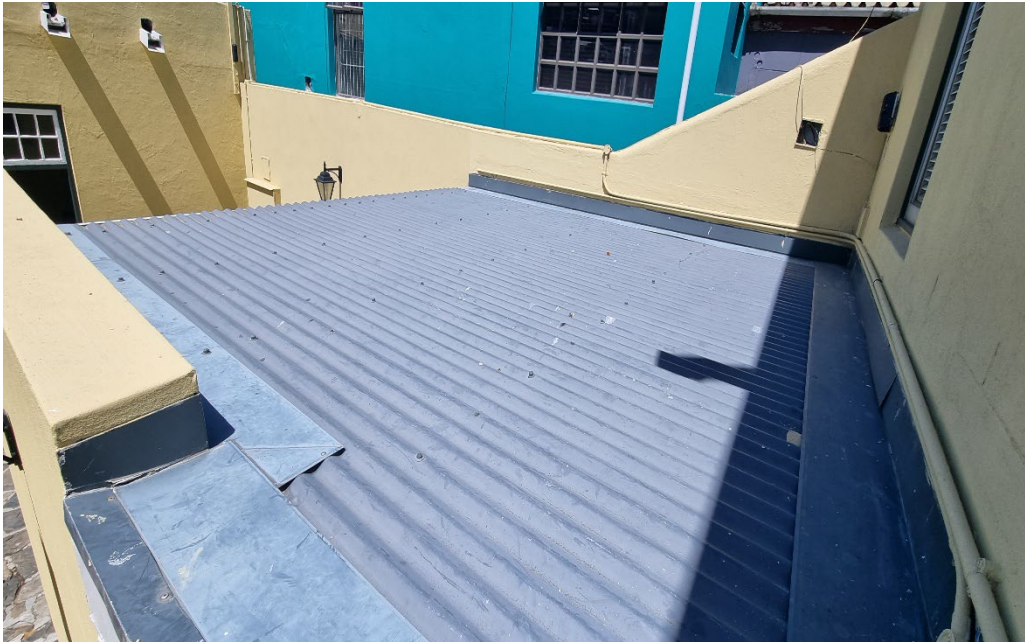
Figure 22: Image shows roof to be in fair condition but visible damage to headwall flashing and retrofitted services penetrating plate and compromising water ingress can be seen.

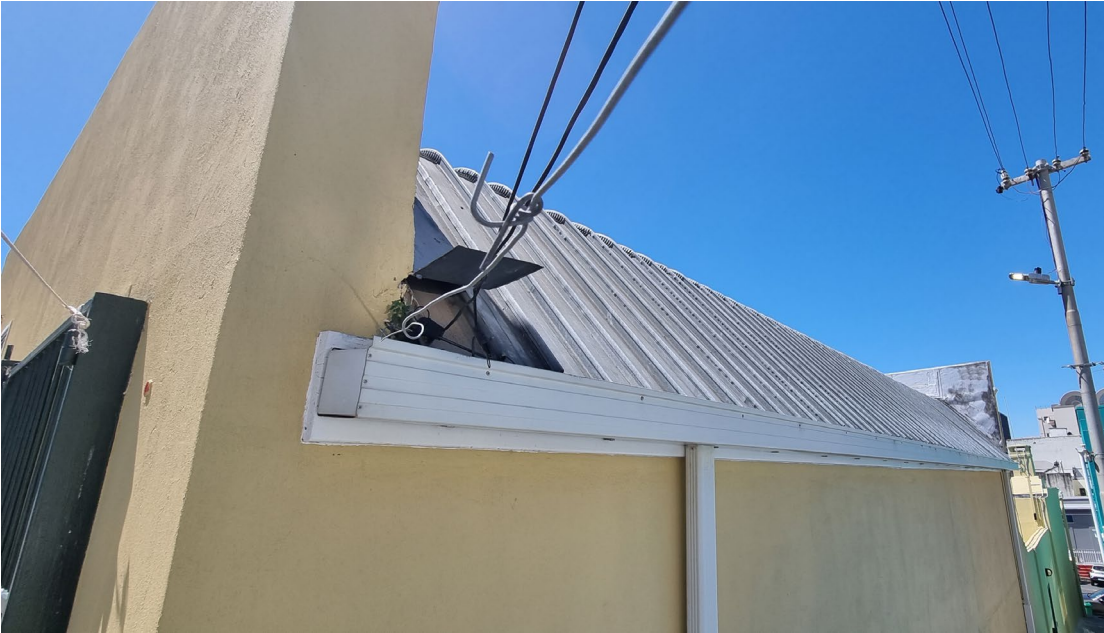
*Figure 23: Image shows damaged sidewall flashing on angled return.*

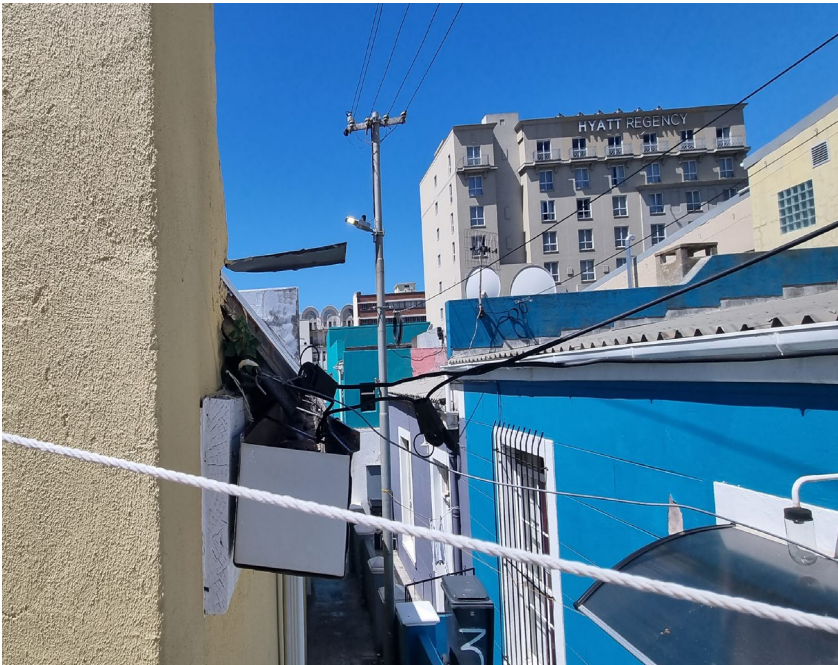
*Figure 24: Image shows the exposed roof structure. Custom flashing to close off corner is recommended.*

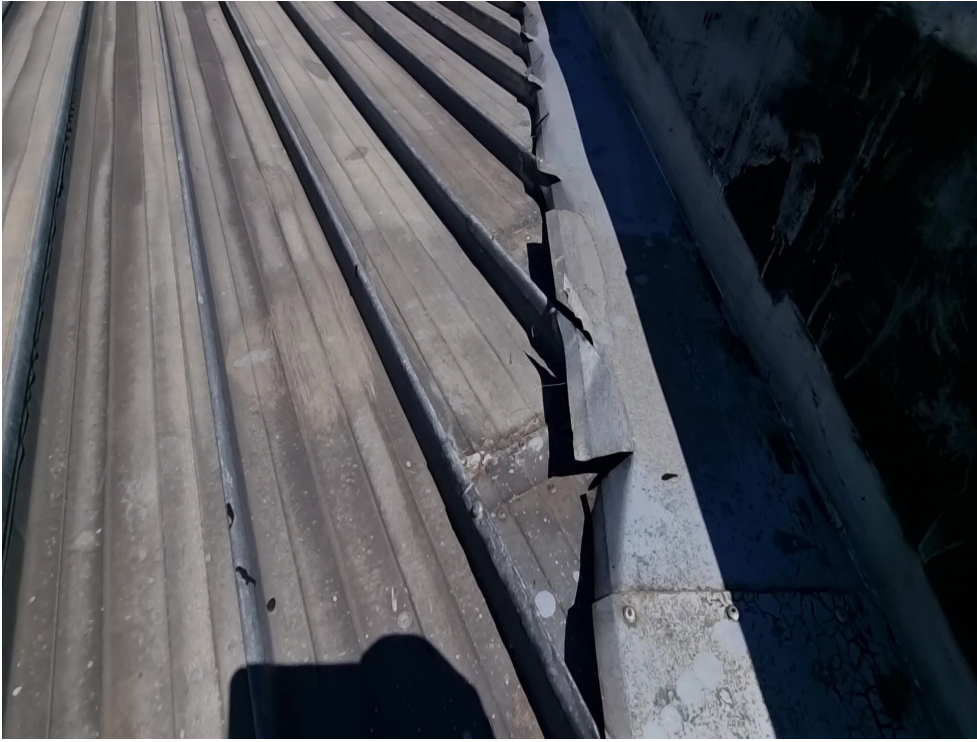
*Figure 25: Image shows noticeable damaged flashing and extended sheets with rivets. New Flashing recommended.*

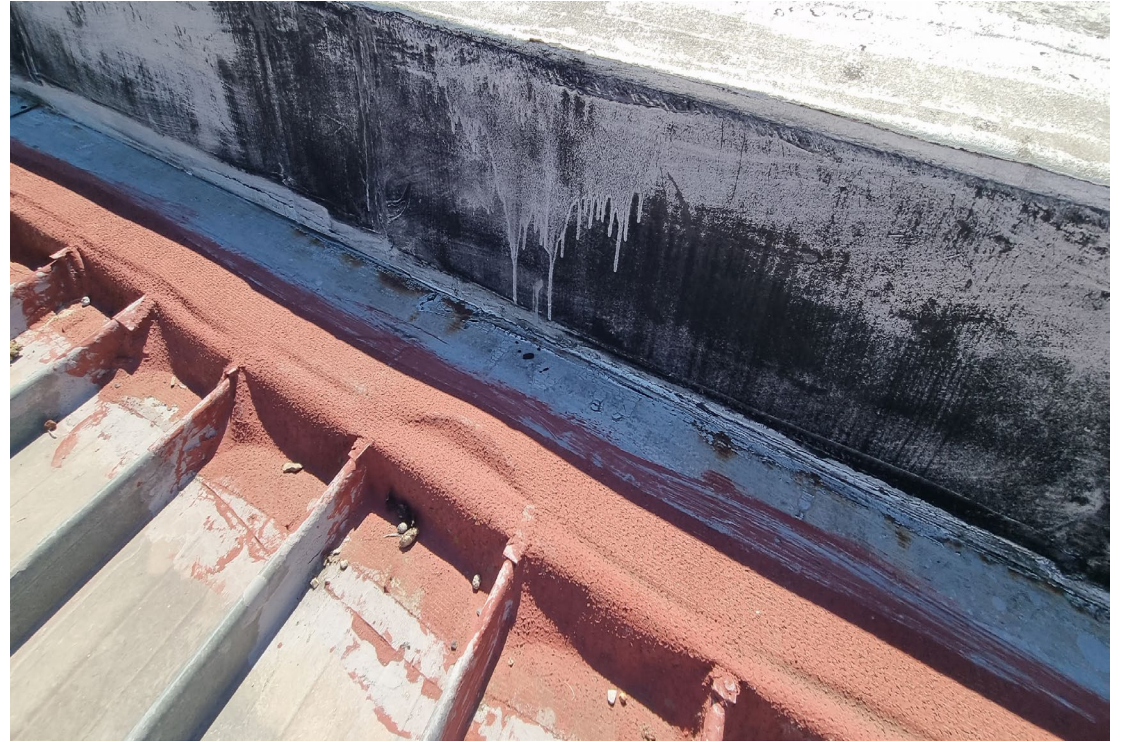
*Figure 26: Image shows poor application of incorrect product. New flashing recommended.*

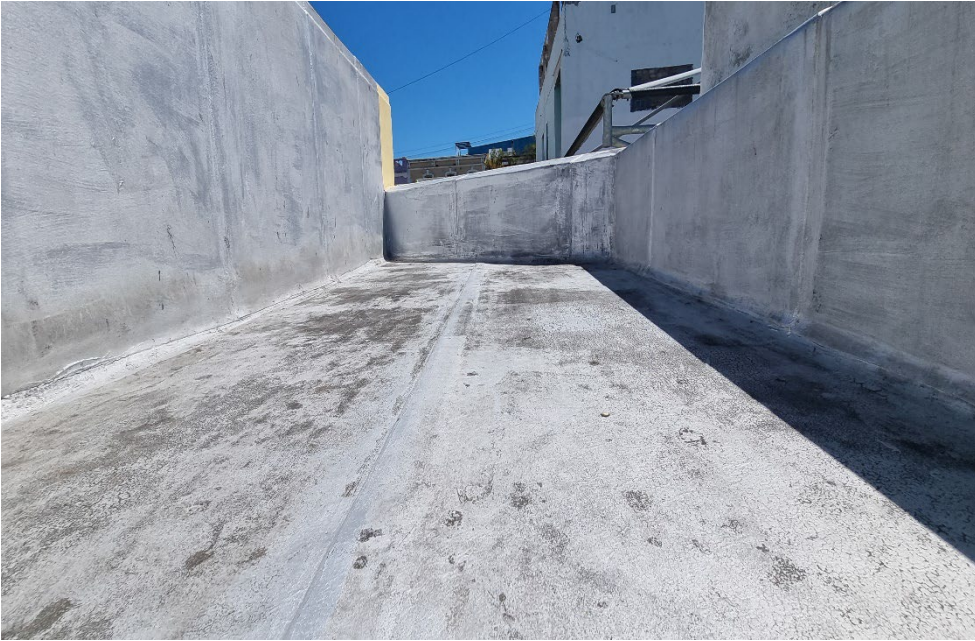
*Figure 27: Image shows the flat roof to entrance. Vertical waterproofing in fair condition, but rather replace with new roof.*

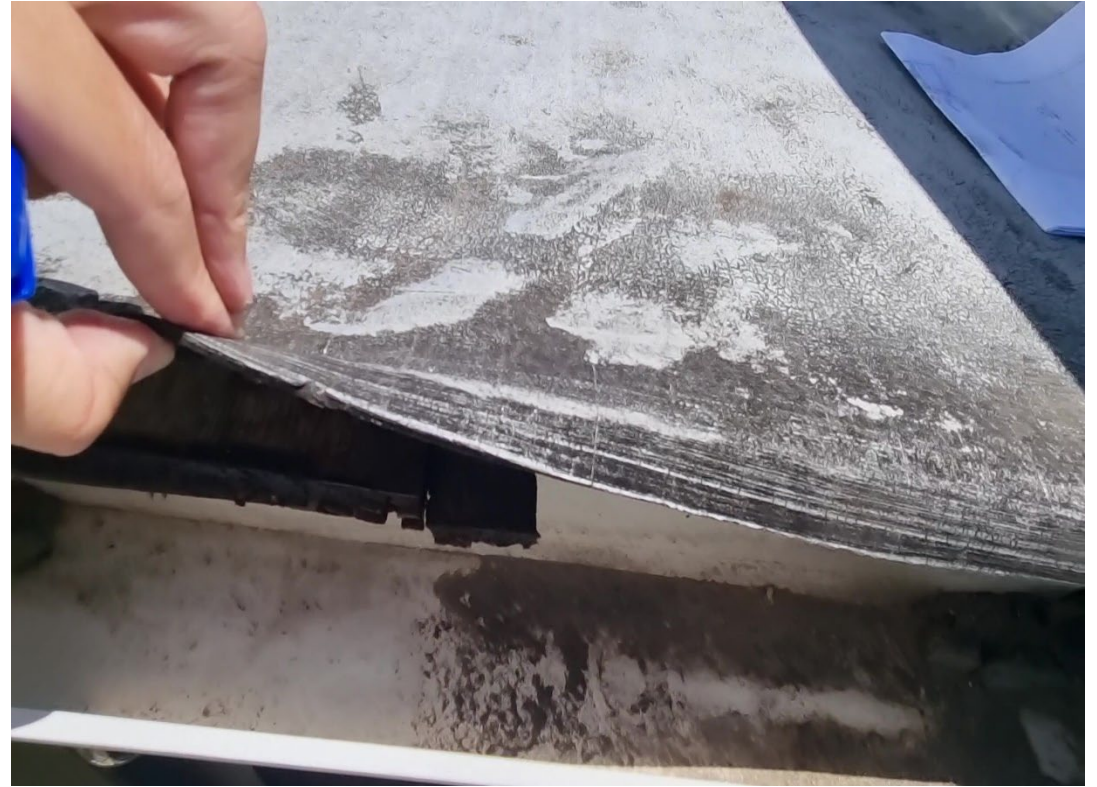
*Figure 28: Image shows visible delamination to flat roof with wood rot below. Replace entire roof.*

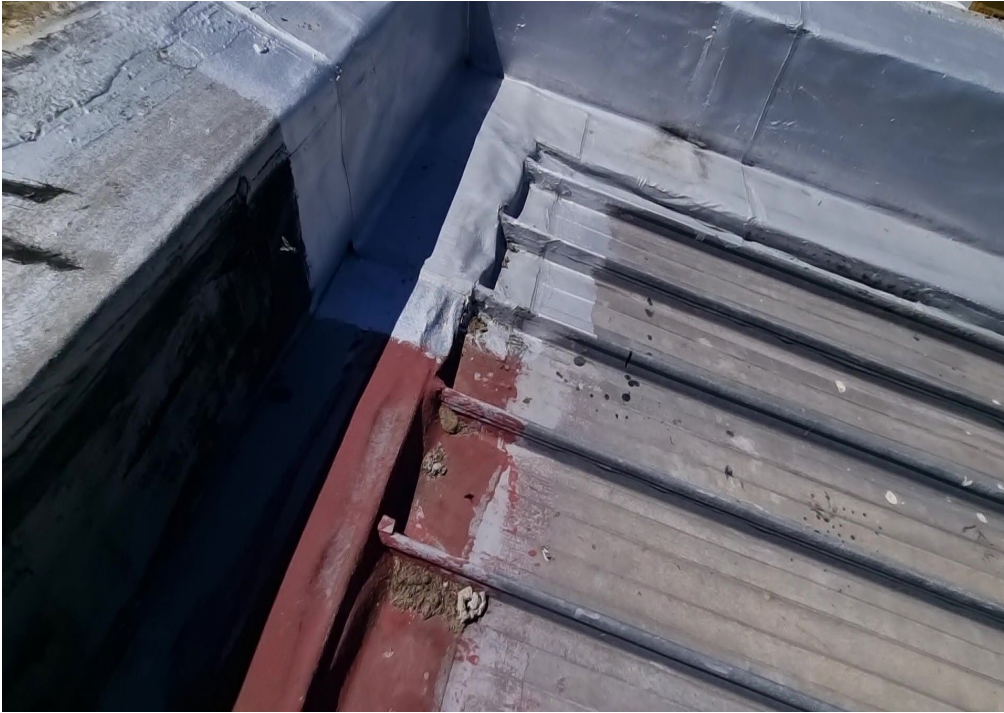
*Figure 29: Image shows poor application of incorrect product. New flashing recommended.*

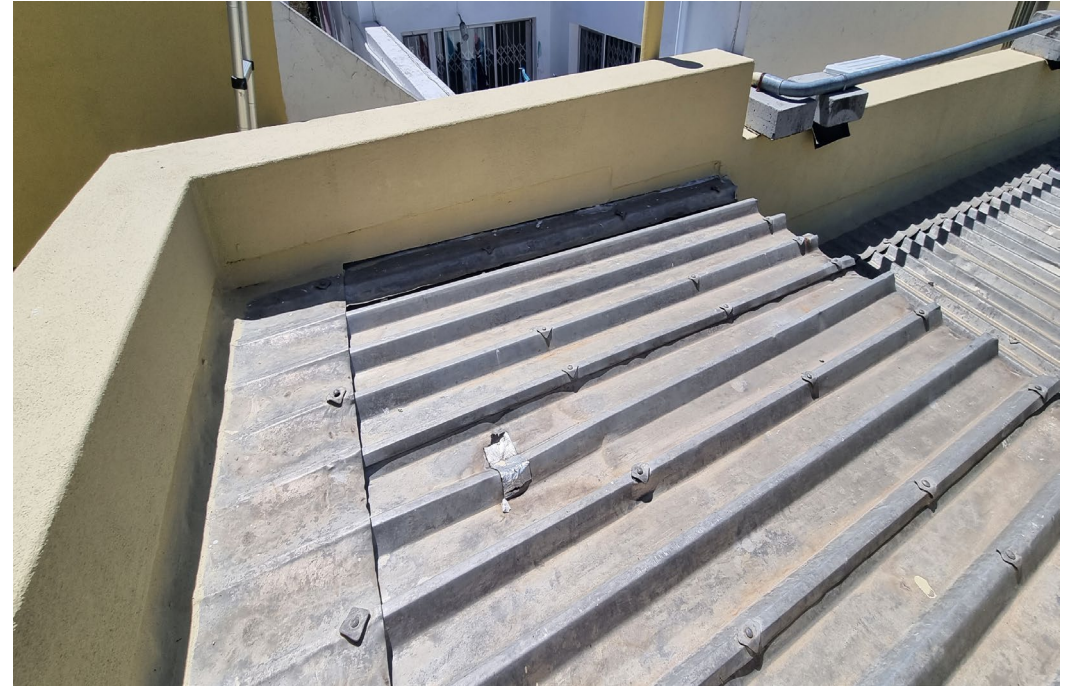
*Figure 30: Image shows the roof sheets have reached the end of lifespan with visible previous repairs and damage to sheets.*

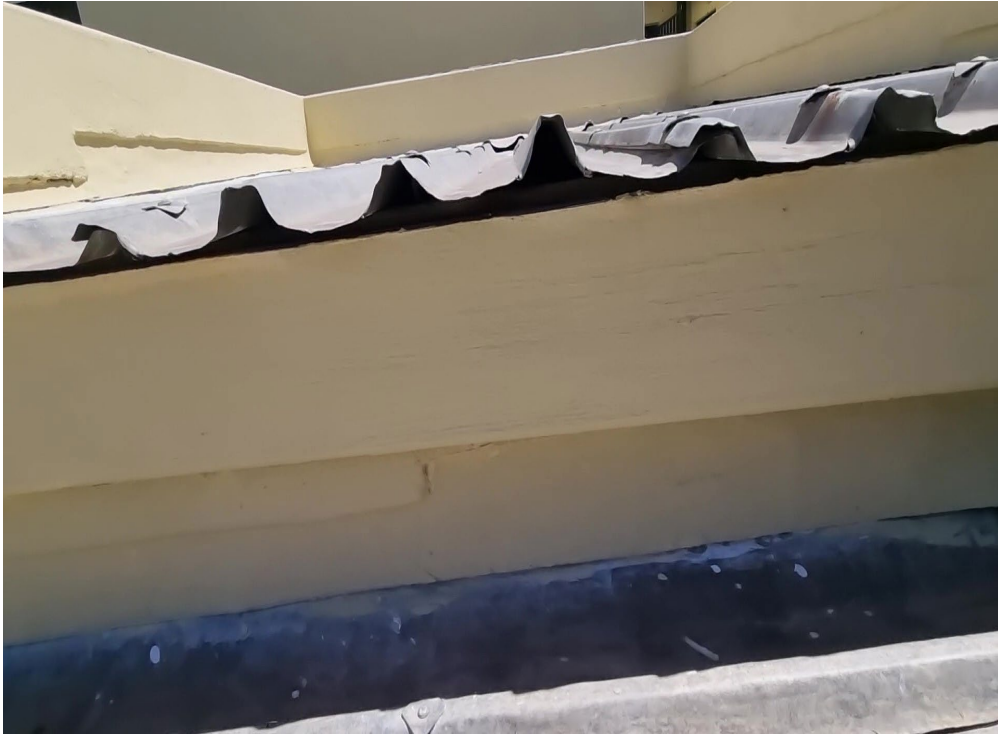
*Figure 31: Image shows that the roof sheets has reached the end of lifespan with visible previous repairs and damage to sheets.*

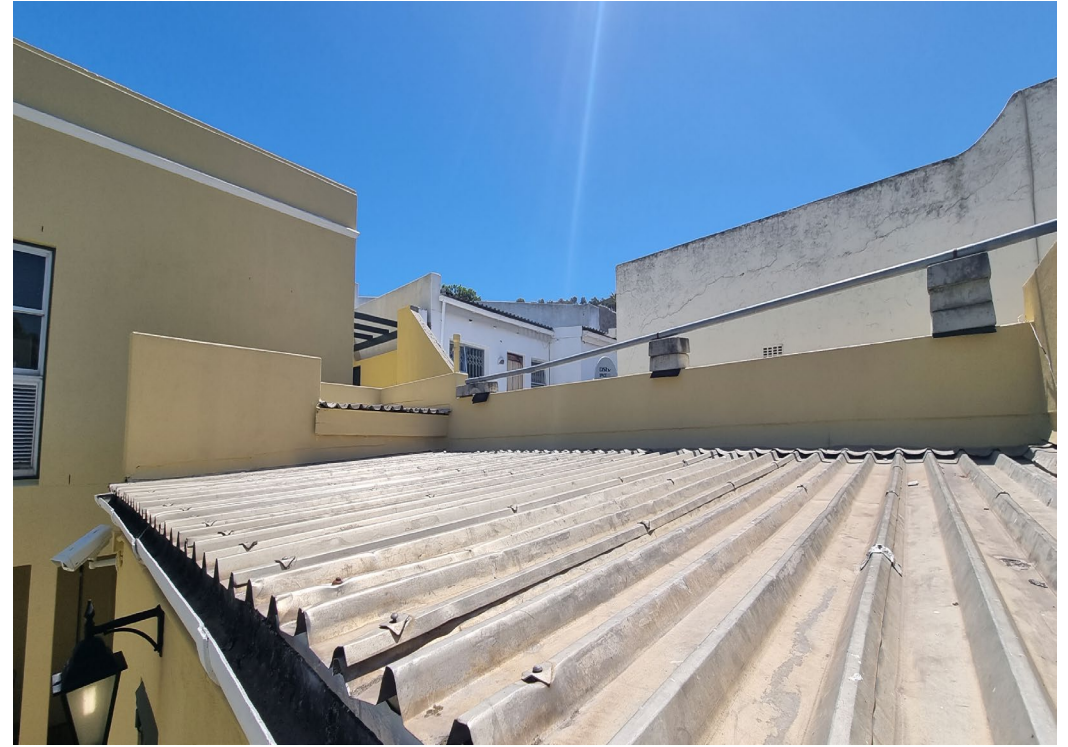
*Figure 32: Image shows the roof sheets have a limited lifespan with visible previous repairs and damage to sheets. Replace fixing screws, fit poly closures to end of sheets.*

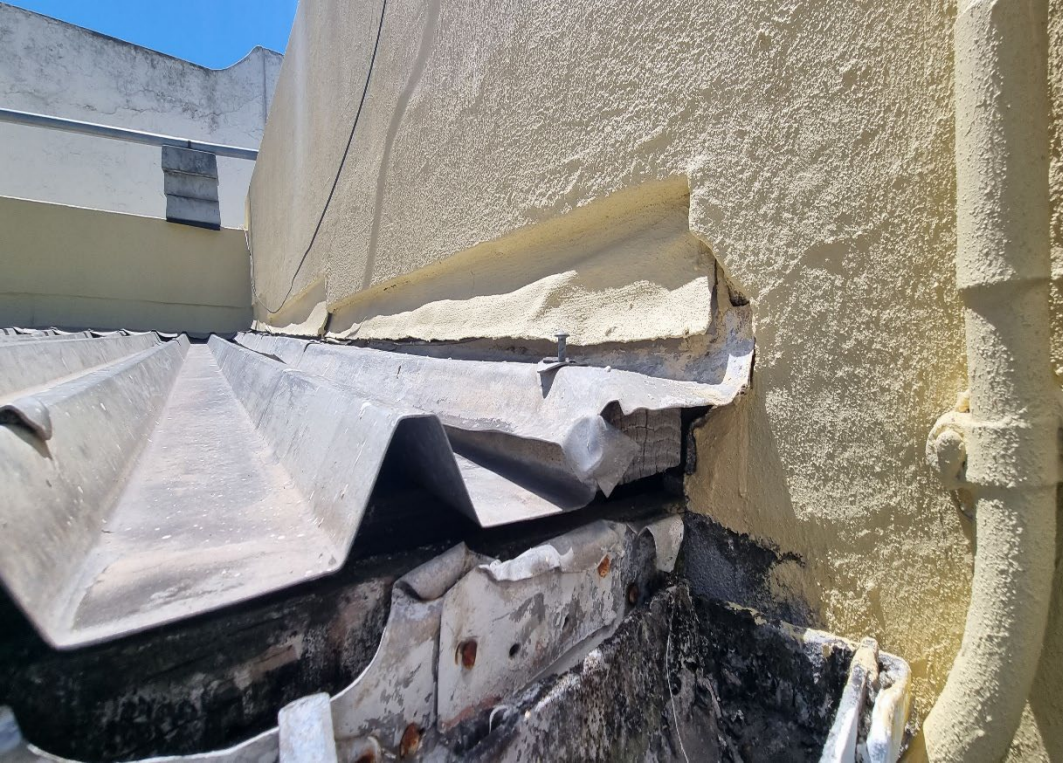
*Figure 33: Image shows the roof sheets have a limited lifespan with visible previous repairs and damage to sheets. Replace fixing screws, fit poly closures to end of sheets. Fit new flashings to head and sidewalls.*

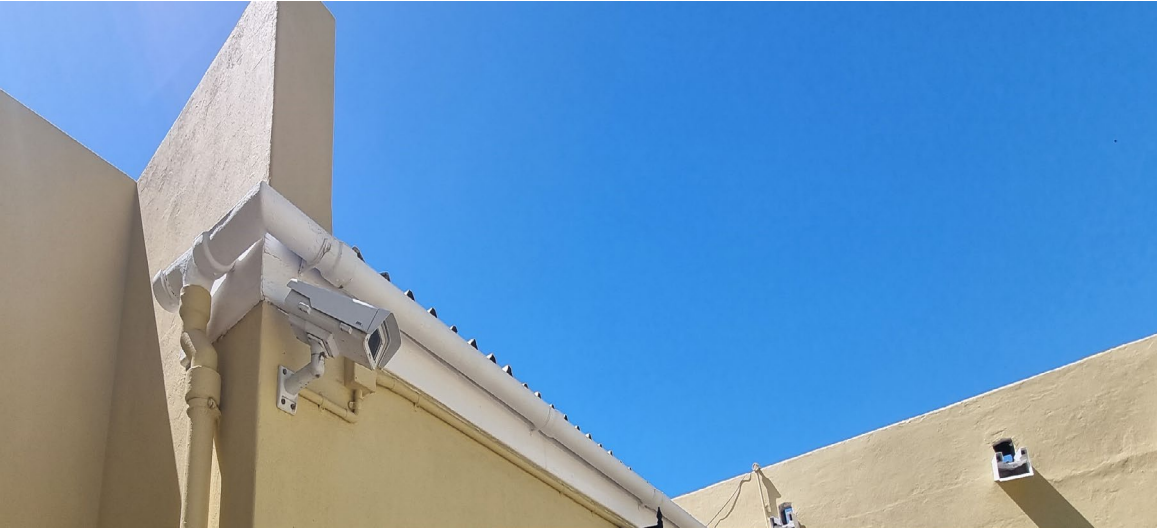
*Figure 34: Image shows visible damage to Rainwater goods – replace with fibre cement.*

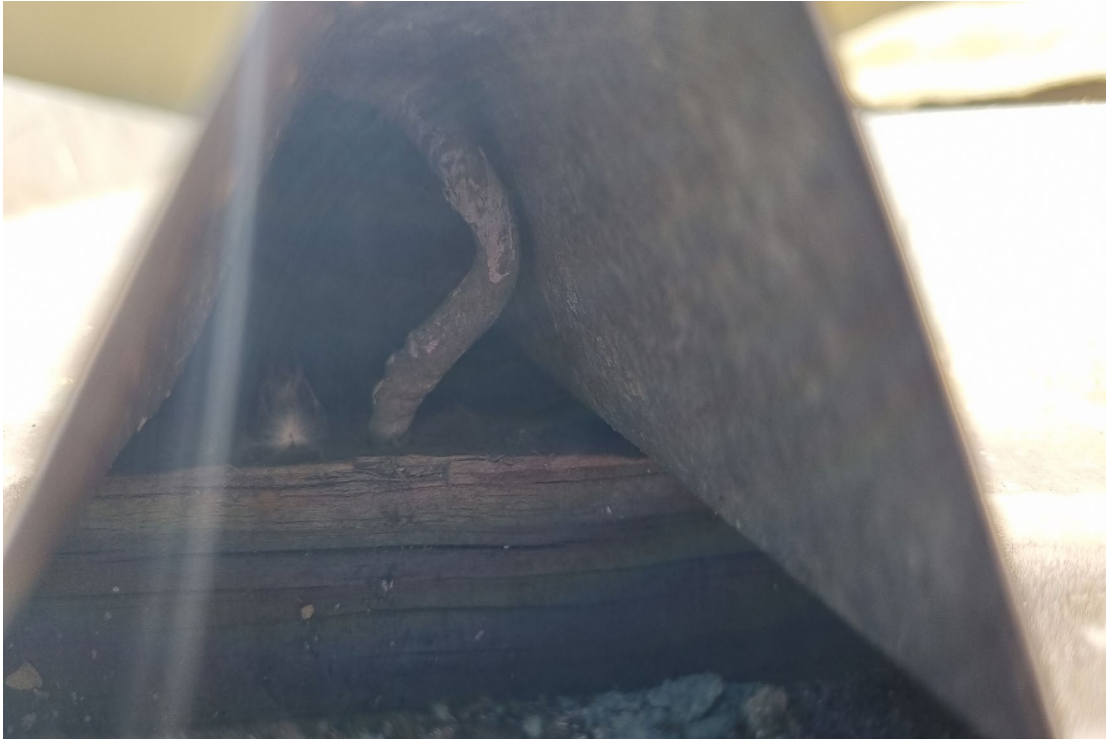
Figure 35: Image shows roof sheets has limited lifespan with visible previous repairs and damage to sheets. Replace fixing screws, fit poly closures to end of sheets.

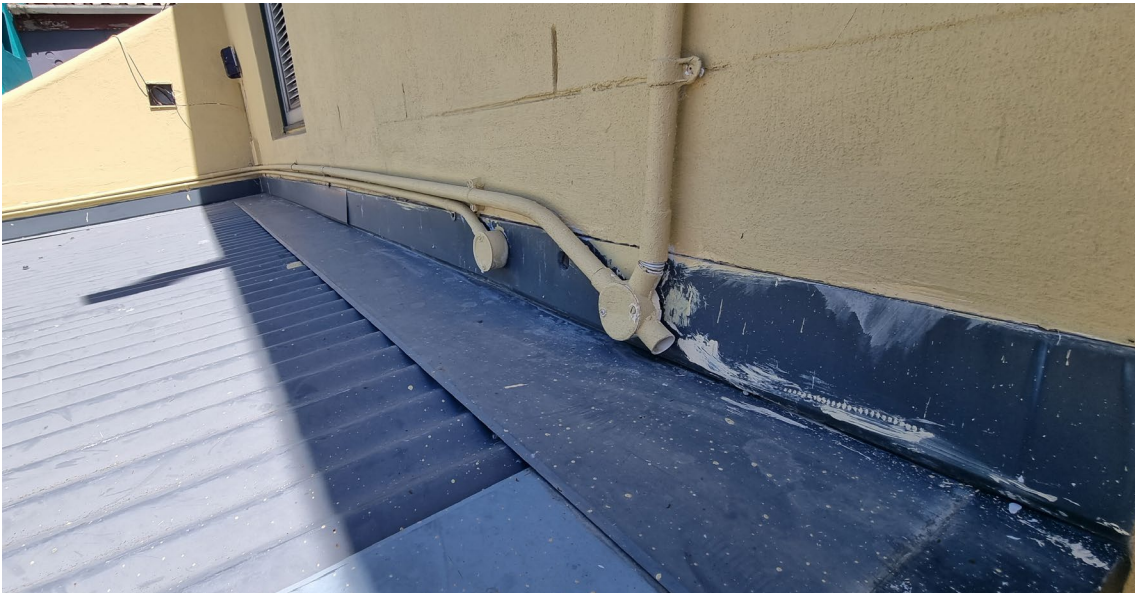
Figure 36: Image shows visible damage to headwall flashing and retrofitted services penetrating plate and compromising water ingress.

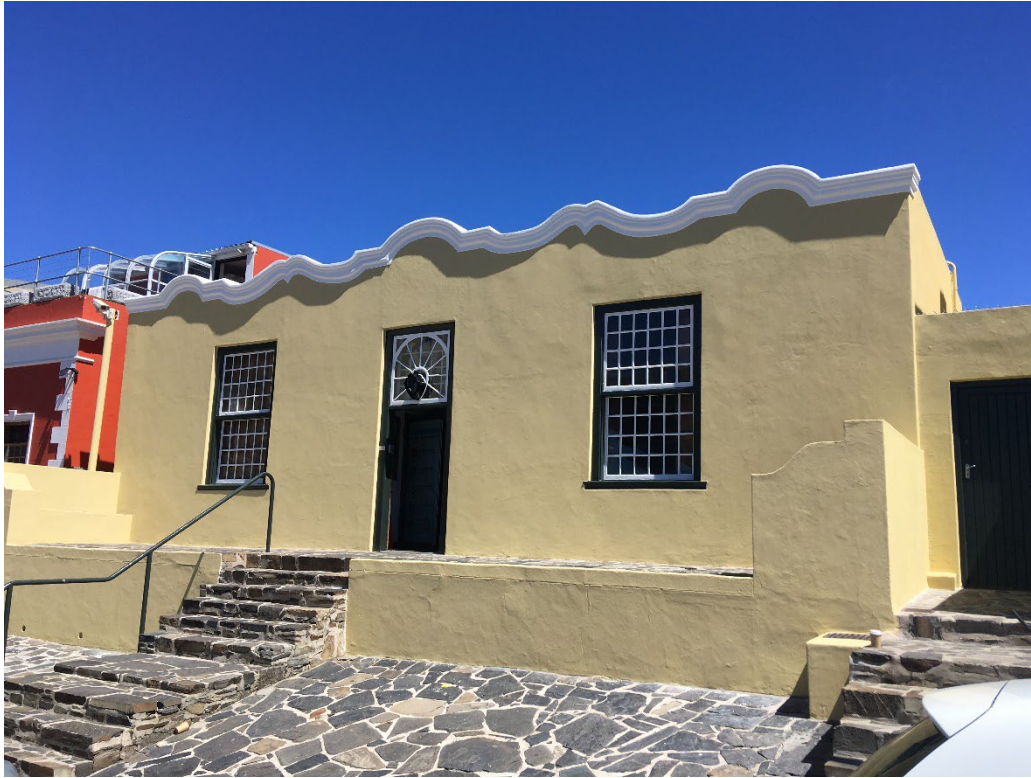
*Figure 37: Image shows the front façade of the museum with neighbouring buildings from Wale Street.*
