Exxaro Matla Coal Mine Biomonitoring Project 2016/2017 Annual Aquatic Ecology Biomonitoring Report 2016/2017

Aquatic Biomonitoring Report

Project Number: EXX3078

Prepared for: Exxaro Coal Mpumalanga (Pty) Ltd

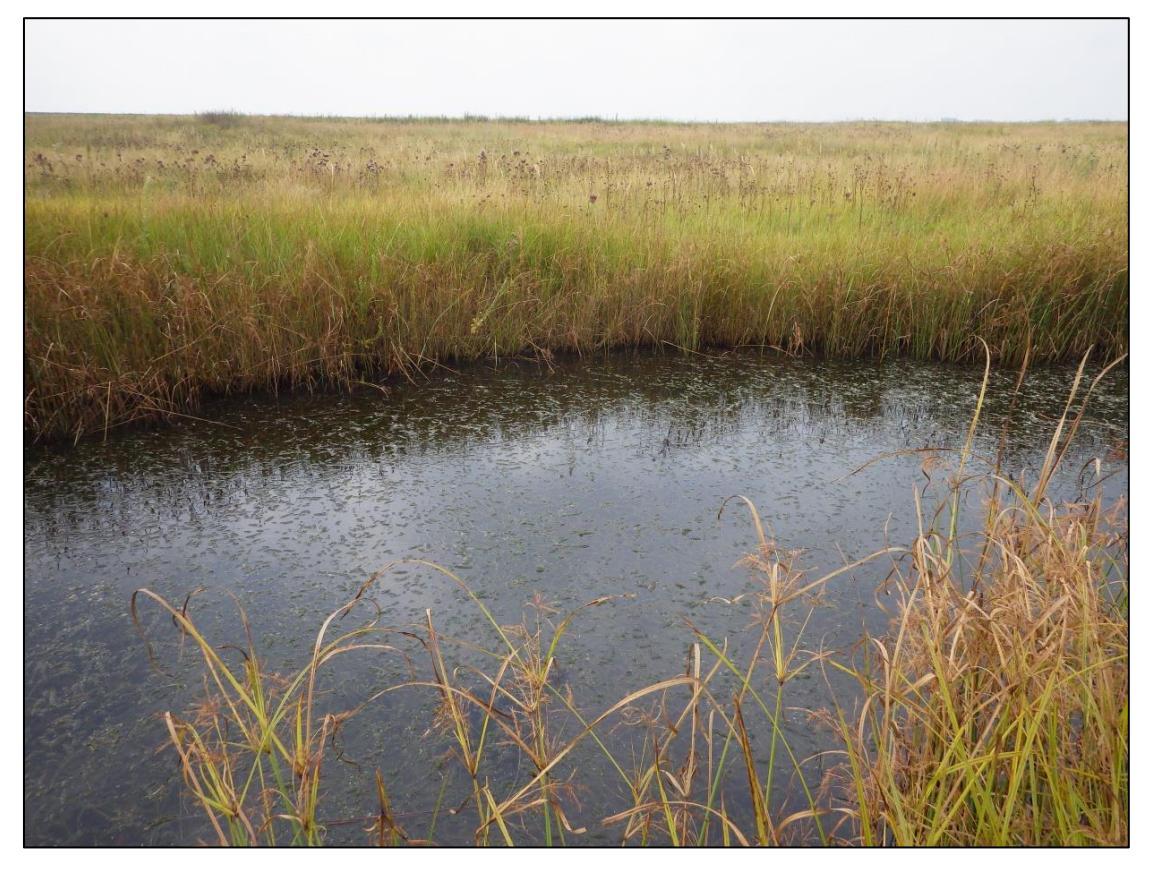
Figure 7-1: Typical invertebrate habitat at NS3 (March 2017)

The IHAS conducted during both surveys also categorised the available aquatic macroinvertebrate habitat at all of the assessed New Shaft Tributary sites as poor. Similarly to the biotope ratings, the lowered scores were mainly a result of lack of flow as well as missing habitat structures such as cobbles.

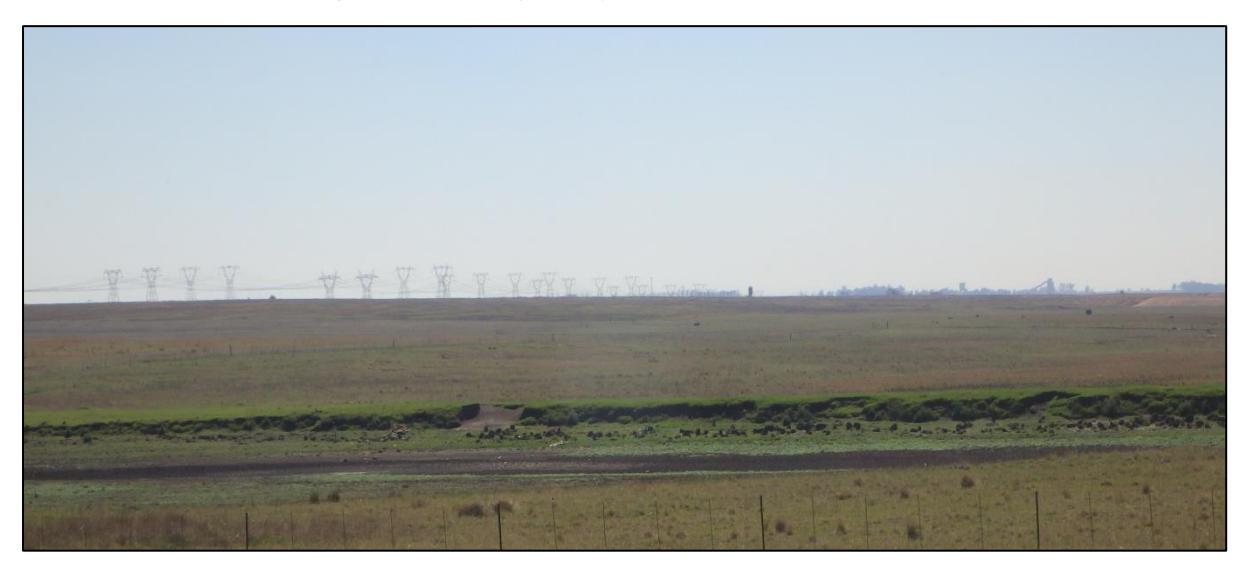
For the purpose of this study MAT1 and MAT2 were kept as the initial monitoring sites which were observed as dry throughout the study. The following image illustrates the dry conditions observed at the initial impounded site (MAT2).

Figure 7-2: Dry conditions observed at the initial MAT2 site

However, no water appeared to be flowing out of the impoundment and it was found to be dry during the 2016/2017 study period. Therefore, it is proposed that the sites officially shift to monitor the water quality entering the river diversion. The proposed new sites are depicted in Appendix A where MAT1 represents the farm dam and MAT2 represents the river diversion below the dam. The initial sites were used in this study (both dry during both surveys) but it is suggested that the new sites are monitored in the future studies. Lastly, a new site (MAT New) was selected downstream of the initial impoundment (MAT2) and was assessed during the high flow survey. The GPS coordinates for this site are 26°15'4.69"S 29° 02'18.10"E. This site provides a better indication of the aquatic health compared to the upstream impounded site. Therefore, it is proposed that this site is also included in future monitoring.

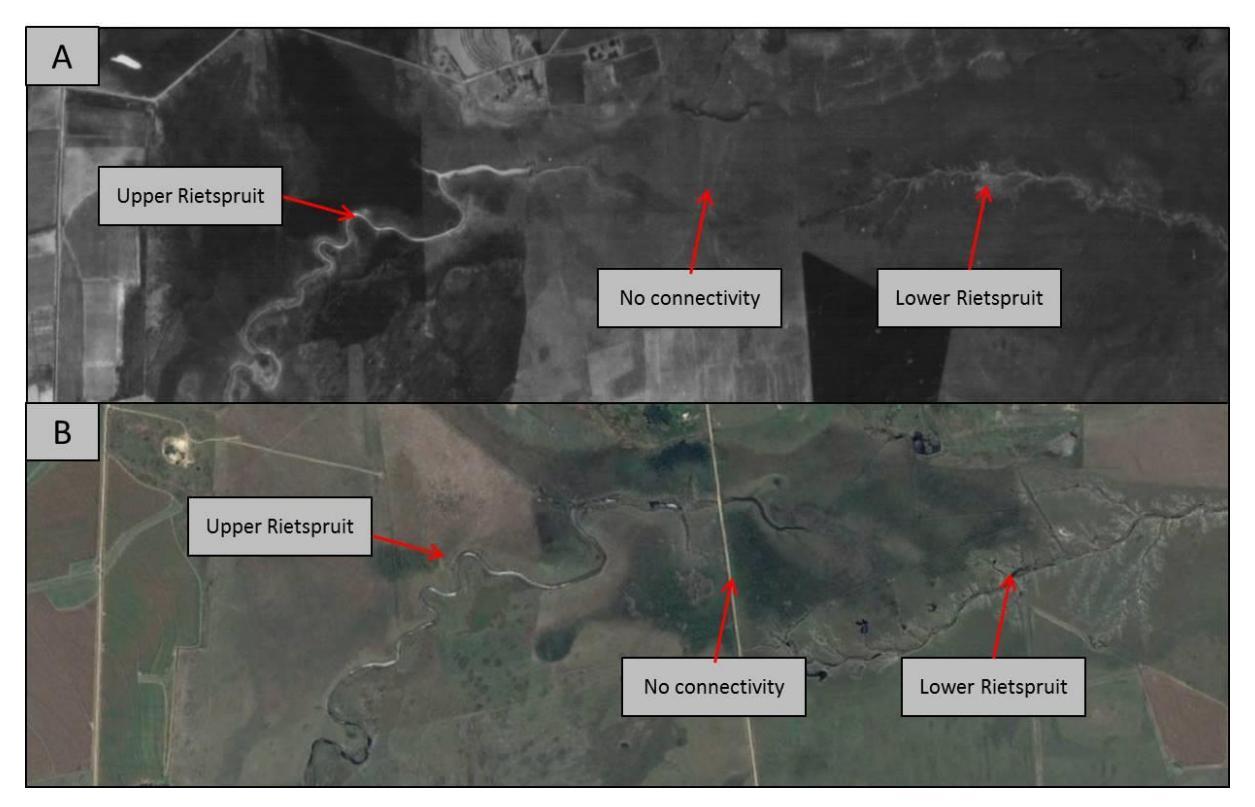
As explained in the previous study conducted by Digby Wells (2015/2016), a loss of connectivity between the Upper and Lower Rietspruit has occurred. Aerial imagery from 1955 suggests that connectivity between the upper and lower Rietspruit has been lost and continues to this day as illustrated in the image below (Figure 7-3). The loss of connectivity can therefore not be attributed to the construction of the river diversion. The likely cause of the loss of connectivity can be attributed to historical mining activities whereby a river was diverted and rehabilitation did not reconstitute the river channel.

Figure 7-3: Loss of connectivity between upstream and downstream Rietspruit. A: 1955; B: 2016 (Google earth™)

Due to the loss of connectivity the sites located in the upper Rietspruit (MAT1-MAT7) cannot be compared to sites located in the lower Rietspruit (BP1-BP4). Therefore, for the purpose of the discussion the Upper and Lower Rietspruit sites have been separated.

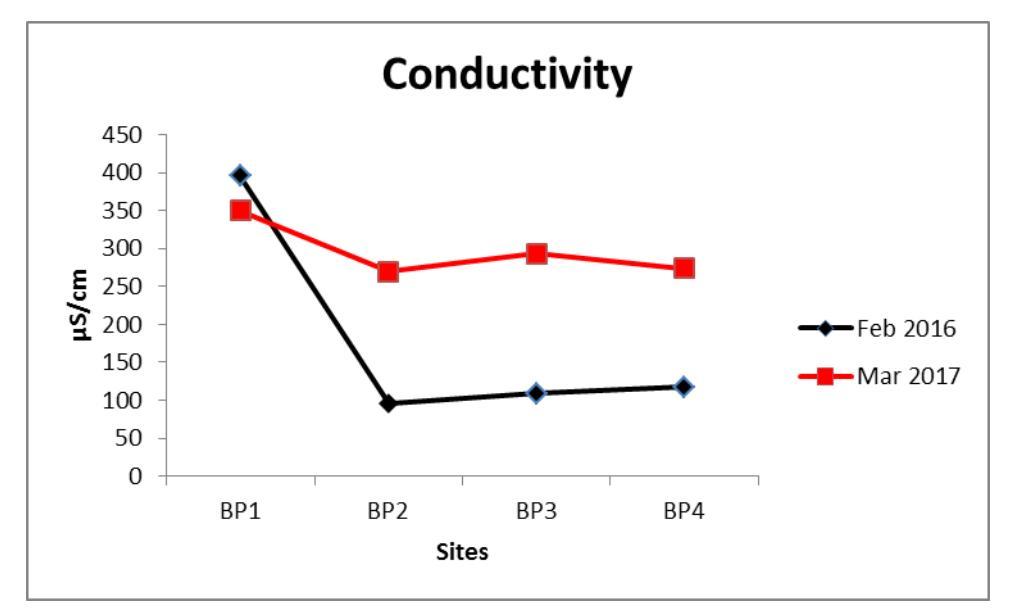
Figure 7-5: Conductivity scores recorded in the Lower Rietspruit during February 2016 and March 2017

As illustrated by the above graph (Figure 7-5), the downstream (BP2-BP4) conductivity values were lower during the 2016 high flow period compared to the 2017 survey. Despite these values being below the threshold effect value of 700 μ S/cm, the increase in overall dissolved solids load is of concern and should be carefully monitored.

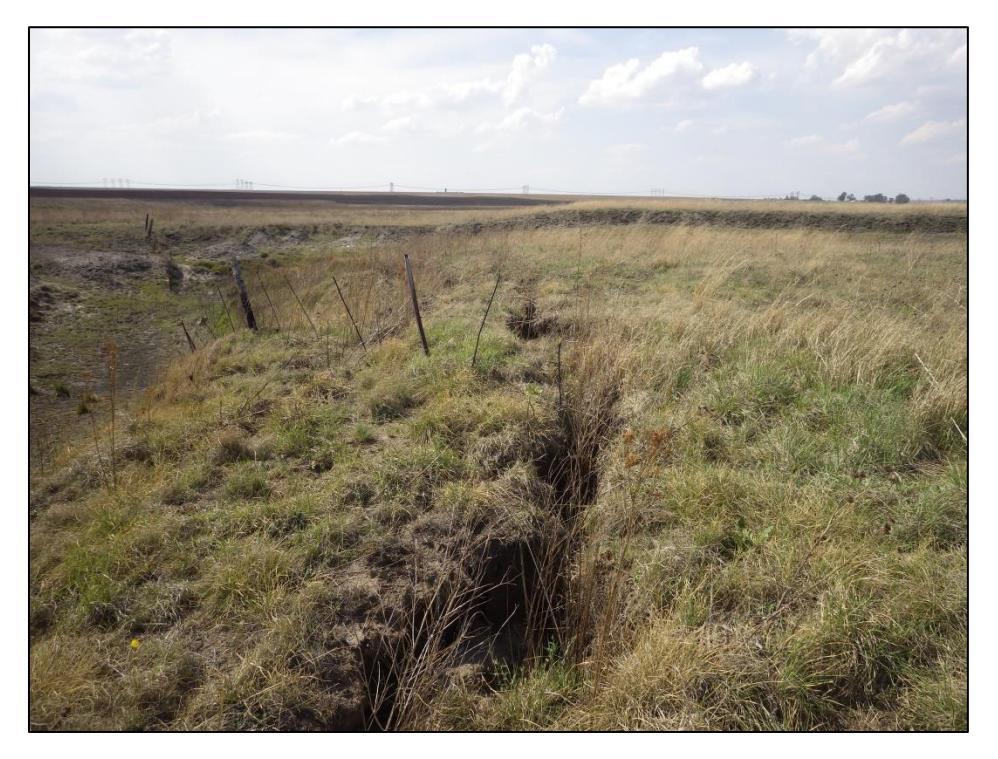
The fractures that were observed in the previous study (Digby Wells, 2015/2016) were still present throughout this study. The image below (Figure 7-6) illustrates one of the large fractures observed along the banks of MAT5. It appears that these fractures are increasing in size and should be carefully monitored.

Figure 7-6: Fractures in the banks of the Rietspruit at MAT5 (October 2016)

The presence of livestock agriculture within the Rietspruit channel should be limited, by increasing the numbers of "no-go areas", as per the approved Wetland Management Plan. In addition, cracks/fractures on the banks of the upper Rietspruit, caused as a result of subsidence should be rehabilitated.

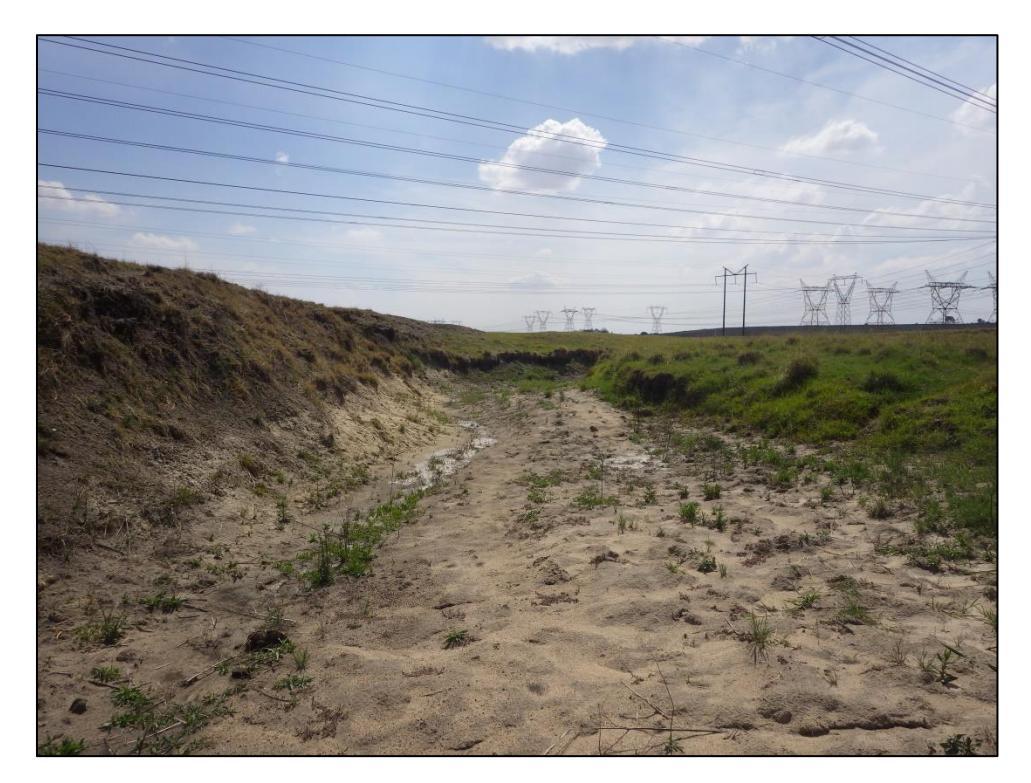
In addition to the fractures, erosion was extensive within the banks of the river diversion itself and in the lower Rietspruit as observed during the 2015/2016 study. The effects of erosion appear to be compounded by the presence of livestock which were observed in abundance within the Rietspruit. The following image (Figure 7-7) represents the bank erosion as well as the resulting sedimentation of the river bed at BP1 during the low flow survey. Large portions of the riparian habitat of the Rietspruit adjacent to the river diversion have been protected from livestock impacts through the implementation of a no-go area for the animals. However, an increase in these no-go areas is suggested as well as the planting of vegetation along the eroded areas of the river diversion banks to maintain long term stability.

Figure 7-7: Erosion and sedimentation observed at BP1 during the low flow survey

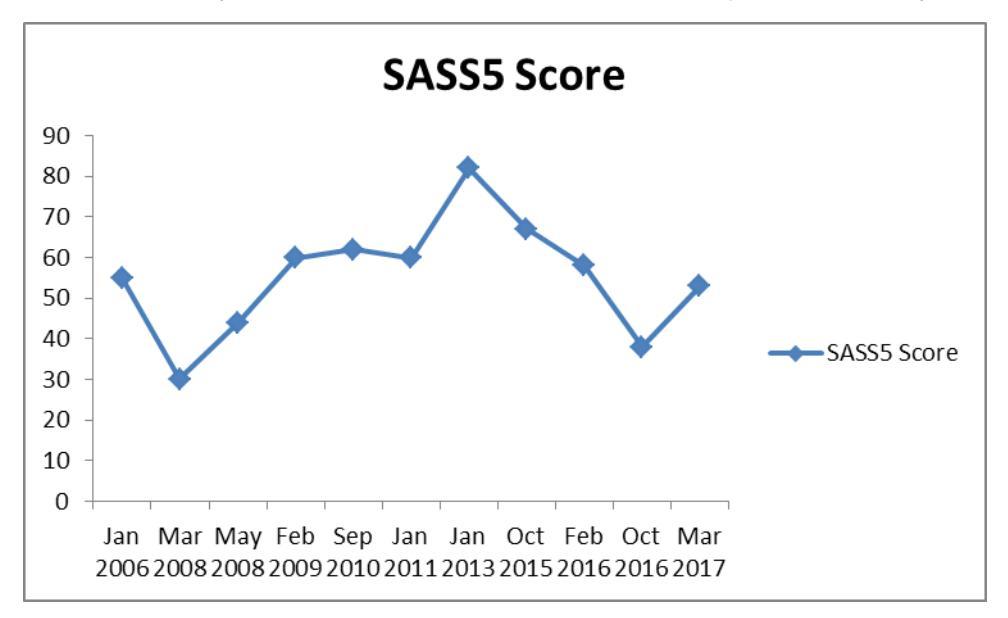
According to the approved WUL for the river diversion the SASS5 scores may not be reduced by 20% with ASPT values not degrading by 10%. Considering the results at MAT6 over the entire study period (Figure 7-8), during the 2016/2017 study period the SASS5 scores have remained in the threshold monitoring value with a value fairly similar to that recorded during the January 2006 survey. The ASPT value for the current survey period has also not been reduced by more than 10% from the mean of the previous surveys.

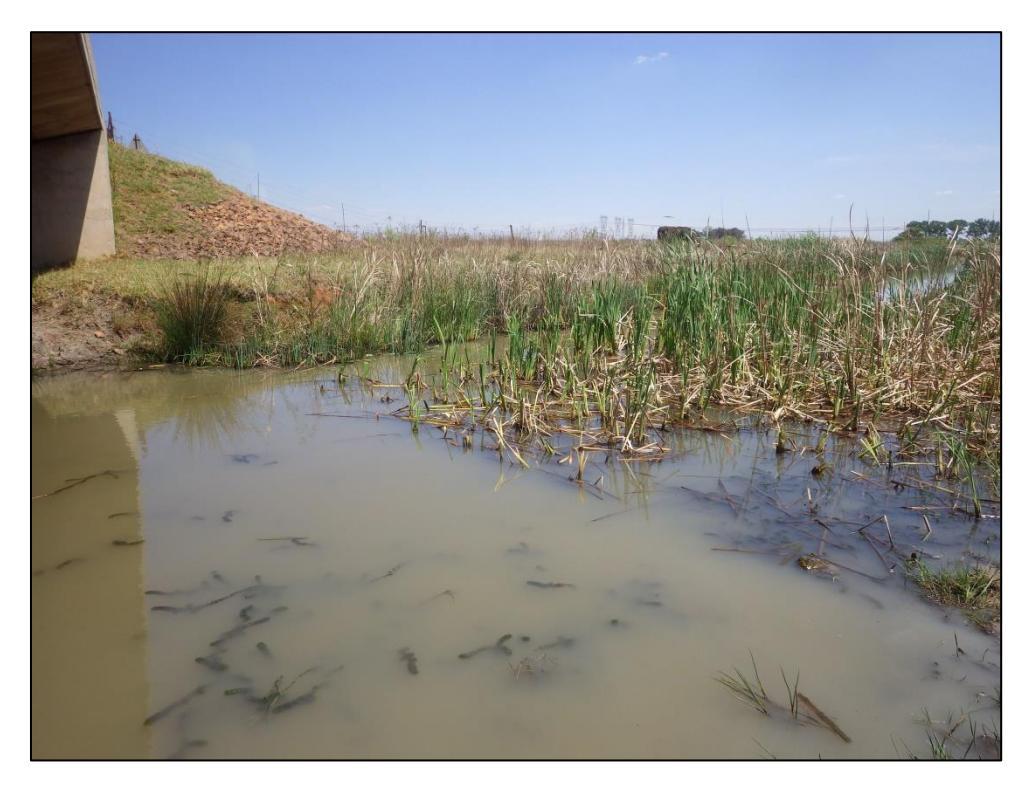
Figure 7-9: Abundance of thick marginal vegetation suited for *Pseudocrenilabrus philander* and *Tilapia sparmanni* observed at BP4

The modified state according to the FRAI for the reach can be attributed to the loss of two sensitive taxa namely *Barbus trimaculatus* and *Chiloglanis pretoriae*. These findings are similar to the previous study conducted by Digby Wells (2016/2017) where habitat loss has resulted in the absence of *Barbus trimaculatus* and historical poor water quality has resulted in the loss of *Chiloglanis pretoriae*. Despite the loss of these two species from the system, the sensitive *Barbus neefi* was sampled during the survey in both the Upper and Lower Rietspruit. This fish species was sampled in the river diversion at the downstream site (MAT7). This provides some indication that the river diversion is functioning as intended and if sampling was extended *Barbus trimaculatus* might have been found to be present.
