HERITAGE STATEMENT OLD ANGLICAN PARSONAGE/ RECTORY NUMBER 40 CHURCH STREET; ROBBEN ISLAND

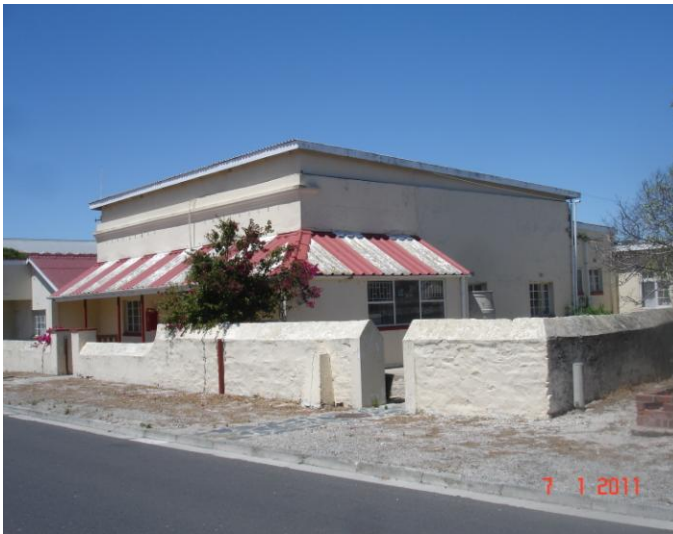
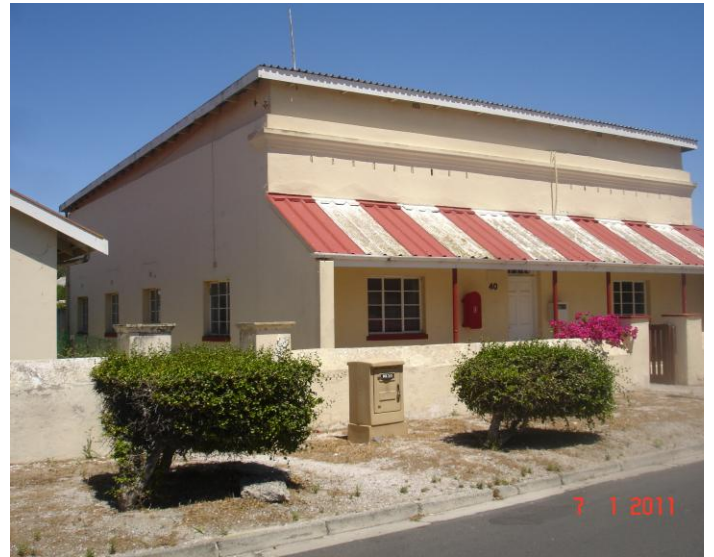
Fig.6.5. and 6.6. Taken January 2011.

The balustrades and verandah supports were made from wood. The original beams still appear to be intact although the supports were replaced by metal poles, presumably sometime during the prison period. The original corrugated iron was replaced with asbestos sheeting. The verandah was also partly glazed in ca 1983.

10.2. The verandah supports should be painted white and not red. This would refocus attention on the building itself, enhance the aesthetics and would be historically based on the colours pre 1994.

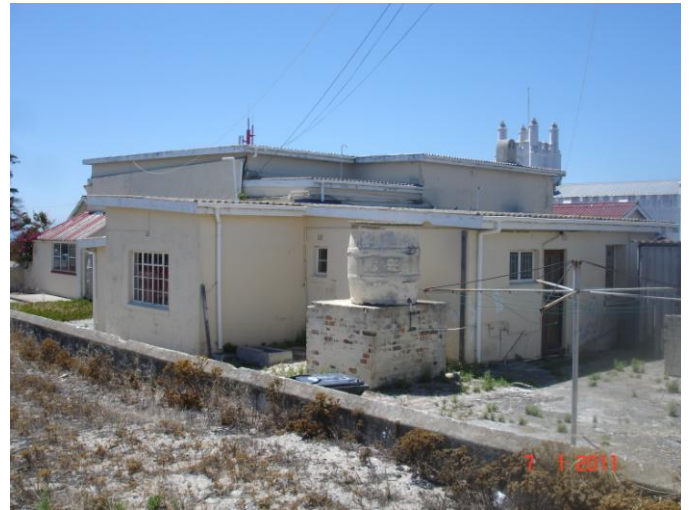
Fig.6.8. annexe ca 2011

The annexe at the back on the NW corner appears to have been built partly from the original outbuildings and the yard wall shown on the 1841 floor plan. More research is required. The annexe was built after ca 1972 but more research is required for confirmation.

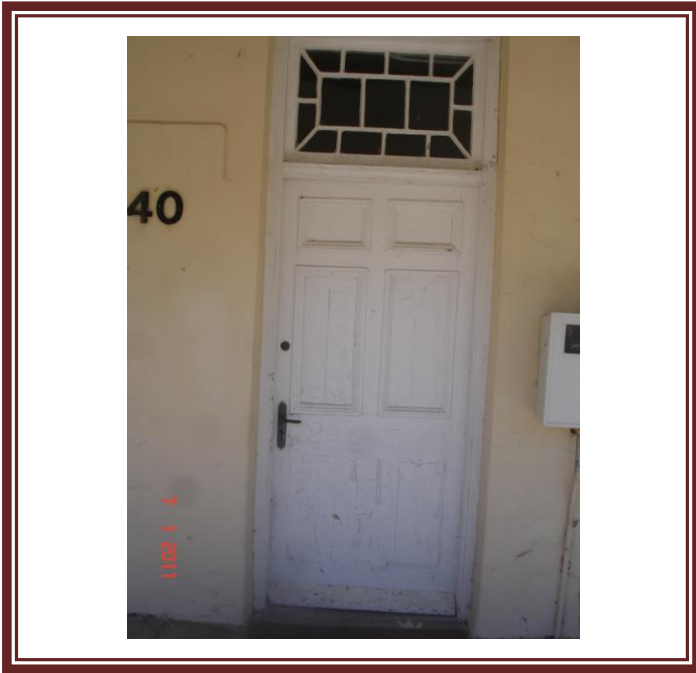
Fig.6.9. Front door

The door is still the original Victorian 'cross and open book' with a fanlight. It appears that it may originally have been green from paint scrapings inspected during January 2011.

Reasonable although modern additions are cracking away from the original structure. The front door was poorly renovated using masonry filler and matt acrylic paint, which is flaking. The boundary wall needs repair in certain places. The water tank plinth bricks need attention. One metal window frame is badly rusted and needs to be replaced. The tin roof is in good condition. The verandah and annexe asbestos roofing requires attention.

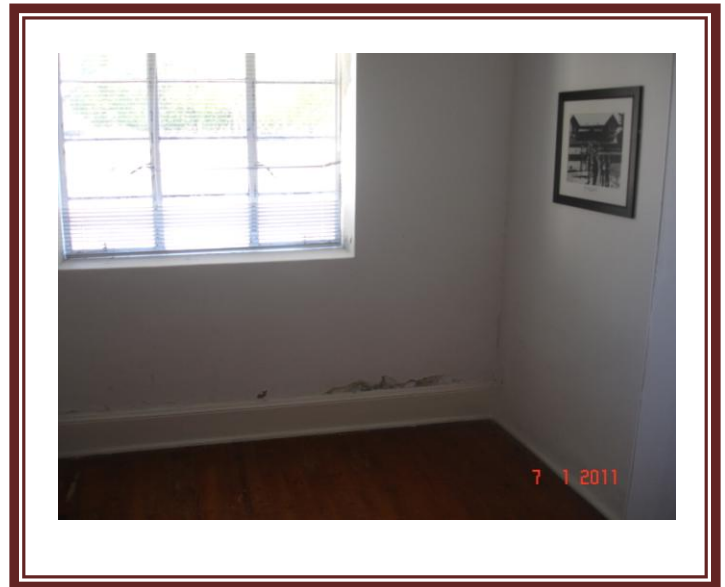
Fig.6.12. Wood floors and rising damp

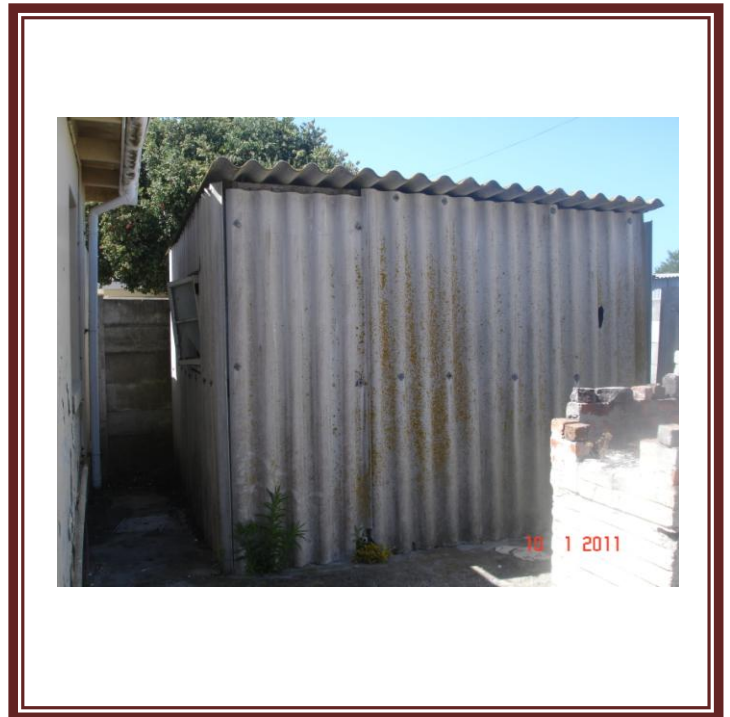
By 1894 the yard wall had been removed and outbuildings consisted of servants quarters and the buttery and creamery. By the late 1980's the asbestos clad tool shed was erected close to the walls of the annexe.

Fig. 6.14. Asbestos tool shed

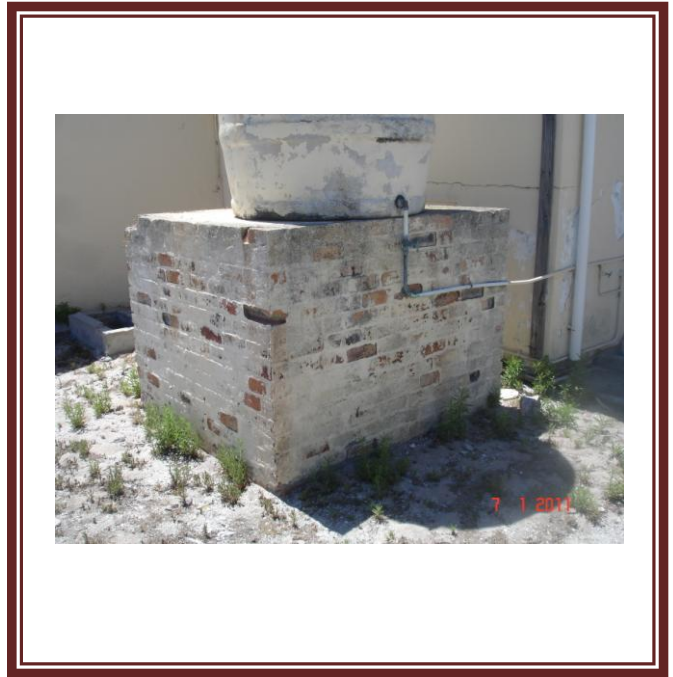
A braai was also built during the 1980's. An asbestos water tank stands on a clay brick plinth, with some of the bricks in a bad state of decay.

Fig.6.16. Asbestos water tank
