HERITAGE STATEMENT HOUSE NUMBER ONE IRISH TOWN; ROBBEN ISLAND

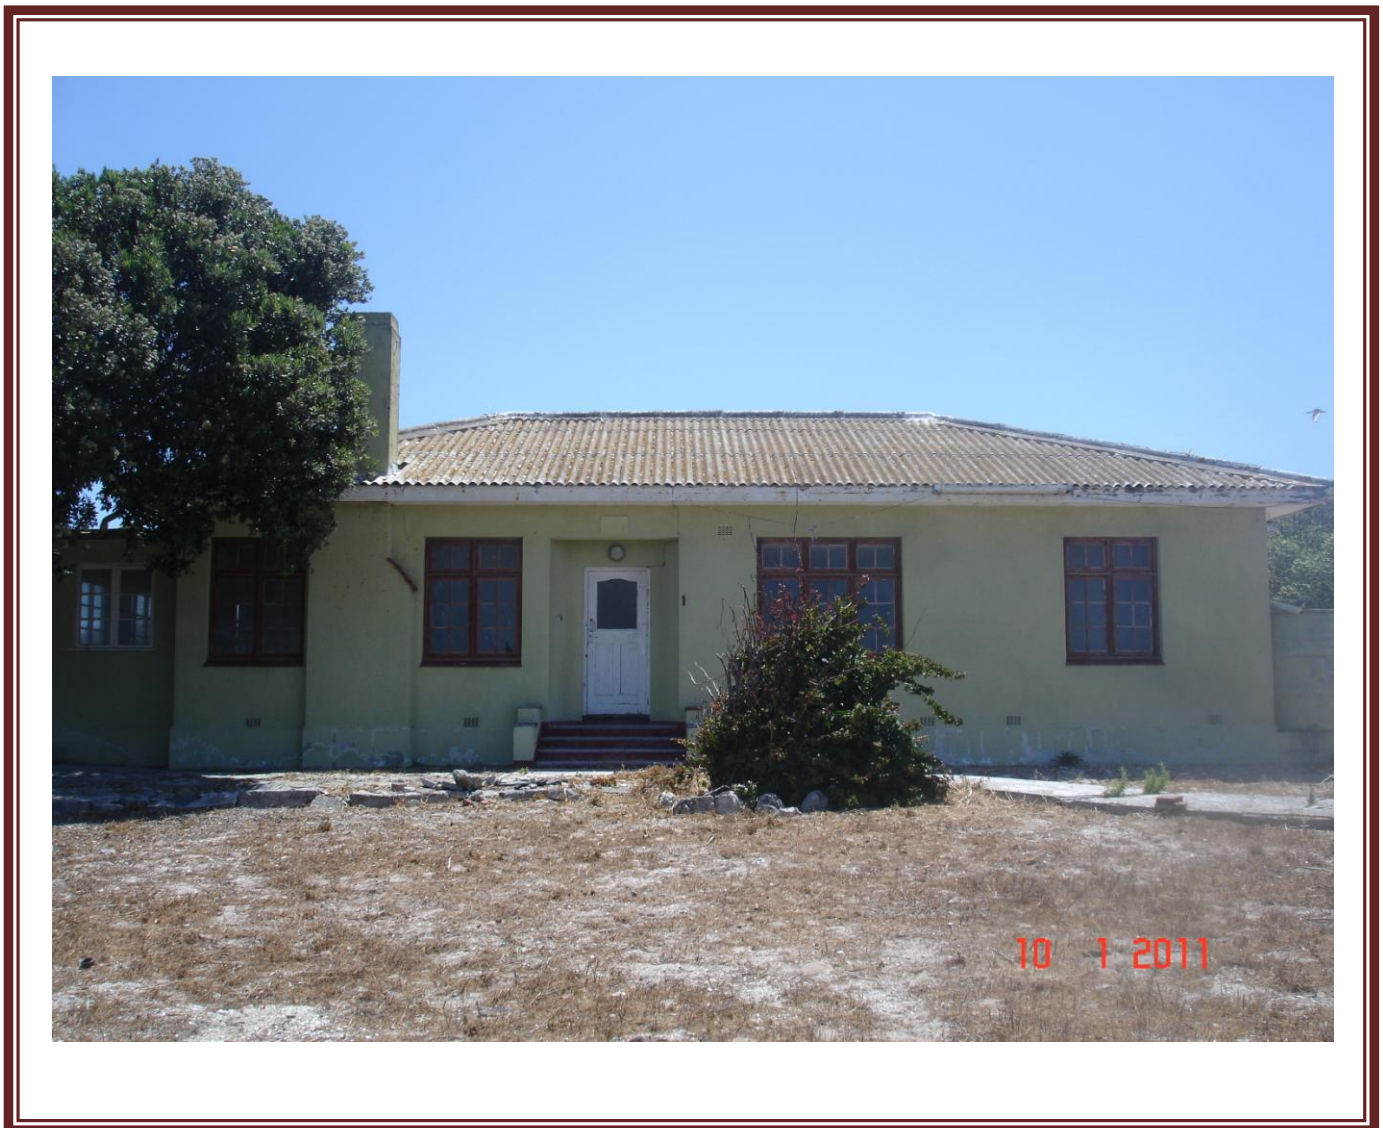
Fig.7.2.1. Front, facing east towards Table Mountain.

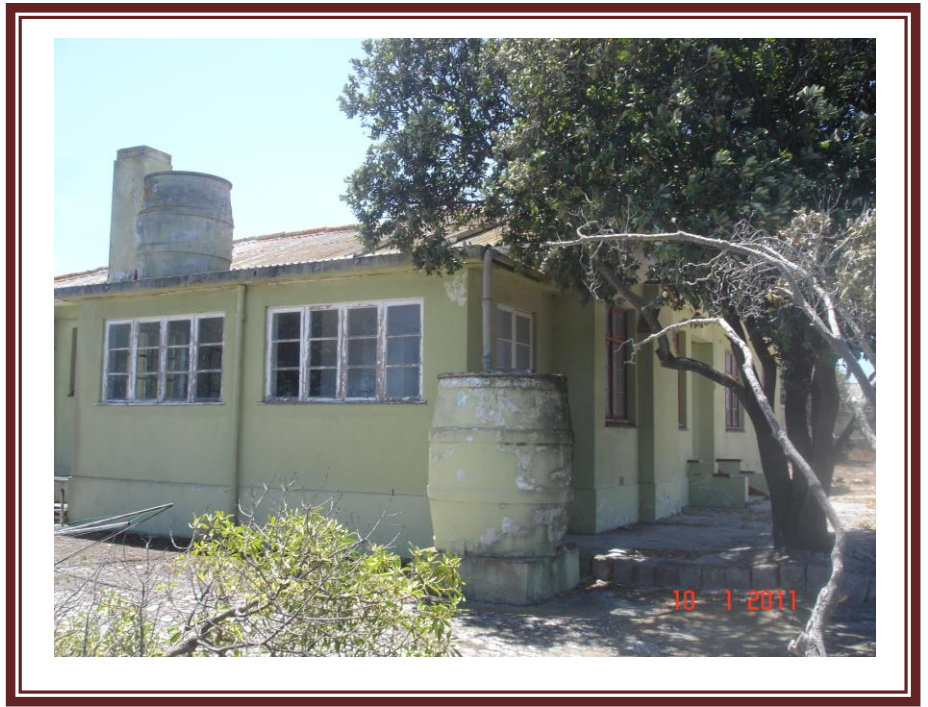
Fig.7.1.3. SE corner with enclosed verandah

The precast roof of the enclosed verandah is spalling, the waterproofing has disintegrated. Some asbestos gutters missing.

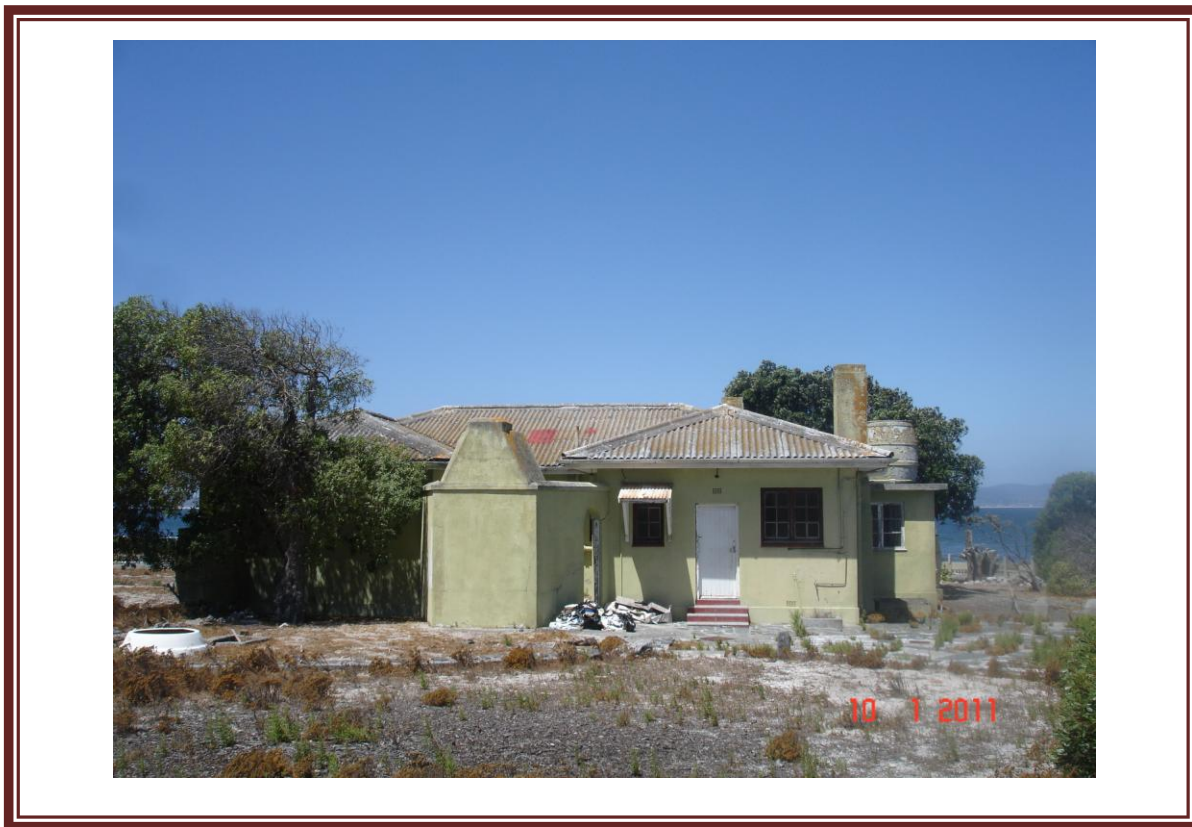
Fig.7.1.4. Rear facing west.

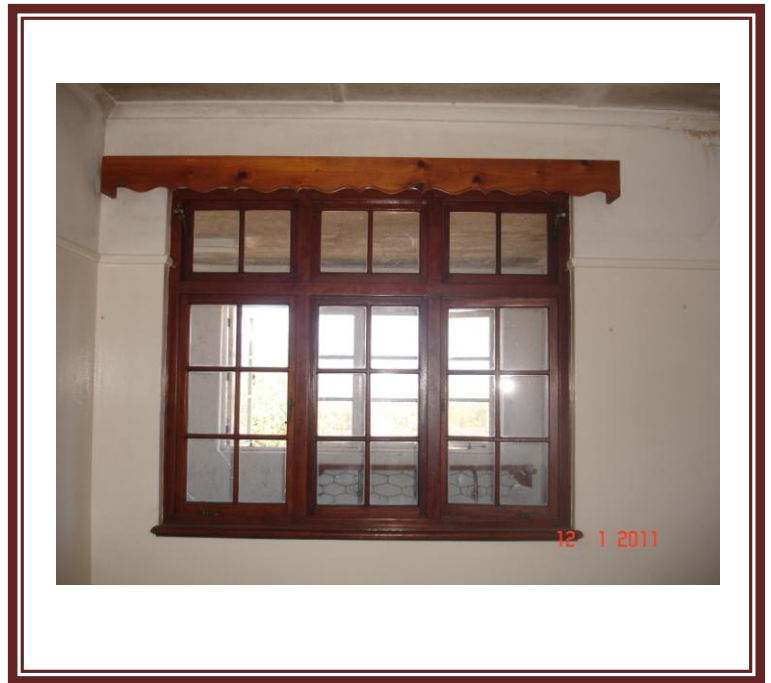
Fig.7.1.8. Wooden window with SA pine pelmet

- 11.1. The varnish stain on the exterior of the wooden windows should be removed and the windows returned to their original clear varnish.
- 11.2. The water tank on the roof of the verandah should be removed and replaced on its historic plinth next to the verandah and kitchen chimney.
- 11.3. Repairs and renovations must be done in accordance with the specifications of the conservation architect.
- 11.4. The interior must also be renovated at the earliest opportunity.
- 11.5. It would be appropriate to reinstate the garden and its landscaped elements.
- 11.6. The vibracrete wall may be removed and replaced provided that a representative sample of the original is retained and interpreted.

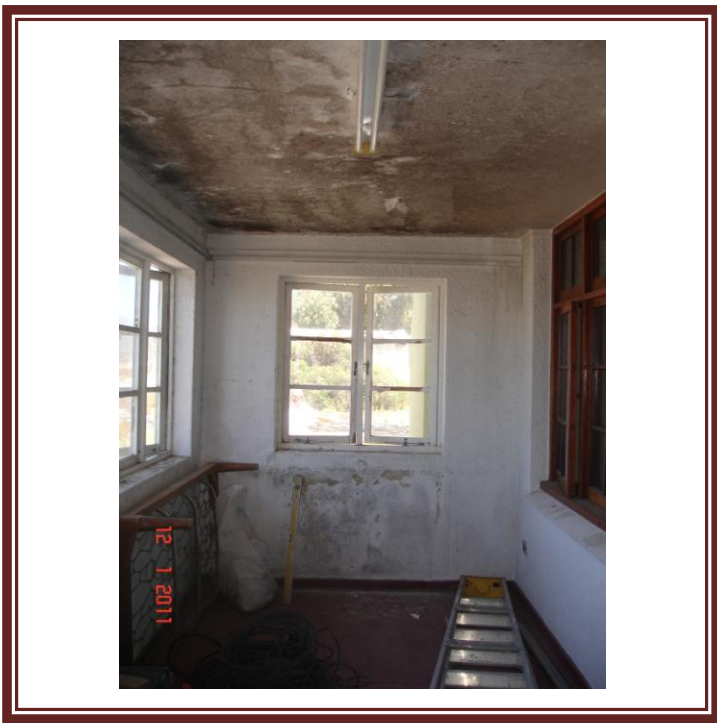
Fig.7.1.9. Interior of enclosed verandah

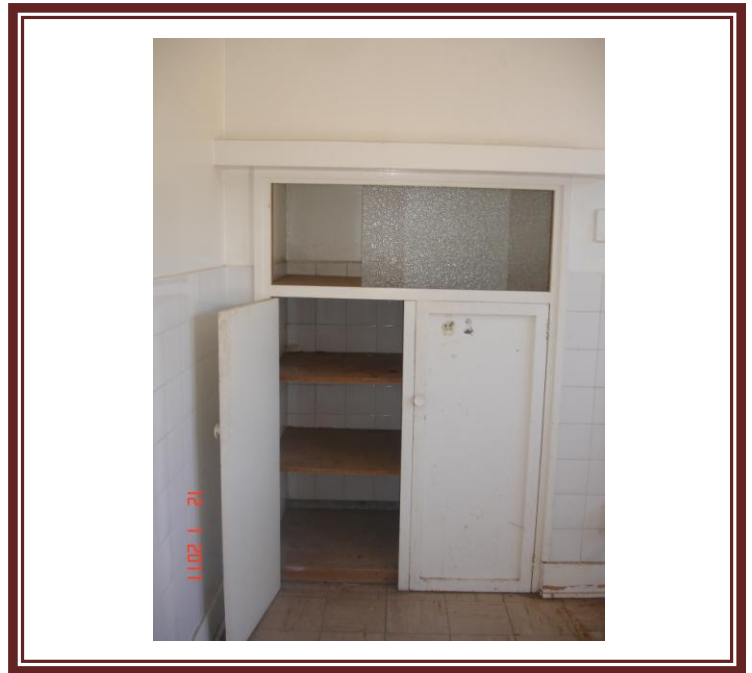
Fig.7.1.12 Alcove for coal stove in kitchen. Cupboard is later addition after removal of stove.

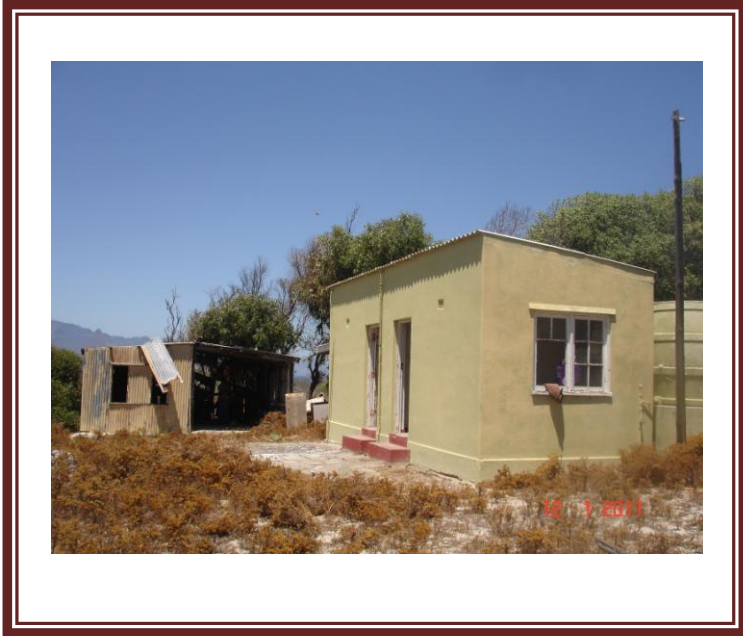
Fig.7.2.1. Servants quarters and garage

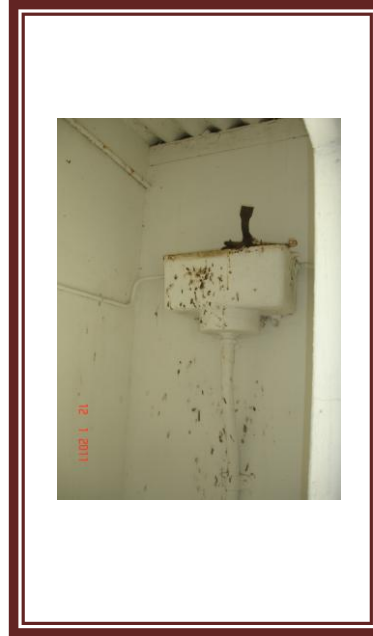
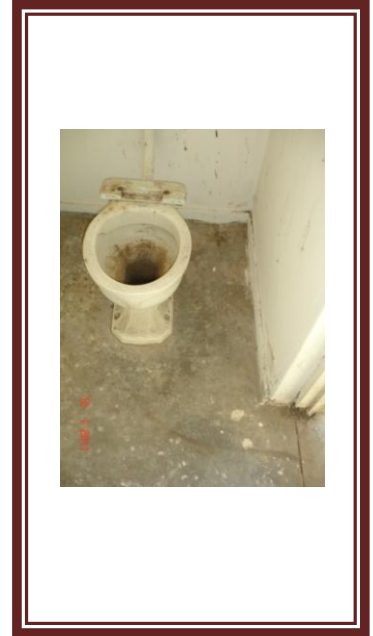
Consists of servants quarters with washing/ toilet facilities. Toilet cistern still the high flush cast iron and chain typical of the period.

Fig.7.2.2. Original toilet system in servants.

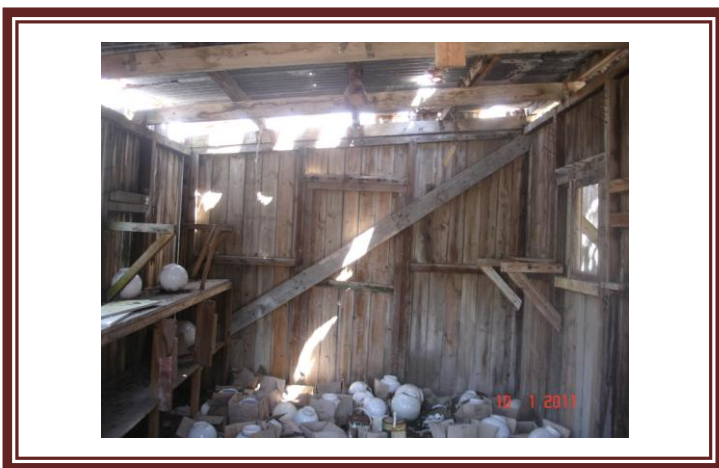
A wooden garage hidden by corrugated iron cladding. The garage is contemporaneous with the house, the corrugated iron being added later. This has to a large degree protected the original structure.

Fig.7.2.3. Interior wooden garage

- 11.7. The wooden garage is contemporaneous with the 1940's style of the house and should be retained. The means must be found to protect the fabric immediately because the corrugated iron roof has rusted and some sheets are missing. The structure must be restored as soon as is practicable.
- 11.8. An alternate use strategy must be provided.
- 11.9. SAHRA must ensure that the maintenance management plan is implemented and monitor its implementation

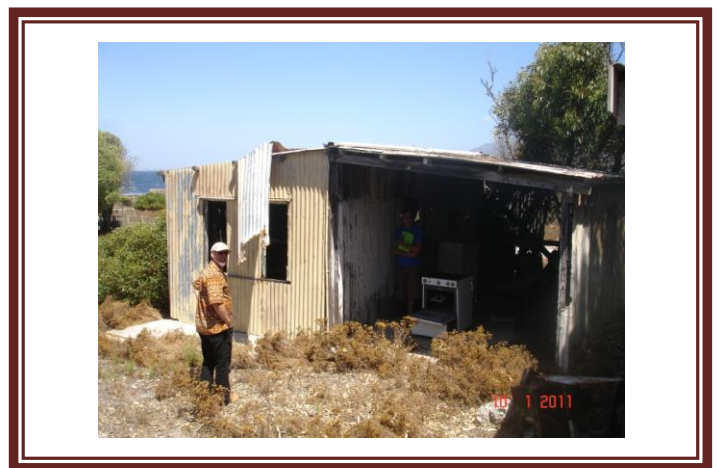
Fig.7.2.4. North face, garage original entrance clad with tin. Original wood exterior can be seen on inside of later tin extension.

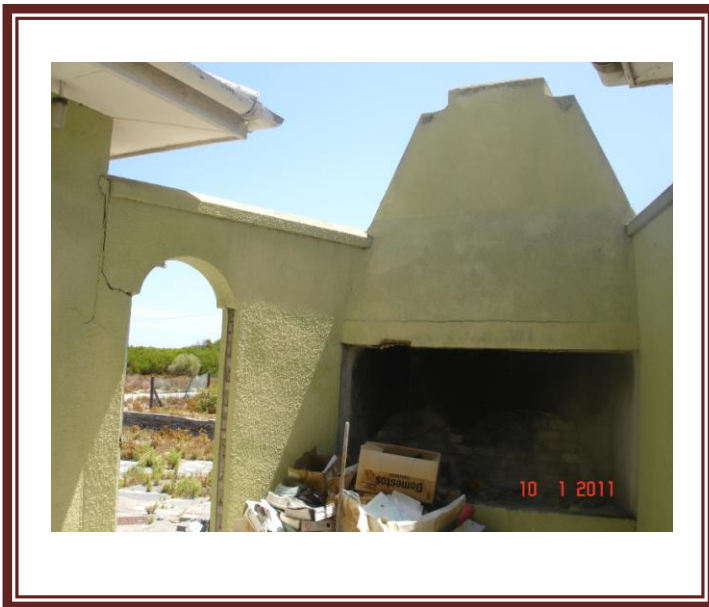
Fig.7.2.4. Braai courtyard.

The main body of the original house is in reasonable condition. The later additions are in a worse state. The braai is detaching itself from the main house where it was latched in. The enclosed verandah window frames are rotten and will need to be replaced in the near future. Some of the plates of the asbestos roof have vertical cracks in the valleys of the corrugation. The roof leaks and attempts appear to have been made to repair these at some later date. Windows were varnished with a stain during the prison period. This has peeled down to the raw wood in most places.

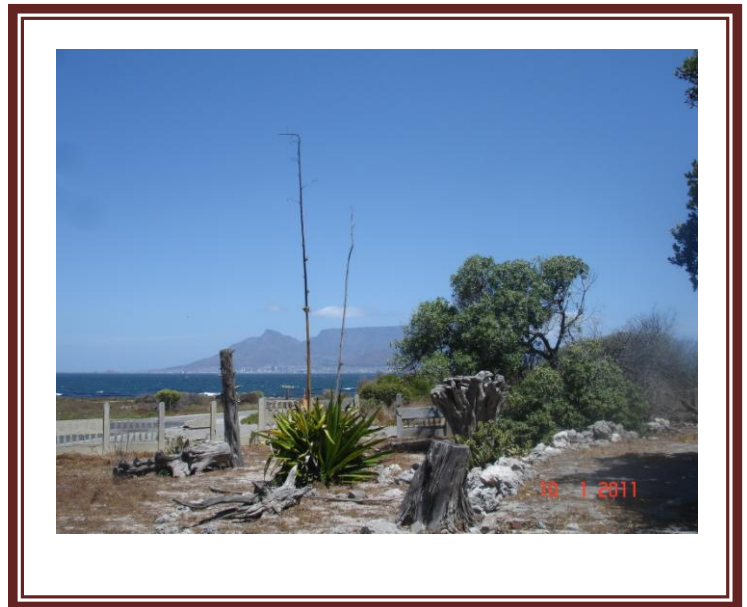
Consist of Vibracrete from the 1970's. In very poor condition.

Fig.7.2.5. Remains of landscape features and vibracrete wall
