HERITAGE STATEMENT HOUSES NUMBERED 35, 36 AND 37 CHURCH STREET ROBBEN ISLAND

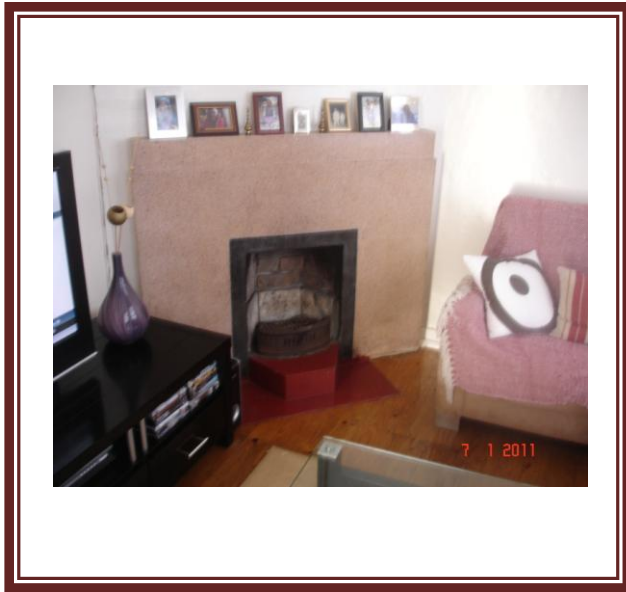
Fig.7.1.1.1. House 35 fire place.

The interior was not examined in depth, except for taking note of ceiling decorations, flooring and the fireplaces for dating purposes. Of note are the early 1940's faux granite fireplaces. As mentioned the masonry square above the front door for the 'T' number is still in evidence.

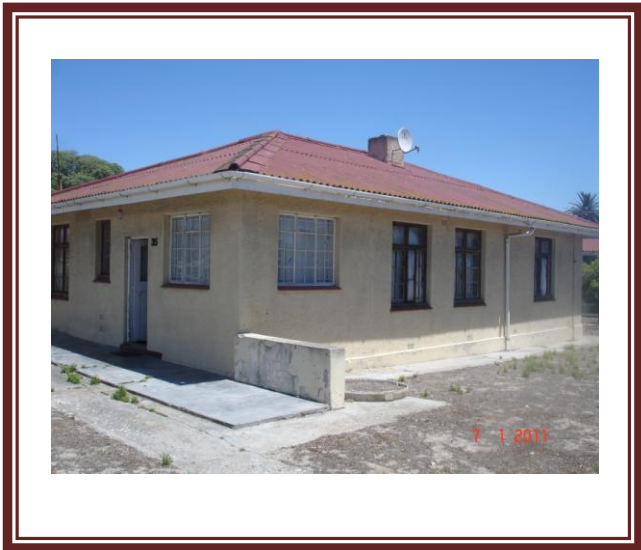
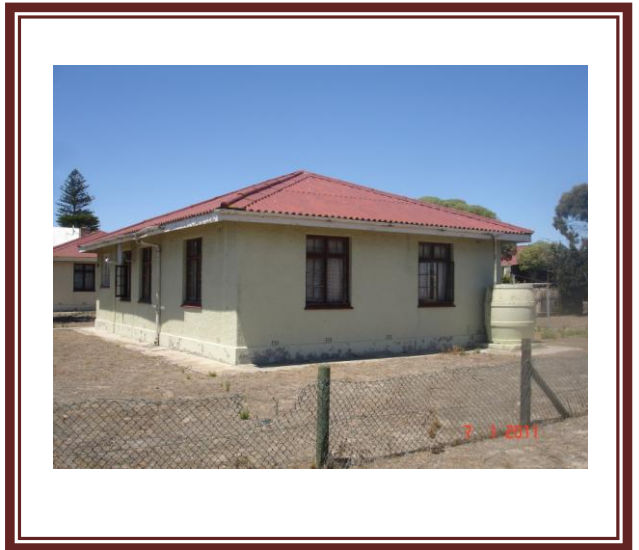
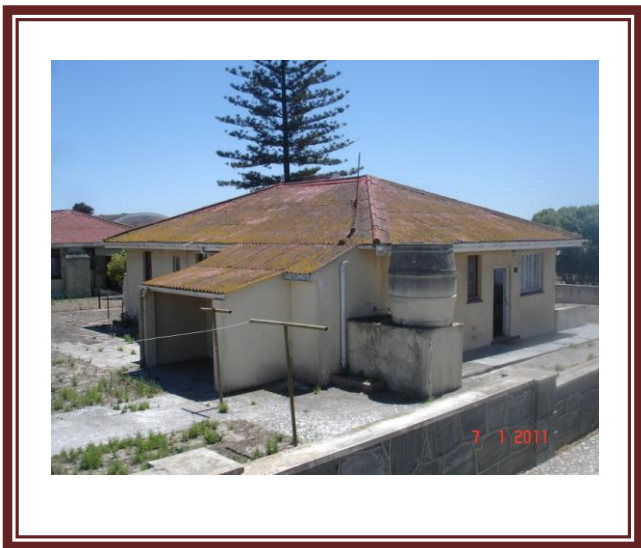
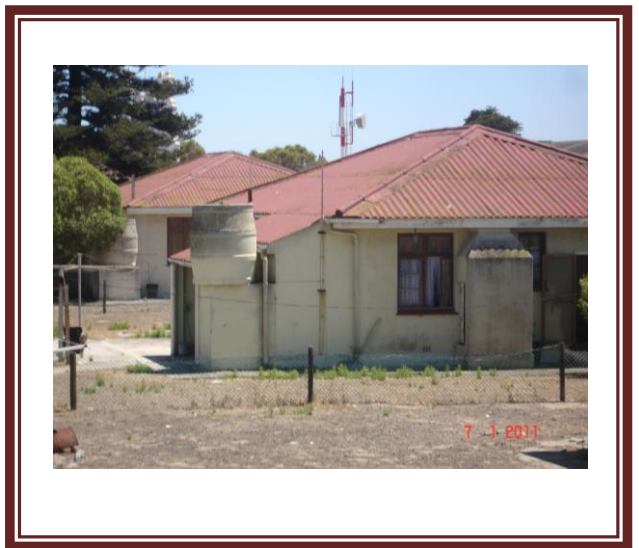
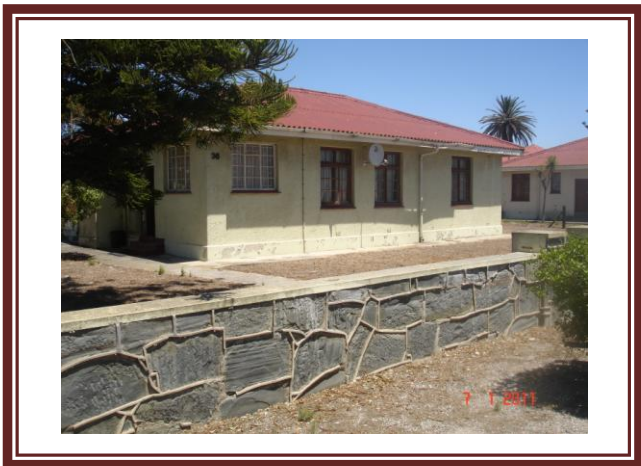
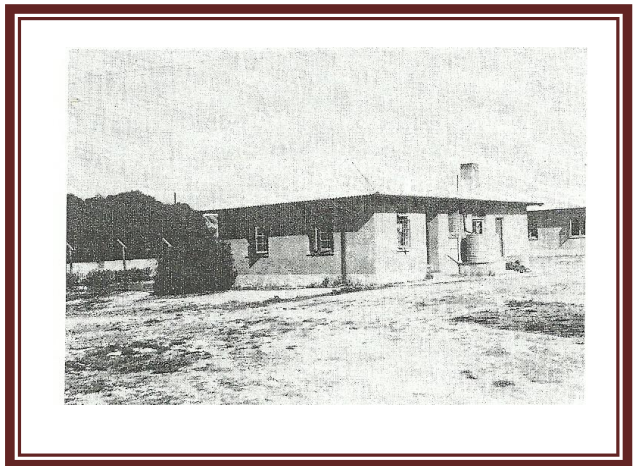
Water tanks were originally positioned for rainwater catchment. This is not the case at present. Considering the Island's and South Africa's severe water shortages it may be prudent to reinstate the tanks in their original positions.

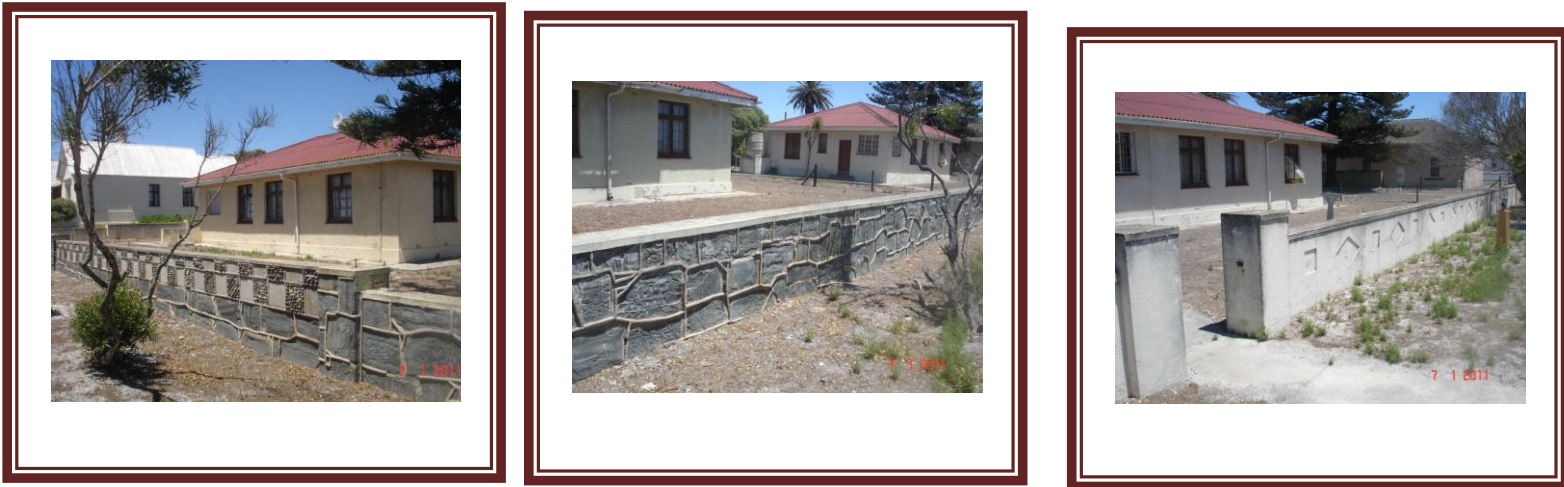
Each house has a unique wall built during the prison period. House 35 has Malmesbury shale cladding on the southern side similar to that of the prison. The same cladding is on the eastern side but with a geometric pattern of squares made from round beach pebbles. House 36 has cladding similar to the prison. House 37 has been plastered with alternating geometric diamonds and squares in the plaster.
