ROBBEN ISLAND MUSEUM: OLD POWER STATION [ca. 1941 to 1991]

PRELIMINARY REPORT No. 5: ARTEFACTS RISK ASSESSMENT.

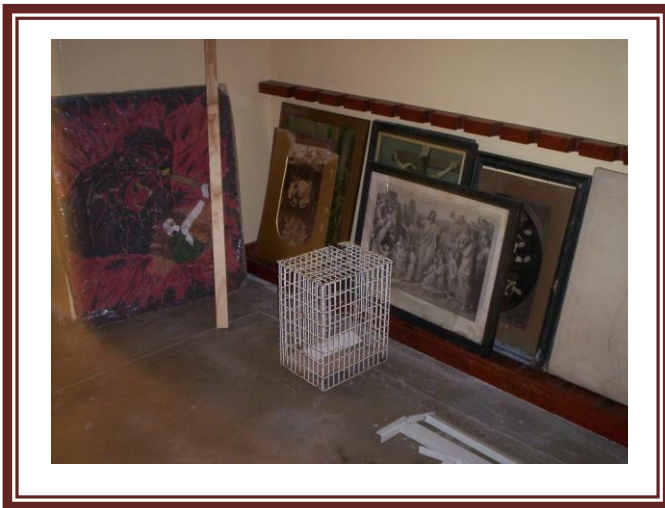
Fig.1. Artworks, Armory

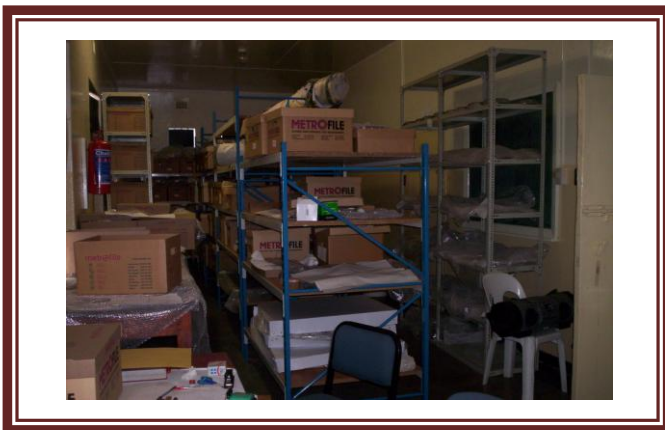
Fig.3. Boxed collections, Armory

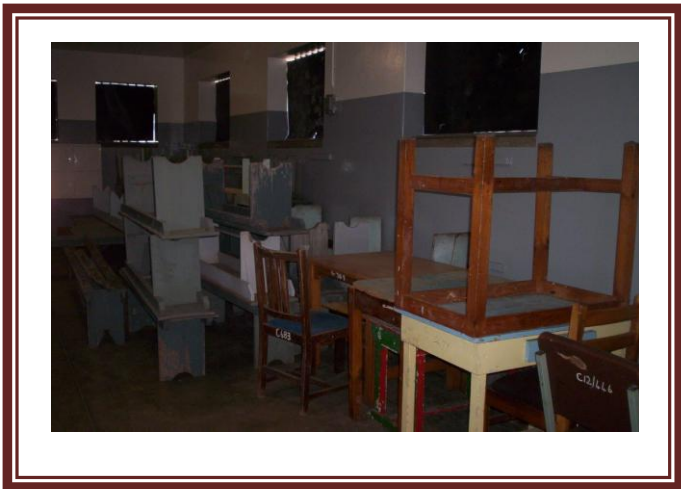
Fig.5. Section E-benches

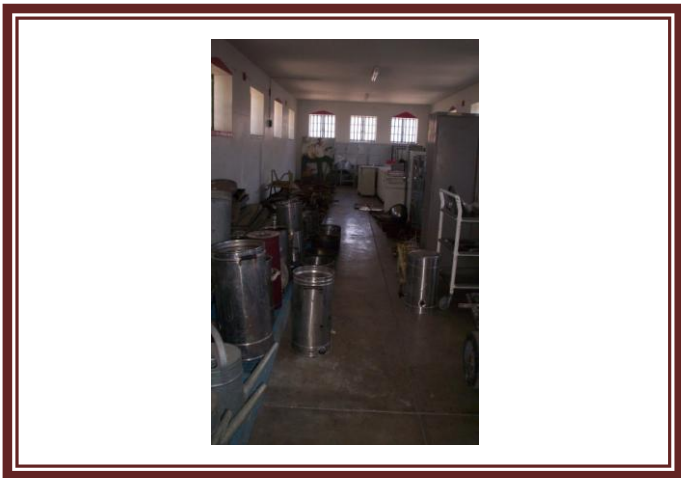
Fig.7. Section E- hospital equipment

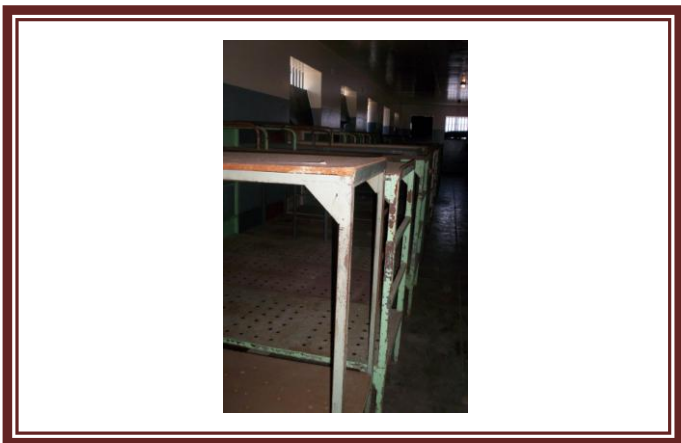
Fig.9. Section E- prison beds

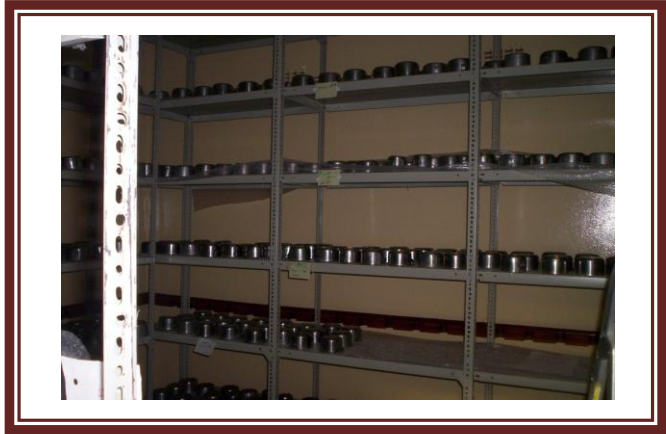
Fig.12. Prison utensils, Armory

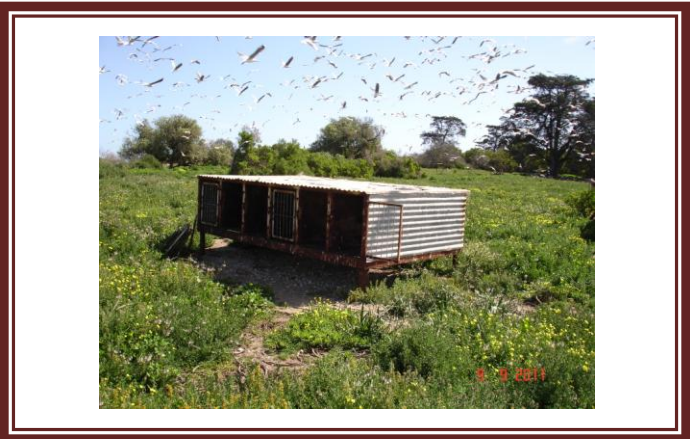
Birds especially have invaded certain sections of the MSP, notably the kitchens and what restoration efforts were made in 2006 are at high risk. Artefacts scattered across the island are at extreme risk, such as the dog kennels removed from the Sobukwe Complex.

Fig.15 Dog kennels ex Sobukwe complex

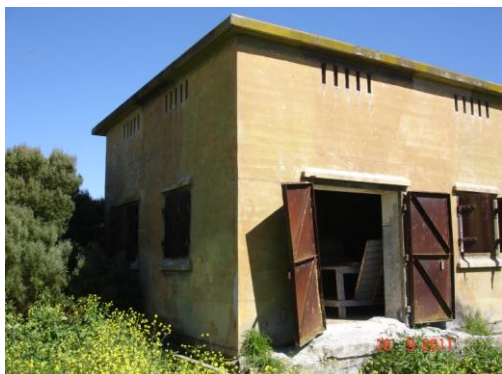
A number of artefacts are housed in scattered places across the island. Lean to's, garages and the armoury near Ou Tronk have been identified as storage facilities for discarded objects. All the sites visited had their doors off their hinges with the concomitant invasion by birds and animals, as well as severe corrosion and weathering.

Fig.16. Entrance to Armory WWII ou Tronk
