PROPOSED EDIBLE OIL PIPELINE for Wilmar SA (Pty) Ltd

FROM BERTH 706 / 707 / 708 TO RB IDZ PHASE 1A

PROPOSED PIPE ROUTE

FROM BERTH 706 / 707 / 708 TO RB IDZ Phase 1A

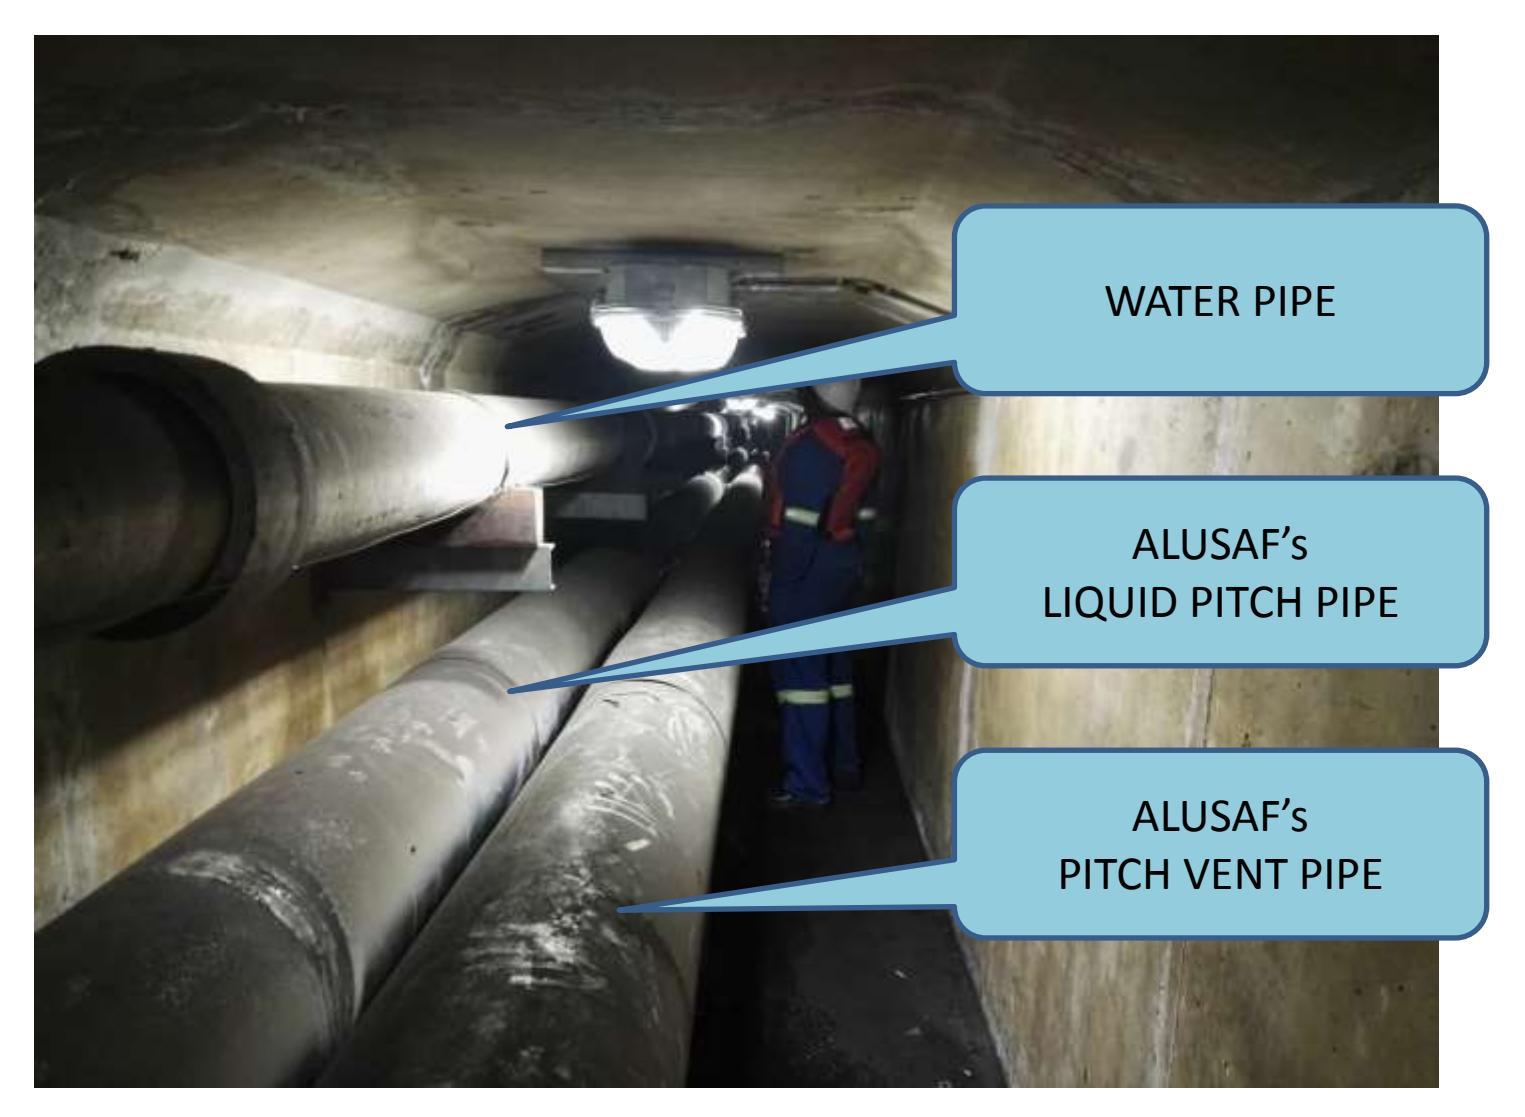
GENERAL SERVICES TUNNEL (Berths 708 / 707 / 706)

Note: Congested conditions, no space for additional 4 x DN200 pipes

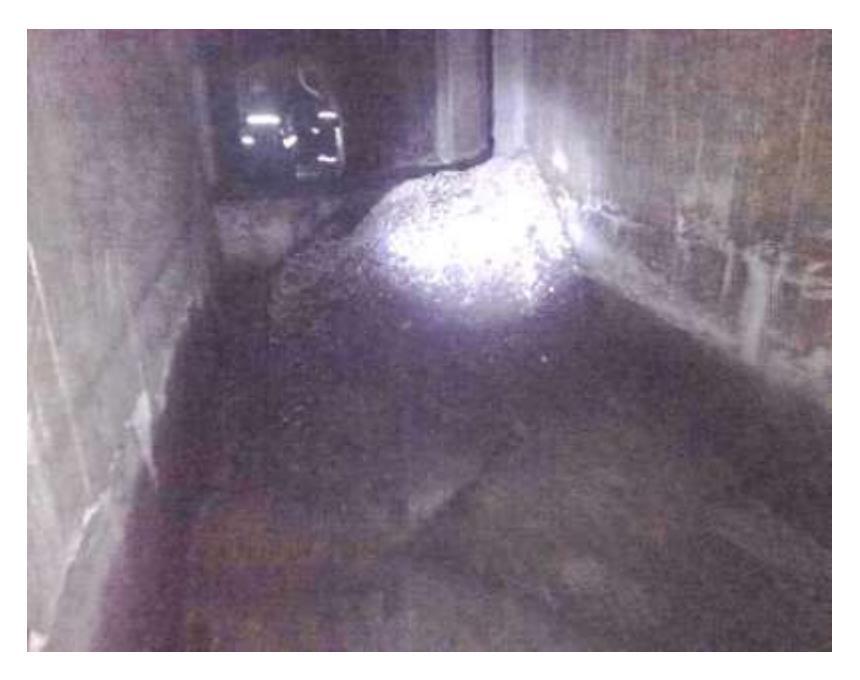
Loose material Mainly at entrances from Electrical Services tunnel

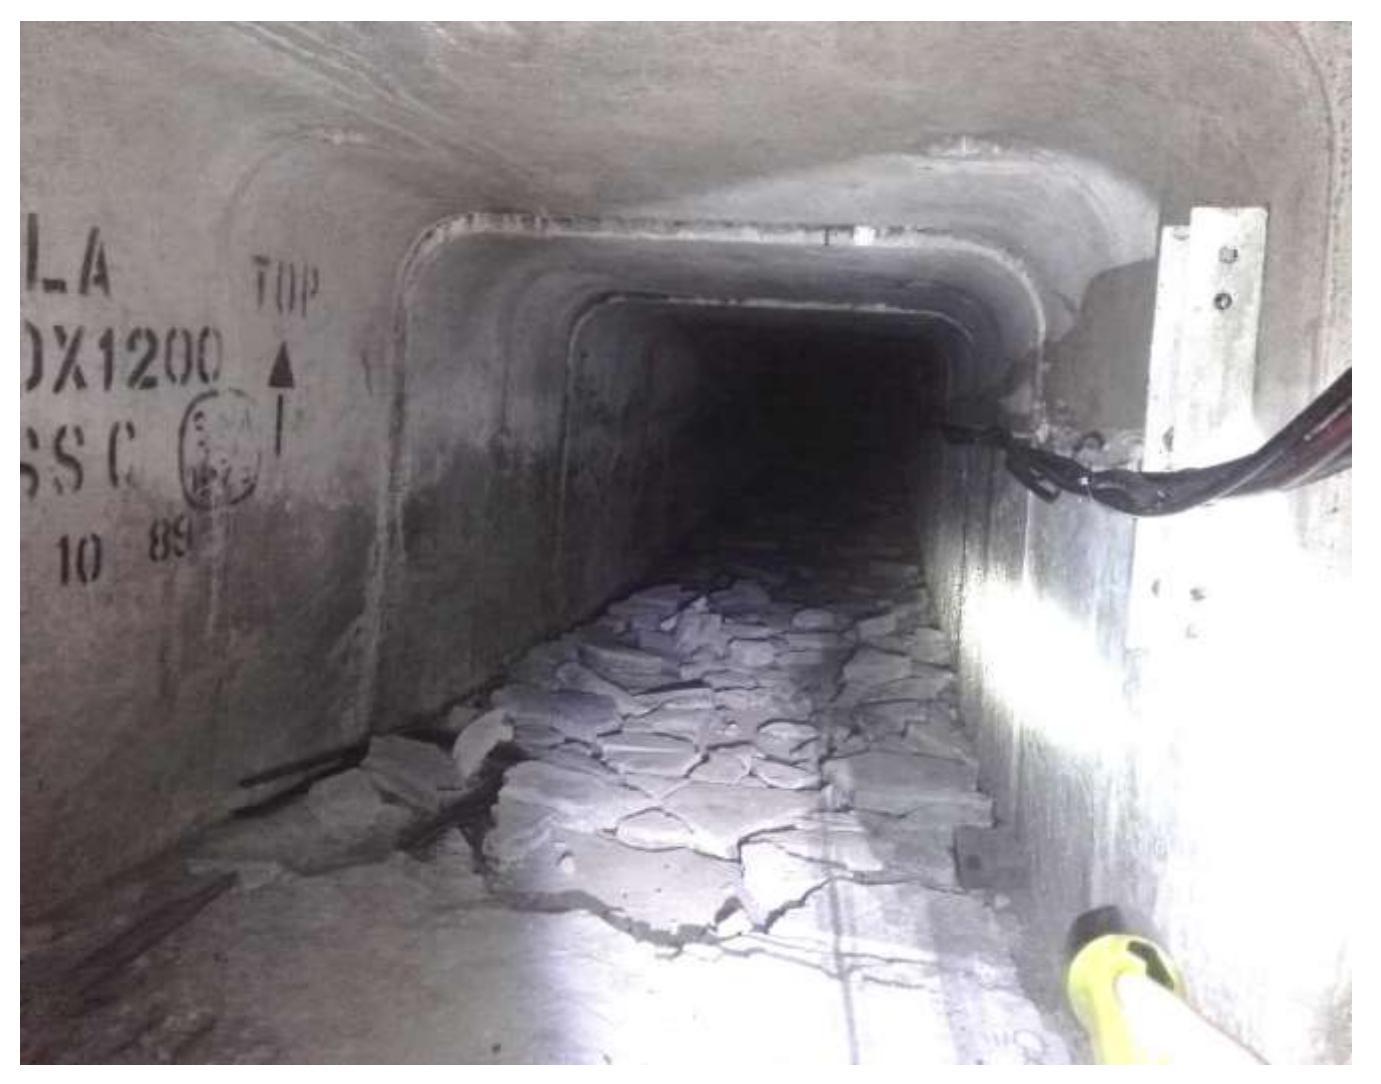
Change of section - Precast concrete culvert

Not same as typical section at Northern and Southern ends. Not part of original Void / 3rd Tunnel

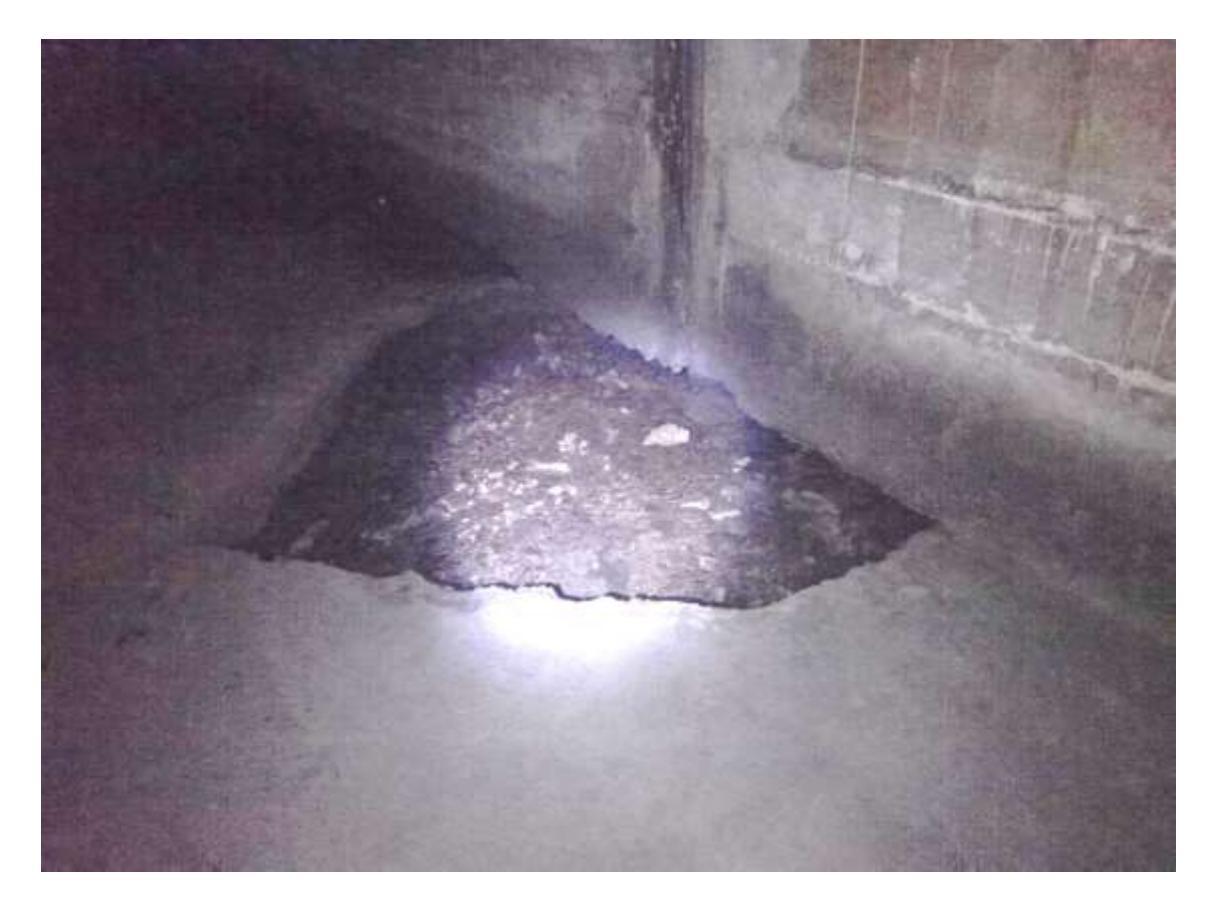
Joints in floor - 1 every 4 m

2 m wide, 'diamond' shaped depressions in the concrete floor Depressions appeared to be filled with "no fines concrete" Some filled with loose stone Others partially filled with concrete Some 'depressions' appeared to have subsided below the mass cappping horizontal joint (up to 100 mm 'subsidence') 2018/08/16

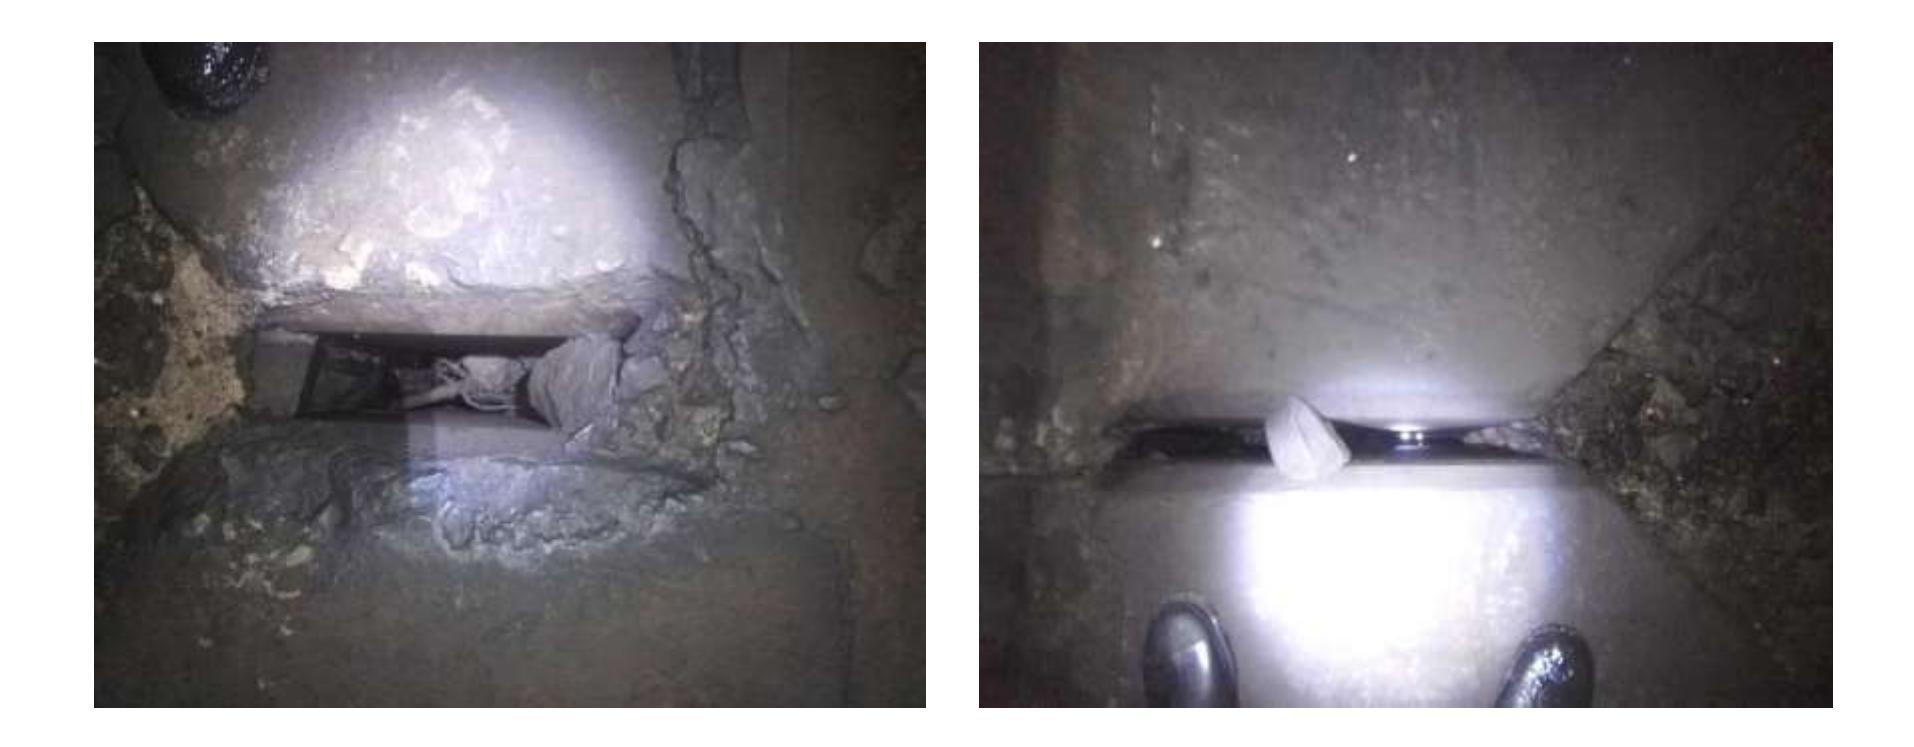
Joints in Floor

Up to 50 mm wide, some partly filled with detritus, some indicated water below

No clear indications of significant goundwater seepage / leakage into the tunnel.

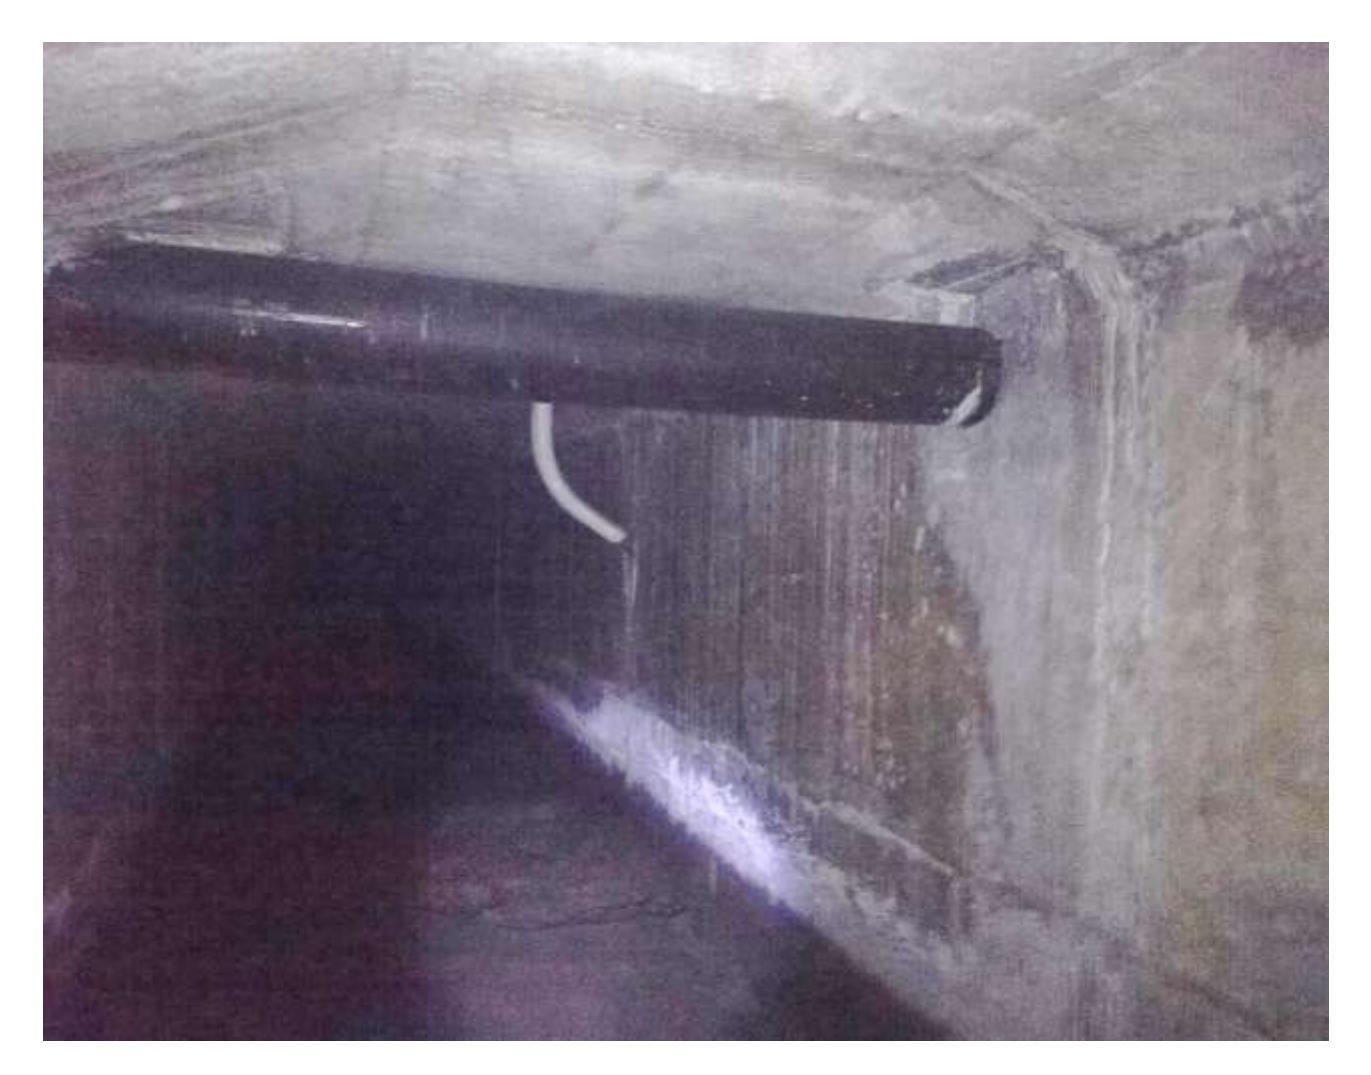
HDPE pipe Only one observed Water? Sewage? Cable duct?

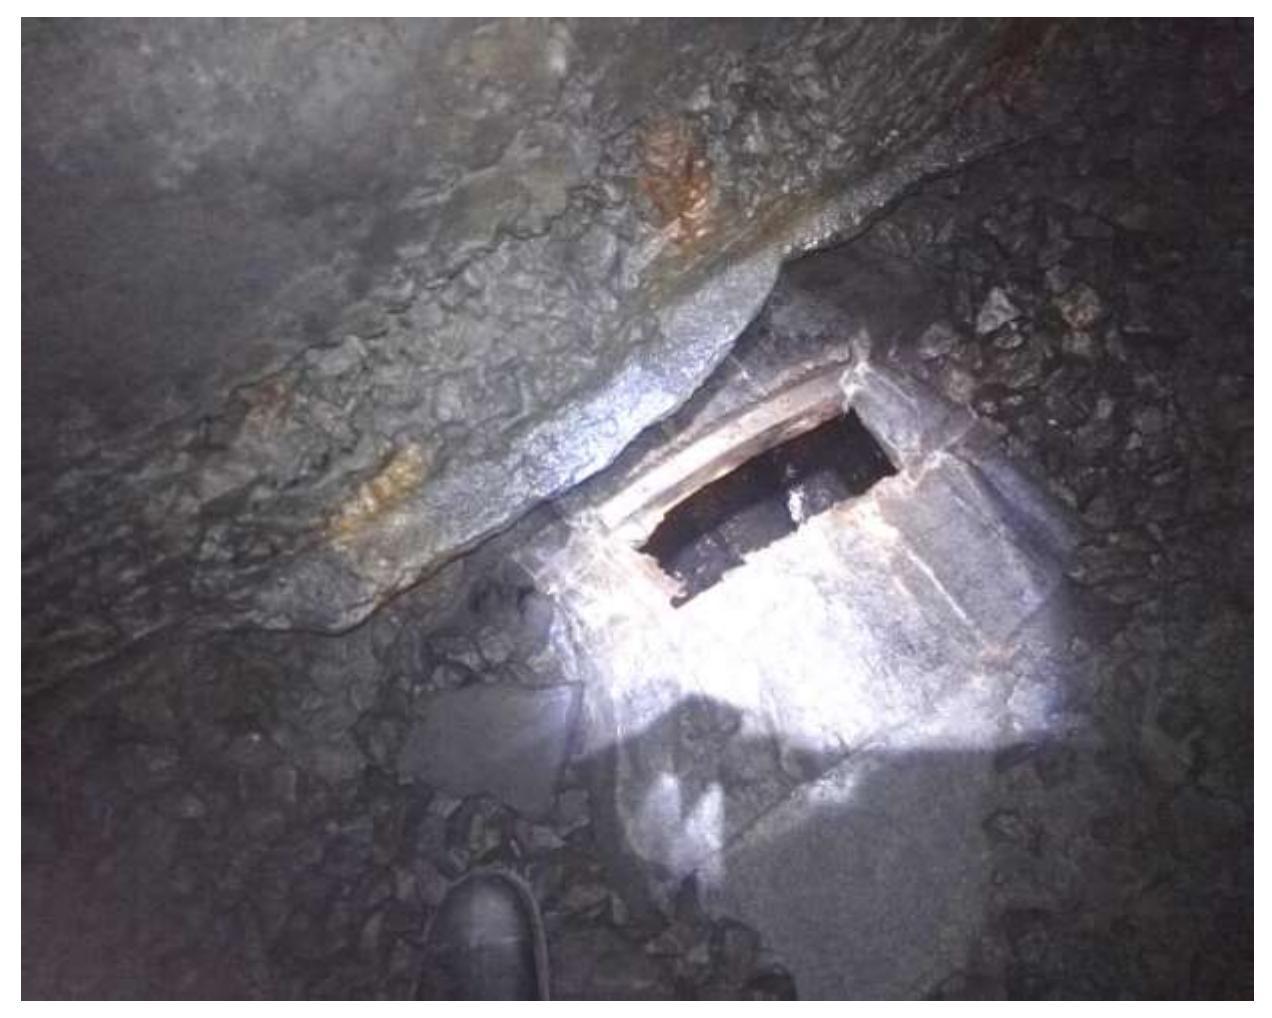
Drain pipe:

Floor was broken away at one point (approx. 150 m from northern end)

- rectangular hole cut into circular pipe below
- moving water could be seen in the pipe
- smelled of sewage, but could have been unclean harbour water

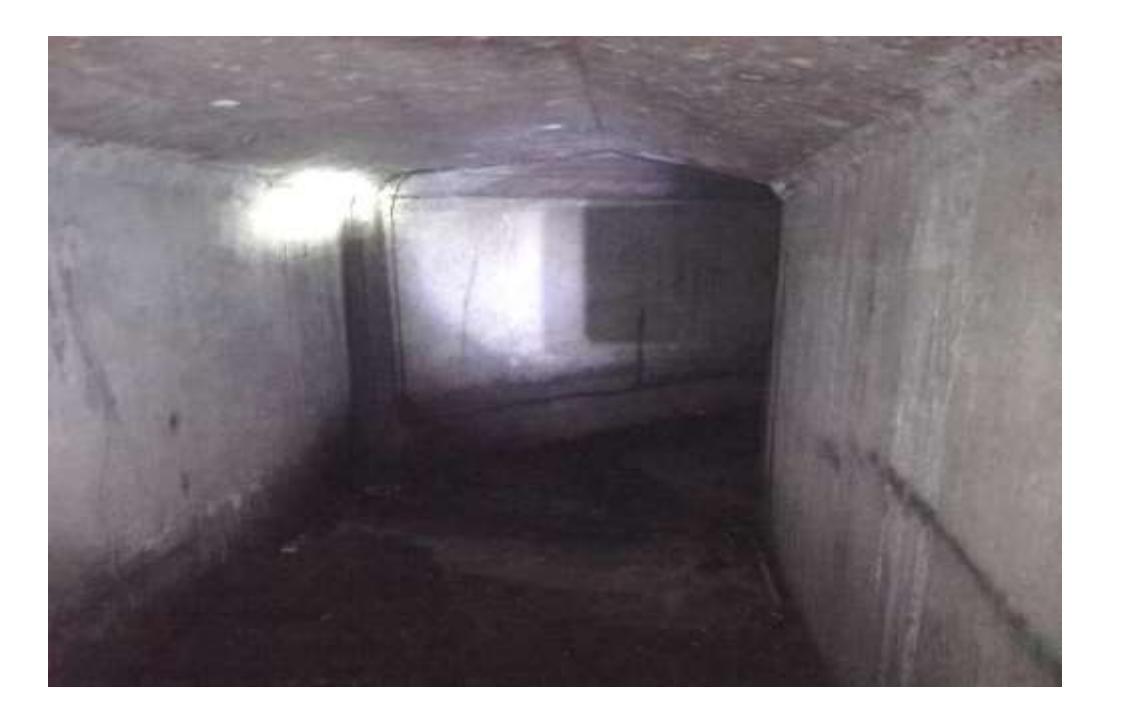
Southern end of tunnel

30° bend to the right

Void continues along berths 704 – 703 – 702 – 701 (not inspected), but appeared to be in a similar condition as along berths 708 – 707 - 706

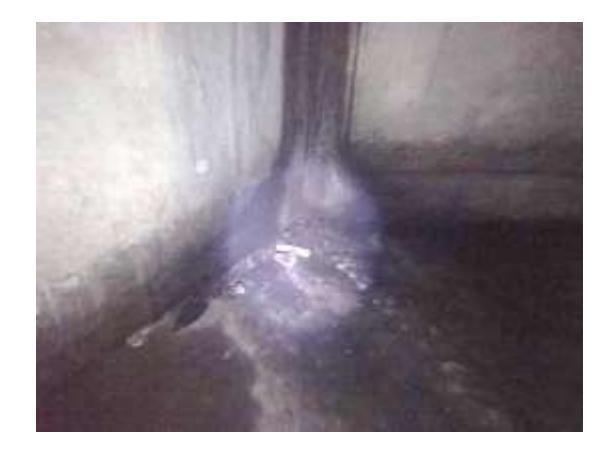
Bottom of tunnel corner (on "water" side) Note: No drain / outlet observed

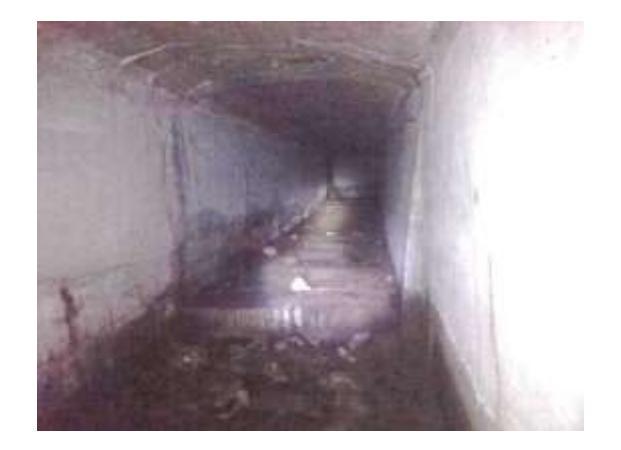
Note step in floor near the bend
