### Hermanus Fishing Harbour: Notification of Intent to Develop

## Professional Consultancy Services for Coastal Engineering Infrastructure Activities – Proclaimed Fishing Harbours Western Cape

### Project Descriptions

Hermanus Harbour

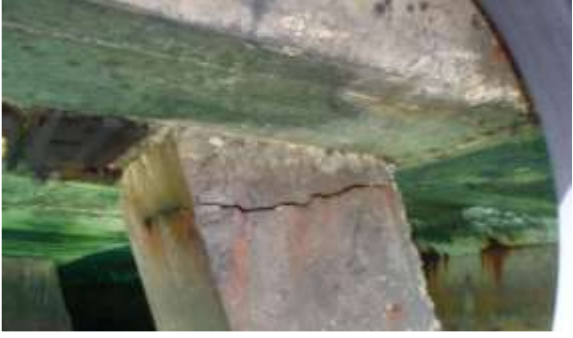
<p><u>Breakwater jetty</u> The two end raker piles of the breakwater jetty are cracked due to overloading and need to be repaired.</p>

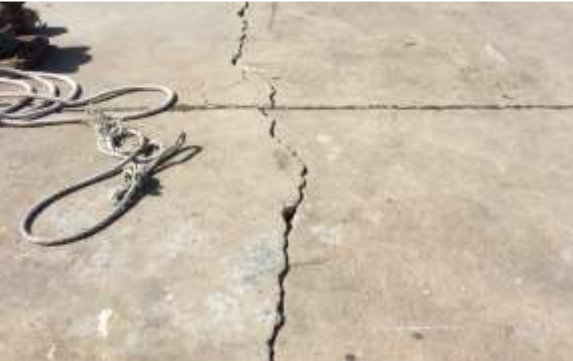
<p><u>Main quay</u> Cast a new concrete paving slabs behind the main quay.</p>

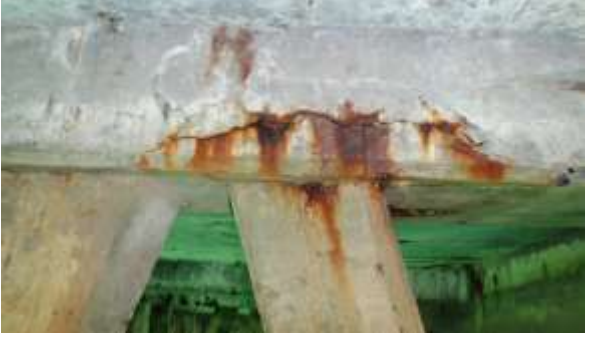
<p><u>Lead-in jetty</u> Concrete repairs are required on the underside of jetties where the reinforcing steel is corroding and the concrete is spalling – typical of the breakwater and lead-in jetty.</p>

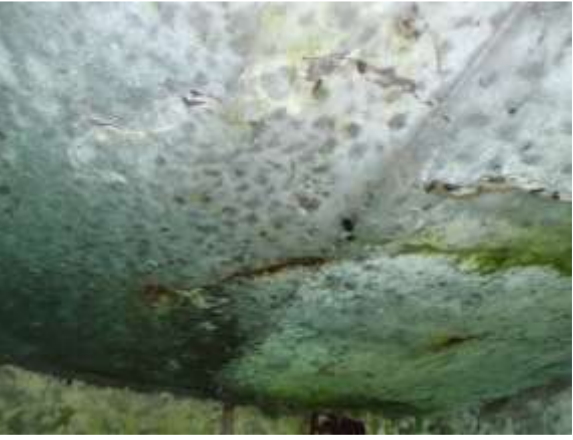
<p><u>Lead-in jetty</u> As above</p>

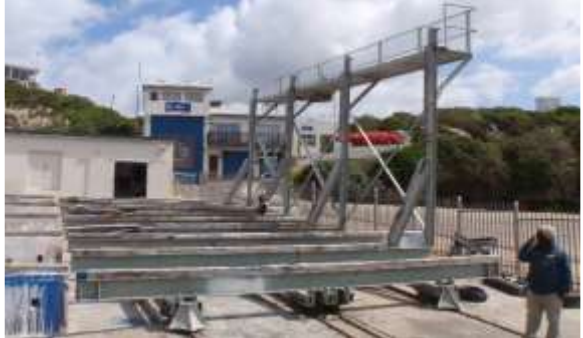
<p><u>Slipway cradle</u> Dismantle, clean and apply corrosion protection to the cradle structural steel.</p>

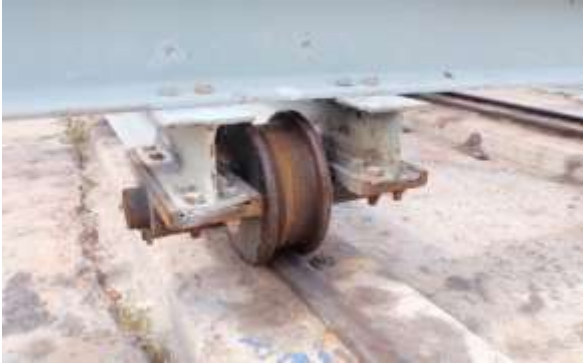
<p><u>Bogie wheels</u> Some of the bogie wheels are worn and corroded and tend to jam during operation. All bogie wheels need to be removed, serviced and re-installed. Badly damaged bogie wheels will be replaced.</p>

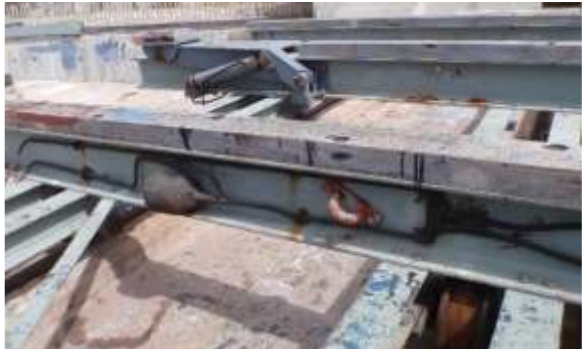
<p><u>Hydraulic supporting arms</u> Service the hydraulic arms and power pack.</p>

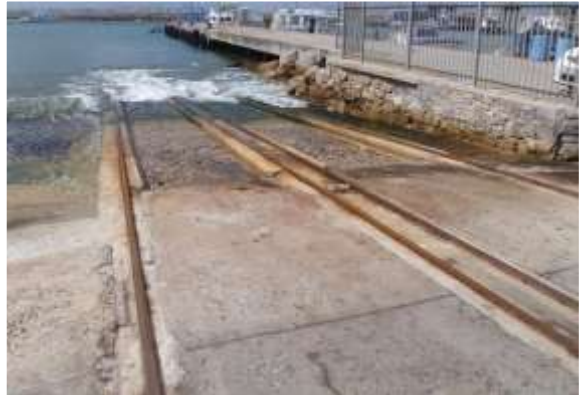
<p><u>Slipway rails</u> Replace sacrificial anodes and damaged fixings.</p>

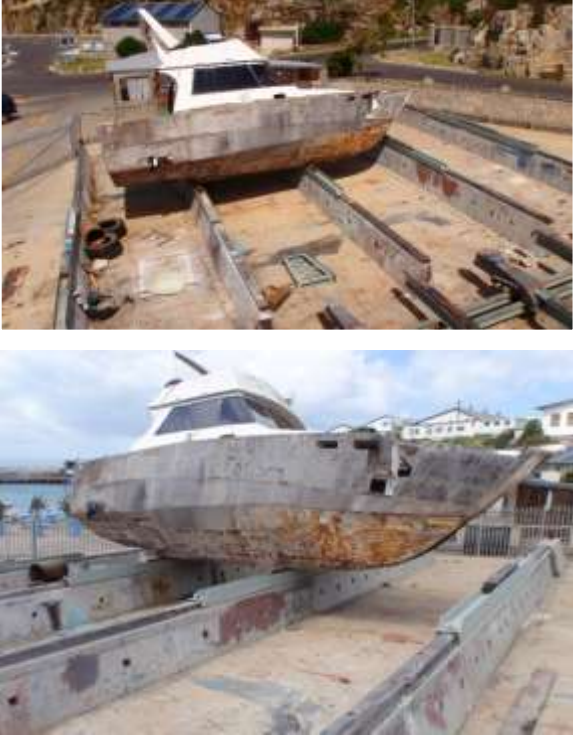
<p><u>Abandoned vessel on the side slip</u> This vessel needs to be removed. Details are as follows:</p> <ul style="list-style-type: none"><li>• Length = 15m</li><li>• Breadth = 5m</li><li>• Timber hull (abandoned since 2012)</li></ul> <p>*measurements are approximate.</p>

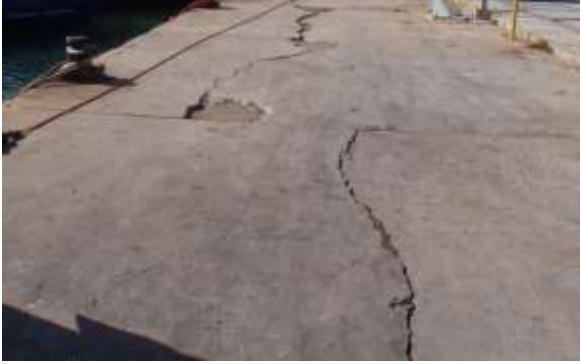
<p><u>Concrete Repair</u> Concrete repairs along the concrete capping of the main quay (excessive cracking).</p>

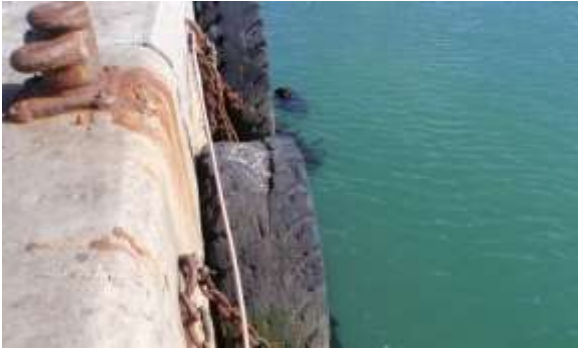
<p><u>Fenders and Fender Fixings</u> Fender fixings along the quay have corroded and need to be replaced. Damaged and missing tyres need to be replaced.</p>

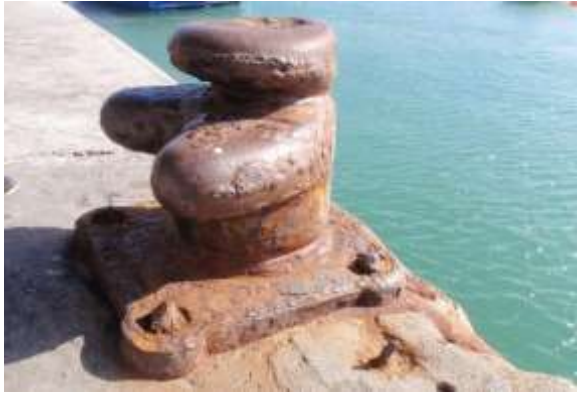
<p><u>Bollards</u> Bollards are in a state of disrepair and need to be replaced</p>

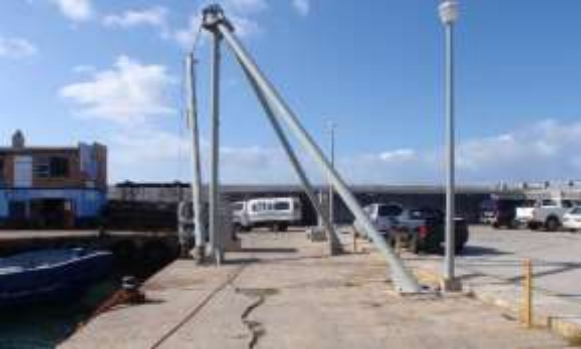
<p><u>Derrick Quay Crane</u> The derrick crane has badly corroded and is not operable. The crane will be replaced with a similar derrick crane with a 7.5 tonne capacity.</p>

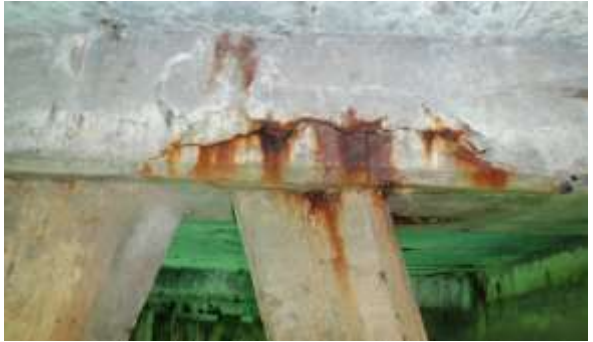
<p><u>Concrete repair to the underside of the jetty</u> Concrete repairs are required on the underside of jetty where the reinforcing steel is corroding and the concrete is spalling.</p>

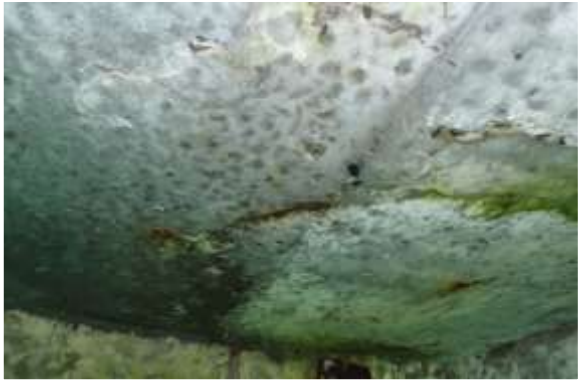
<p><u>Concrete repair to the underside of the jetty</u> As above</p>

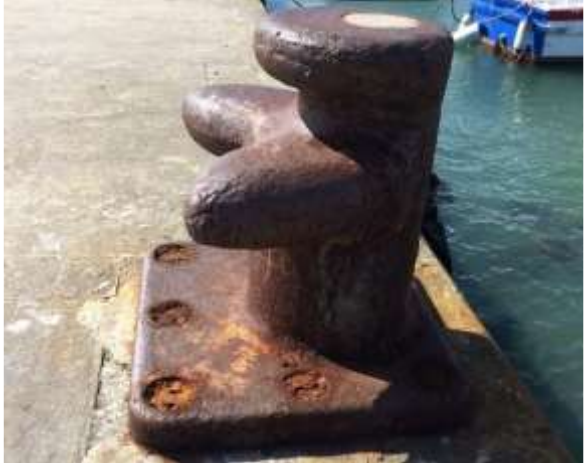
<p><u>Bollards</u> Bollards are in a state of disrepair and need to be replaced</p>

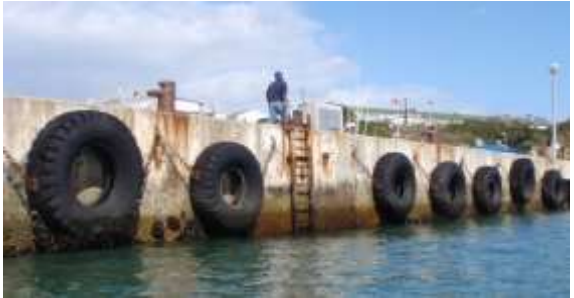
<p><u>Fenders and Fender Fixings</u> Fender fixings along the jetty have corroded and need to be replaced. Damaged and missing tyres need to be replaced.</p>

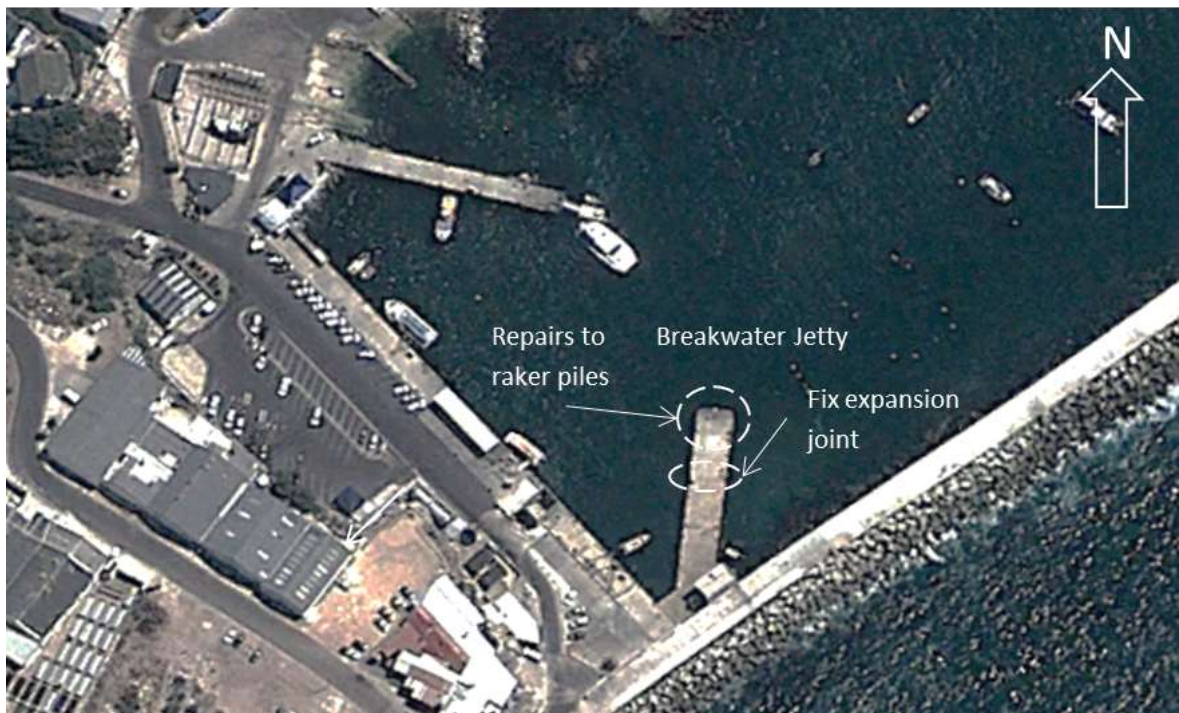
**Figure 2-6: Breakwater Jetty Structure**

- Repair of the cracks in the two end raker piles. These have been overstressed and have cracked along the top section of the pile;
- Concrete repairs on the underside of the jetty;
- The gap in the jetty deck expansion joint is widening. It is approximately 50mm wide. Further movement should be restrained by providing fixity across this joint;
- Replace corroded bollards;
- Replace corroded and missing fender fixings; and
- Replace damaged and missing fenders.

<p><u>End Raker Piles</u></p> <p>The two end raker piles of the breakwater jetty are cracked due to overloading and need to be repaired.</p>	 
<p><u>Expansion Joint</u></p> <p>The expansion joint is separating and requires fixity along the joint.</p>
