Hout Bay Fishing Harbours: Notification of Intent to Develop

Professional Consultancy Services for Coastal Engineering Infrastructure Activities – Proclaimed Fishing Harbours Western Cape

Project Descriptions

Hout Bay Harbour

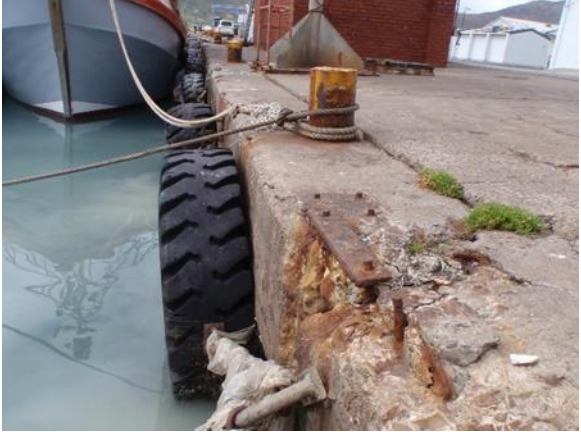
<p><u>Quay 1</u> Concrete repair along the cope edge and construction joints of quay 1. This work is typical along the length of a number of jetties within Hout Bay.</p>

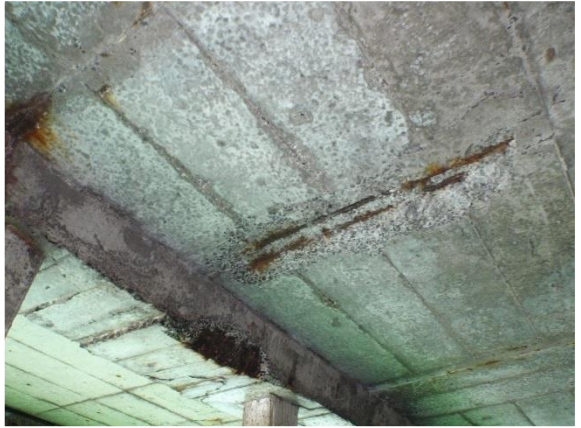
<p><u>Secondary Breakwater</u> Sections of the breakwater show signs of steel corrosion and require repair work.</p>

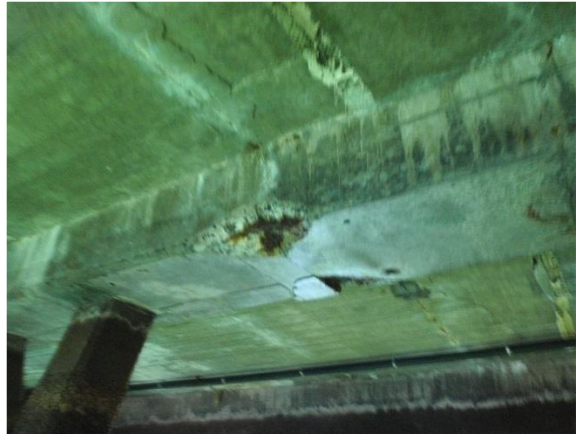
<p><u>Jetty 2</u> Concrete repairs are required on the underside of jetties where the reinforcing steel is corroding and the concrete is spalling.</p>

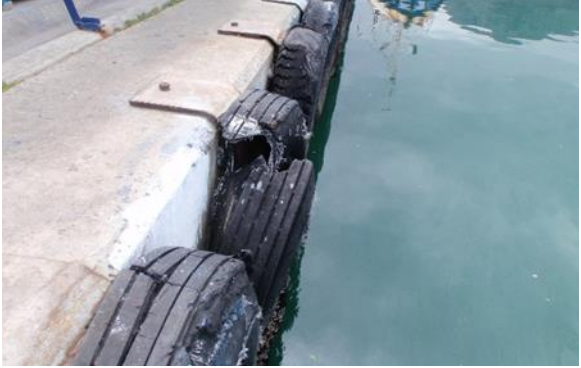
<p><u>Quay 2</u> A large number of tyre fenders along the quay are damaged, badly worn or missing and need to be replaced. The corroded steel fixings also need to be replaced.</p>

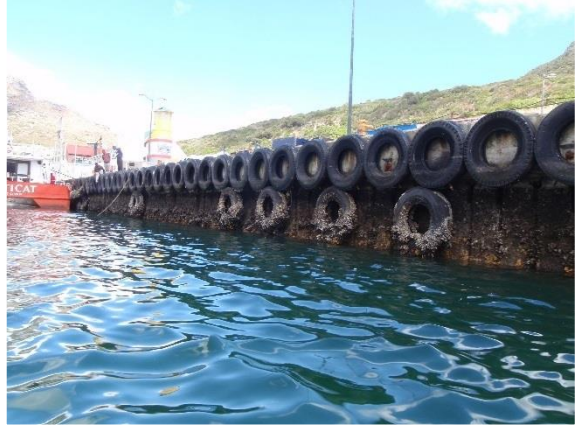
<p><u>Quay 2</u> As above</p>

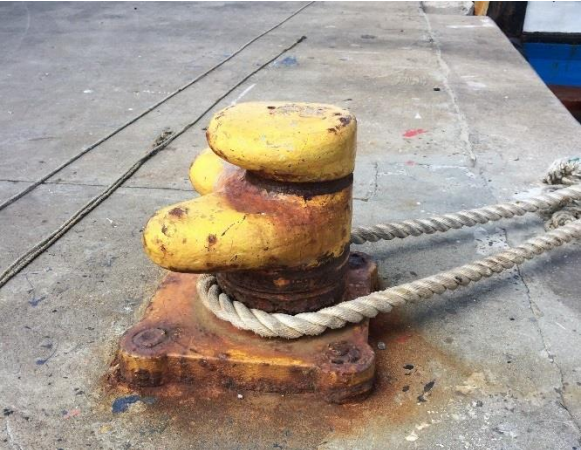
<p><u>Secondary Breakwater</u> Bollards need to be cleaned and painted. Corroded bollard holding down bolts must be replaced.</p>

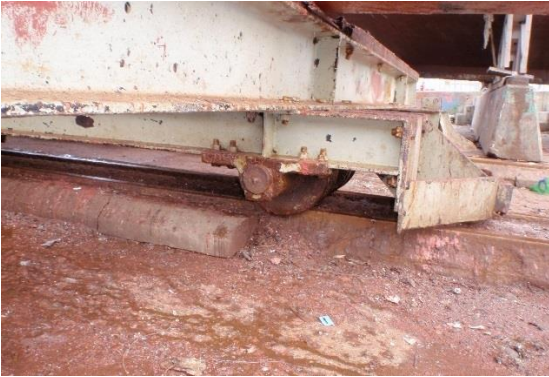
A photograph showing a blue boat on a slipway cradle. The boat is elevated on a wooden structure, and the hull is visible. The cradle is made of metal and wood.
<p><u>Bogie wheels</u> Some of the bogie wheels are worn and corroded and tend to jam during operation. All bogie wheels need to be removed, serviced and re-installed. Badly damaged bogie wheels will be replaced</p>

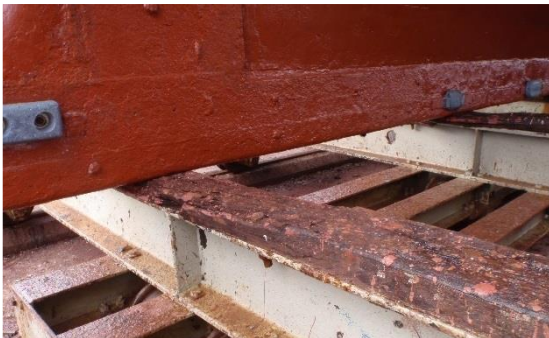
A close-up photograph of a bogie wheel on a slipway. The wheel is heavily corroded and appears to be jammed or stuck.
<p><u>Timber support blocks</u> Remove and replace damaged timber support blocks.</p>

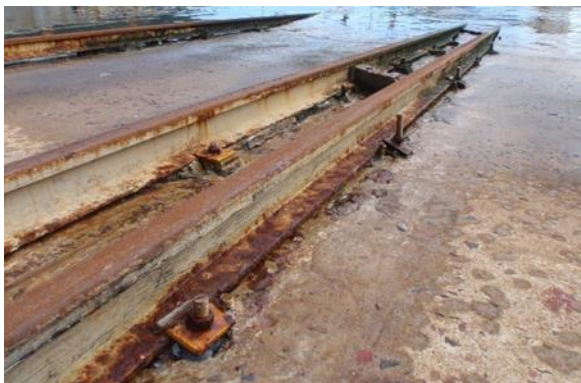
A photograph showing timber support blocks on a slipway. The blocks are made of wood and are supporting a metal structure. Some blocks appear to be damaged or missing.
<p><u>Slipway rails</u> The slipway rails are badly corroded and need to be replaced together with all rail fixings and sacrificial anodes.</p>

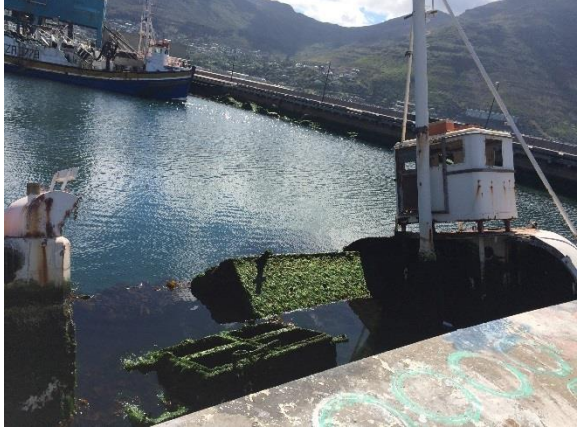
<p><u>Lead-in Jetty (9)</u> There are nine sunken vessels along the lead-in jetty, making this jetty virtually unusable.</p>

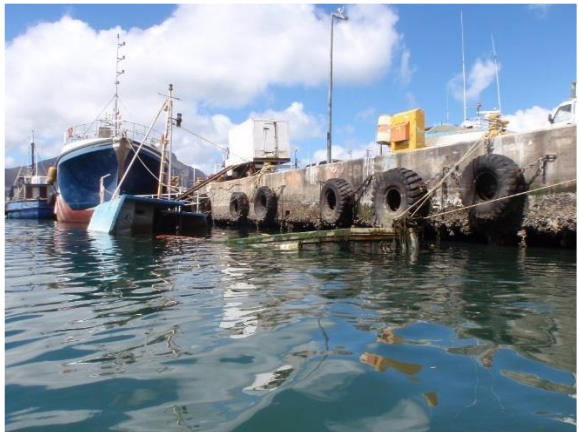
<p><u>Jetty 3 (3)</u> There are three sunken vessels along jetty 3.</p>

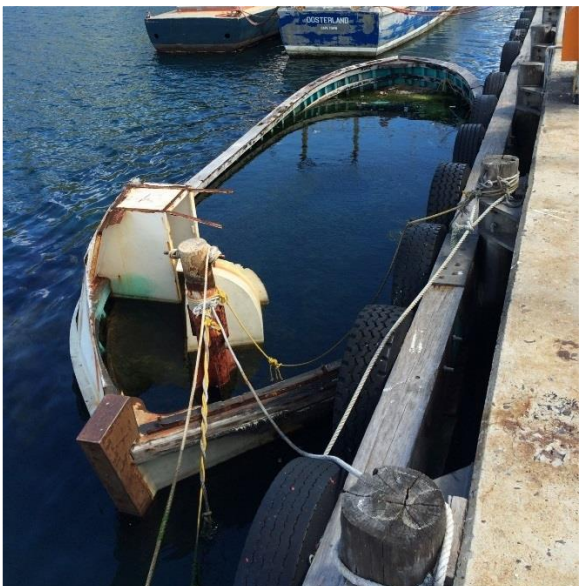
<p><u>Secondary Breakwater (2)</u> There are two sunken vessels (one on top of the other) adjacent to the secondary breakwater.</p>

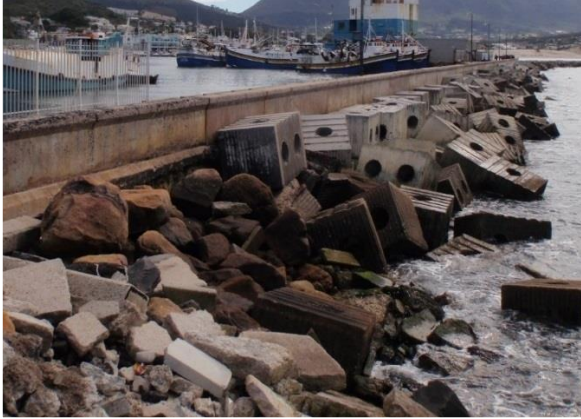
<p><u>Main Breakwater</u></p> <p>A few additional concrete armour units are required to fill a few gaps that have formed along the breakwater. (Approx. 20 additional units)</p>

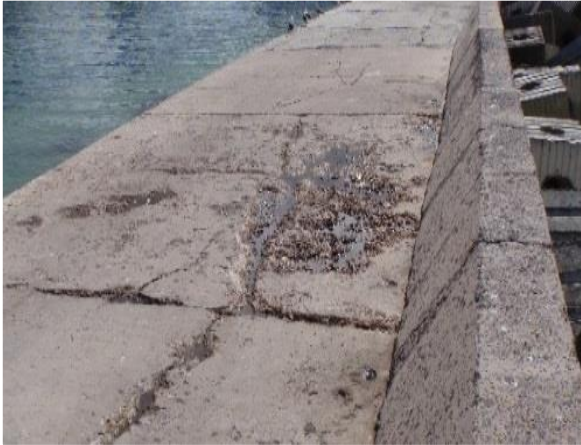
<p><u>Main Breakwater</u></p> <p>The concrete cap at the end of the main breakwater is in poor condition and needs replacement. The new concrete cap will be doweled into the existing one and will increase the breakwater height by 0.25m.</p>

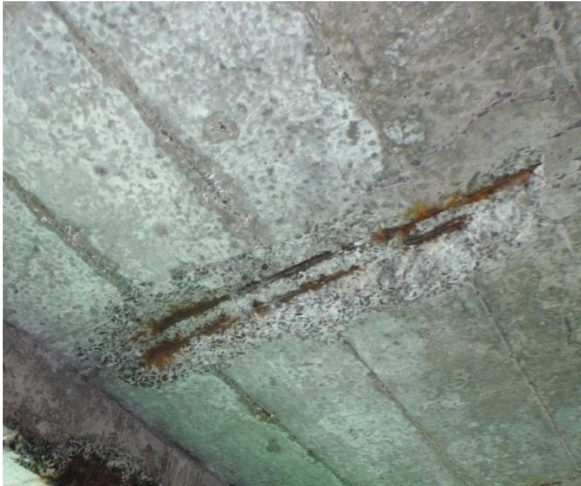
<p><u>Secondary Breakwater</u></p> <p>Concrete repairs are required on the breakwater capping and underside of the breakwater. This is a reinforced concrete suspended deck structure.</p>

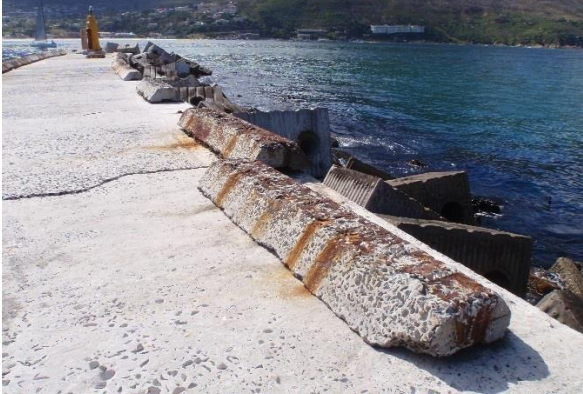
<p><u>Main Breakwater – Splash barrier removal</u></p> <p>The splash wall barrier along the end of Hout Bay has become a safety hazard and must be removed.</p>
