13123germK

A FEASIBILITY INVESTIGATION FOR THE PROPOSED DEVELOPMENT  
OF THE ROBERT STRACHAN HOSTELS AND PORTIONS 103 AND 193  
ON THE FARM DRIEFONTEIN 171-IR,  
EKURHULENI METRO, GAUTENG.

RELLY, MILNER AND SHEDDEN  
PRETORIA

DATE: June 2013

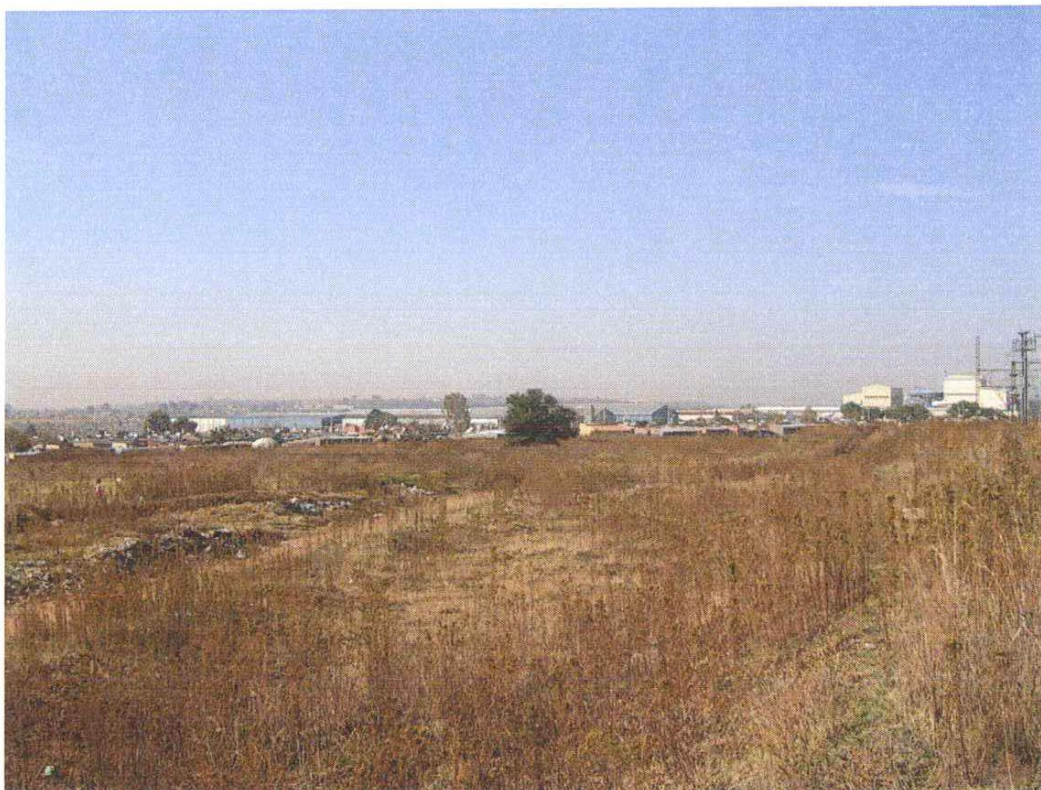
Photograph 1: View of Kutalo site towards south-east.

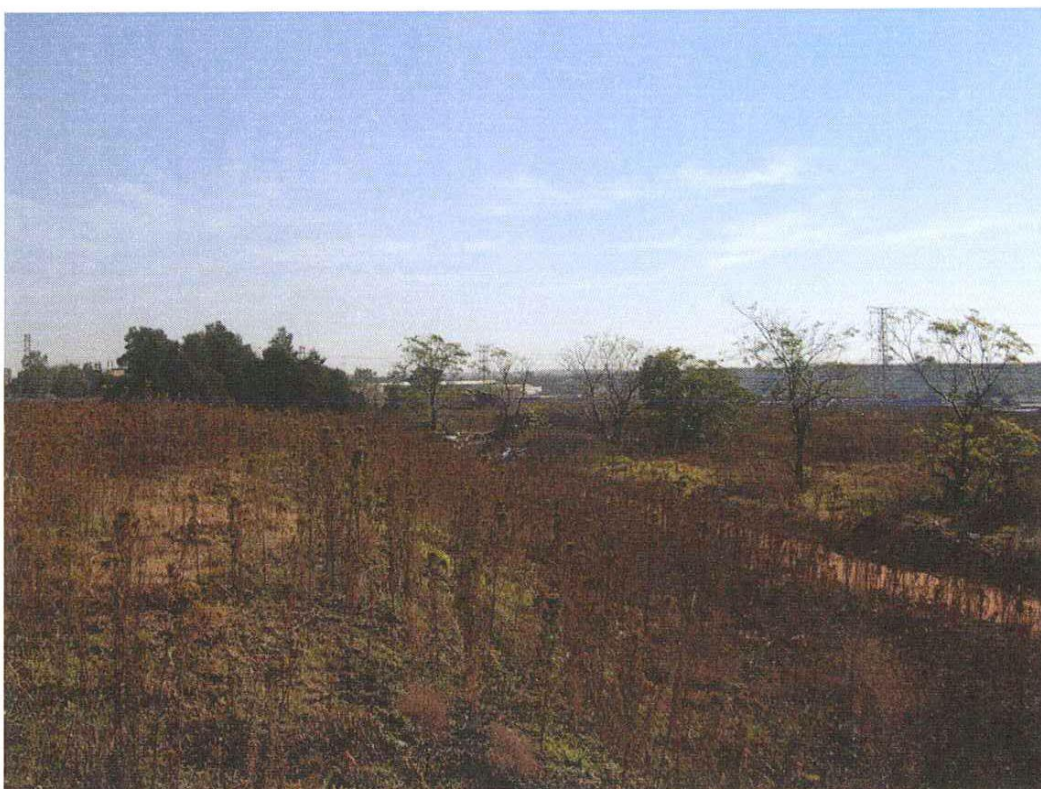
Photograph 2: View of Kutalo site towards north-east.

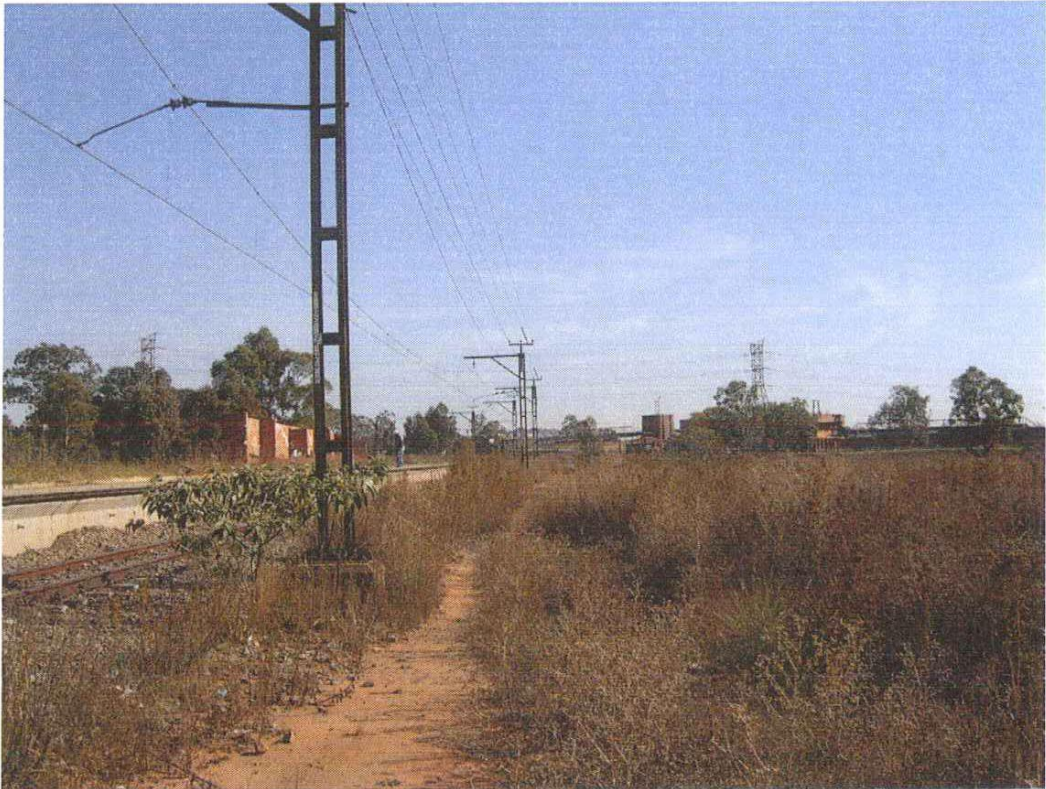
Photograph 3: View of Kutalo site towards north along western boundary.

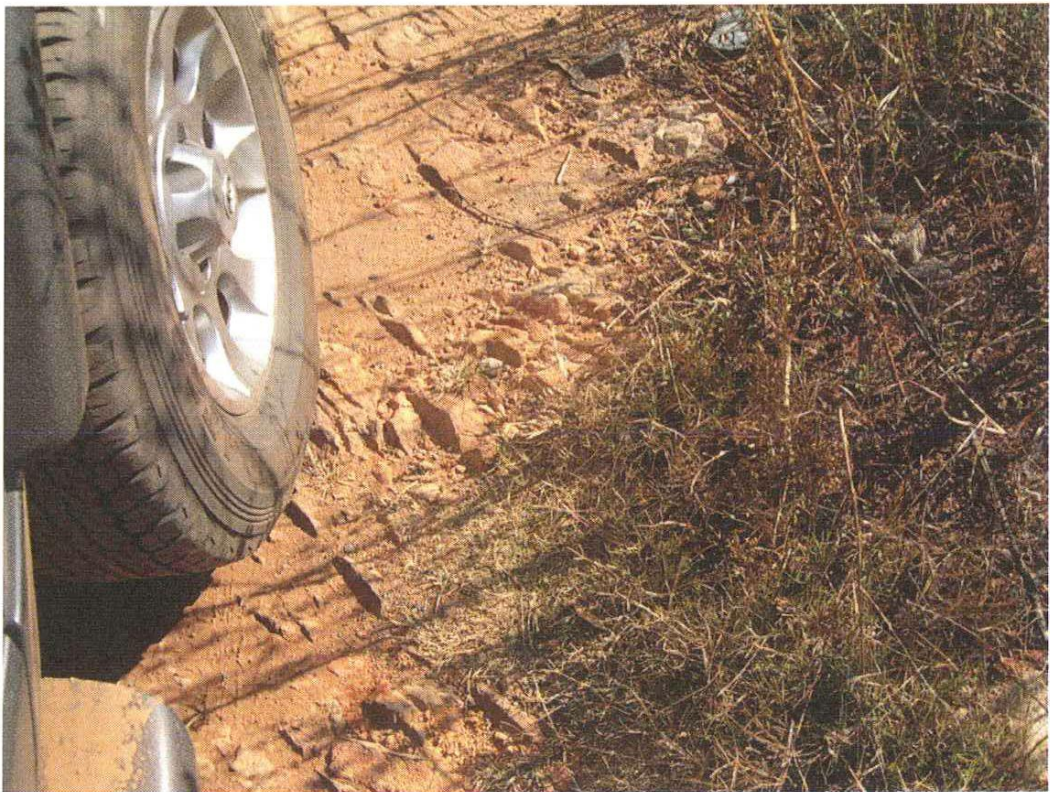
The hard rock geology is blanketed by a variable thickness of both colluvial and residual soils. Limited exposures of completely weathered quartzite were observed at one locality (see photograph 4 in Appendix C) but it is unsure whether or not the exposures represent imported road building material.

Photograph 4: Shallow quartzite bedrock exposed in track along western boundary.

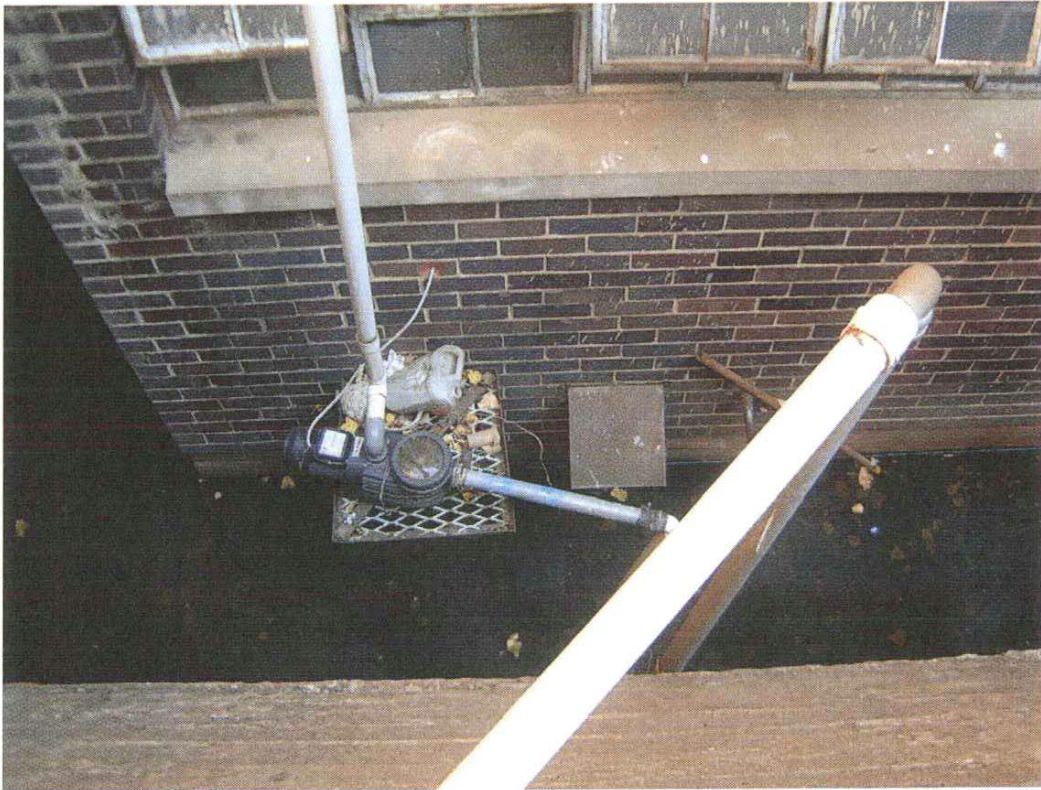
Although no evidence of perched water tables was apparent on the hostel site, the two hostels have an elaborate pumping system to control storm water from next to the basements. The writer is of the opinion that the pumping system is a consequence of the building design and not because of extensive, shallow perched water tables. It would appear that ground on either side of parts of the basements were excavated in order to allow windows to be installed. The openings allow the ingress of rain water that then has to be pumped out of the excavations. The water alongside the basements is not believed to be as a result of shallow perched water tables. *Geotechnical assessment: 2B.*

5.12 **Flooding:** No drainage features cross the site. The risk of extensive flooding is not regarded as a problem on these sites. Minor flooding of the hostel basements may occur if the pump system is allowed to fall into disrepair. *Geotechnical assessment: 1L.*

Photograph 5: Water at basement level. Pump used to deliver water to ground level.

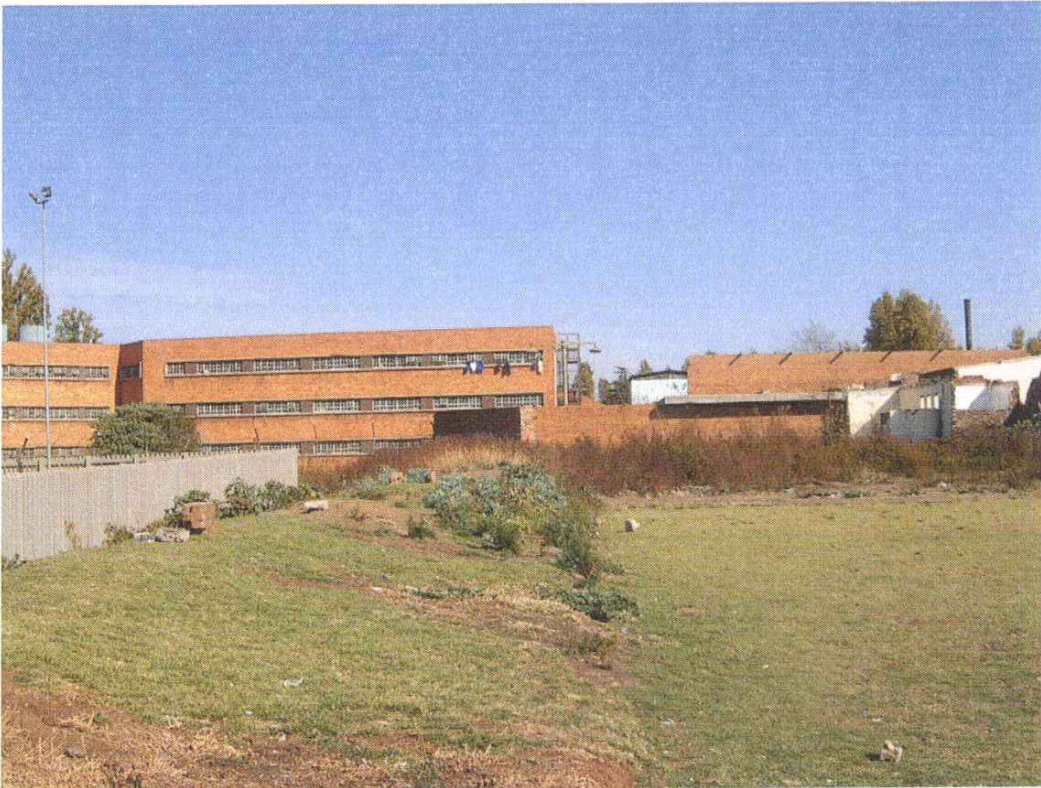
Photograph 6: View of Robert Strachan Hostel from Jan Hofmeyer Street on eastern boundary.
