APPENDIX B:

Photographic Report

A site visit was undertaken on 29 October 2022 to determine the environmental condition of the site.

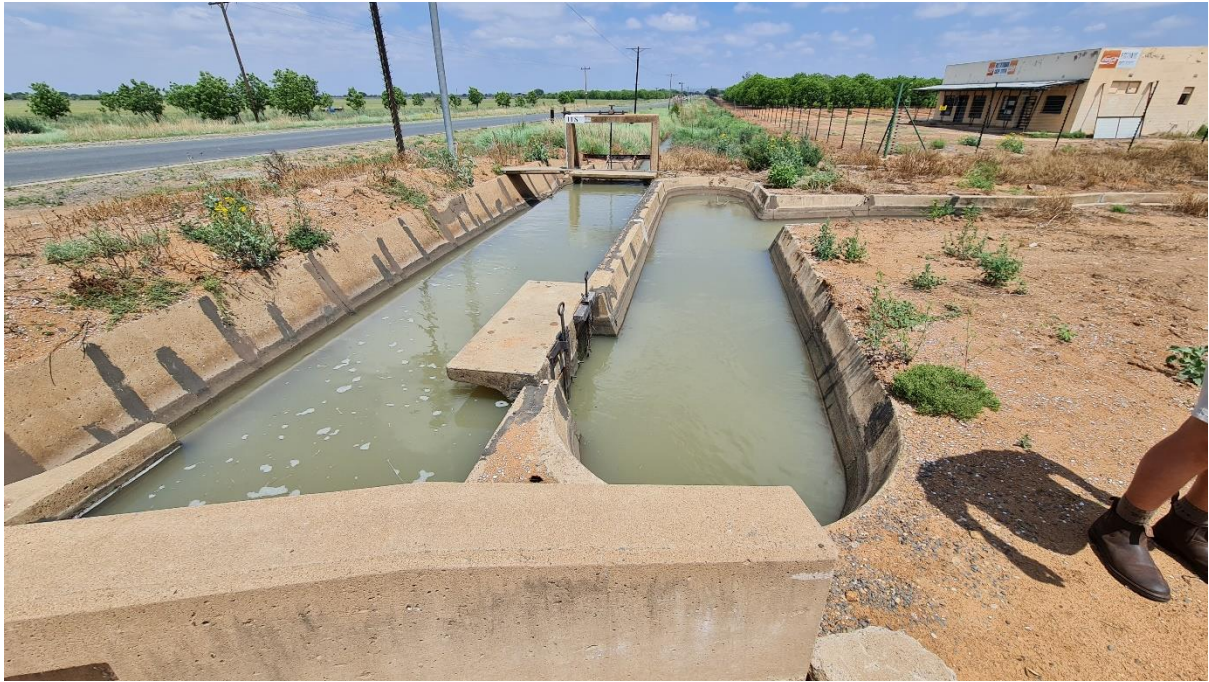
Figure 1 Irrigation channel of the Vaal-Harts Irrigation Scheme at the southern border of the site.

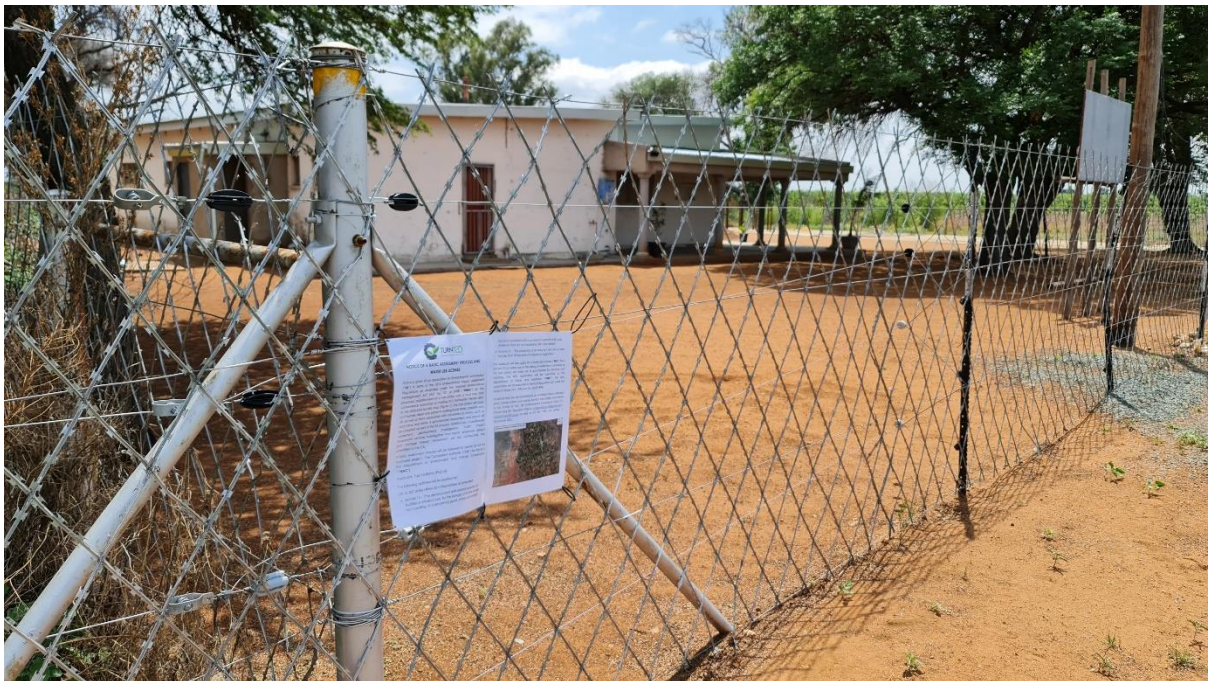
Figure 2 Infrastructure on the site.

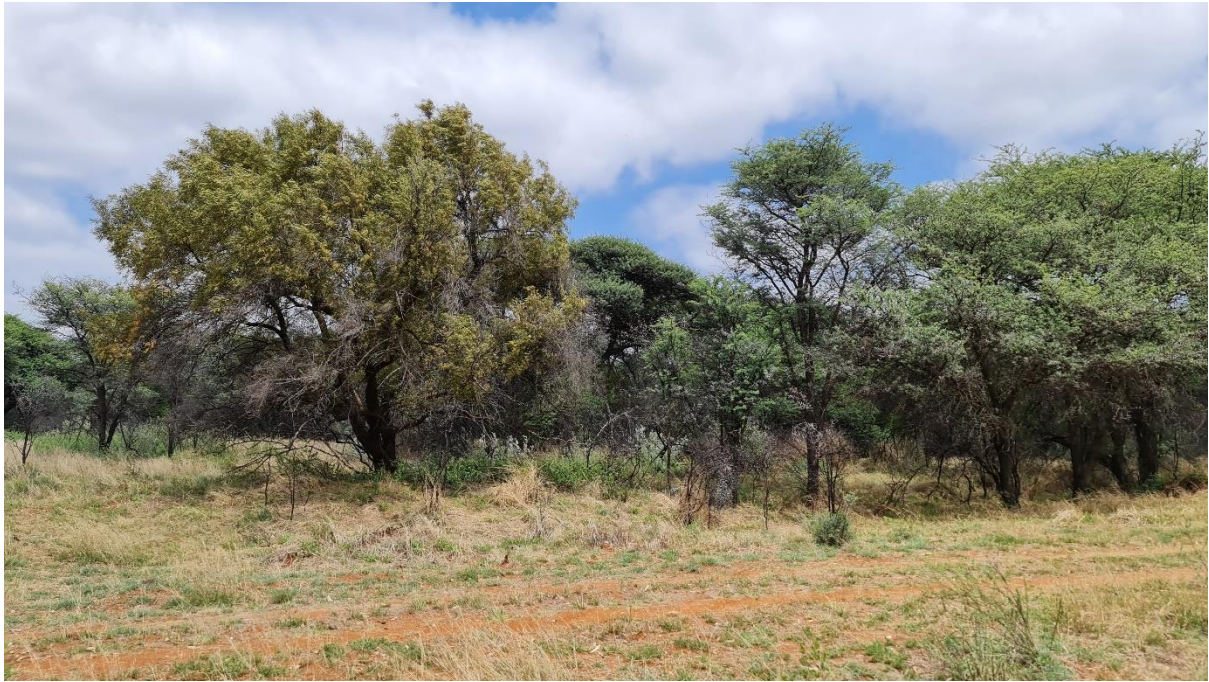
Figure 3 Indigenous and alien vegetation on the site

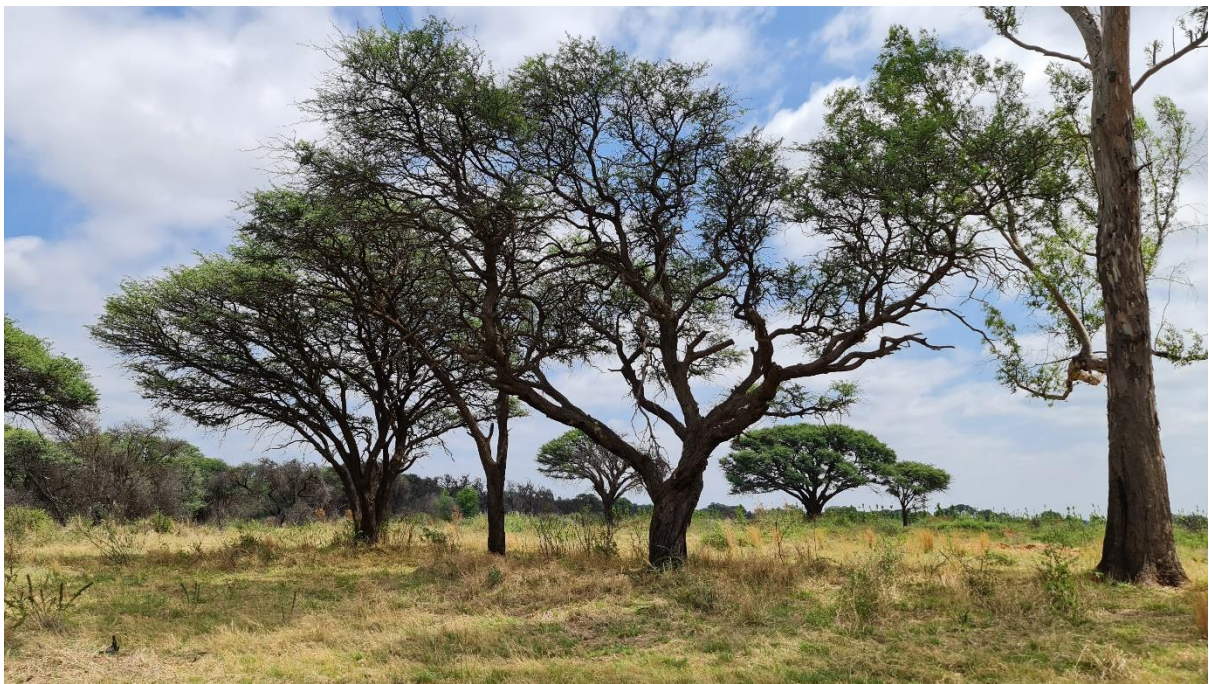
Figure 4 Camel Thorn trees on the site

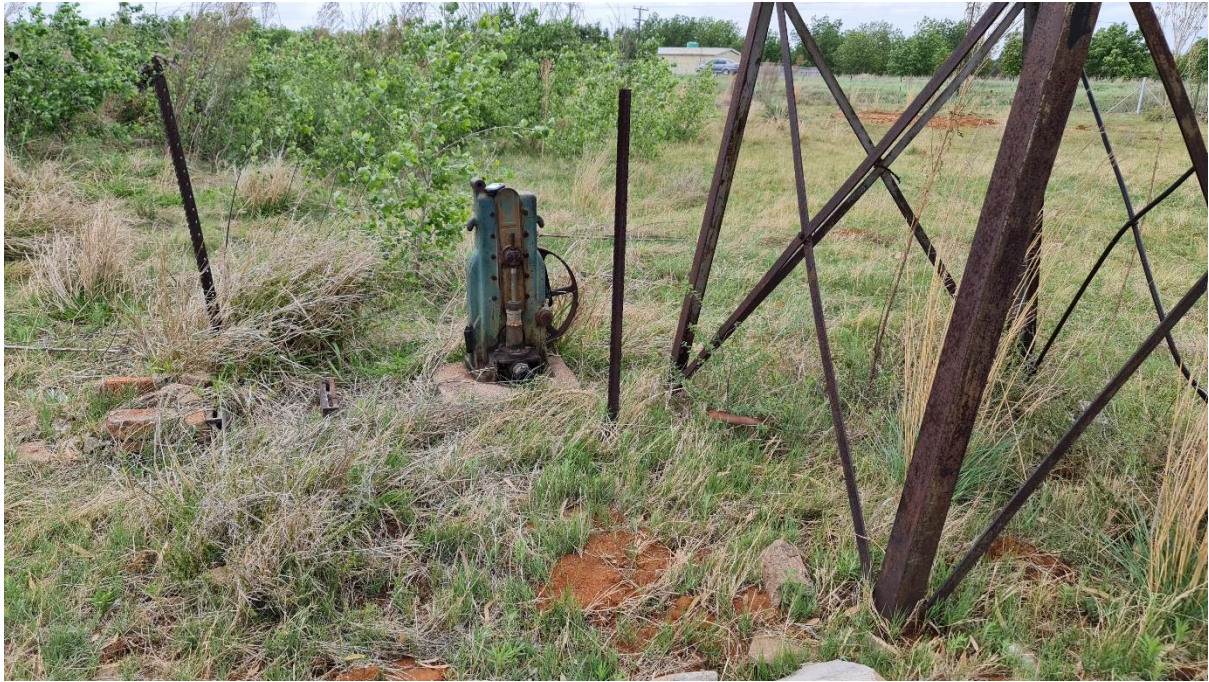
Figure 5 Borehole on the site

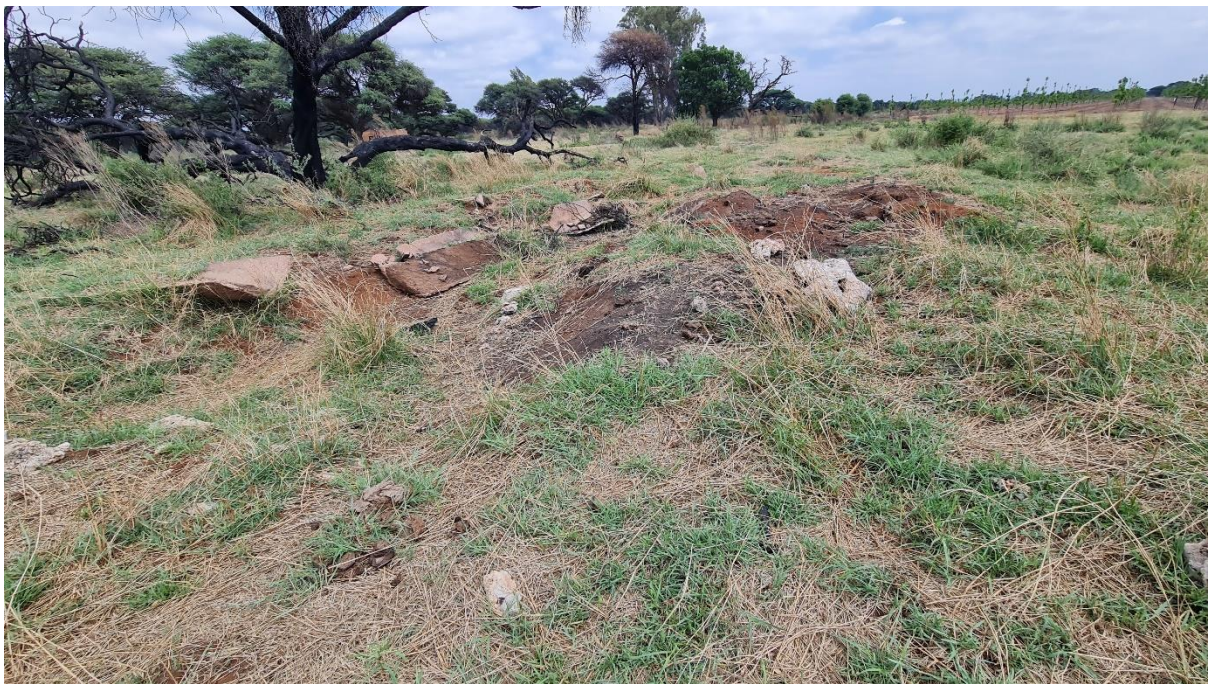
Figure 6 Construction waste/disturbance on the site

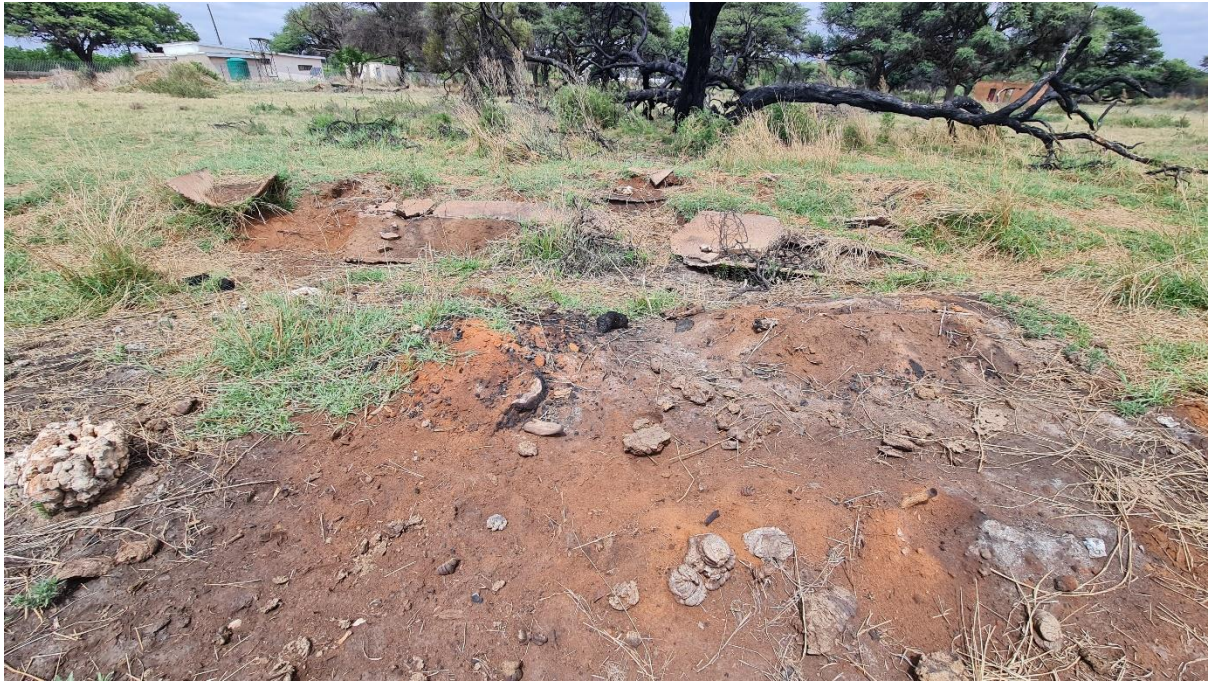
Figure 7 Disturbance on the site: construction waste, old infrastructure, no ground cover

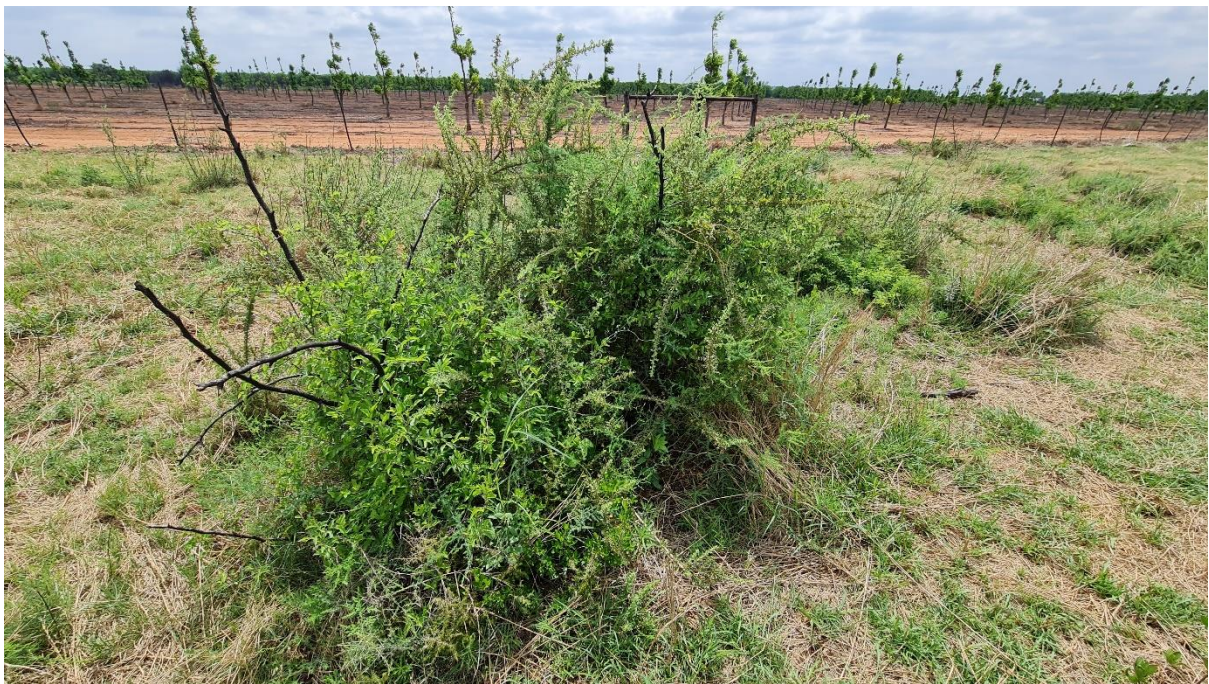
Figure 8 Invasive species on the site

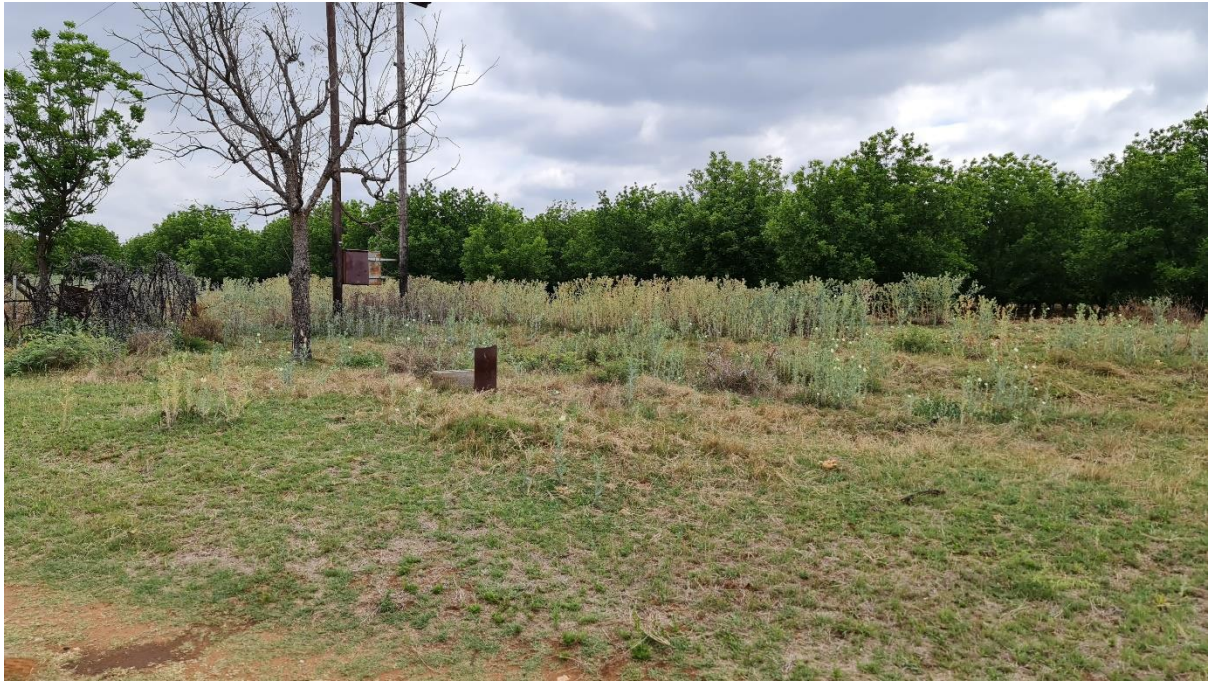
Figure 9 Borehole on the site
