**AQUATIC ECOLOGICAL ASSESSMENT AND
WETLAND DELINEATION OF THE OF THE AQUATIC
RESOURCES ON A PORTION OF PORTION 62 OF
THE FARM WITPORTJE 117 IR**

Prepared by: Scientific Aquatic Services
Report Authors: Stephen van Staden (Pr. Sci. Nat)
Report Reference: SAS 28145
Date: January 2009

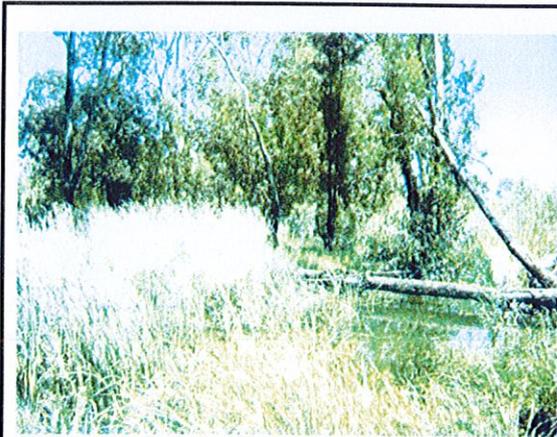
Figure 1: Local view showing surface water present in the eastern drainage feature. This wetland has been called Wetland 1.

This wetland is found in the north of the assessment site. A channel has been artificially dug next to a road and has water flowing into from the neighbouring property. The source of this stream could not be identified, given that a large wall prevented investigating the surrounding areas. However, the most likely source is a combination of surface water runoff and seepage water from the tailings dam on the neighbouring property. Within the channel, water appears to be constantly available and has allowed for the establishment of reeds, particularly *Typha capensis*. The wetland zones found next to the stream are characterised by the presence of the exotic tree *Eucalyptus camaldulensis*, rubble from construction activities, and disturbed grassland. The majority of the disturbance is located in the northern half of this wetland. The southern half of the wetland is dominated by sedges and water loving herbaceous species such as *Nidorella anomala* and *Berkeya radula*. It should also be noted that the wetland was only found to the west of the channel, with the eastern bank consisting of a road and disturbed veld. Overall, the presence of exotics in the wetland, the rubble and construction in the adjacent veld and the low indigenous diversity are indicative of the ecosystem whose ecological integrity has been degraded. It would best be described as a system which is highly modified with an extensive loss of natural habitat, biota and basic ecosystem function.

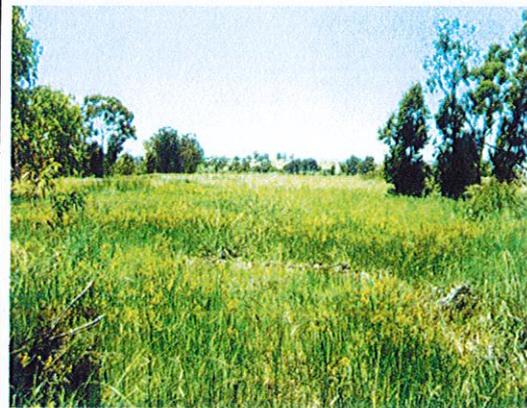
Figure 2: Local view showing the abundance of sedges and water loving wild flowers found adjacent to the eastern drainage feature. This wetland has been called Wetland 1.

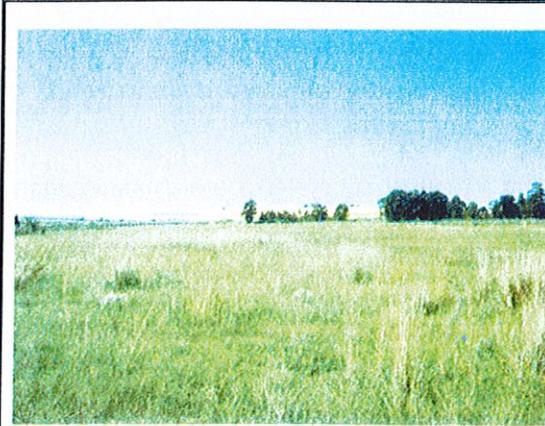
Figure 3: Local view showing the vegetation found in the floodplain of the river that flows to the east of the assessment site. The vegetation found here was indicative of clay soil and most conditions. Overall, this section in moderate ecological condition. This area has been called wetland 2.

This wetland is a portion of the floodplain which neighbours the river flowing to the east of the assessment site. As such, it is dominated by species associated with clay soil and moist conditions, e.g. grass species such as *Agrostis lachnantha*, *Eragrostis capensis*, *Eragrostis gummiflua*, *Eragrostis trichophora* and *Themeda triandra*, and herbaceous species such as *Berkeya radula*, *Nidorella anomala* and *Haplocarpha scaposa*. The dominance of species such as *Themeda triandra*, which is common in undisturbed veld, indicates that this section of the floodplain is still in relatively good condition. The habitat in this section indicates a loss and change of natural habitat and biota, but the basic ecosystem functions are still predominantly unchanged. However, once the Rietspruit flows next to the tailings dam, exotic species such as *Verbena bonariensis* become more prevalent, and the grass species observed, such as *Cortaderia selloana*, are indicative of a more disturbed environment.

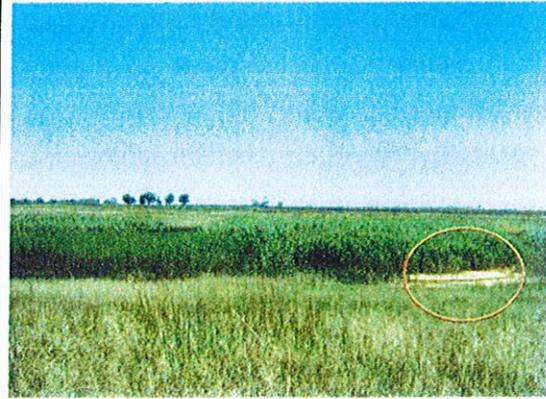
Figure 4: General view of the eastern drainage feature indicating sedimentation caused by tailings deposition (circled in red). This area has been called wetland 2.

| ASPECT | |
|---|--|
| Signs of pollution | The site shows evidence of impact by from the adjacent tailings dam, with clear evidence of sedimentation within wetland 2, with the source of the material being fines. Sedimentation has significantly altered the substrate of the channel and led to the proliferation of <i>Phragmites australis</i> . To the west of the tailings dam, streams that were historically indicated are no longer found, probably as a result of earthworks associated with the tailings dam. However, the presence of the tailings dam has a resulted in a more diffuse distribution of water, with signs of moisture being found almost along its entire length. The combination on disturbance and extra moisture has result in some exotic species such as <i>Verbena bonariensis</i> and <i>Pseudognaphalium luteo-album</i> being extremely abundant. |

- The presence of a tailings dam has altered the integrity of wetland 2 and 3. Severe sedimentation is observed in river to east of the tailings dam. With regards to wetland 3, the integrity of the wetland system here has been severely degraded by the altering of the terrain. In addition, water leaking from the tailings dam results in moist conditions in areas that would have historically been terrestrial zones. In these areas, the vegetation that has been allowed to flourish is exotic species, particularly *Verbena bonariensis* and *Pseudonaphalium luteo-album*. After establishing in these recruitment areas they have often invaded the natural wetland areas.

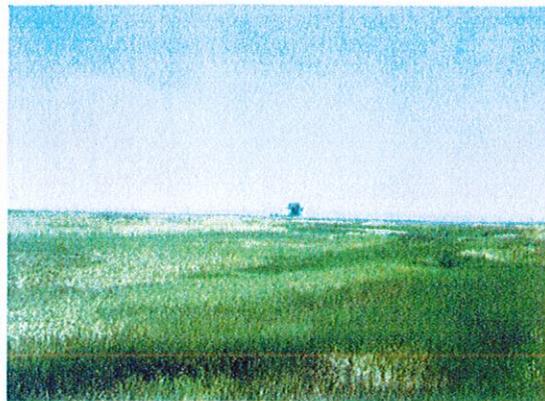
Figure 5: Local view overlooking the narrow channel found in the west of the assessment site. No water was observed in the channel, although water loving grass species such as *Setaria spachelata* and *Andropogon appendiculatus* were prevalent. This area has been called wetland 3.

Further west the channel is found. Although no water was observed in the channel, indigenous water loving grass species, e.g. *Setaria spachelata* and *Andropogon appendiculatus*, and herbaceous species, e.g. *Nidorella anomala*, were abundant. However, overall there was a low diversity of indigenous species as well as an abundance of exotic species, particularly *Verbena bonariensis* and *Pseudognaphalium luteo-album*. This area of the feature can be considered to have suffered a large loss of natural habitat, biota and basic ecosystem functions.

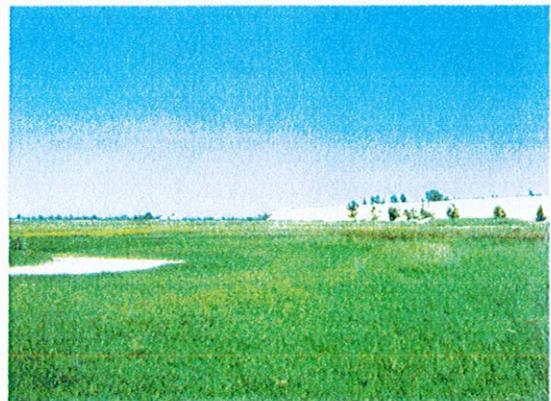
Figure 6: Historical maps indicated a stream found immediately adjacent to the western side of the tailings dam. No such channel was observed during the assessment and the vegetation found in the area was typical of an area that has been critically transformed with an extremely low diversity of indigenous species and an abundance of exotic species.

Historically, a stream was found to the west of the tailings dam most likely originating from tailings seepage or at a minimum significantly recharged by seepage from the tailings dam. The

vegetation that dominated this area was exotic species such as *Verbena bonariensis* and *Pseudognaphalium luteo-album*. The dominant grass species here, e.g. *Cynodon dactylon*, are also indicative of disturbance. The presence of such species can mostly likely be attributed to increased wetness from seepage from the tailings dam, rather than a natural wetland system that may have historically been found here. Some impact on the vegetation due to impacts on soil chemistry is also deemed likely.

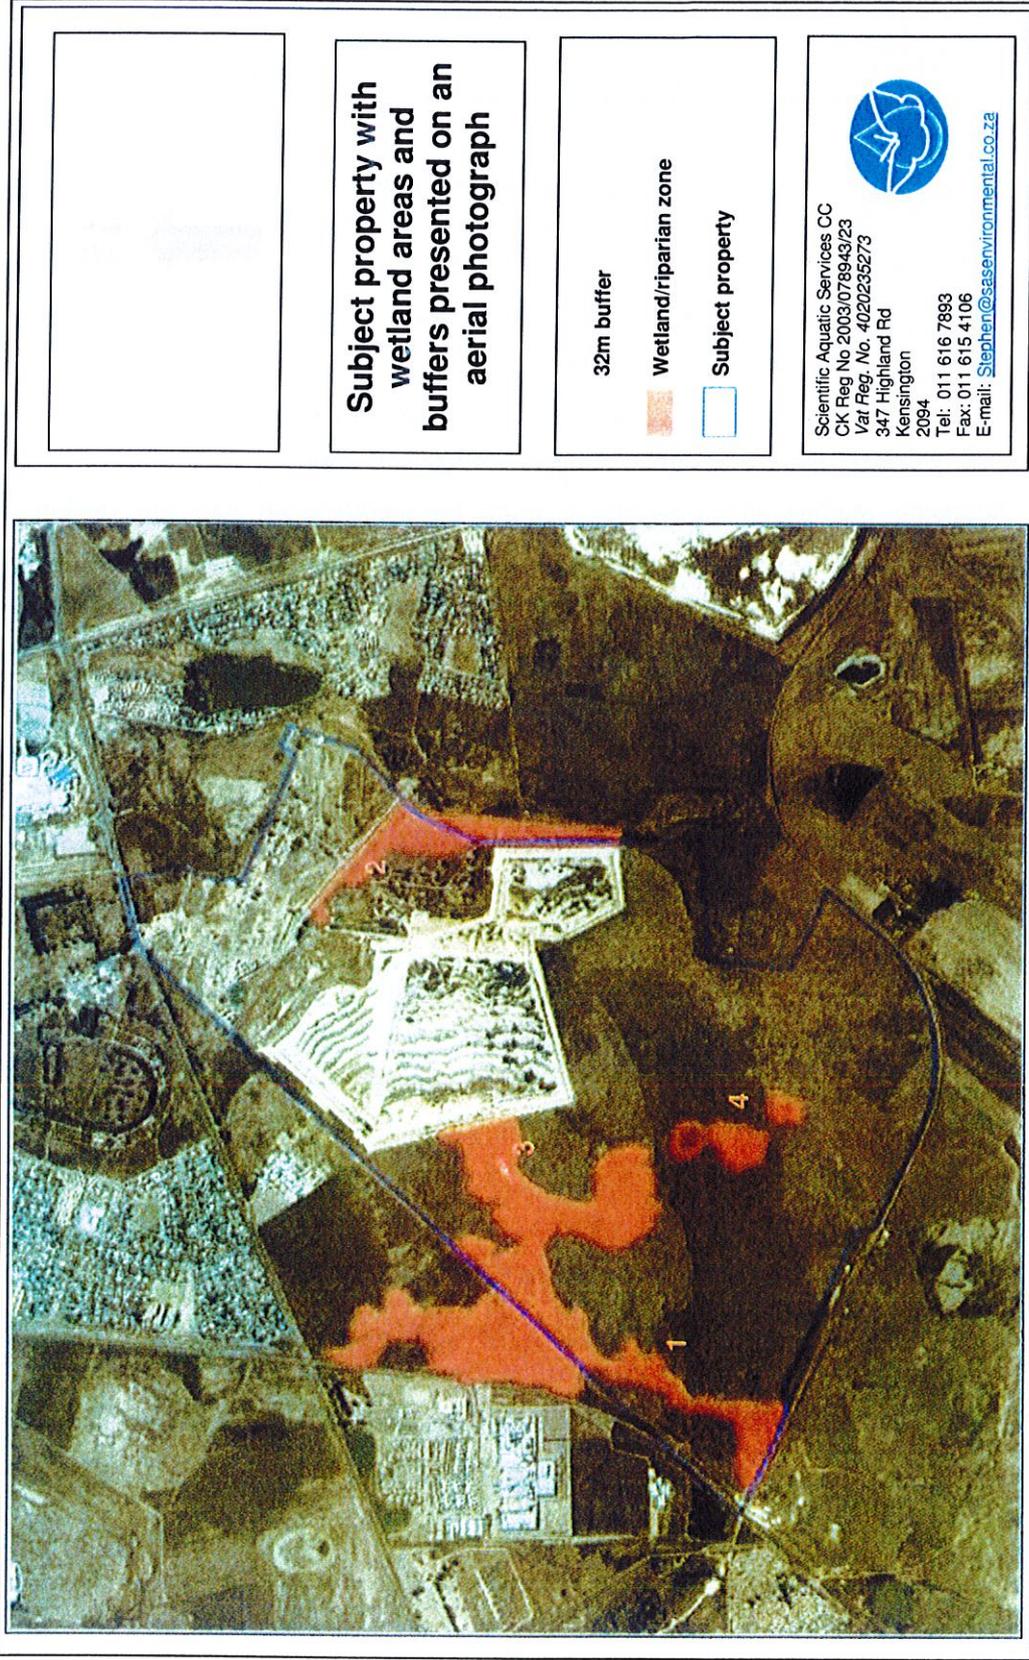
The figures below serve to conceptually present the location of the wetland boundary on the property, as well as the 30 meter buffer zone in relation to the proposed development layout. Please also refer to the associated digital files presenting the wetland boundary and buffer zone to allow for further planning of the layout of the proposed development.

Figure 7: Subject property with wetland areas and buffers presented on an aerial photograph

- Based on the findings of this report, it is deemed necessary that a 30m buffer be maintained around all the wetland features as described in this document, which remains undeveloped as private or public open space.

- No development within the wetland areas and their associated buffers should be permitted.
- Connectivity between the pans and the western main wetland system should be maintained by either a private or public open space linkage.
