A Dolomite Stability Investigation for a Proposed Photovoltaic Plant

Westonaria

February 2016

SG-G16-CX02V01-GSU

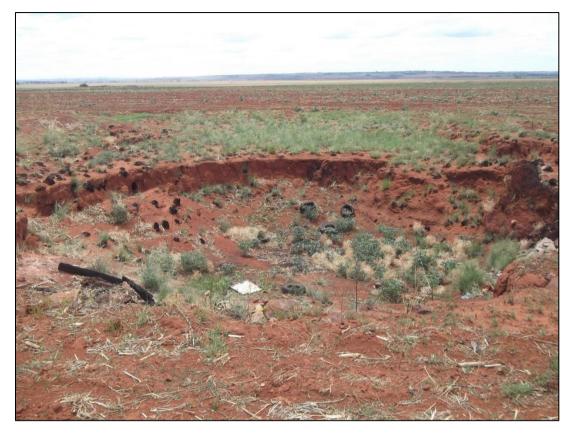
The most significant sinkhole is situated in the south central portion of the main site and measures approximately 30m in diameter. Being greater than 15m it is classified as a 'very large sinkhole'. It is not known when this sinkhole developed however the presence of existing vegetation within the sinkhole, suggests it is greater than 20 years old (aerial photos indicate between 1988 and 2013). With no obvious source of

ingress water in the vicinity its' formation is presumed to be related to dewatering of the Bank Groundwater Compartment. A second event, consisting of concentric cracks occurred in 1990 which are situated approximately 200m north of the previous event. A third sinkhole is situated approximately 350m west of the western boundary and has a diameter of approximately 9m. Again the date of origin is unknown but believed to be from a similar era.

Figure 5. Very large sinkhole situated in south central portion of site

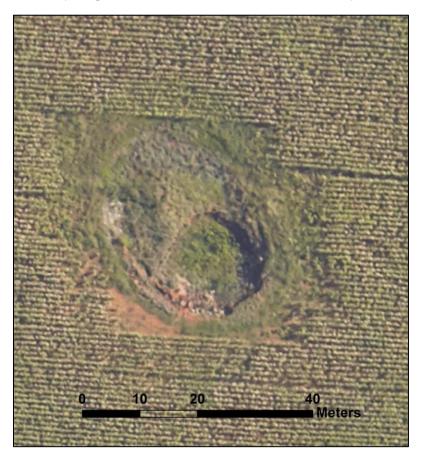
Figure 6. Sinkhole in south central portion of the main PV Plant site (LIDAR, April 2015)

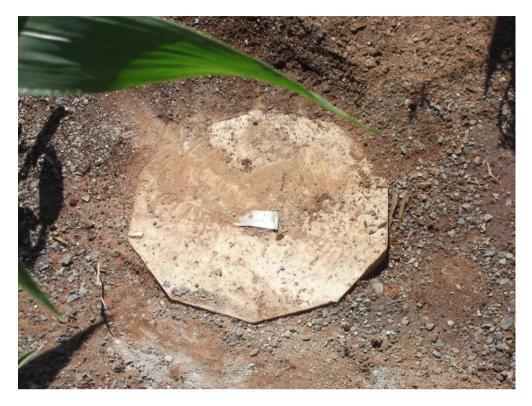
- The boreholes must be suitably backfilled. This was undertaken here by returning the spoils and completely filling the hole, mixing with cement to create a soilcrete mixture and then sealing with a small concrete plug (Figure 7).
- The drilling was supplied by JK Developments over the period 11/12/2015 to 19/1/2016. Borehole profiles, indicating the nature of the ground profile, drilling rates and air/sample losses were produced, see Appendix 2. Chip samples were taken for every metre of borehole drilled and both a gross and a washed sample (fines removed) were saved in the chip trays (Appendix 2).

Figure 7. Concrete plug placed on top of backfilled borehole (Borehole 5106)

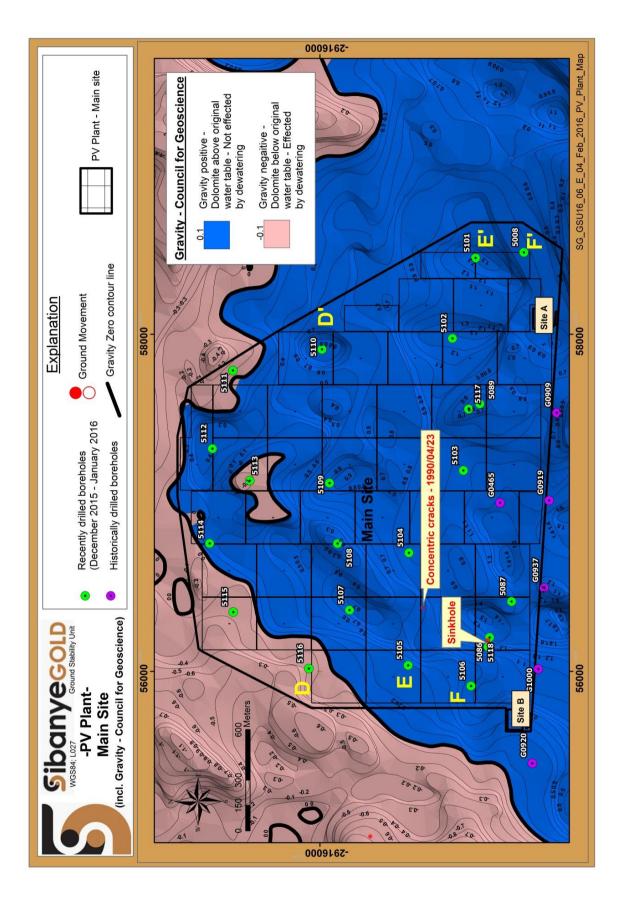
The regional Bank Compartment gravity survey indicates that this site is dominated by a major gravity 'high' with gravity 'low' features (1.8mgal lower) towards the south west corner and northwest border. The 'zero' gravity contour, which is taken as the line separating areas potentially affected by dewatering (gravity lows) and those not (gravity highs), runs on this site just inside and roughly parallel to the western and northern boundaries. According to Bezuidenhout and Enslin (1969), the major portion of this site then, should not be affected by dewatering.

Figure 8. Bank Groundwater Compartment gravity survey (Council for Geoscience)

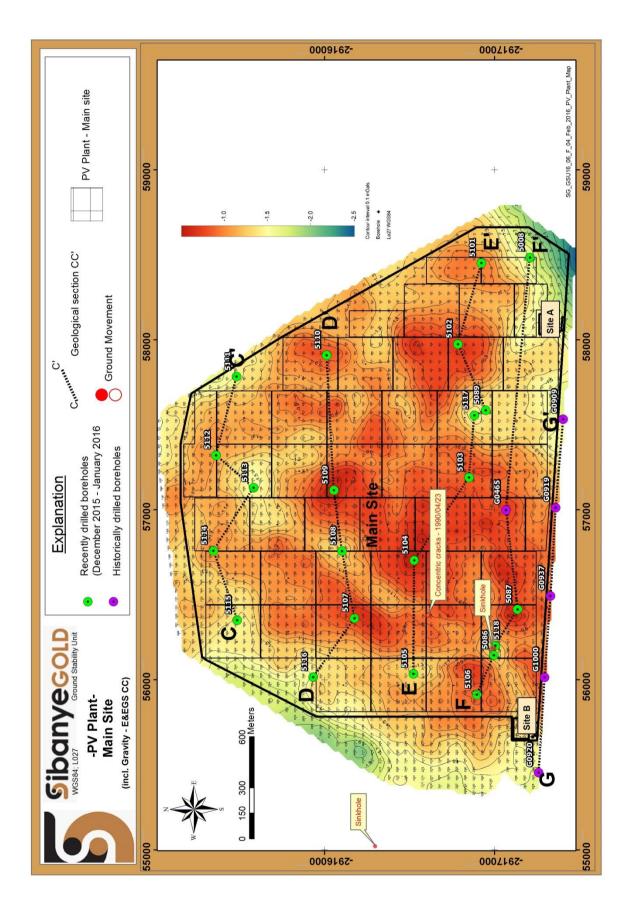
The detailed (50m spacing) conventional residual gravity survey (Figure 9) conducted for the main Site, as expected, shows a similar pattern to the Bank Compartment survey. The value range here is from 0.9 to -0.30mgal from the 'highs' to the 'lows', with a relative 'high' covering the major portion with deeper 'valley' features in between. There may be deeper local gravity features amongst the highs but not detectable on the scale of this grid, see opinion by R. Day (Appendix1). Deeper gravity features are found towards the south eastern corner and north western border.

Figure 9. Residual gravity map showing borehole positions and cross sections

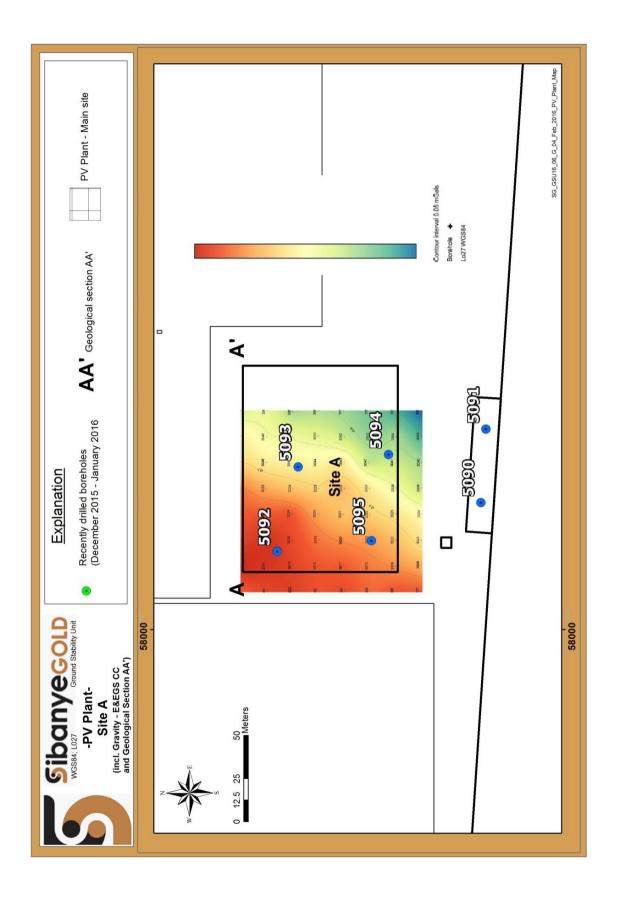
This detailed gravity survey (Figure 10) indicated a gentle gravity gradient of 0.2mgal towards the south east. Borehole 5092 drilled on the 'high' intersected bedrock at

63m, and borehole 5094, drilled on the 'low', intersected bedrock much deeper at >100m.

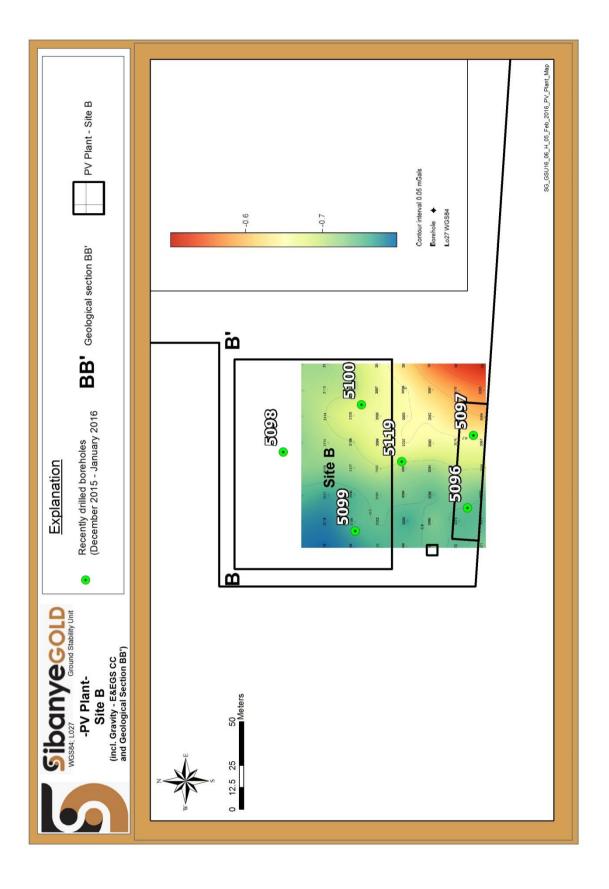
This detailed gravity survey (Figure 11) indicated a gentle gravity gradient of 0.2mgal deepening towards the northwest with borehole 5097 drilled on the 'high' and borehole 5099 drilled on the 'low'.

Figure 11. Residual gravity map of Site B

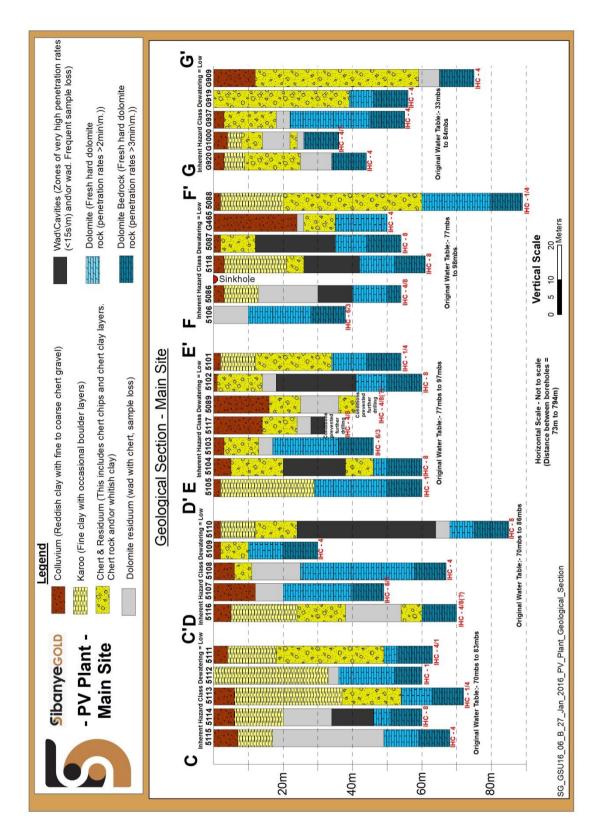
Five cross sections (C-C', D-D', E-E', F-F', G-G') for the Main Site (Figure 12) are provided, in rows of boreholes, each approximately 2,5km long, which provide an overview of the typical conditions to be expected across the site from north to south.

- The northernmost boreholes (C-C') show a consistent layer of clay, essentially 20m thick. The chert residuum is less well developed there and with a dolomite rock layer followed by dolomite bedrock, which was consistently deep (52-60mbs). Only borehole 5114 here shows poor a zone or poor material (wad etc.), depth 34mbs.

- The northern central line (D-D') shows less overlying clay and chert than to the north, with zones of wad and chert (dolomite residuum) commonly present. Borehole 5110 had a prominent zone of very poor material, possible cavity, from 24-64mbs (40m).

- The central cross section (E-E') shows a consistent layer of chert residuum, with some Karoo clay, across all seven boreholes, of at least 15m thickness followed by occasional layers of dolomite residuum. Zones of very poor material are found in three of these boreholes particularly at borehole 5102 (24m thick). As boreholes 5103 and 5117 were not drilled to bedrock it is unknown whether further poorer conditions exist at depth.

- The southernmost row (F-F'), nearest to the R501, shows a mixture of thick clay and some gravels in the upper part of their profiles but with very poor material zones (cavities) in the centre of the site (along this line).

• The southernmost section (G-G'), nearest the R501, and consisting of historical boreholes, shows consistent Karoo age clay and significant thicknesses of chert, 15-59m. Some dolomite residuum is present in most of these boreholes.

Two boreholes (5086 and 5118) were drilled either side of the sinkhole (see position on F-F') on this site in order to try and understand the subsurface conditions that may have triggered this event. Both show a protective covering of Karoo age clay (10-18m) and chert and both show vulnerable zones at a depth of 30-40mbs. It is these vulnerable zones that contributed to the development of this very large sinkhole (30m diameter), despite the protective layers.

Figure 12. Cross sections through the Main site

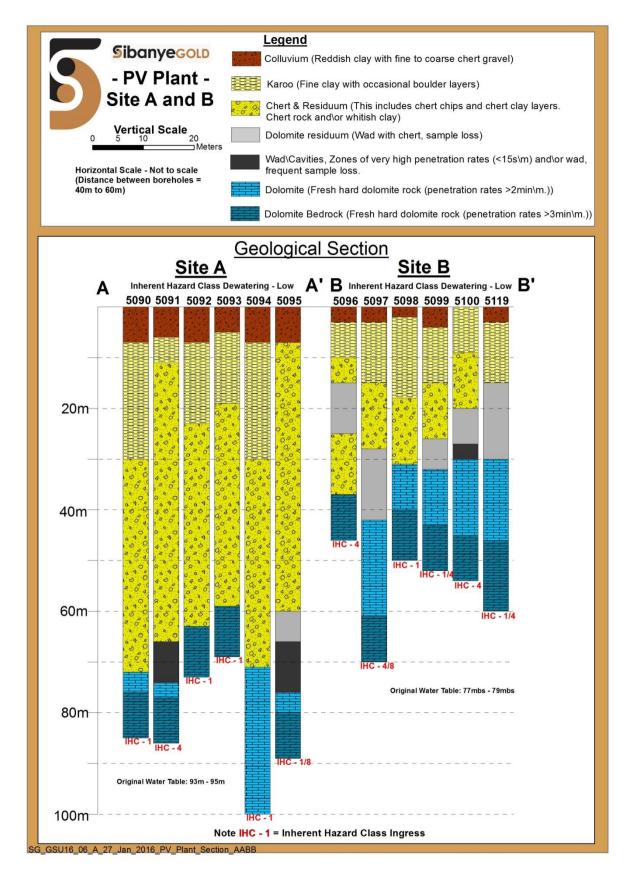
The cross section for Site A (A-A', Figure 13) provides an overview of the typical conditions to be expected where a thick sequence (always >60m) of clay (either Karoo age or chert derived) and chert rock is found overlying dolomite rock. Only

boreholes 5091 and 5095 had a weak zone (depth 60-77m) of wad with high penetration rates.

The cross section for Site B (B-B', Figure 13) provides an overview of the typical conditions to be expected where a moderately thick sequence, at least 15m of Karoo age clay is found. Underlying this is a consistent layer of chert rock and clay (10-15m thick) however a consistent layer of wad with chert though with moderate penetration rates is present in five of the six boreholes here. Only one borehole (5100) showed a small weak, cavernous zone (depth 27m).

Figure 13. Cross sections through Site A and Site B
