**HYDROGEOLOGICAL EVALUATION FOR THE
PROPOSED ADDITIONS AND ALTERATIONS TO THE
SAPS TRAINING FACILITY AT VERDRAG, THABAZIMBI,
LIMPOPO PROVINCE**

HYDROGEOLOGICAL ASSESSMENT

February 2012

WH11122 GW VERDRAG SAPS TRAINING FACILITY

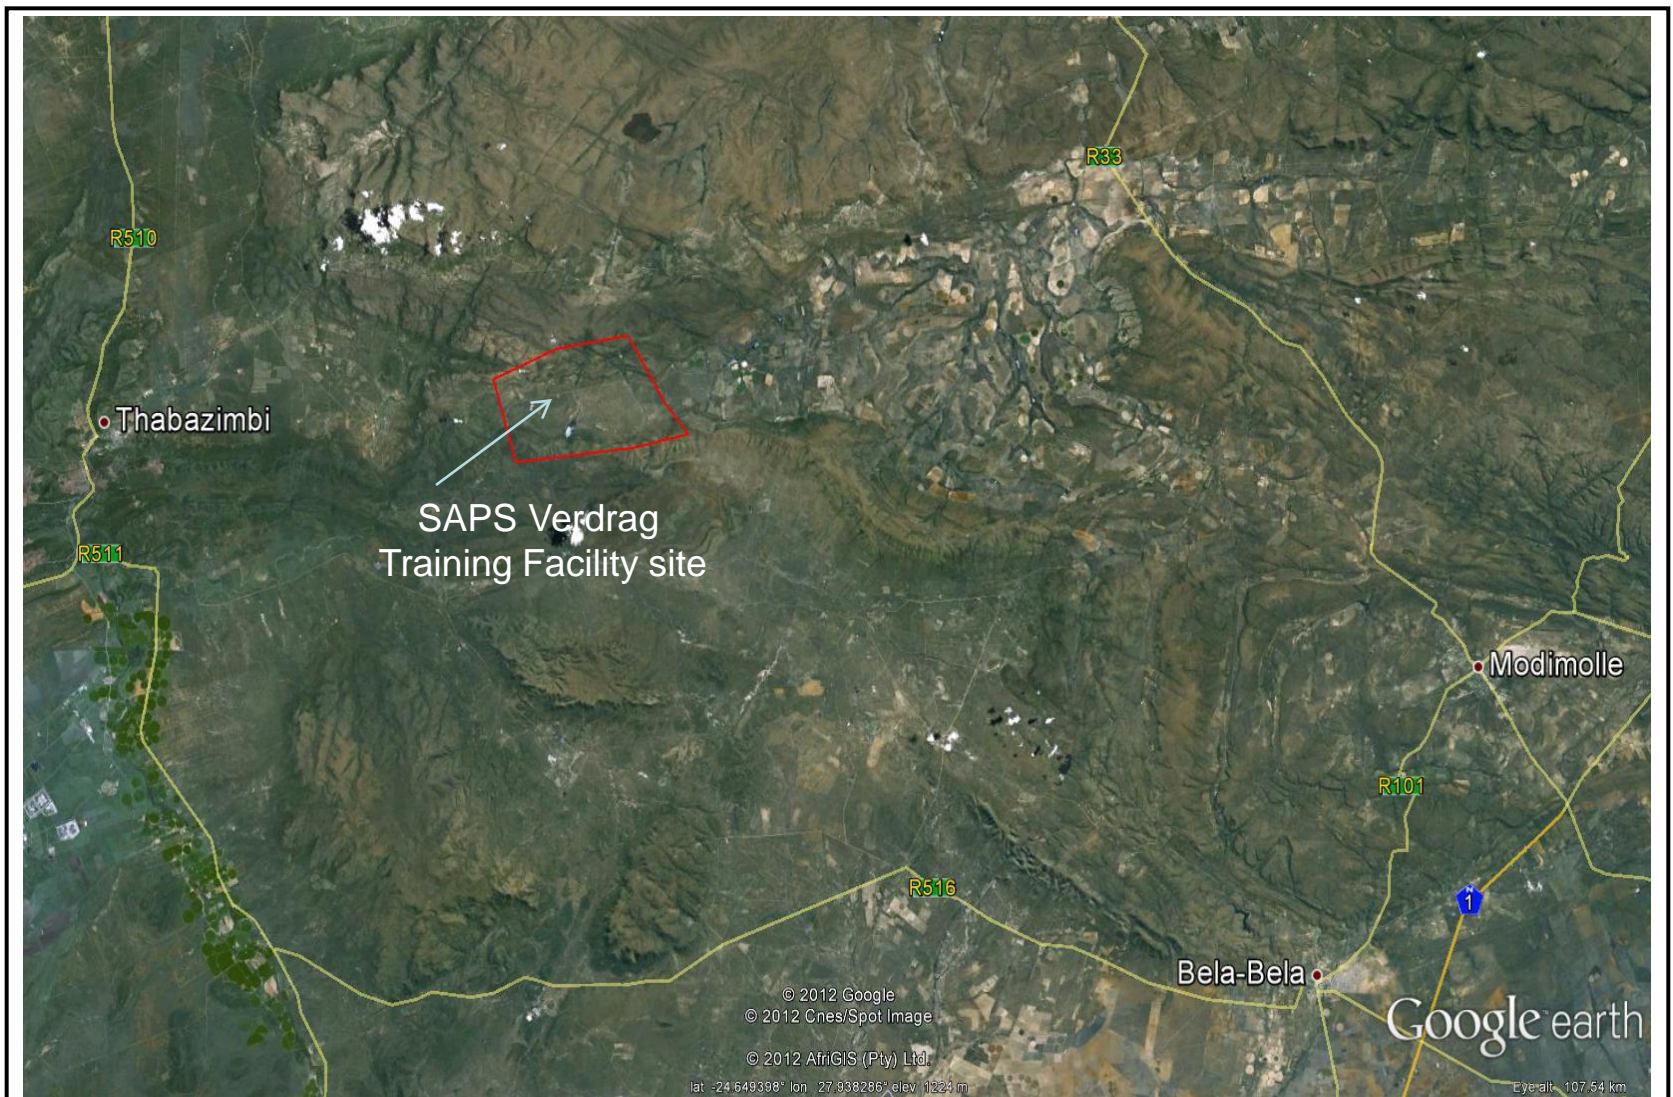
Figure 1 : Locality Map

The site is situated approximately 35 kilometres directly east of Thabazimbi along the Thabazimbi Alma Road. The area consists of the farms Buffelskloof 452 KQ, Groenfontein 458 KQ and Buffelspoort 459KQ located in the Thabazimbi Municipal area, Limpopo Province, see figure 1. The land is owned by the Department of Public Works.

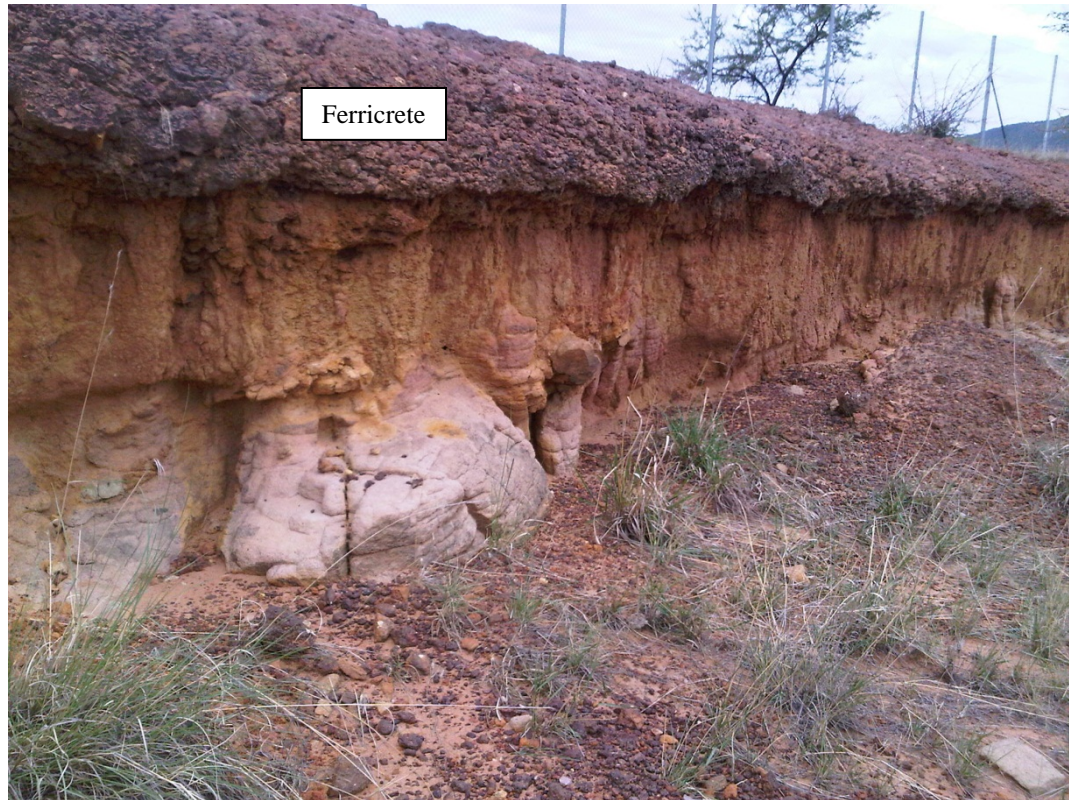
the elevated plateaus. Ferricrete was observed at the eastern oxidation ponds (see photo below) overlying completely weathered sandstone.

Photo 1: Soil profile at eastern oxidation ponds

It is recommended that during the upgrading, the sewage system be replaced with properly designed treatment works. It would also be preferable if all the sewage can be treated in one plant.

The existing oxidation ponds will then need to be closed and rehabilitated.

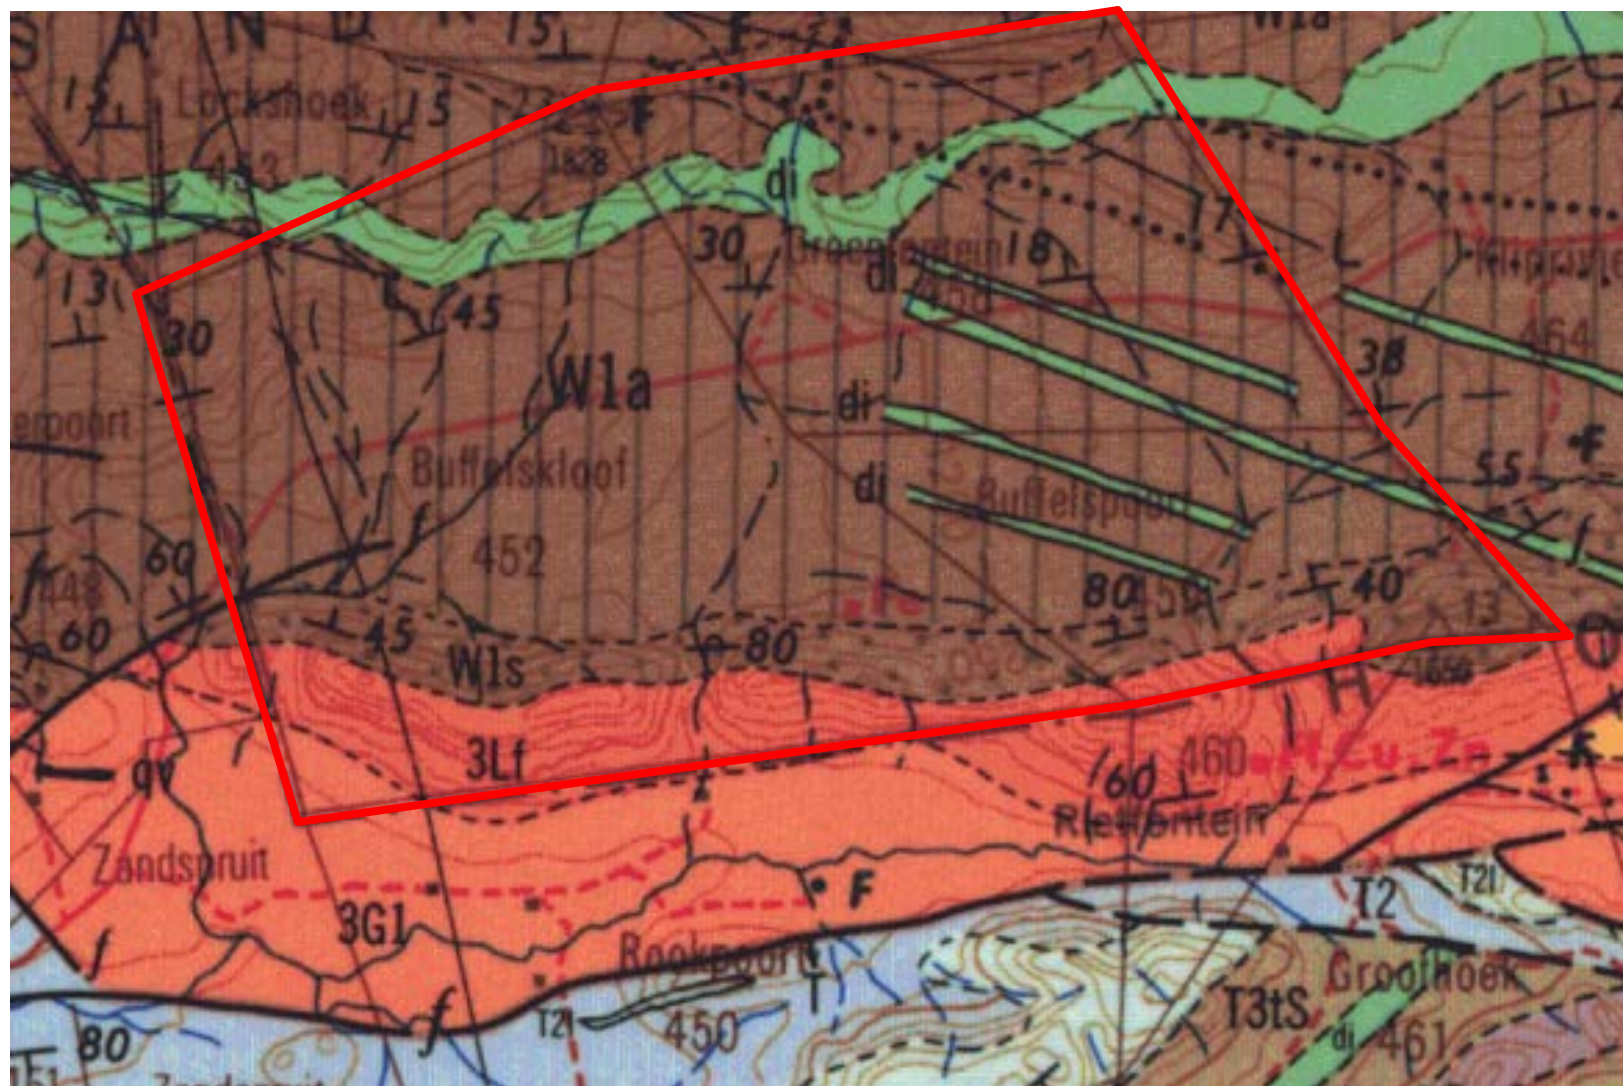
Figure 2 : Geology Map

The 1: 250 000 geological map 2426 Thabazimbi indicates that the site is underlain mainly by rocks of the Alma formation (W1a) of the Nylstroom subgroup of the Waterberg Group. These rocks consist of siltstones, sandstones, conglomerates, feldspathic grouwak and arkose.

The ridges on the southern boundary consist of Felsite (3Lf) with granite (3G1) and dolomite (T2) occurring further south.

Numerous Diabase (di) sills and dykes have intruded into the Waterberg Group rocks See figure 2.

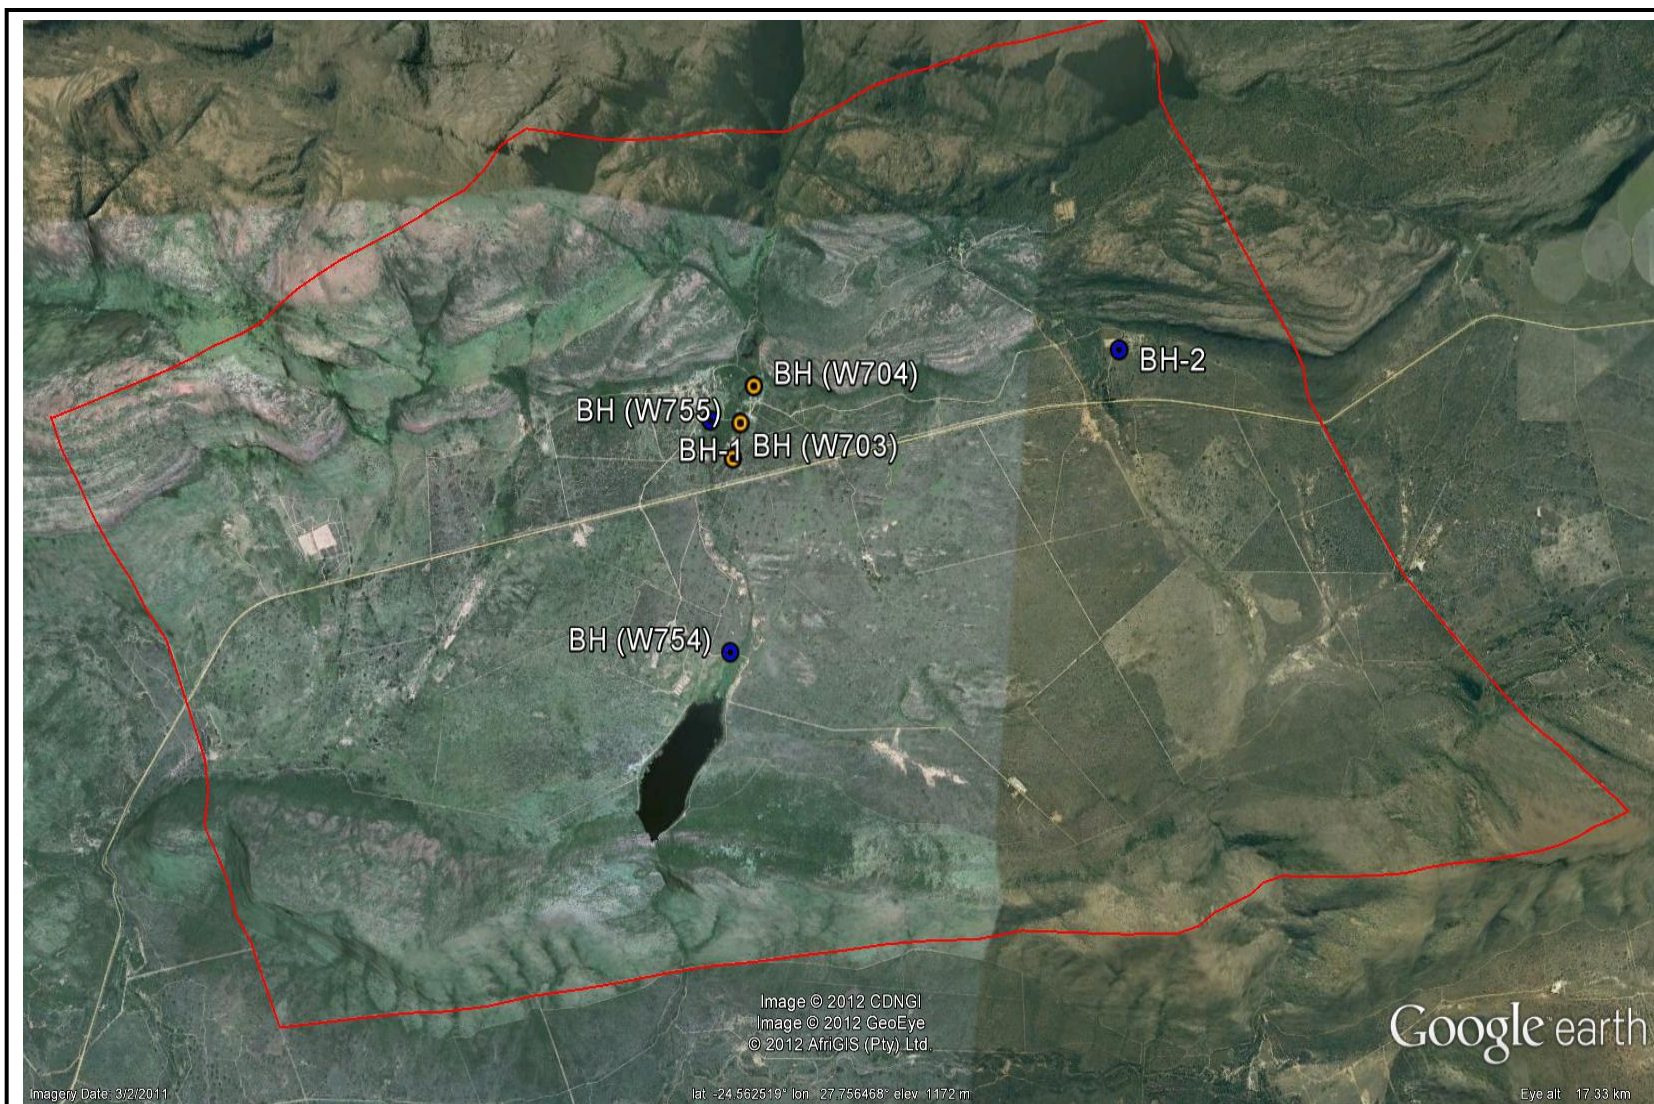
Figure 3 : Borehole Locality Map

Six existing boreholes were said to exist on the site. Only 3 were found during the site visit (see table 1 below and figure 3).

Not located during field census

Yields have been estimated by considering the pump head gear and discharge pipe sizes. It is recommended that these boreholes be tested to determine their sustainable yields.

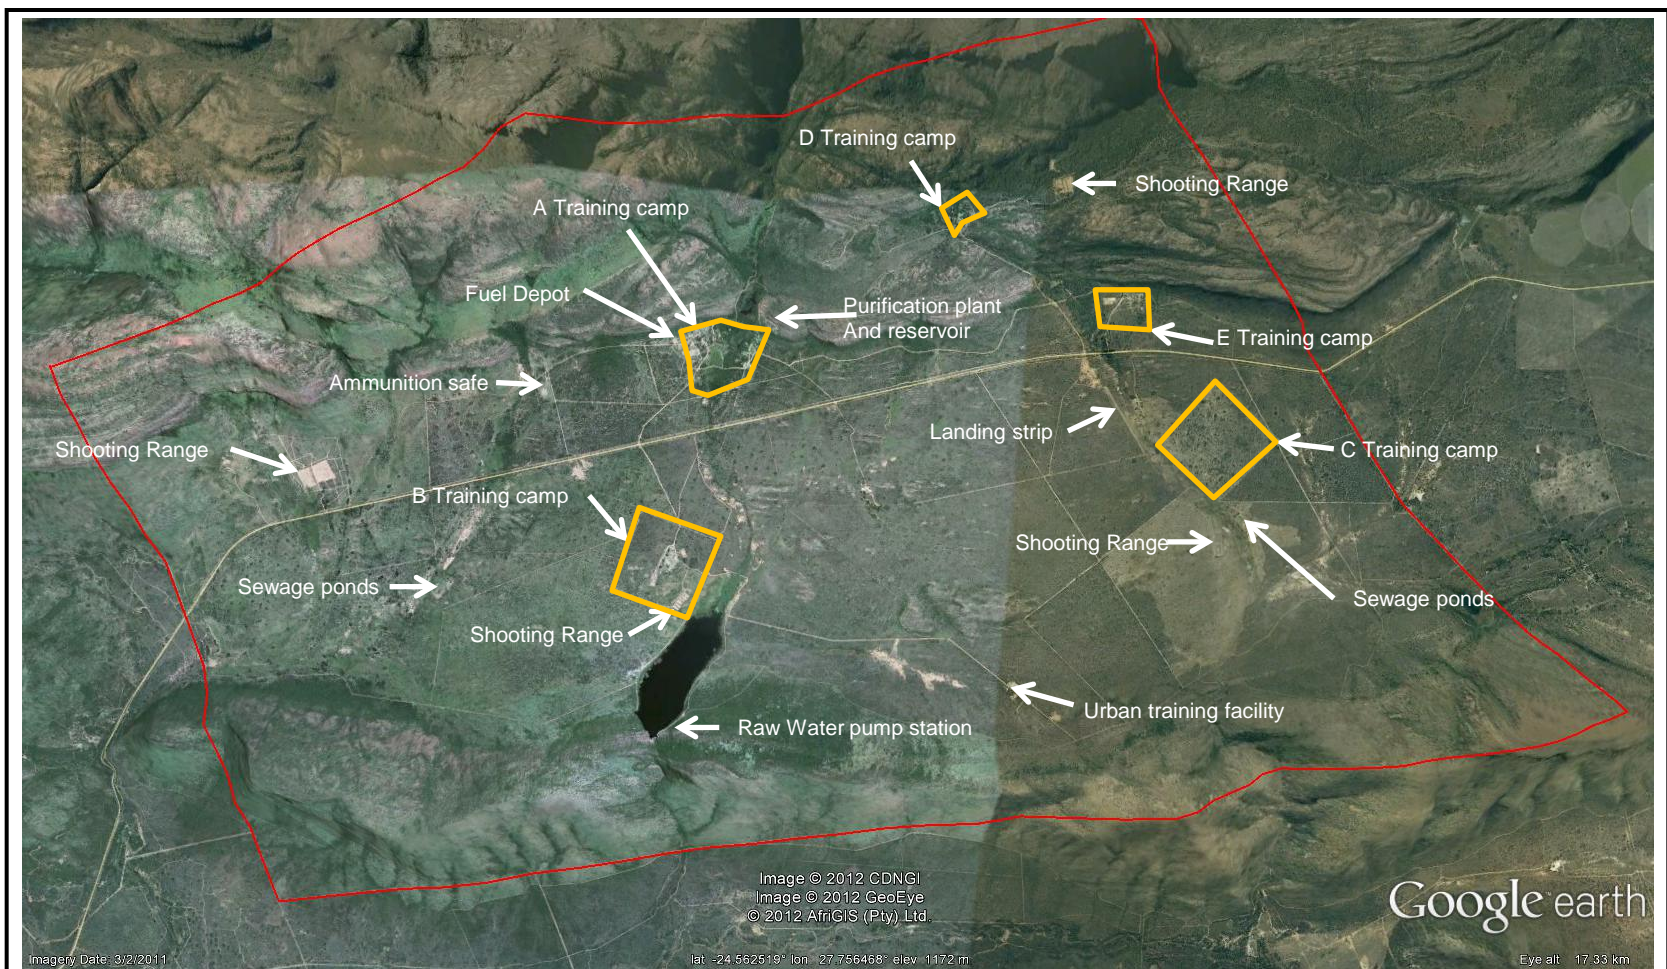
Figure 4 : Existing infrastructure development

- Training camps A, B, C, D and E
- Workshops at training camp A
- Shooting range
- Sewage ponds
- Ammunition safe
- Fuel Depot
- Water purification works and storage reservoir
- Raw water pipeline
- Clean water reticulation pipelines
- Sewage pipelines
- Electricity lines
- Landing strip
