GEOHYDROLOGICAL SITE ASSESSMENT AND REPORTING LETSEMENG LOCAL MUNICIPALITY LANDFILL SITE DEVELOPMENT

NOVACRAFF GROUNDWATER CONSULTANTS

21 July 2021

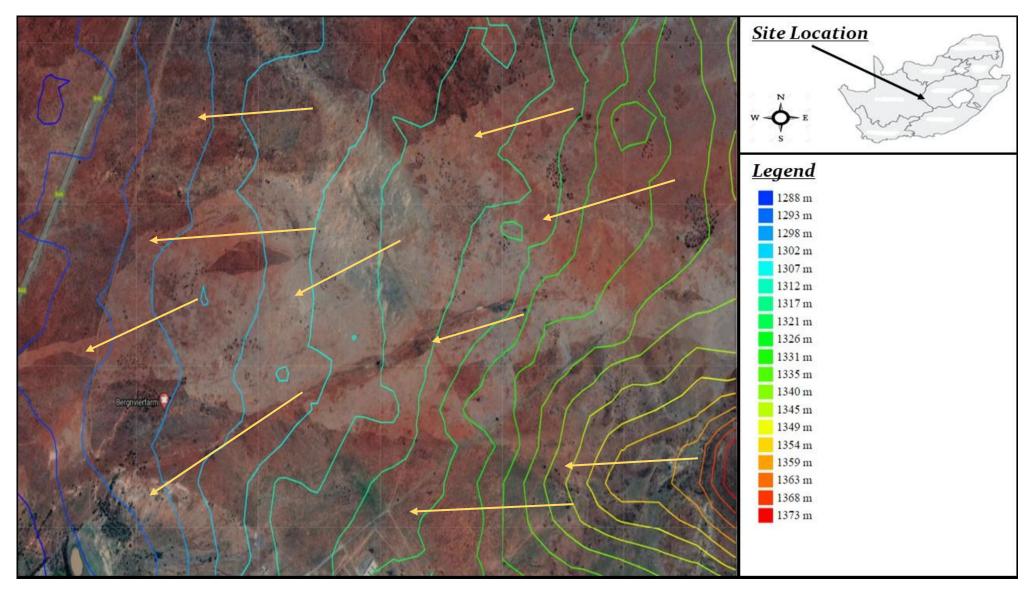
Figure 2. Surface topography and drainage.

The topographical map can be perused in Figure 2. The surface water drainage direction from the proposed waste site is primarily into a south-western and western direction (refer Figure 2). The south-western drainage direction contributes to the downstream dam (SW01) that was identified and sampled during hydrocensus investigation.

- The surface water drainage direction from the proposed waste site is primarily into a south-western and western direction (refer Figure 2). The south-western drainage direction contributes to the downstream dam (SW01) that was identified and sampled during the hydrocensus investigation. It is recommended to contain run-off water on site, as contaminated runoff water will flow to the downstream dam if not contained.

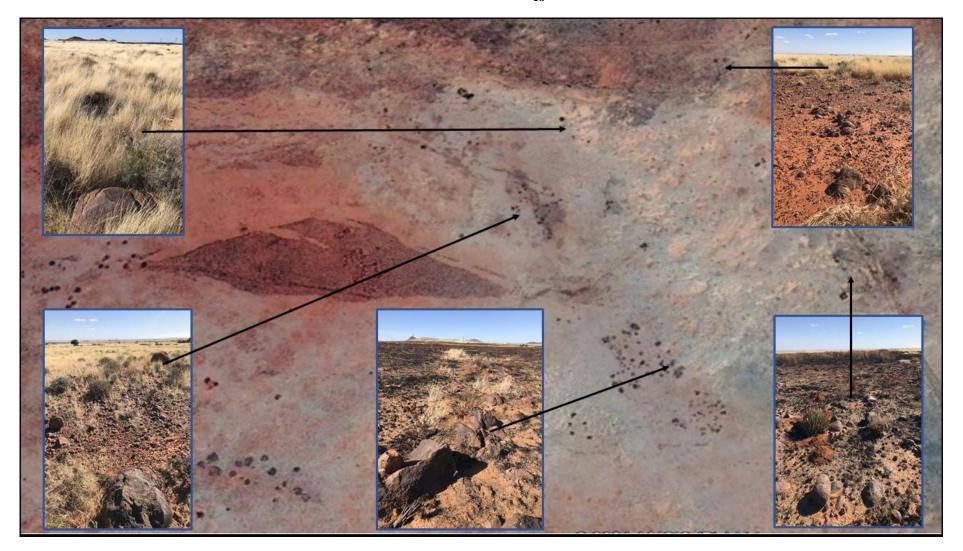
Figure 13. Dolerite outcrops identified during site assessment.

The geophysical survey on site was completed with a G5 Proton Magnetometer to determine possible dolerite structures in the local area. The traverse locations can be viewed in Figure 12. According to the data and graphs, a dolerite sill is underlying the the local area. Dolerite outcrops from the dolerite sill was encountered throughout the site under investigation.

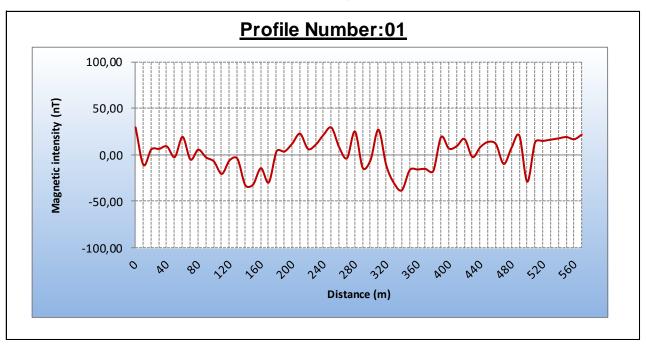
Figure 14. Magnetic profile 01.

Figure 14 is a presentation of the data in a graph format for interpretation. Predominant magnetic anomalies are evident across the entire traverse, indicating a possible underlying dolerite sill. This is verified with outcrops encountered throughout the site under investigation (Figure 13).

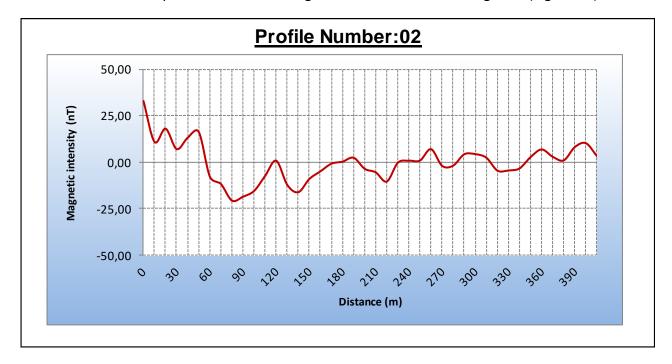
Figure 15. Magnetic profile 02.

Figure 15 is a presentation of the data in a graph format for interpretation. Predominant magnetic anomalies are evident across the entire traverse, indicating a possible underlying dolerite sill. This is verified with outcrops encountered throughout the site under investigation (Figure 13).

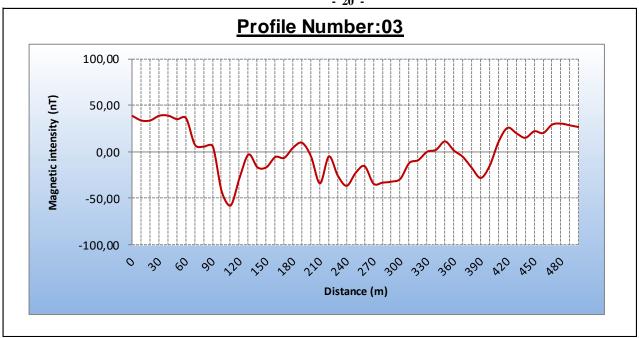
Figure 16. Magnetic profile 03.

Figure 15 is a presentation of the data in a graph format for interpretation. Predominant magnetic anomalies are evident across the entire traverse, indicating a possible underlying dolerite sill. This is verified with outcrops encountered throughout the site under investigation (Figure 13).

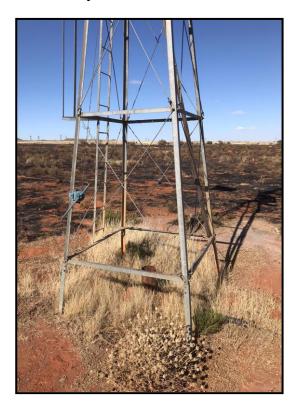
1 borehole and 2 surface water sites were encountered during the hydrocensus survey, 1 sample was collected, and no water level could be verified as the borehole is blocked. Borehole and surface water site locations can be viewed in Figure 17.

- The Hydrocensus investigation indicate no major groundwater abstraction or groundwater dependence however, borehole BH01 was blocked but is an indication that a feasible groundwater resource is present downstream. Thus, the lining of the site is recommended to ensure no leaching of pollutants into the subsurface.

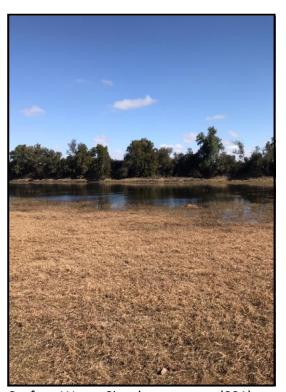
Surface Water Site downstream (S01)

According to the chemical results in section 5.3, no pollution is detected (this sampling event) for surface water site SW01 downstream for the elements analysed. Indicating no current surface water pollution from the surrounding environment.
