APPENDIX B: PHOTOGRAPHS

Greenbushes Erf 77
33°55'18.56"S; 25°25'32.40"E

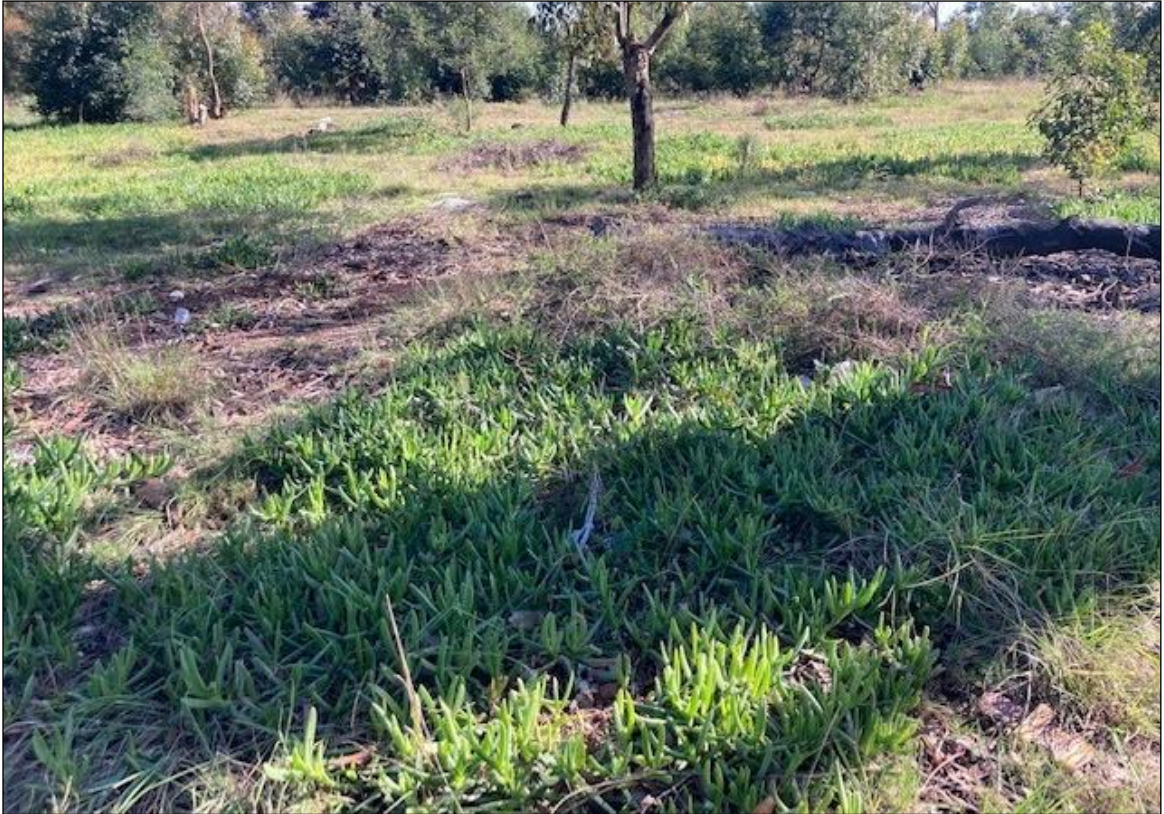
PHOTO SITE A: SOUTH-EASTERN SECTION OF THE SITE

Natural groundcover observed within certain sections of the property.

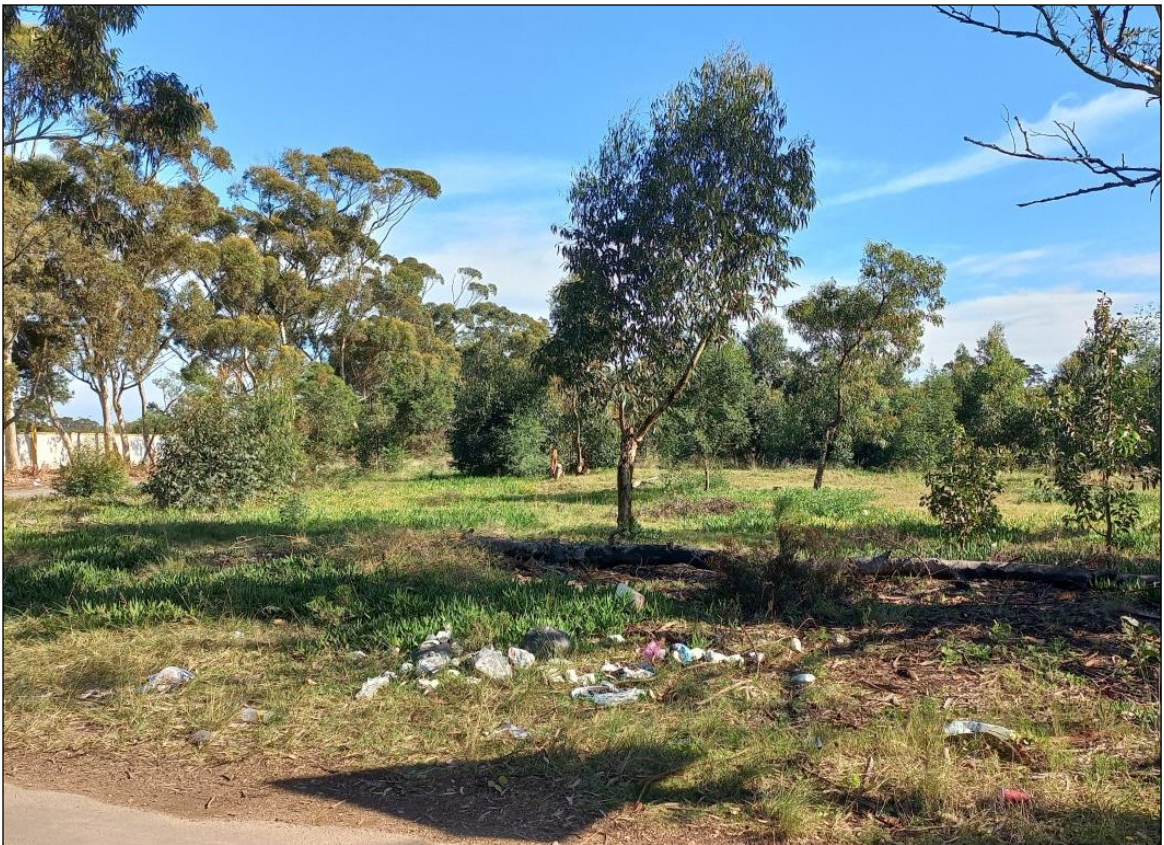
Illegal dumping observed along the inner boundary of the property.

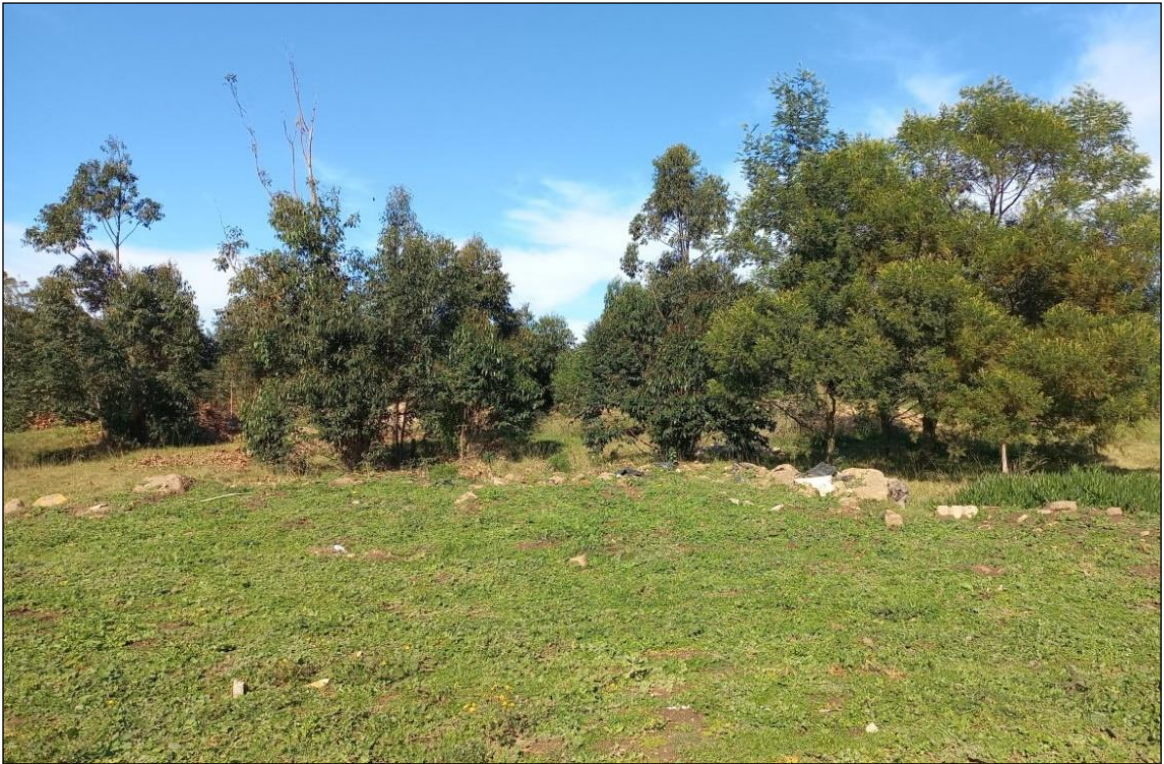
PHOTO SITE B: NORTH-WESTERN SECTION OF THE SITE

Alien vegetation and some spoil material covered with grass.

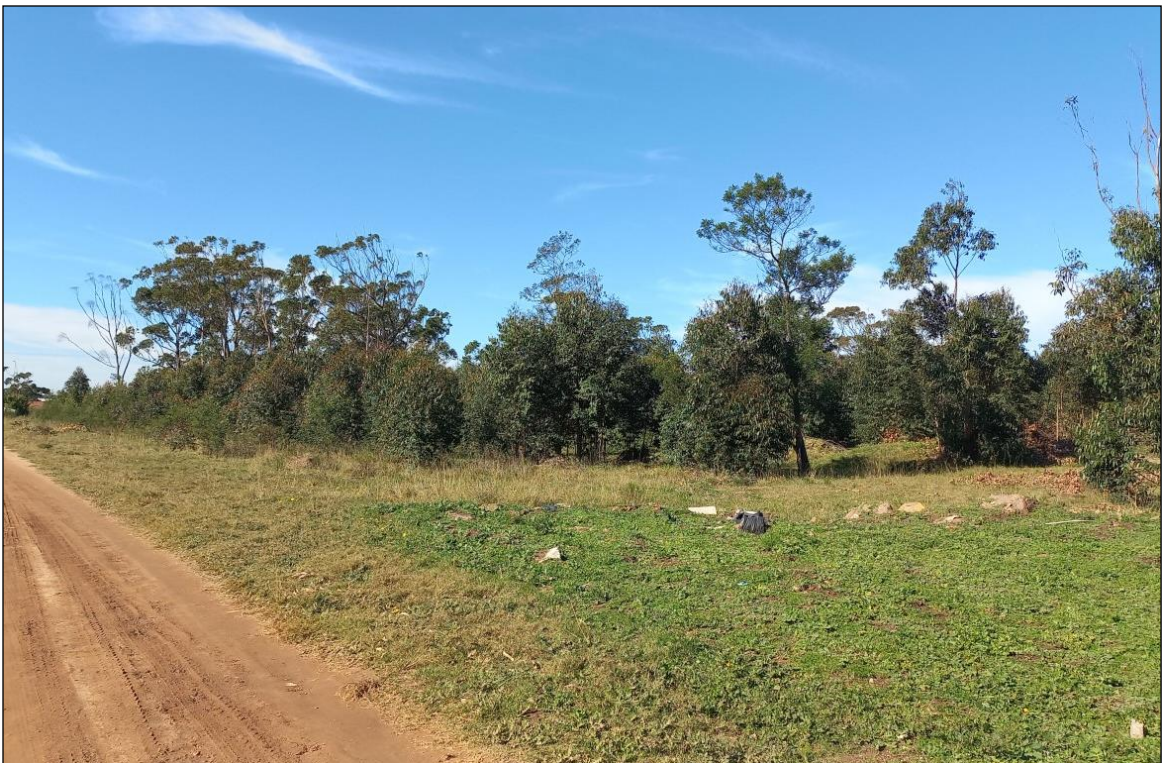
View of the site from the north-west corner.

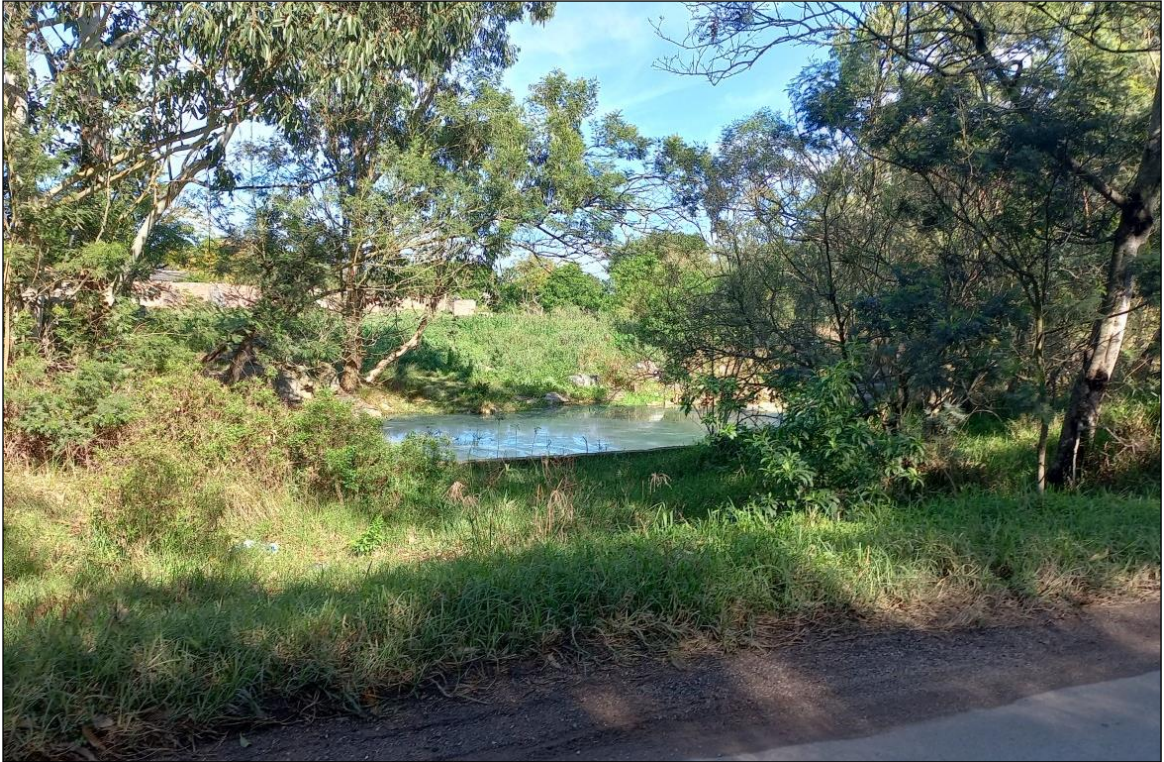
PHOTOS OF NEARBY SURFACE WATER FEATURES

Drainage line located approximately 80m from the south-east corner of the site.

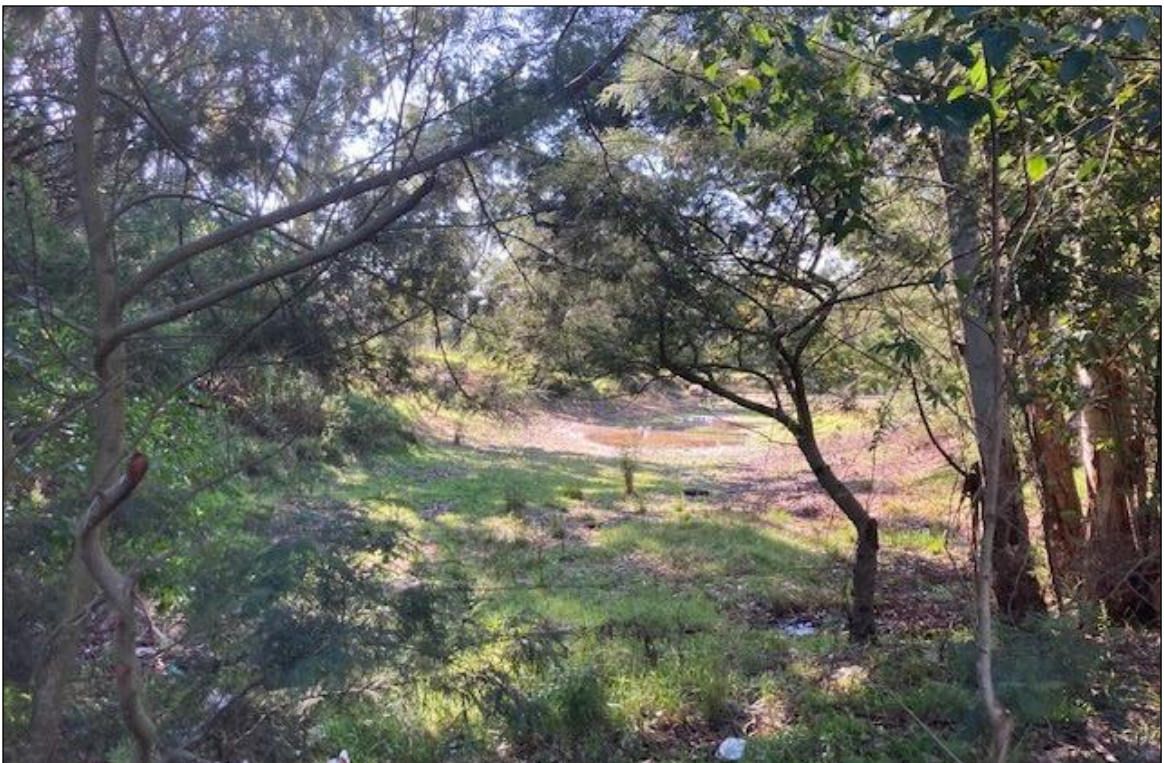
Wetland located on neighbouring property approximately 90m east of the site.
