APPENDIX B

Photographs

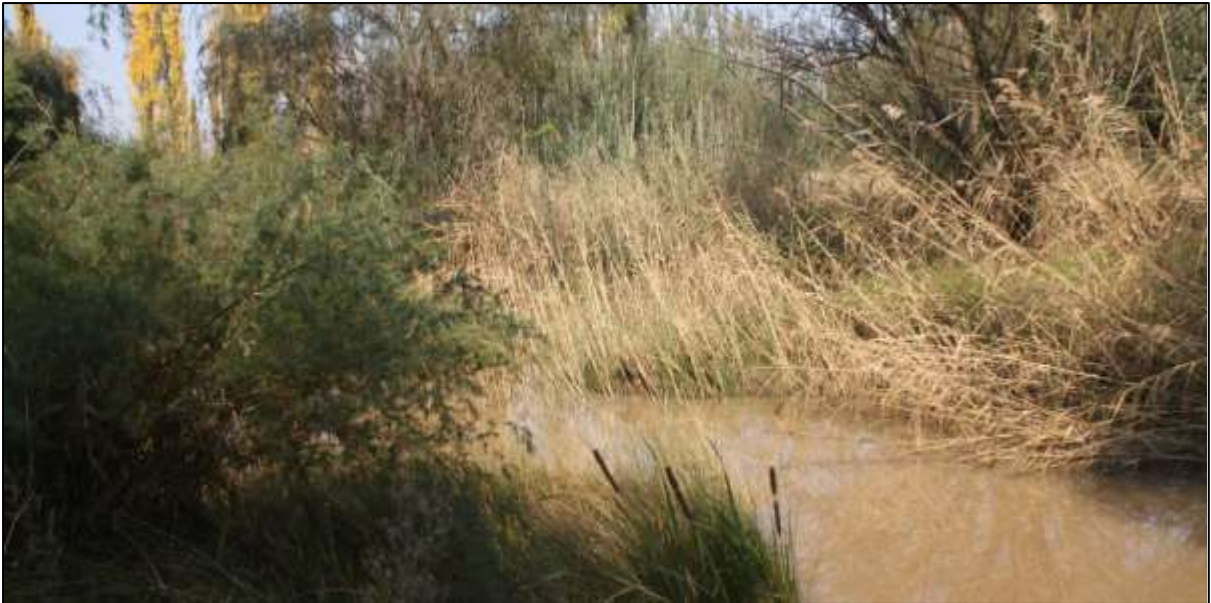
View of the main channel of the Sand River.

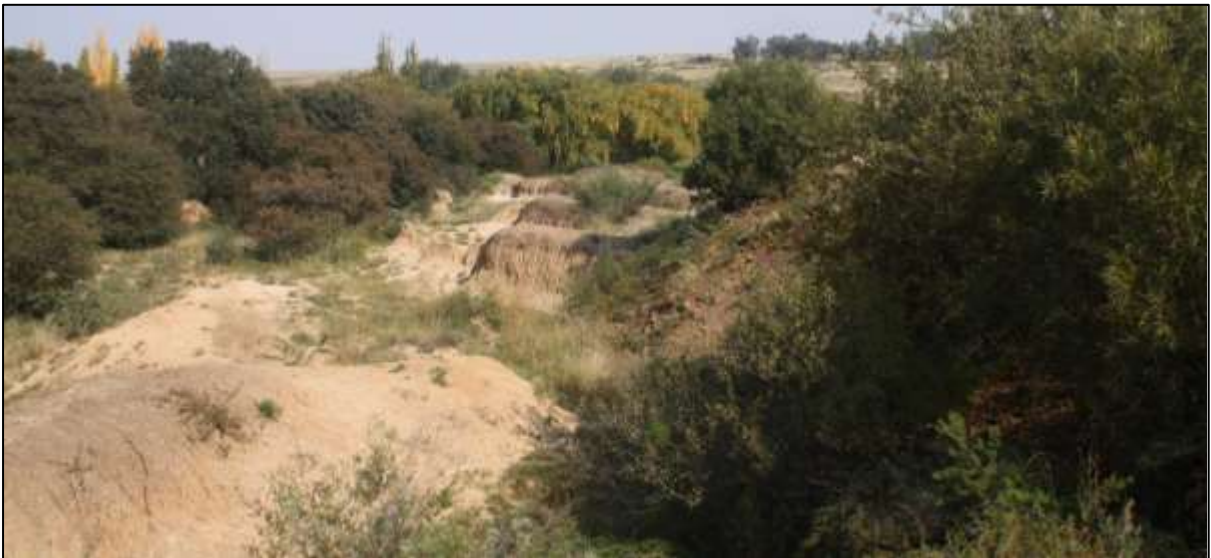
View of the floodplain of the Sand River. Note the extensive erosion gullies, considered to be mostly natural.

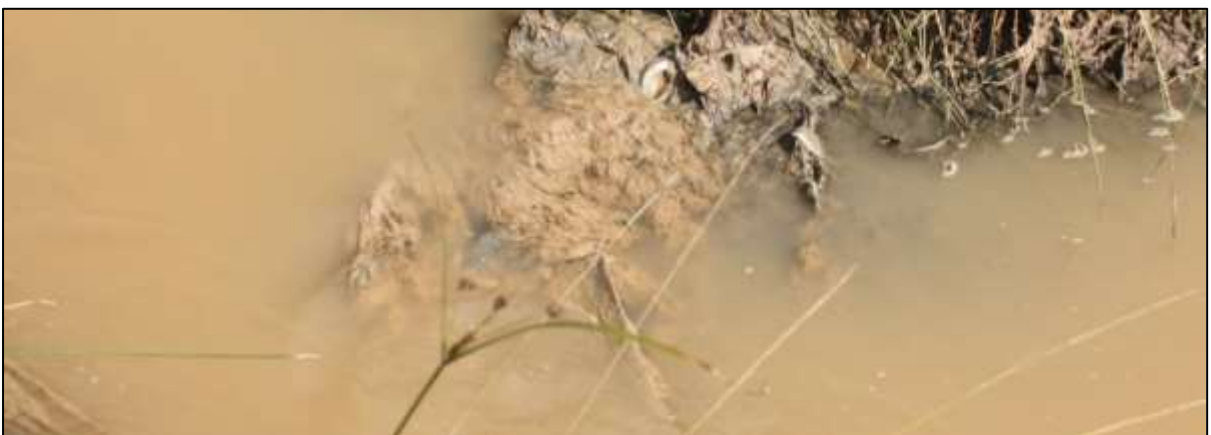
Dense algal mats indicate high nutrient levels and poor water quality.

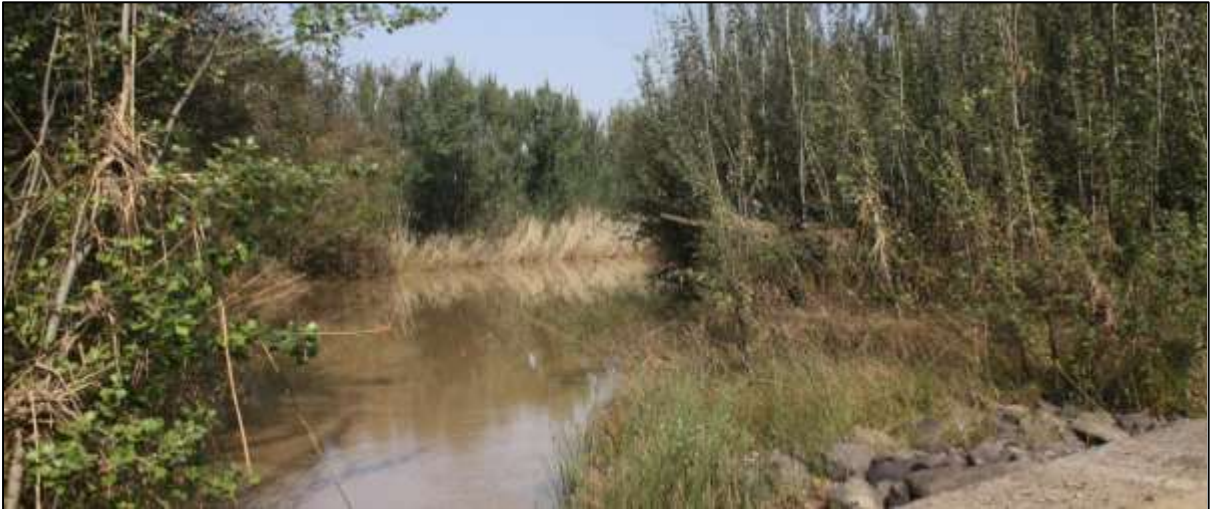
View of the main channel of the Sand River. Note that riparian trees in this area is dominated by exotic *Populus x canescens*.

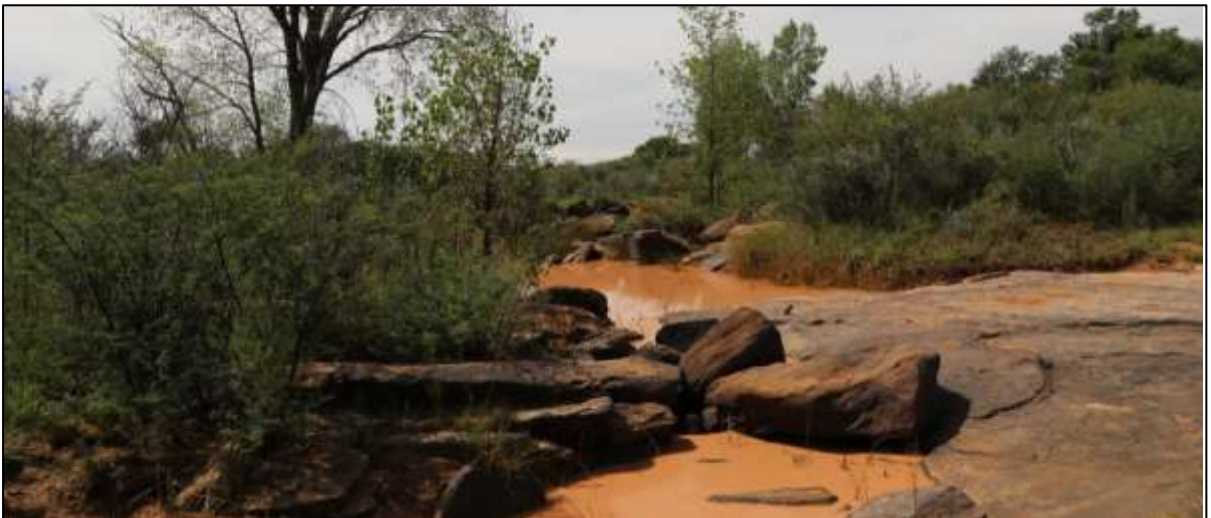
The main channel of the Sandspruit clearly indicates that it is a large and significant watercourse. Note the large exotic tree in the background.

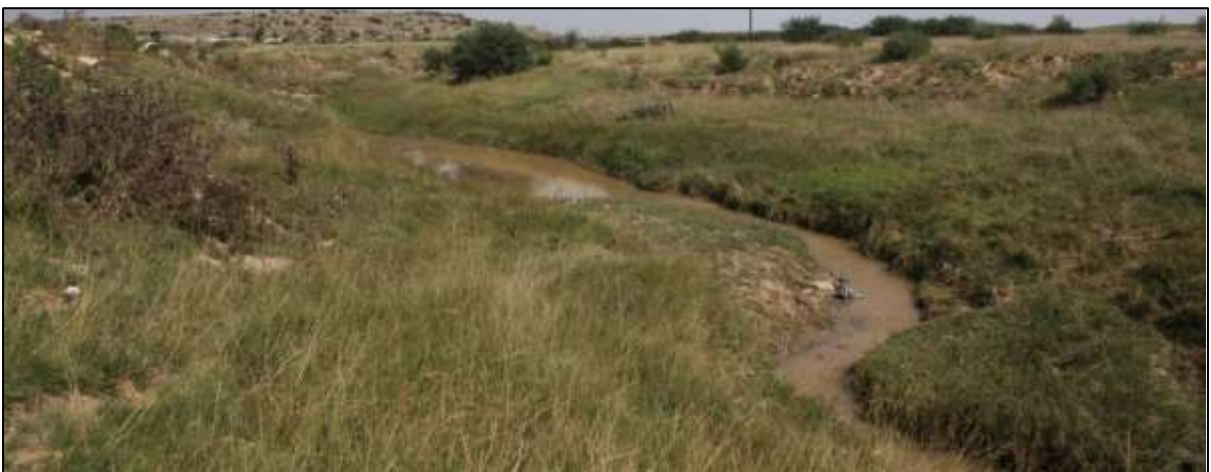
View of the main channel of the river.

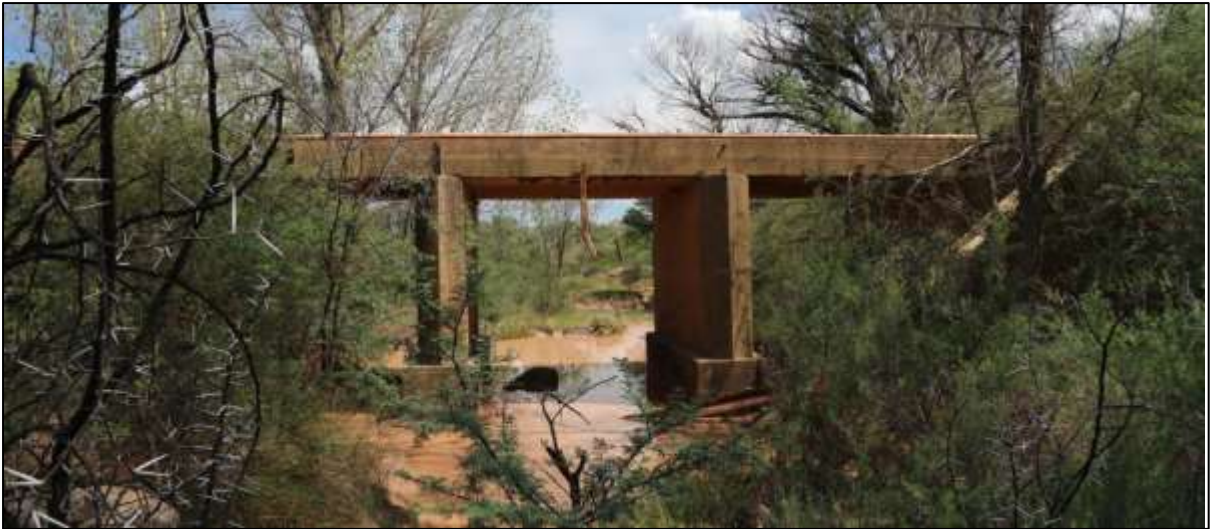
View of the gravel road and bridge over the Sandspruit. This will clearly have some impact in terms of flooding and scouring.

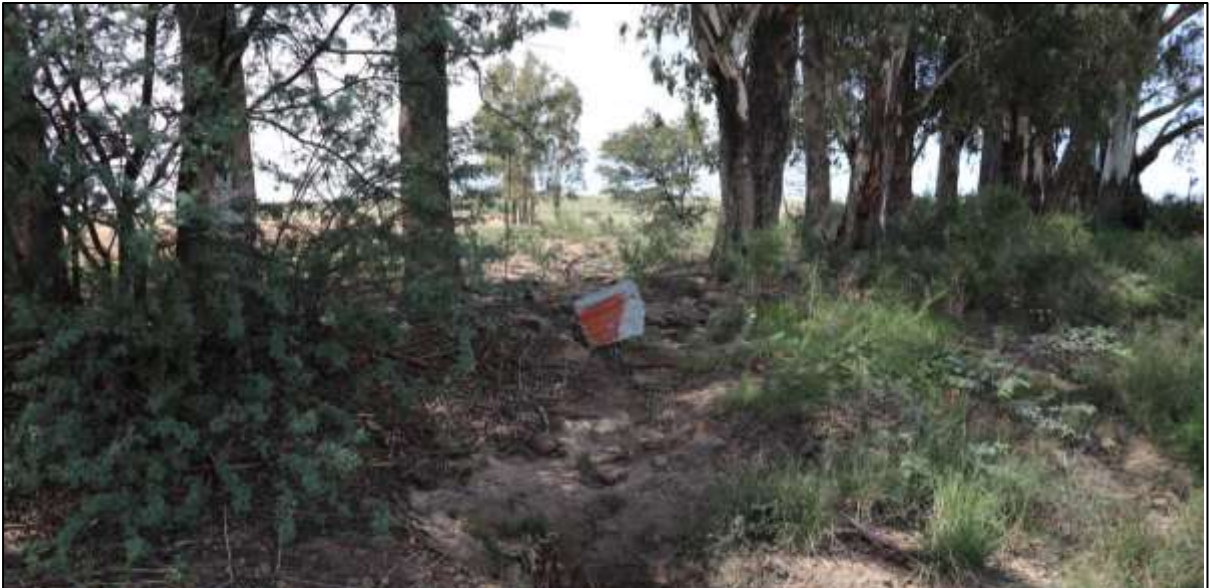
Indication of a heavily degraded drainage line. Note row of exotic *Eucalyptus camaldulensis* trees.

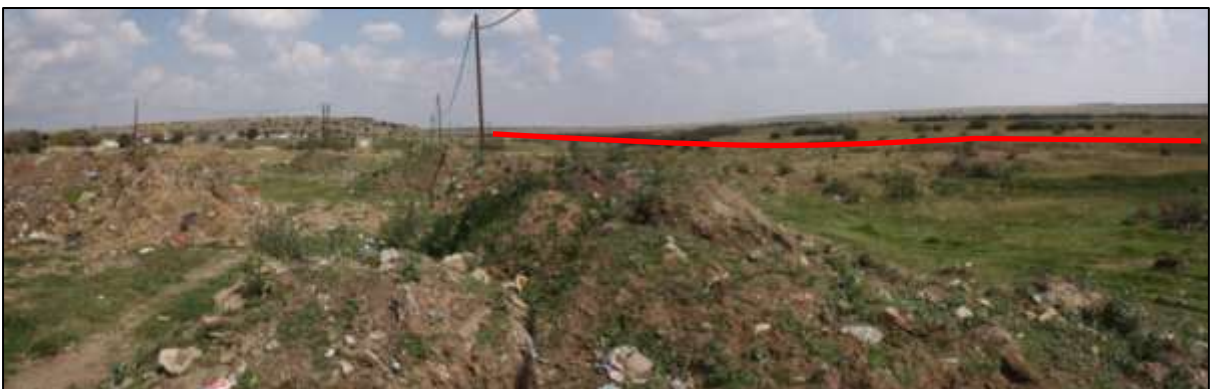
View of the illegal dumping in the floodplain. The location of the river is indicated (red).

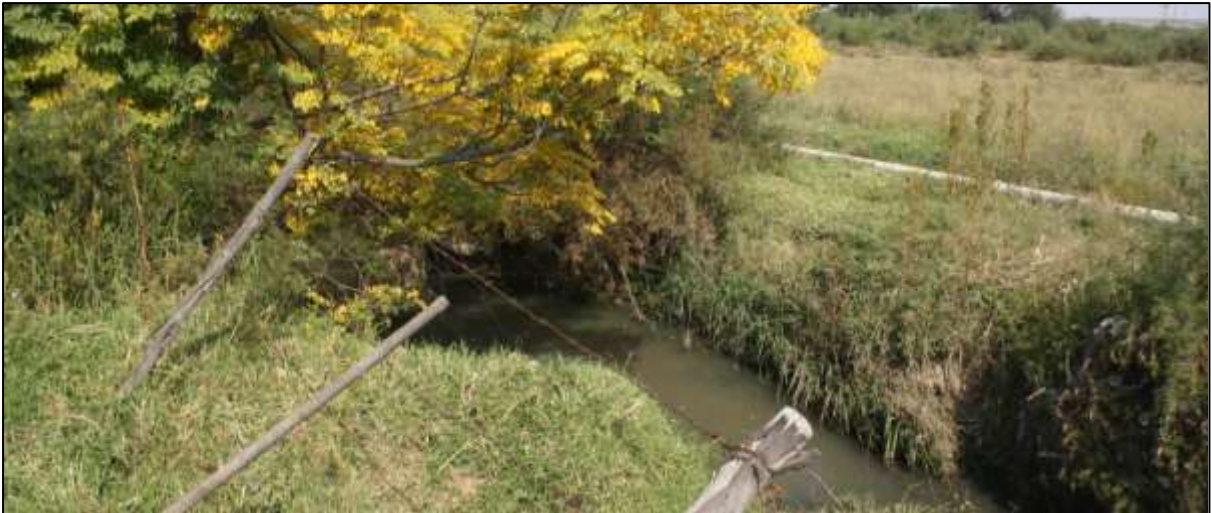
View of the seasonal stream which has clearly been degraded.

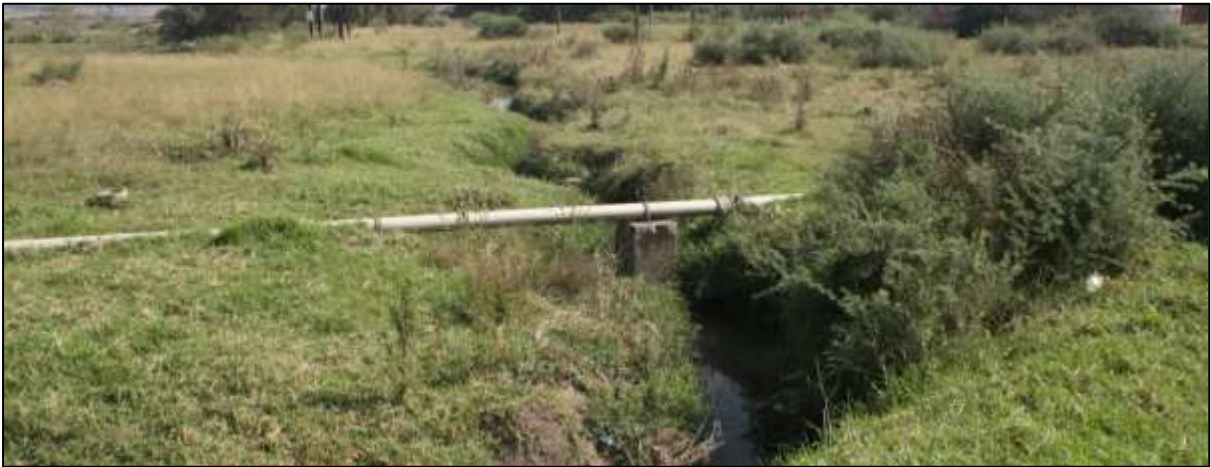
View of the main channel of the stream which is clearly modified by increased effluent. Note also the crossing by existing pipeline.

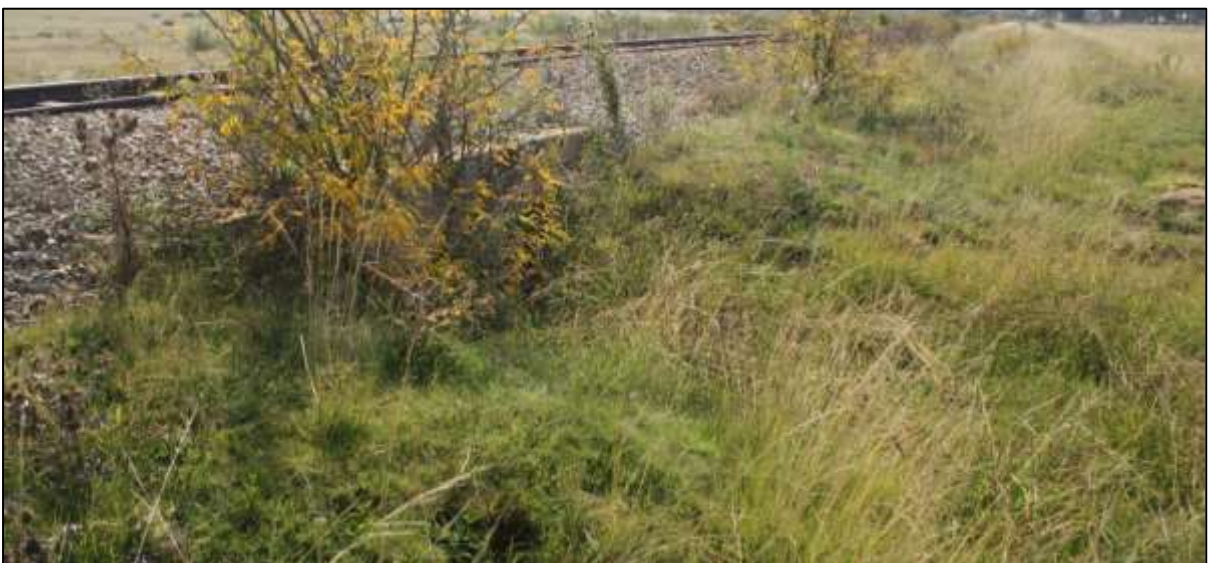
View of the artificial wetland area and accumulation of moisture adjacent to the railway line.
