Specialist basic assessment report: Tshatane/Lesego project

Dr Wynand Vlok (BioAssets)

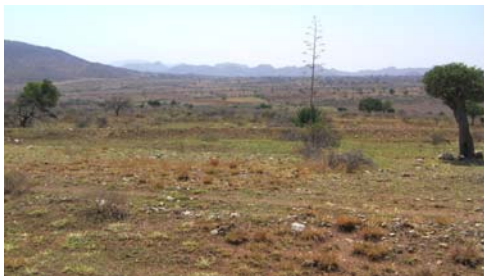
Figure 7: View of proposed area - sub Alternative 1.

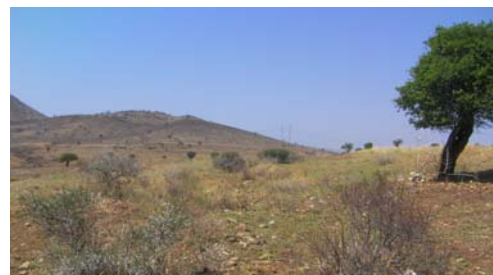
Figure 9: View towards sub Alternative 2 – many impacts visible, some *Boscia albitrunca* present.

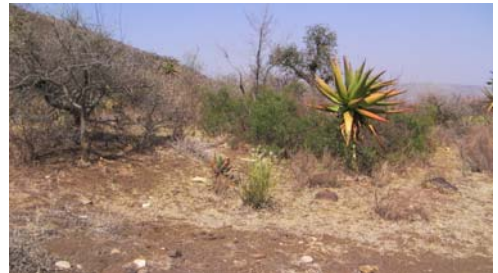
Figure 14: Steep slopes with trampling and overgrazing resulting in erosion in the hills.

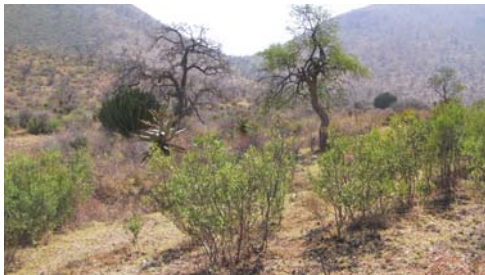
Figure 15: View of slopes between the hills. Natural vegetation is in a fair condition, but signs of increased harvesting were observed.

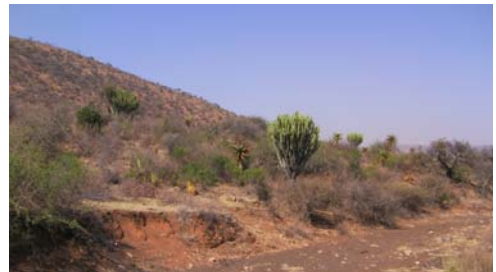
Figure 16: Some trampling and sand mining impact on streams – erosion visible.

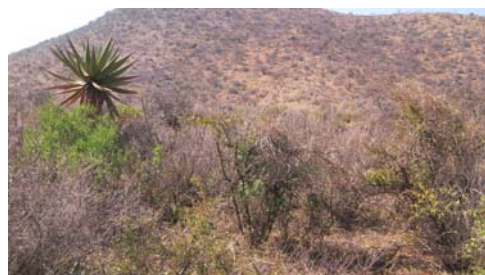
Figure 17: Vegetation on the lower slopes with some encroachment – result from over grazing and wood collection.

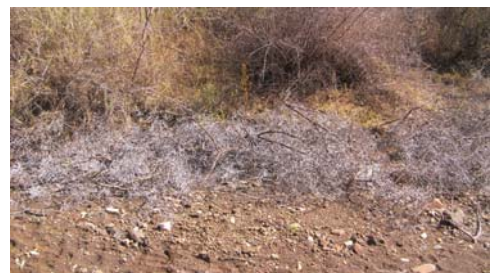
Figure 18: Wood harvesting near the village south of the hills visible over large areas.

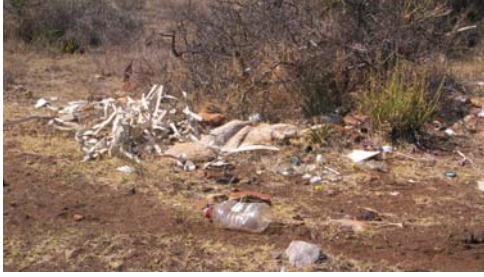
Figure 19: Dumping of refuse near the village a common occurrence.

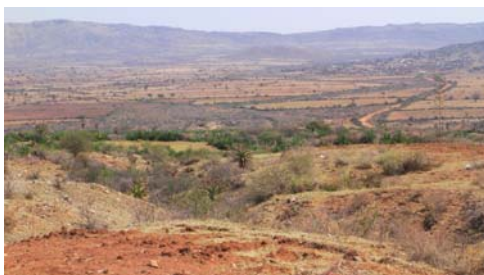
Figure 22: Erosion on exposed soils on slopes towards the river.

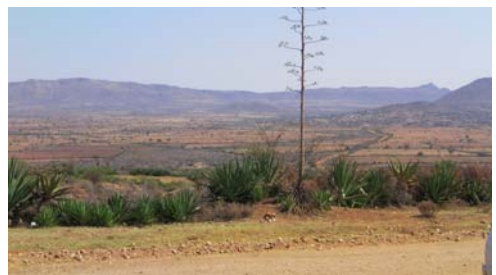
Figure 23: Grazing and cultivation on slopes aggravates erosion problems.

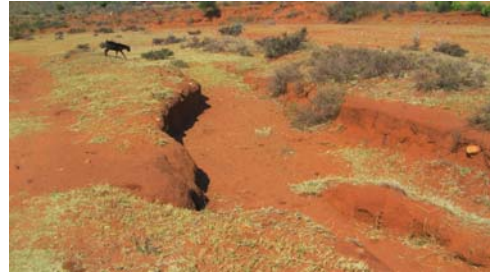
Figure 36: Trampling and overgrazing causes of erosion.

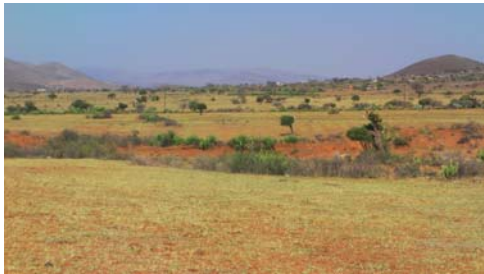
Figure 37: Areas around stream heavily impacted. Alien invasive plants such as *Agave ssp.* present.

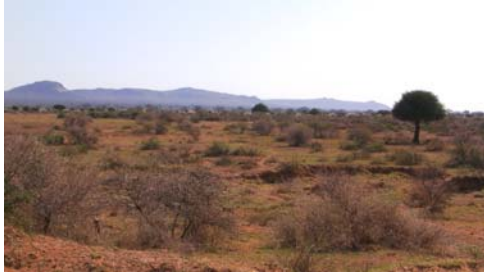
Figure 48: Erosion a problem along the corridor – due to overgrazing and trampling.

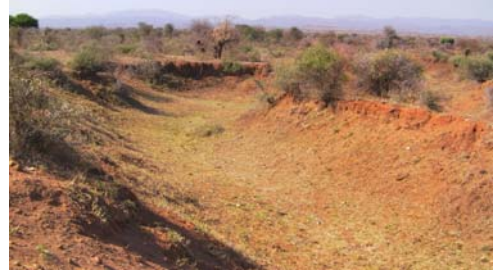
Figure 49: Deep eroded gullies present.

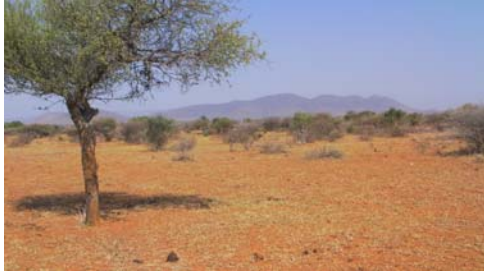
Figure 54: Most large trees removed, natural vegetation severely modified – some *Boscia albitrunca* remain.

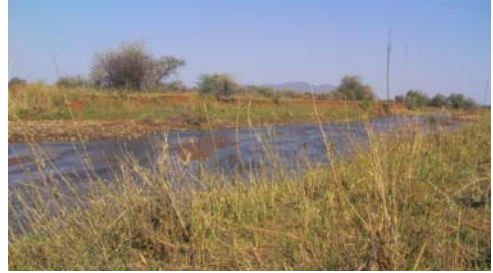
Figure 55: Point where the power line crosses the Lepellane River – riparian vegetation totally modified.

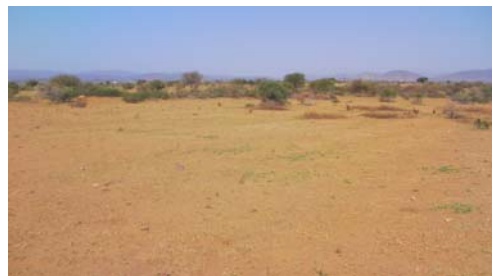
Figure 57: Over grazing and wood harvesting a cause of erosion.

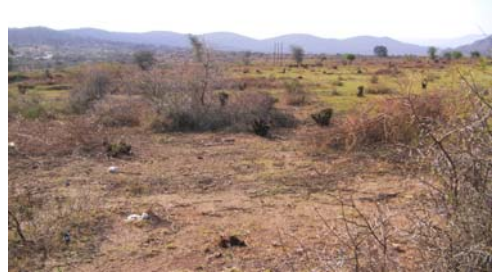
Figure 62: Wood harvesting having negative impact on natural vegetation community.

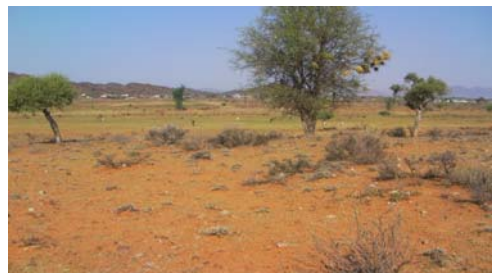
Figure 66: Most of the natural vegetation removed – a few *Boscia albitrunca* and *Faidherbia albida* present.

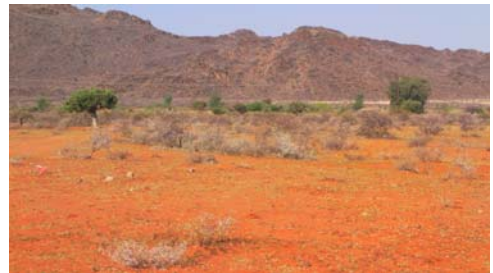
Figure 71: Over grazing present – exposed soils prone to erosion, some *Boscia albitrunca* left.

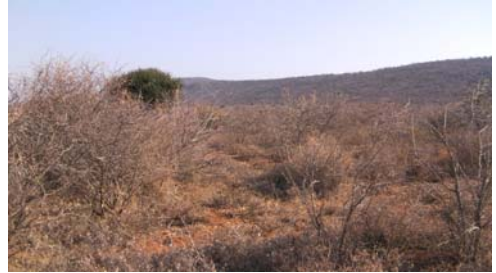
Figure 74: Encroachment of *Acacia mellifera* present – some *Boscia albitrunca* on the site.

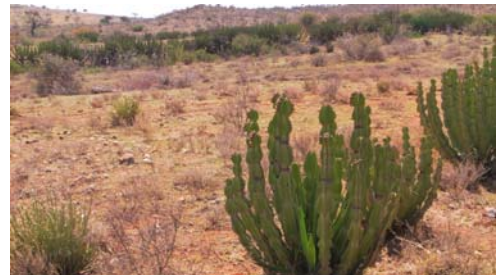
Figure 87: Natural vegetation modified – exposed soils susceptible to erosion.

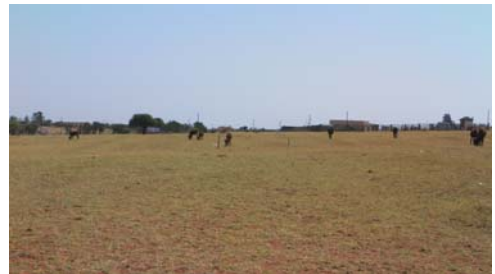
Figure 95: Natural vegetation severely modified in rural areas.

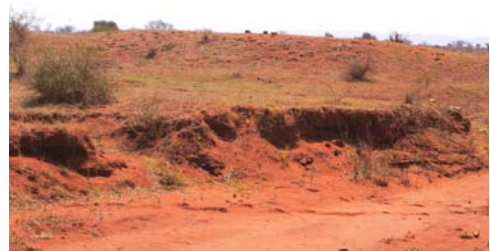
Figure 101: Erosion a problem in the area due to poor land use practices.
