**A SUPPLEMENTARY PHASE ONE GEOTECHNICAL REPORT FOR THE
PROPOSED ESTABLISHMENT OF ROOSBOOM EXTENSION ONE ON
PORTION 502 OF THE FARM ROOSBOOM 1102 GS IN LADYSMITH,
KWAZULU-NATAL**

Report Number: 2019/J011/SSS

FINAL REPORT
30 April 2019

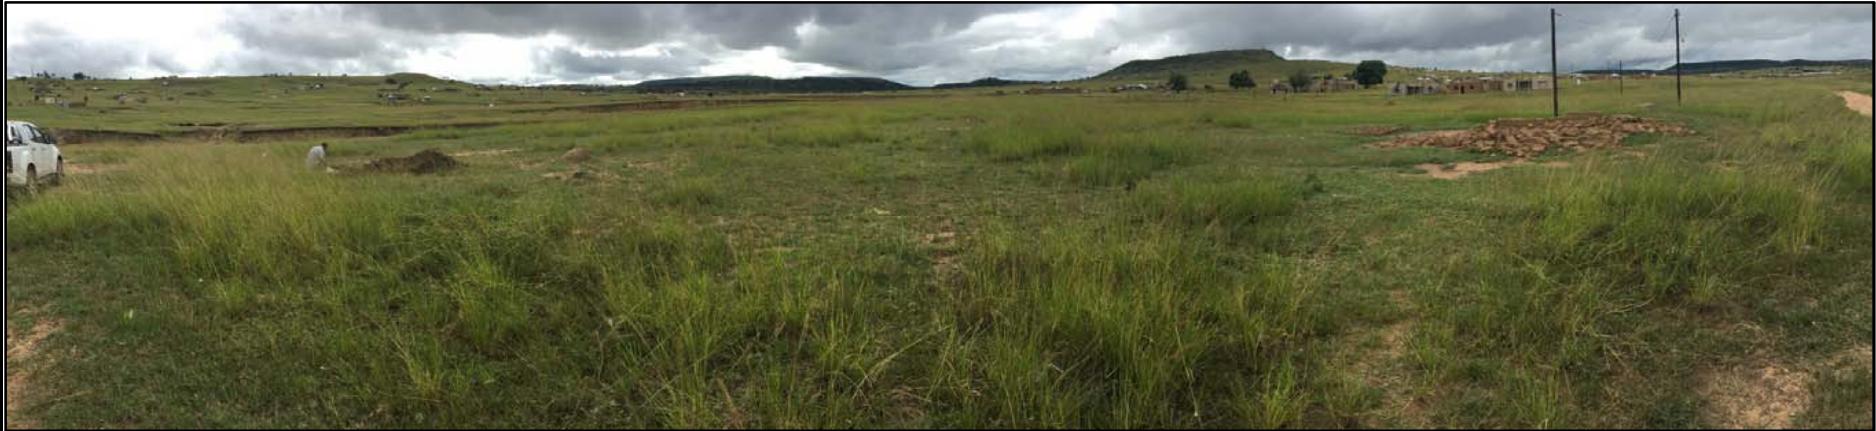
PHOTO 1

Photo 1: Site Conditions shows typical site conditions at the time of the site investigation.

SITE CONDITIONS

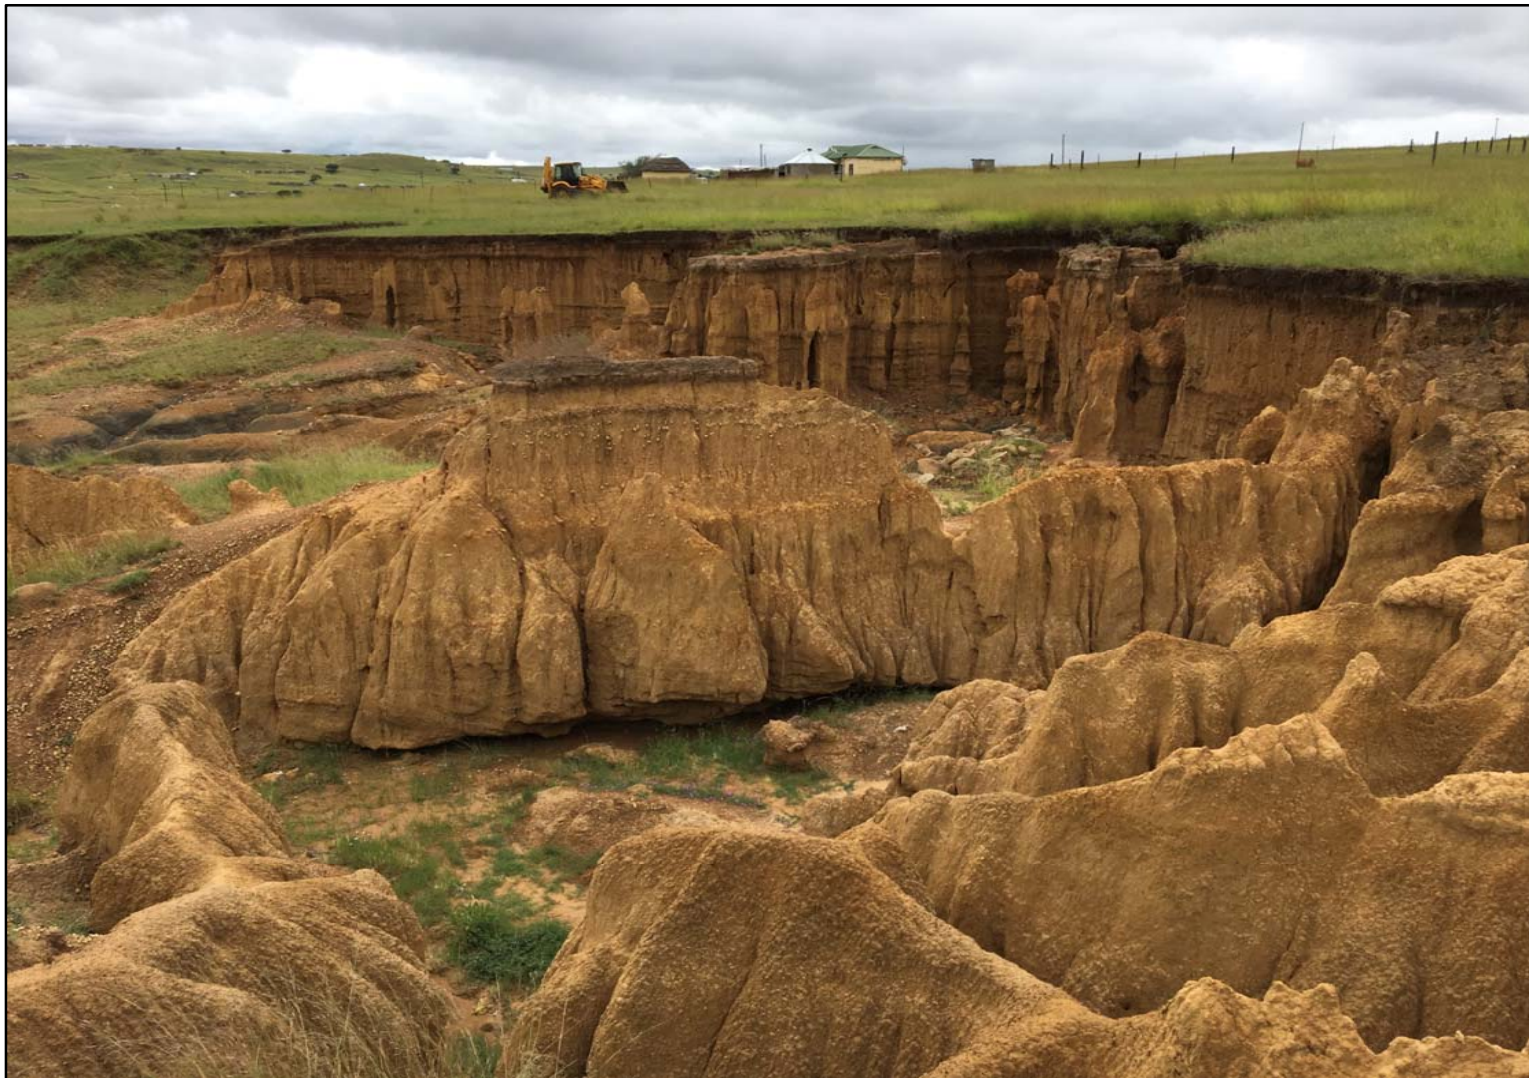
PHOTO 2

- *Perched Water and Seepage:* It is expected that much of the study area will experience seasonally perched water or shallow groundwater ingress.
- *Erosion and Dispersive Soils:* Erosion channels were abundant in the vicinity of the study area, with one particular example found adjacent to the study area being illustrated in Photo 2. A small soil pipe was also found in the study area, which manifested on surface near trial hole D. The feature is shown in Photo 3.

SOIL EROSION AND DISPERSIVE SOILS ADJACENT TO STUDY AREA

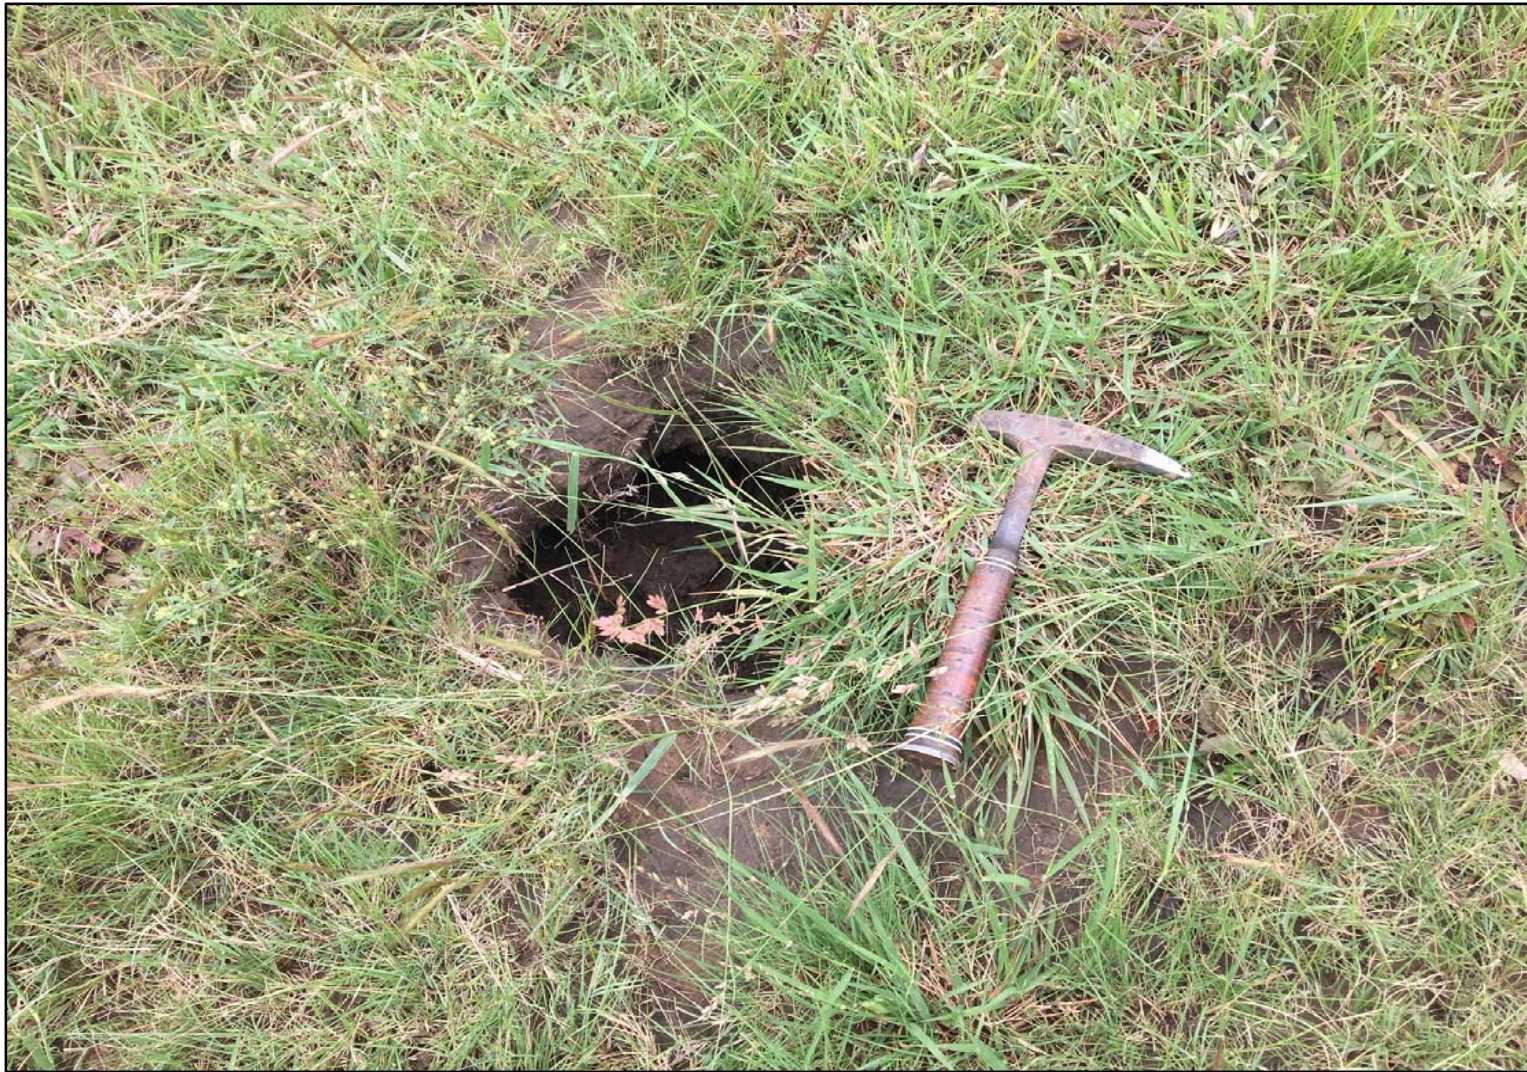
PHOTO 3

SOIL PIPING ADJACENT TO TRIAL HOLE D

- *Historic Monuments:* To the author's knowledge there are no historic monuments on the site.
- *Undermining:* The area is not subject to undermining.
- *Cemetery Sites:* No graves or cemeteries were noted during the investigation.
- *Soil Piping:* Soil piping was noted on at least one occasion.

In areas where soil piping is common or frequently found, founding should preferably be done by means of a soil replacement raft, as designed by a suitably qualified structural engineer.

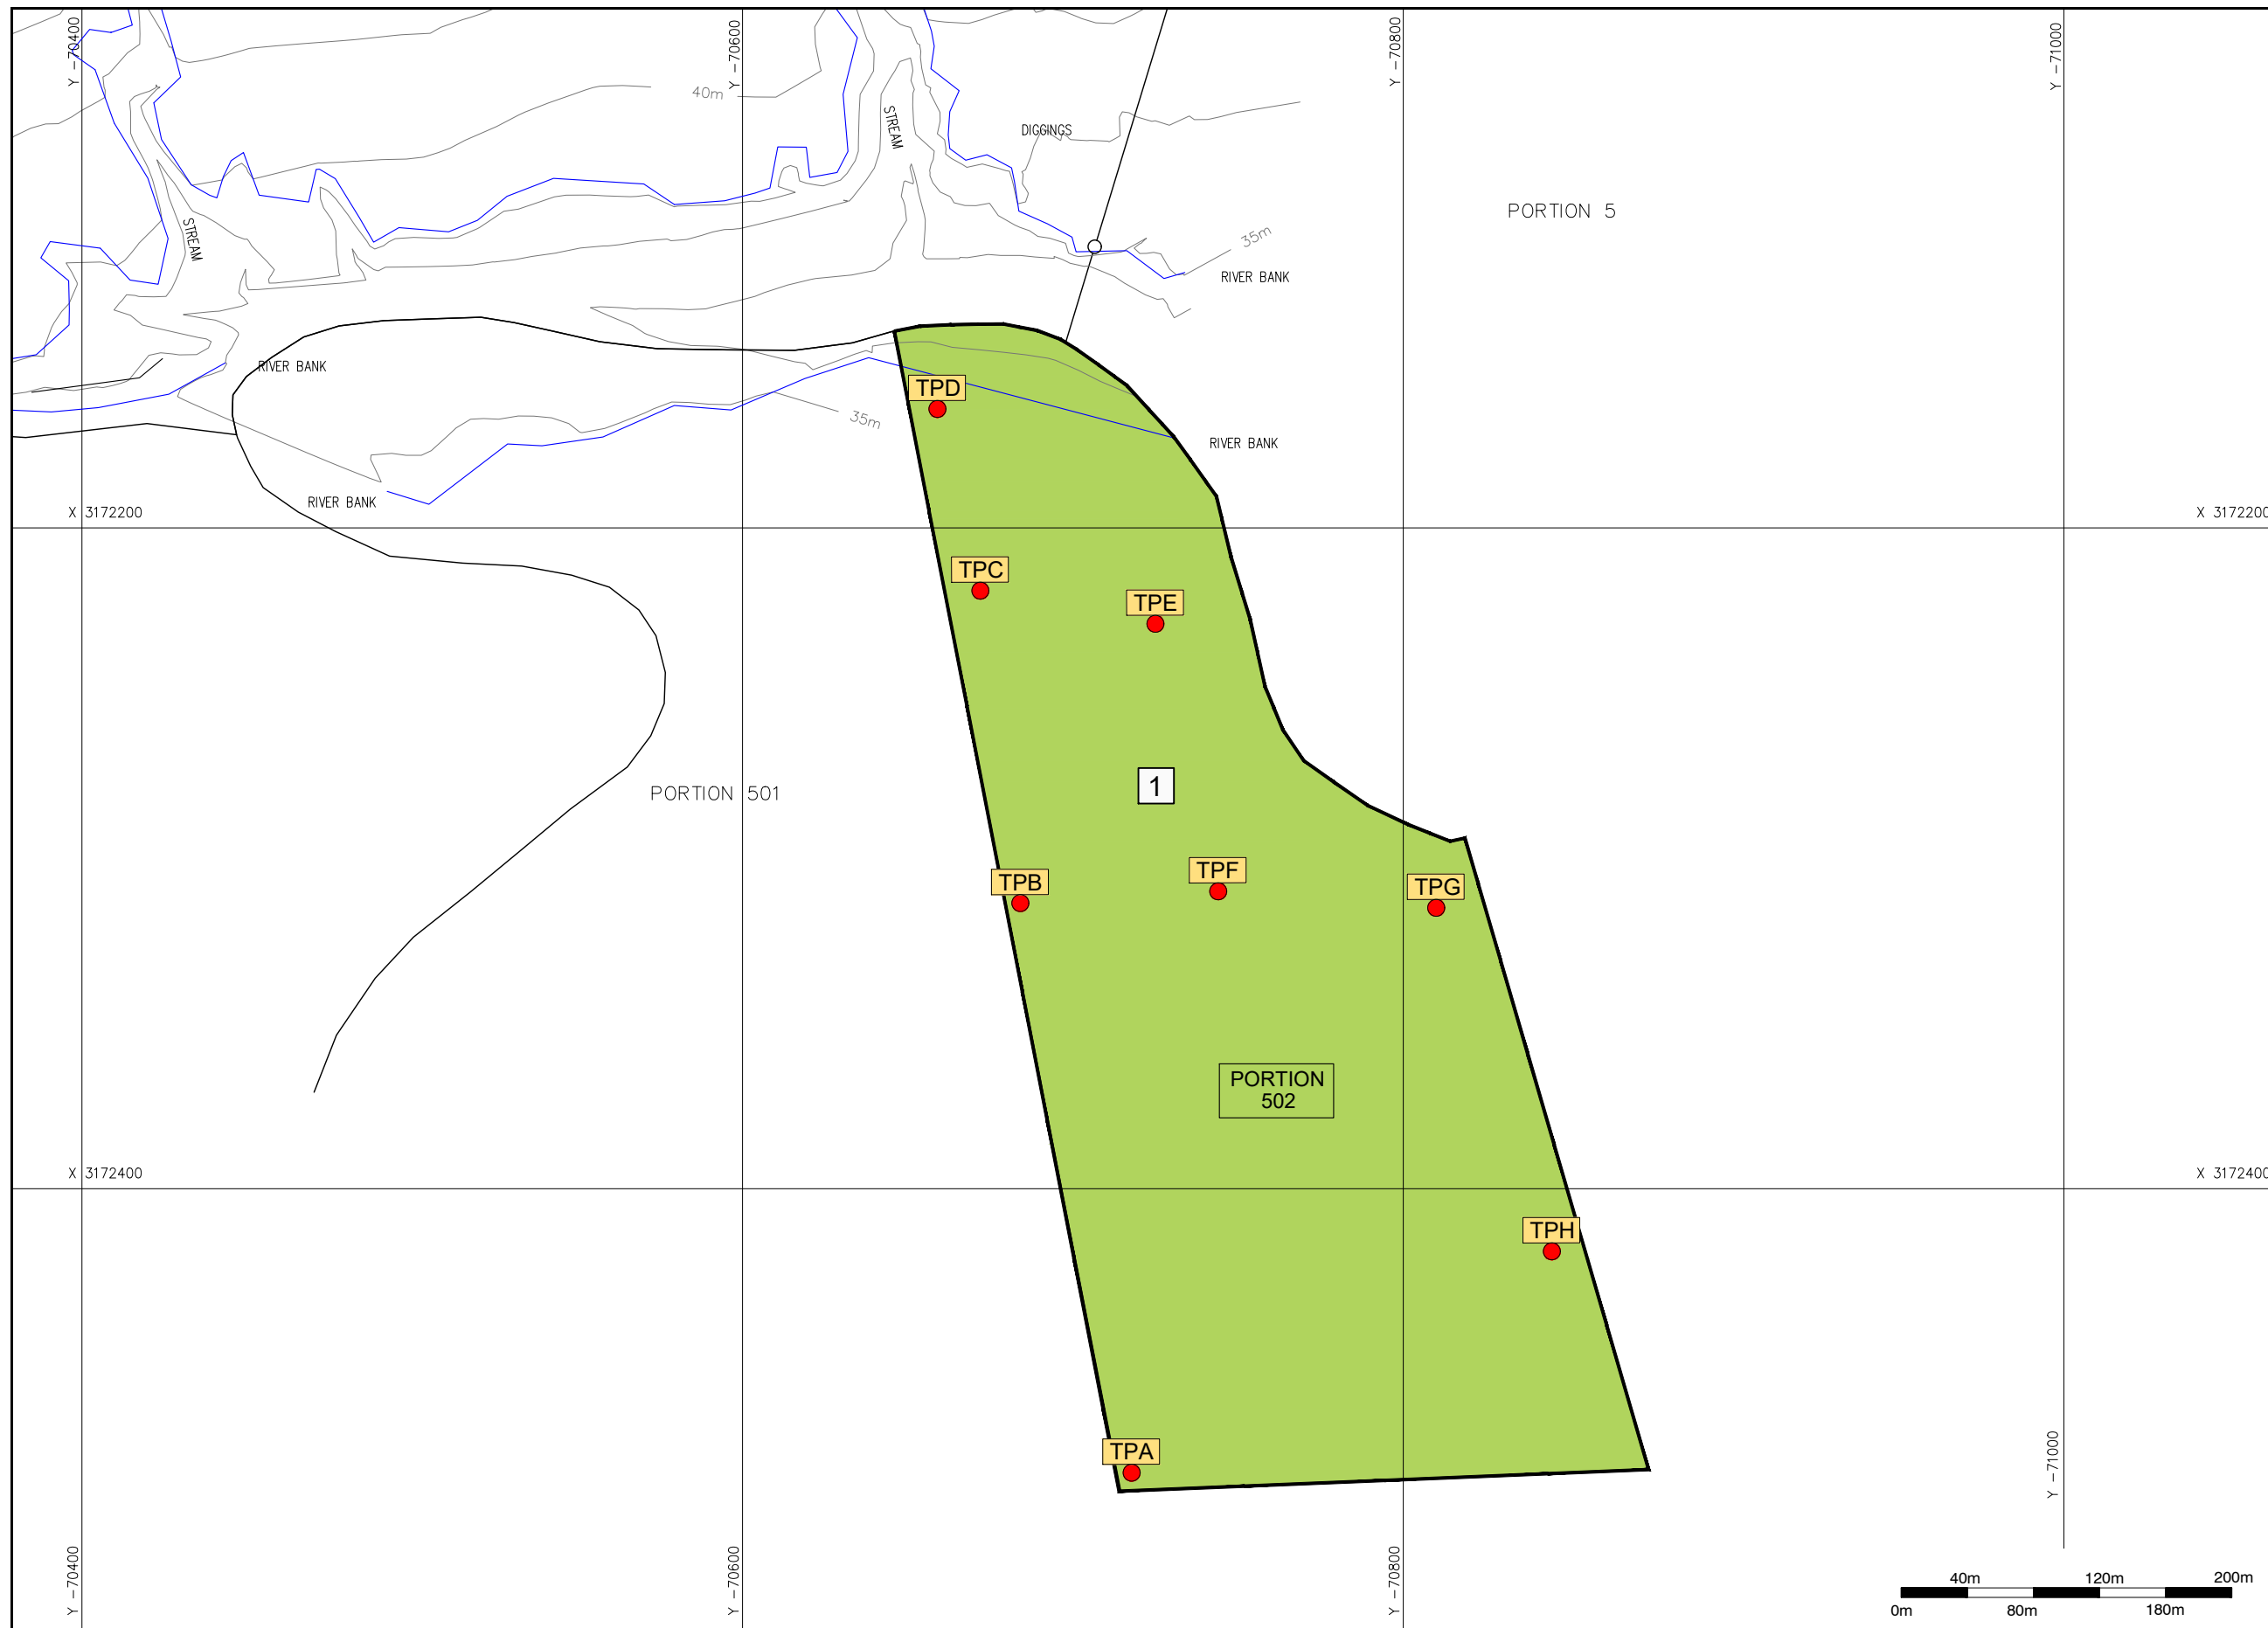
FIGURE 4

AREA	GEOTECHNICAL CLASS	% OF TOTAL AREA	ESTIMATED SOIL MOVEMENT	SOIL PROFILE	DEVELOPMENT POTENTIAL	CONSTRUCTION TYPE	FOUNDATION DESIGN	ASSOCIATED PROBLEMS
1	H2-H3	100,0%	Unrestrained heave of up to or exceeding 30mm	Colluvium overlying alluvium and/or residual shale	Intermediate	Modified	Reinforced raft OR Soil replacement raft	Corrosive soils Possible seasonal groundwater Risk of flooding Dispersive soils Erosion dongas

- *Founding Conditions:* The entire study area is classified as **H2-H3**, though zoning was complicated by the fact that excavations were only of a limited depth due to material consistencies. The zoning must also be revisited once flood line and groundwater assessments have been completed.

Founding in this zone must be done by means of a reinforced raft capable of accommodating unrestrained heave exceeding 30mm. The exact amount of heave must be determined for each stand during the phase 2 geotechnical investigation, but as a guideline, maximum unrestrained heave of up to 45mm is expected. The superstructure must contain articulation joints and masonry must be lightly reinforced. Floor slabs must be fabric reinforced.
