APPENDIX A1

Photograph Log – Environmental Observations

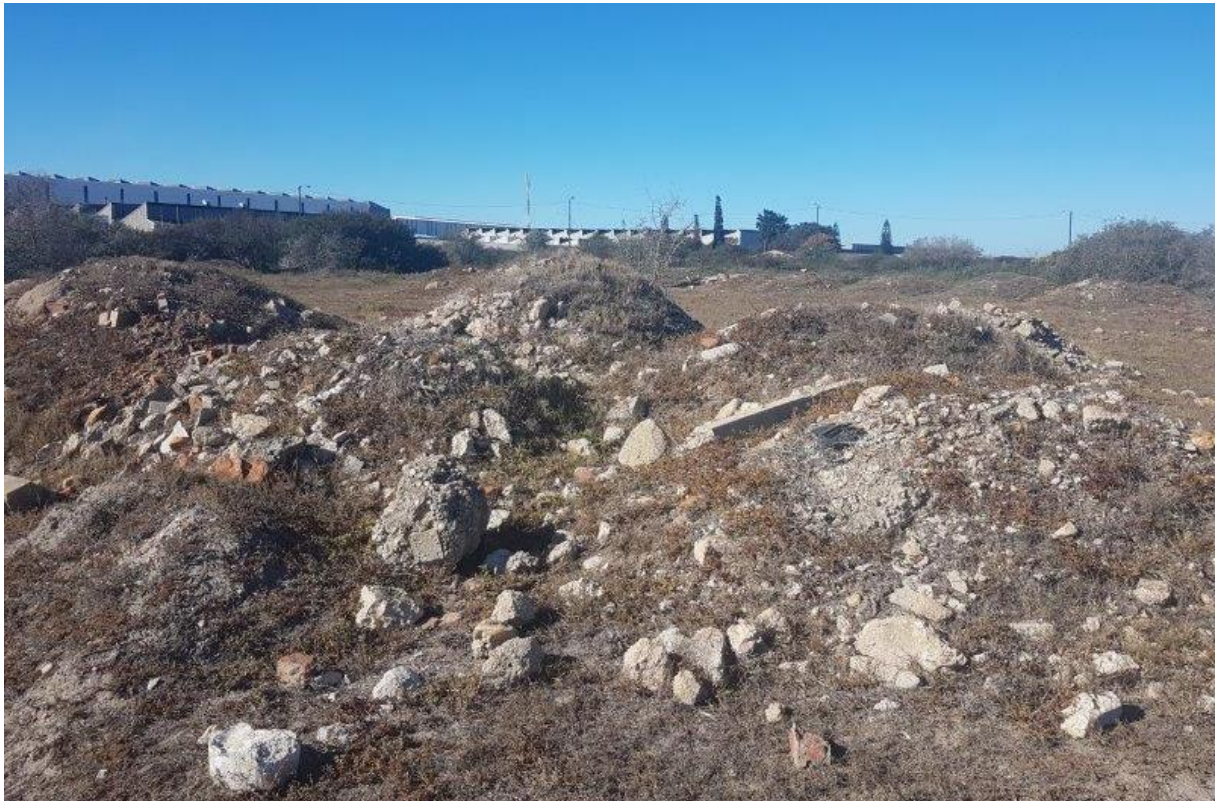
Photograph 25: Rubble and building waste observed on the vacant undeveloped land situated south of the fence which runs from east to west.

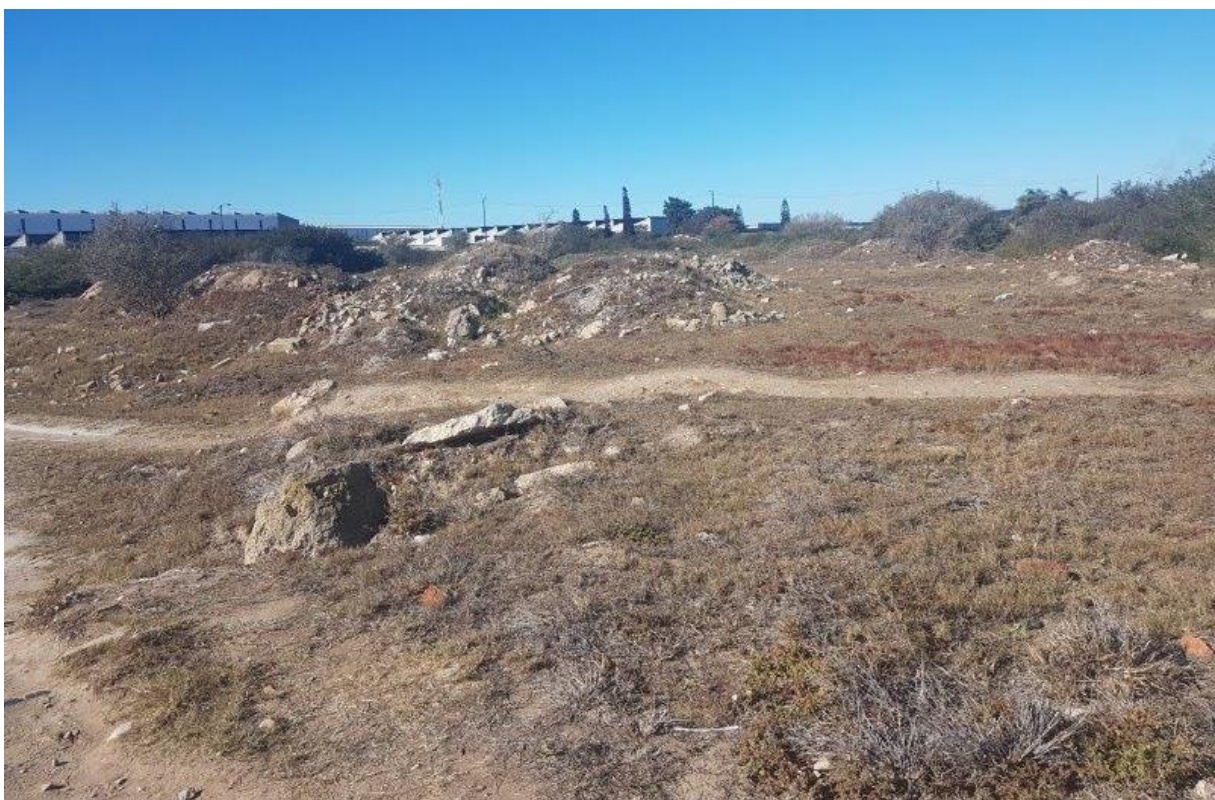
Photograph 26: Illegal dumping, human and livestock disturbance have degraded the natural vegetation likely to occur in this area.

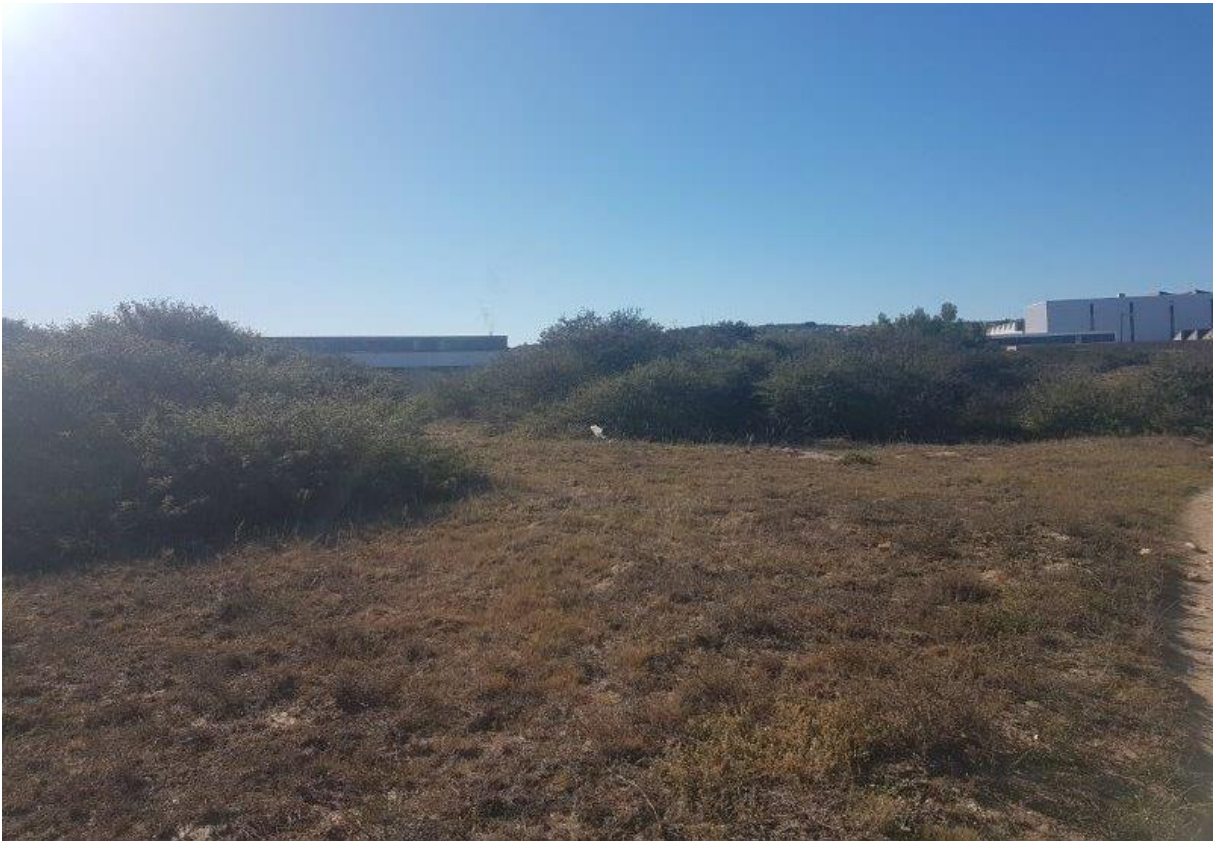
Photograph 27: The property lies in the general area that supports Albany Alluvial Vegetation which is classified as endangered according to the new vegetation map of South Africa (Mucina & Rutherford 2006).

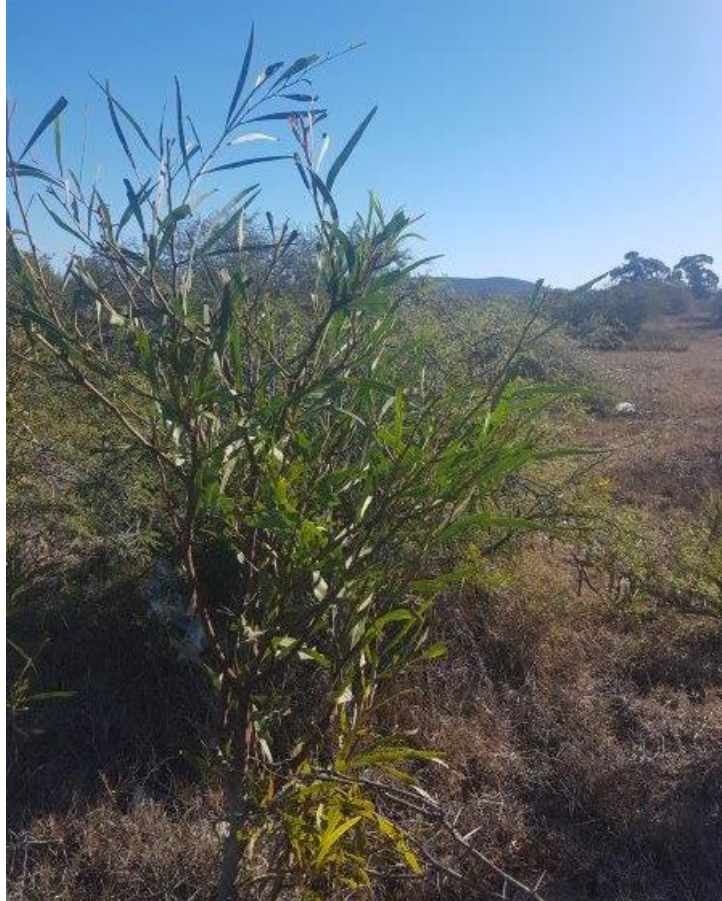
Photograph 28: During the site inspection some alien species were noted such as Port Jackson.

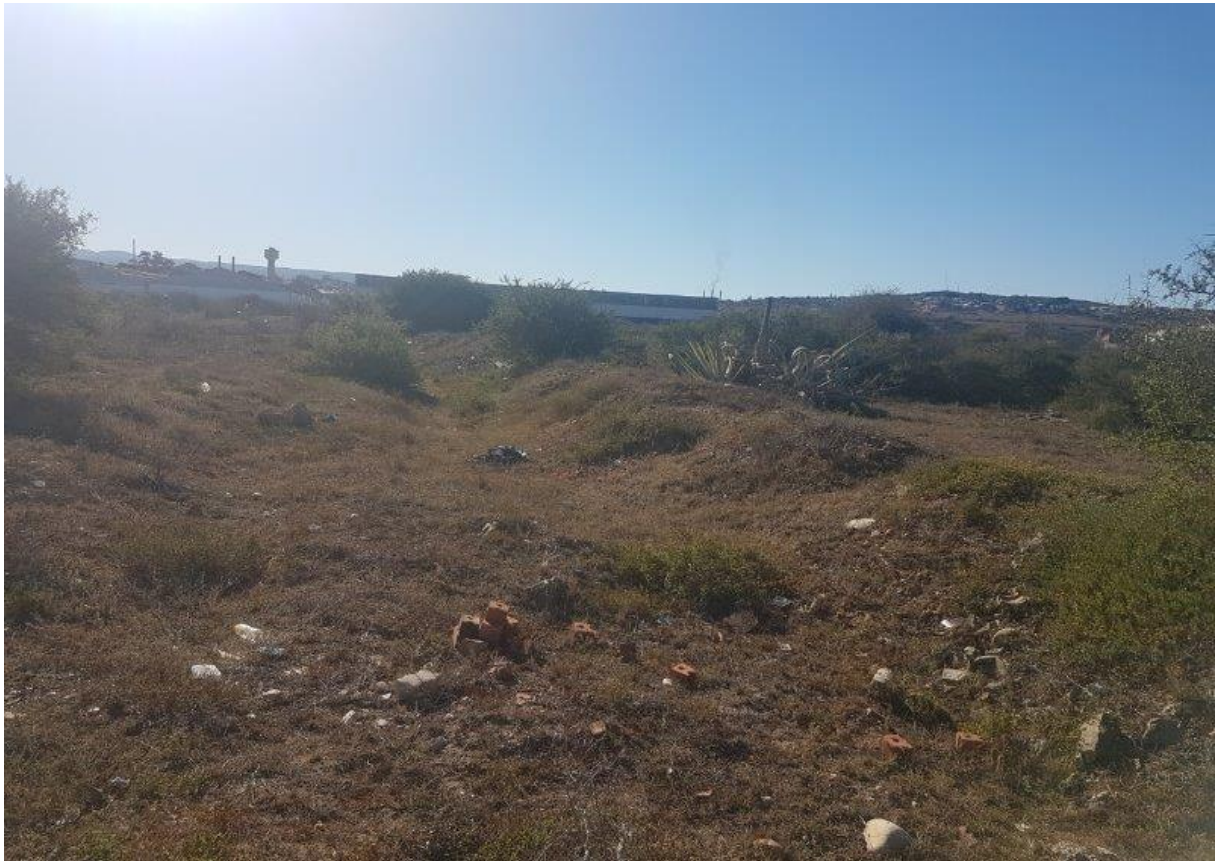
Photograph 29: A trench which runs from the fence line all the way to Kelvin Street, is evident on the western boundary of the undeveloped vacant property.

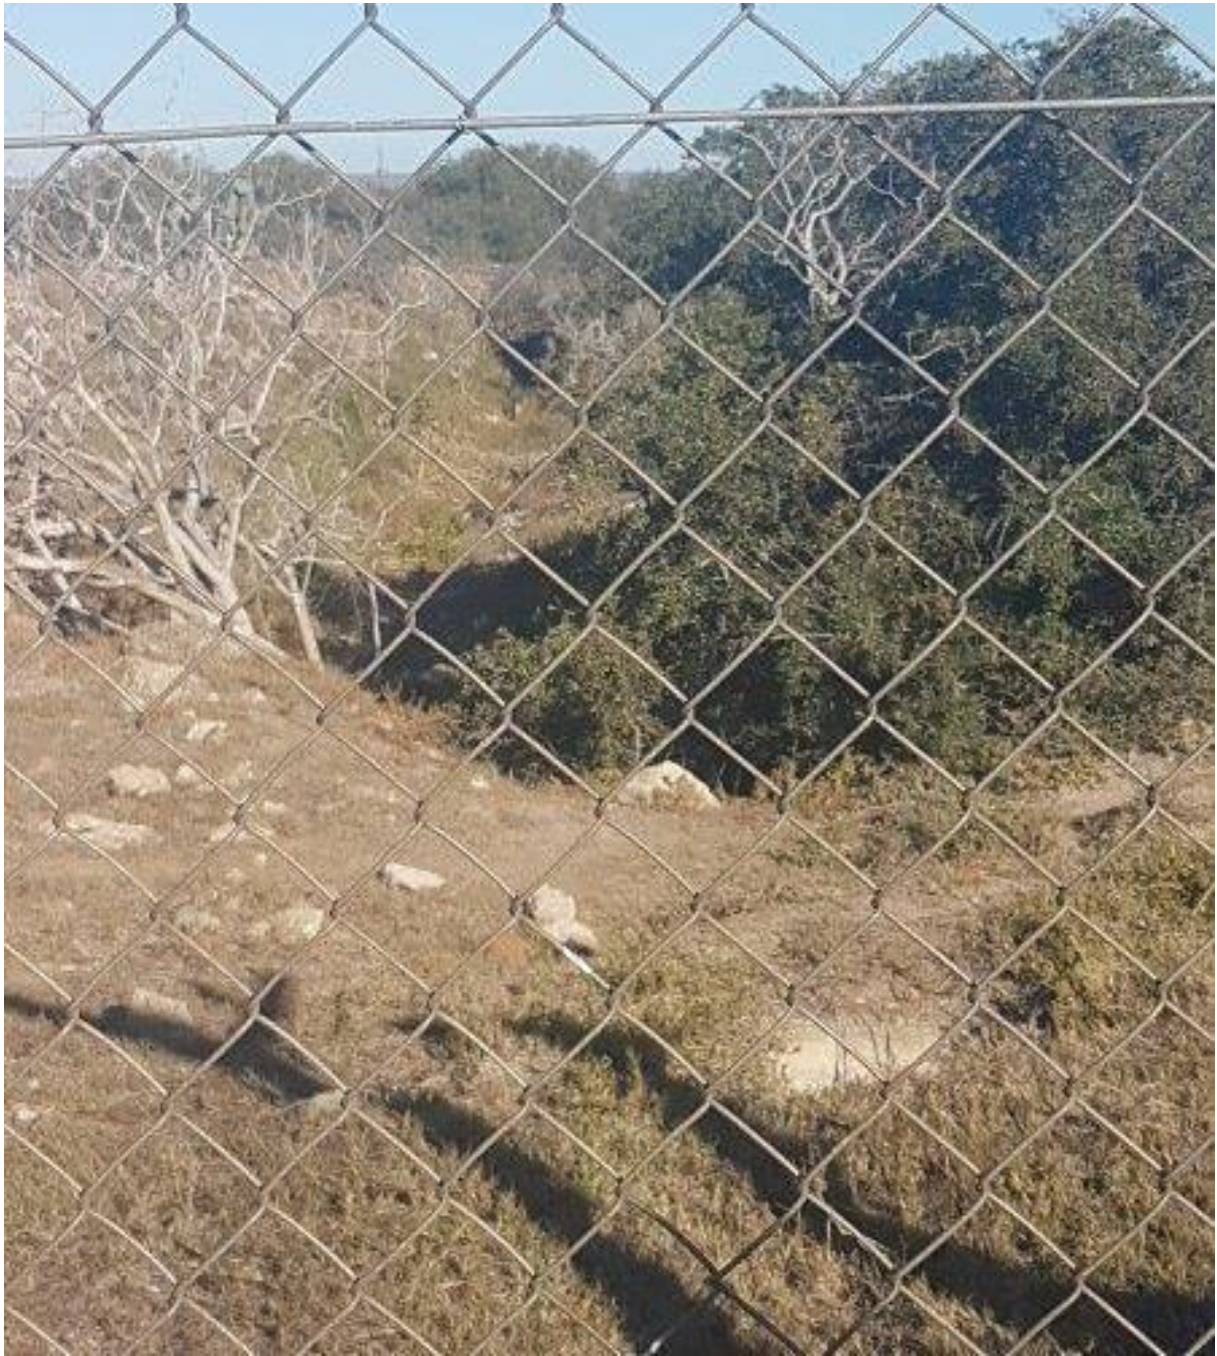
Photograph 30: A trench which runs from the fence line all the way to Kelvin Street, is evident on the western boundary of the undeveloped vacant property.
