ANNUAL PERFORMANCE ASSESSMENT REPORT FOR ST LUKES QUARRY

PERFORMANCE ASSESSMENT OF THE ENVIRONMENTAL MANAGEMENT PROGRAMME
FOR THE MINING OF DOLERITE BY INDEPENDENT CRUSHERS IN THE MAGISTERIAL
DISTRICT OF EAST LONDON, FOR THE PERIOD ENDING SEPTEMBER 2007

PERFORMANCE ASSESSMENT OF THE ENVIRONMENTAL MANAGEMENT PROGRAMME
FOR THE MINING OF DOLERITE BY INDEPENDENT CRUSHERS IN THE MAGISTERIAL
DISTRICT OF EAST LONDON

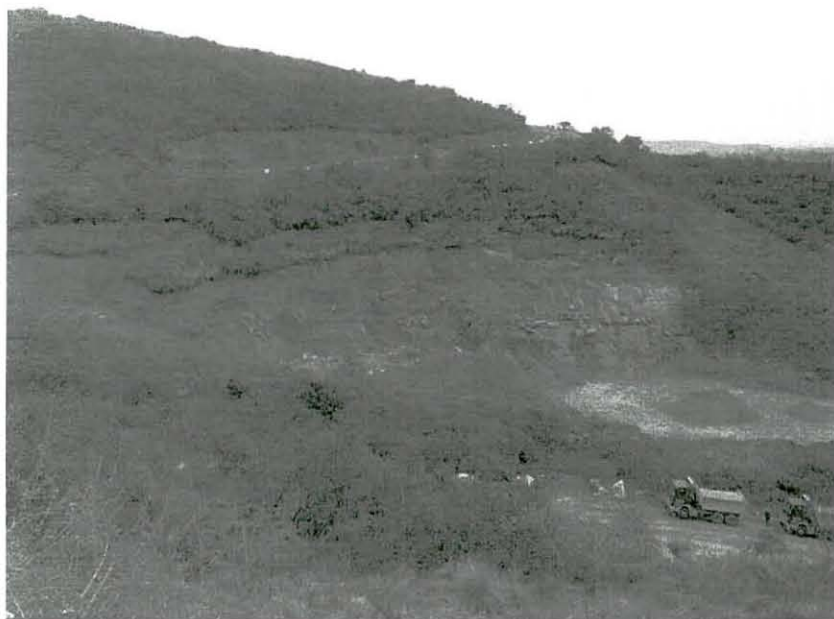
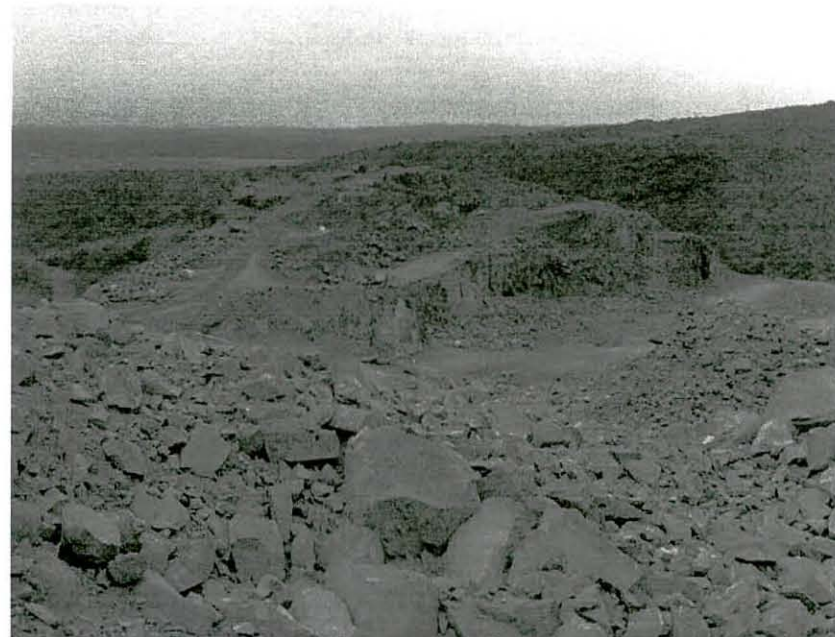
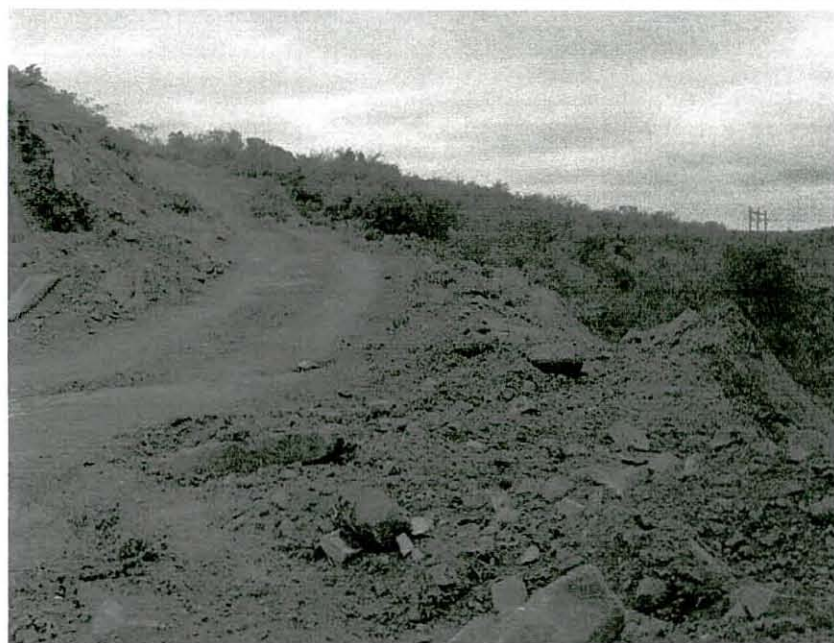
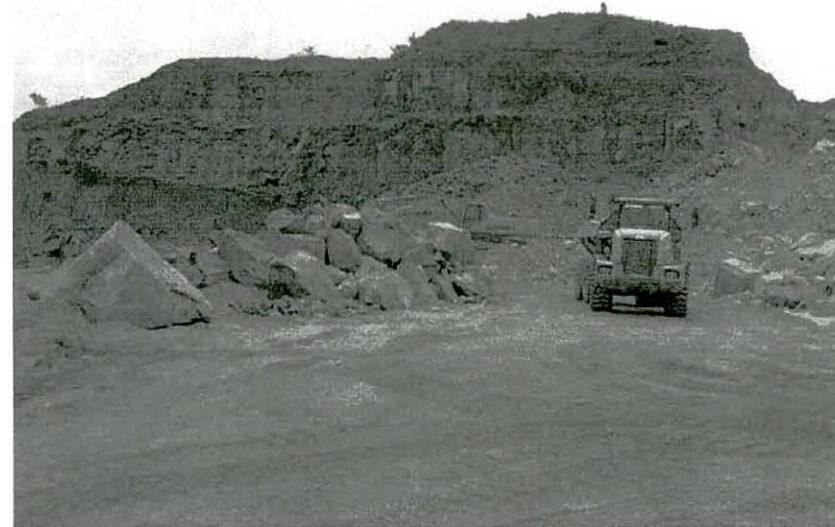
Clockwise from top left: Dolerite borrowpit. Mining area, looking north. Mining area looking south. Access road to top of face. Need to ensure that topsoil is not used as roadways.

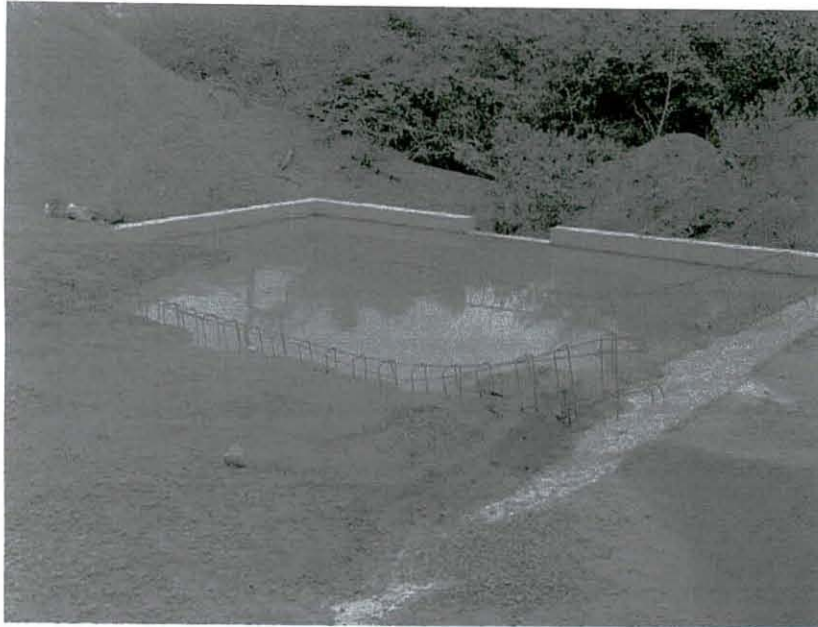
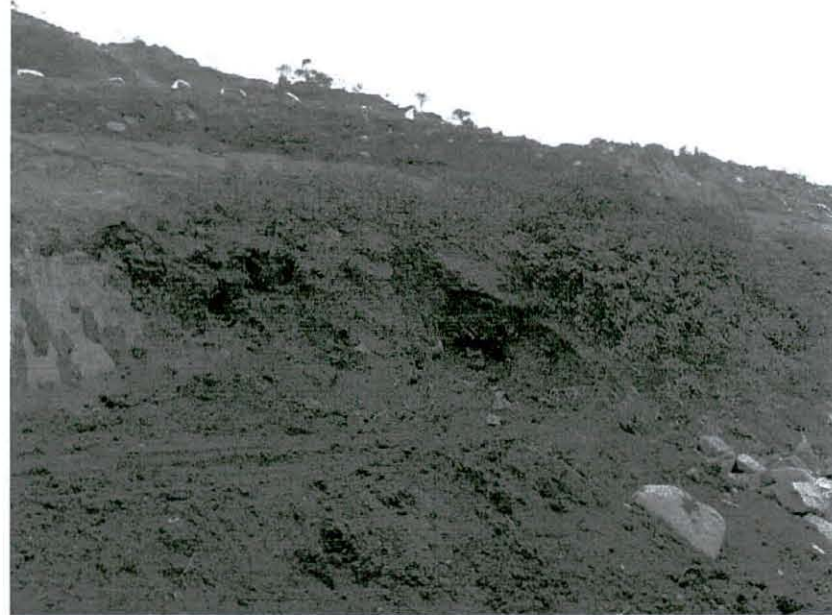
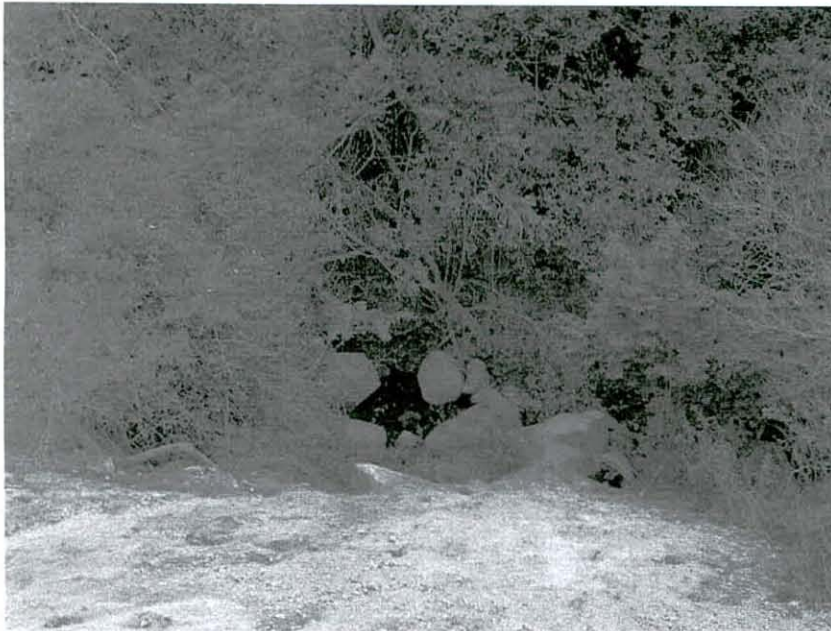
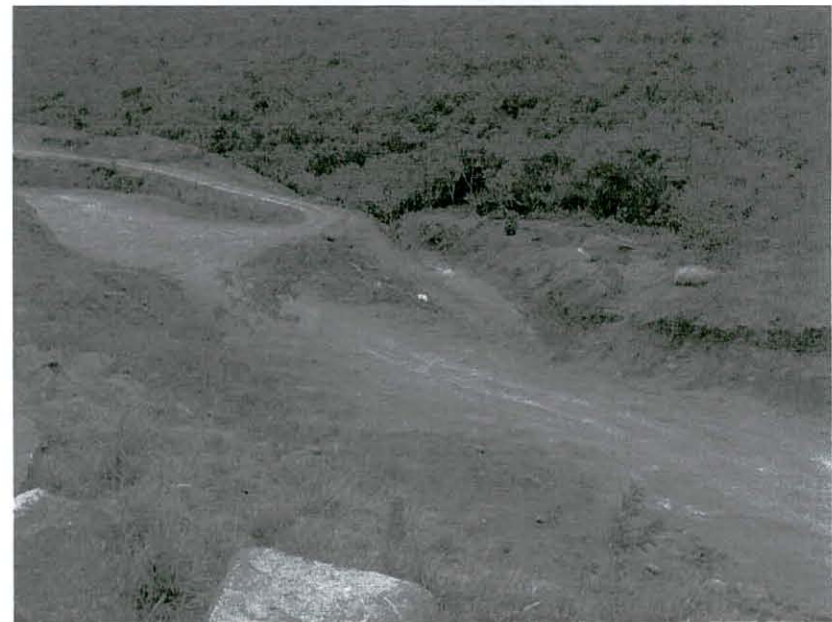
Clockwise from top left: Sediment Trap requires regular cleaning.
Outlet from borrowpit must be filled with boulders to filter water.

Topsoil must be in designated areas and protected.
Mining area still encroaching on water course.
