GEOHYDROLOGICAL ASSESSMENT OF THE AQUACULTURE DEVELOPMENT ZONE, AMATIKULU

PROJECT No: LL3224
REPORT VERSION: 1
DATE: November 2018
PREPARED BY: P.G. Hansmeyer *Pr.Sci.Nat.*

Report Type: GEOHYDROLOGICAL ASSESSMENT

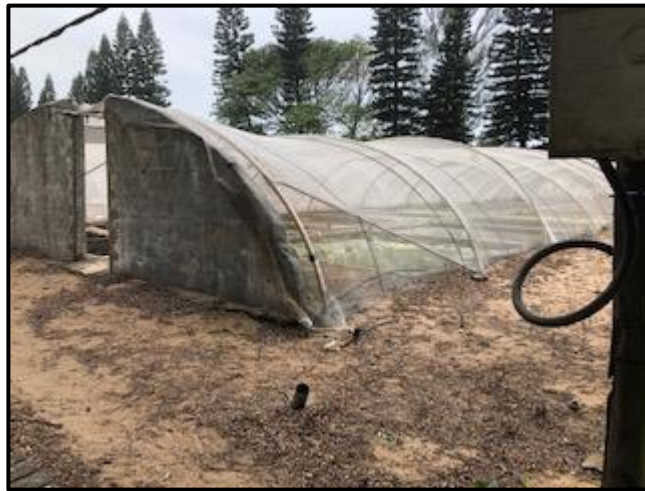
PLATE 1: TYPICAL TUNNEL

Amatikulu Fish Farm was established on Portion 2 of Lot 15828 in the 1980's and supplied ornamental aquarium fish through various outlets to the public. Aquarium plants were also produced and sold to the same market. Some 50 tunnels (a shade cloth covered fresh water pond) were constructed along the toe of the landward longshore foredune and used as breeding bays for the fresh water fish – refer to Plate 1 on the following page.

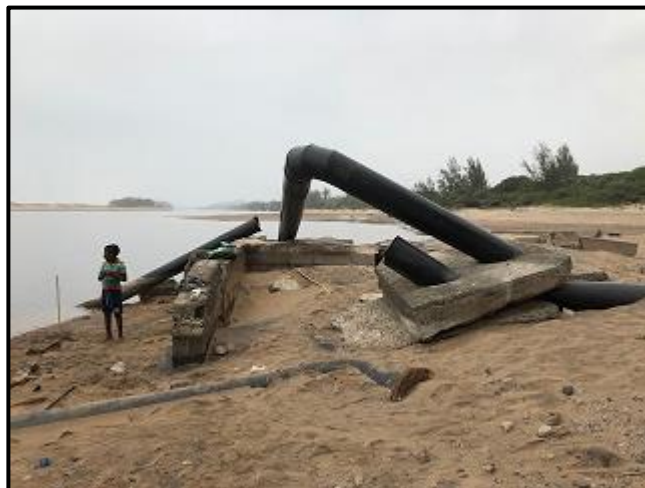
PLATE 2: PUMPHOUSE ON AMATIKULU LAGOON

At the time of the field visit, the prawn dams were overgrown, the pump house on the lagoon was demolished by wave action in 2015 and the fish farm is currently running at about 30% of the capacity with most of the tunnels and fish dams in a state of disrepair – see Plate 4 below.

Revival of the prawn hatchery will require the dams to be grubbed and cleared, the pipeline re-established and the pumphouse rebuilt and electrical cabling refitted. Unless future and rehabilitated dams are lined with impermeable membranes, salt water intrusion will be repeated and fresh water regime affected.

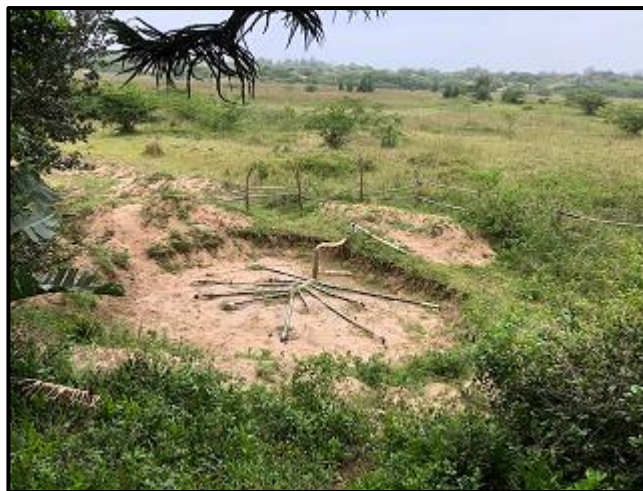
PLATE 3: WELL POINT SYSTEM WITH POOL PUMP

Fresh water supply to the 50 tunnels was managed through a number of well points installed in the 'dune slack' with its shallow water table located close to surface (<0.5m) along the toe of the landward longshore foredune, just below the office complex – refer to Plate 3 below. During the drought of 1997, the then JSB (Joint Services Board) funded the drilling of four boreholes (BH 1 – BH 4) along the access road to Amatikulu Fish Farm to supplement the fresh water supply – refer to the Site Plan, Figure 2 and the appended borehole profile (Appendix A). The boreholes were vandalized, and the pumps were stolen regularly, leading to several confrontations with the community.

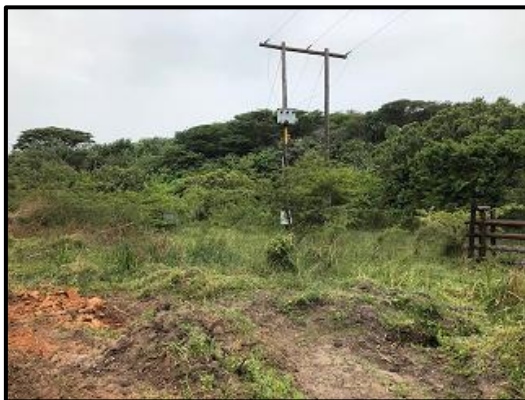
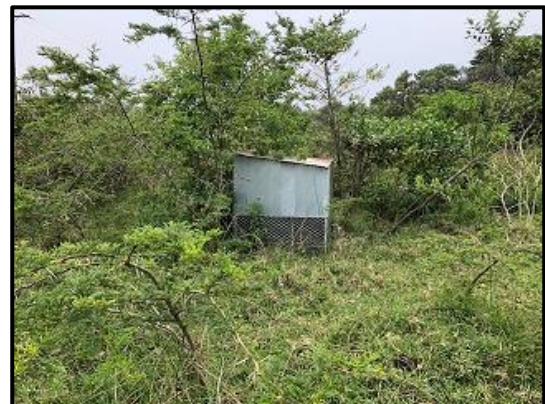
PLATE 5: BOREHOLE NEAR CATTLE DIP WITH ESKOM POWER SUPPLY

The site was viewed on Friday 16 November 2018 and a walk- and drive-over survey was conducted. Besides examining the site and the Amatikulu lagoon, the boreholes drilled in vicinity were also recorded – refer to Plate 5 below. A summary of sites that were recorded is attached as TABLE A and the various sites recorded are indicated on the Site Plan, Figure 2.

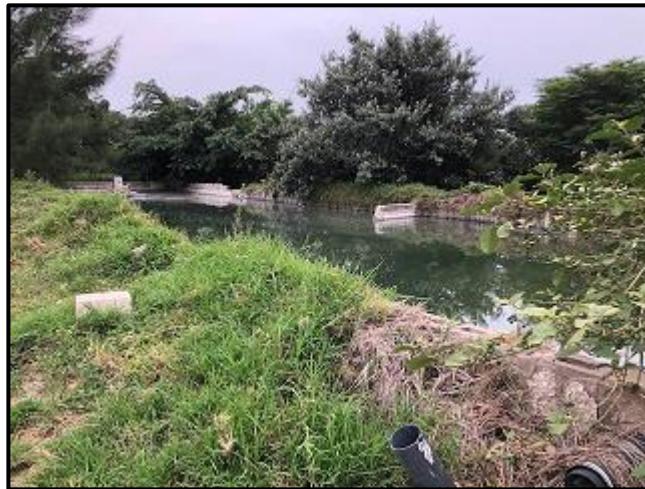
PLATE 6: EFFLUENT DAM

The pollution control measures at the Amatikulu Pet Food factory are seemingly dysfunctional and the effectiveness of the equipment doubtful, posing a potential pollution threat.

As a pollution control measure, the effluent from the Amatikulu Pet Food section is pumped into an effluent dam (EF2) near the factory where it is aerated and filtered and then pumped to a settling pond (EF1) from where it seeps into the ground – refer to Plate 6 below and EF1 and EF2 on the Site Plan, Figure 2. During the walk-over survey and an inspection of the dam and surroundings, the pollution control measures were seemingly dysfunctional as the effluent dam was filled to capacity and a pungent odor pervaded the surroundings.

The pollution threat associated with the Amatikulu Pet Food enterprise has never been established and groundwater abstraction should not be considered within a 200m radius until a thorough investigation has been carried out.
