***Report to VNA Consulting on the Results of a Geotechnical  
Investigation for the Proposed Emoyeni (Emedweleni)  
River Vehicular Bridge, KwaZulu-Natal***

***Reference: 344-12.R01***

***Dated: 29 April 2013***

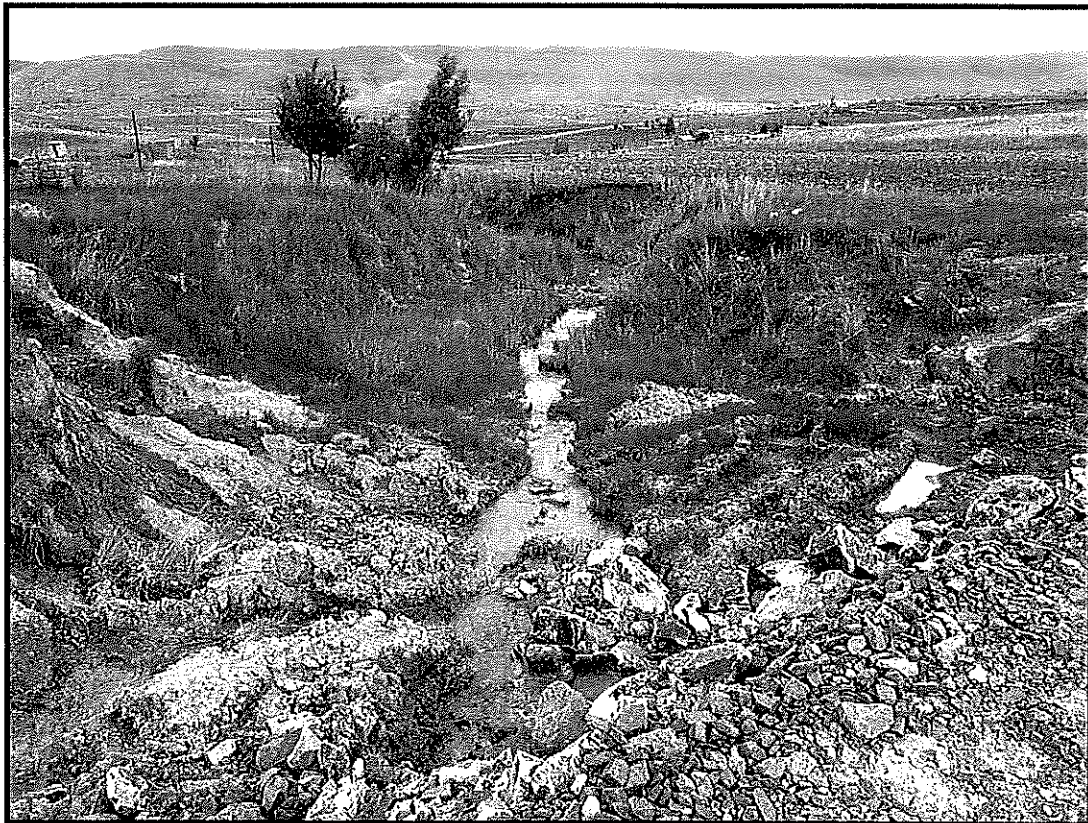
There is a temporary bridge that has been constructed at the site to allow for vehicles to cross the stream. The structure consists of shale fill, overlying concrete pipes which allow water to pass through. The diameter of the pipes is considered insufficient resulting in water pooling upstream of the structure. Some seepage was observed near the base of the temporary structure.

Plate 1. Downstream view of the proposed site.

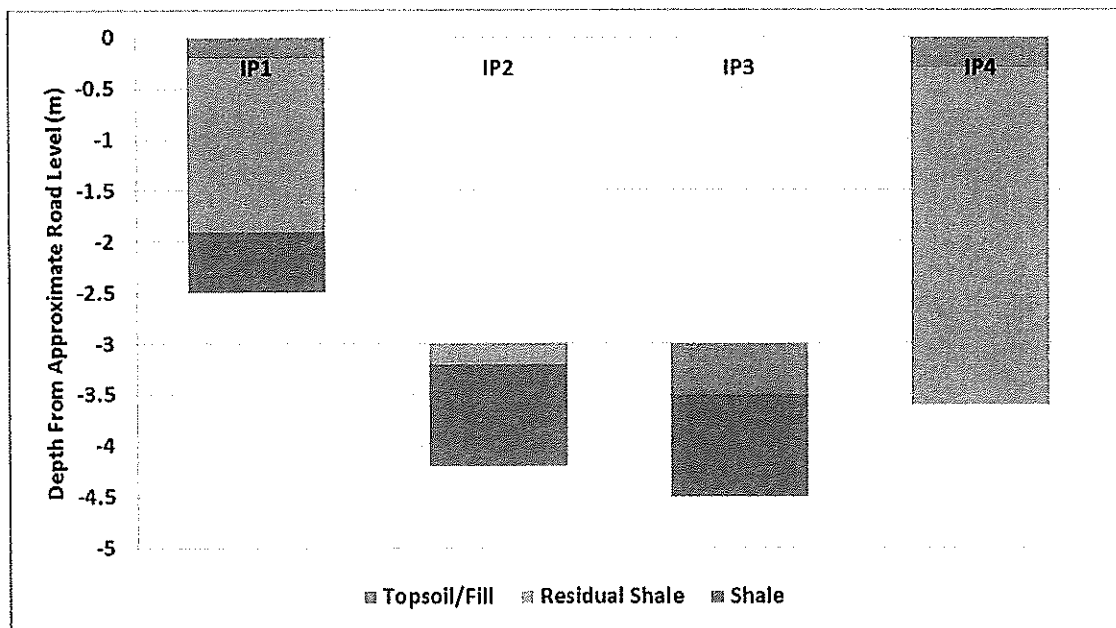
Diagram 2. Graphical representation of soil profiles referenced to approximate existing road level.

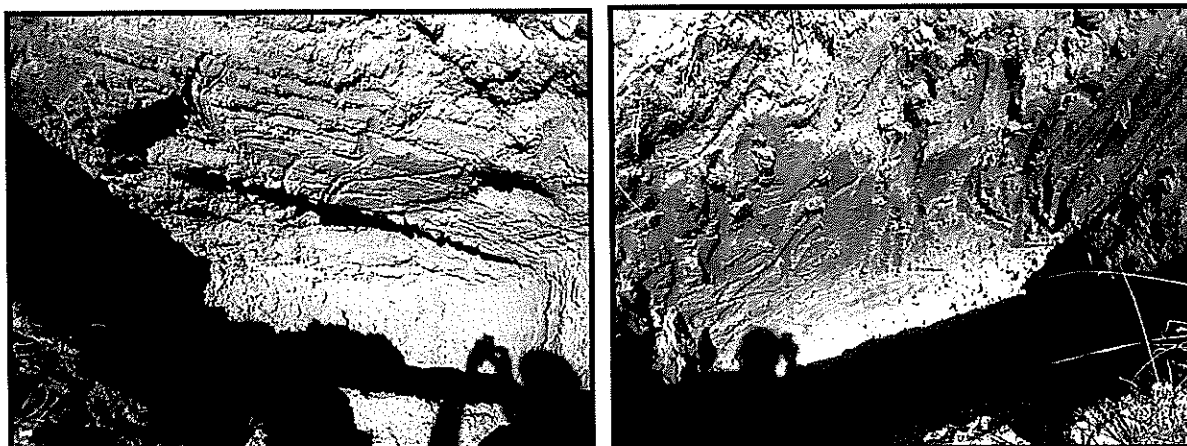
The site is generally underlain by silty sandy topsoil, overlying residual shale, which grades into very soft to soft, highly fractured shale bedrock of the Beaufort Group, of the Karoo Supergroup.

An indication of the typical subsoil geology encountered across the site given in Plate 2 and Plate 3 below. Plate 4 and Plate 5 below show the shale bedrock outcropping in the river bed downstream of the proposed bridge site.

Plate 2 and Plate 3. The general soil profile observed at the proposed bridge site.

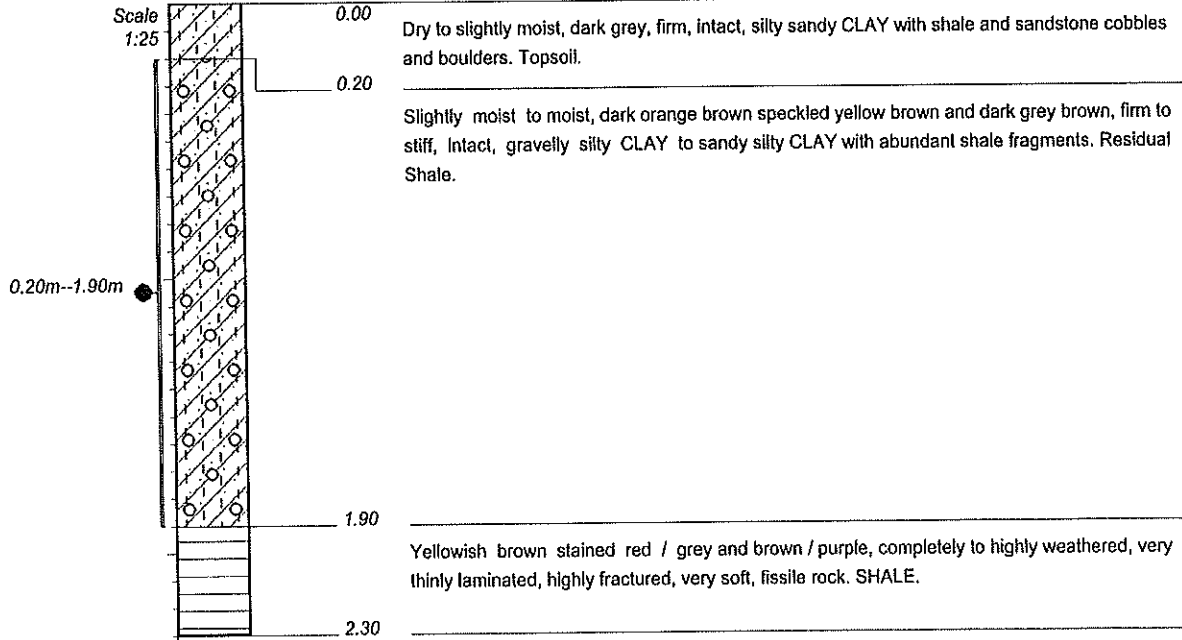
HOLE No: IP1

- 1) No ground water seepage observed.
- 2) Sample taken at:  
S1 0,20m--1,90m (Ind)
- 3) Refusal depth on rock at 2,30m.

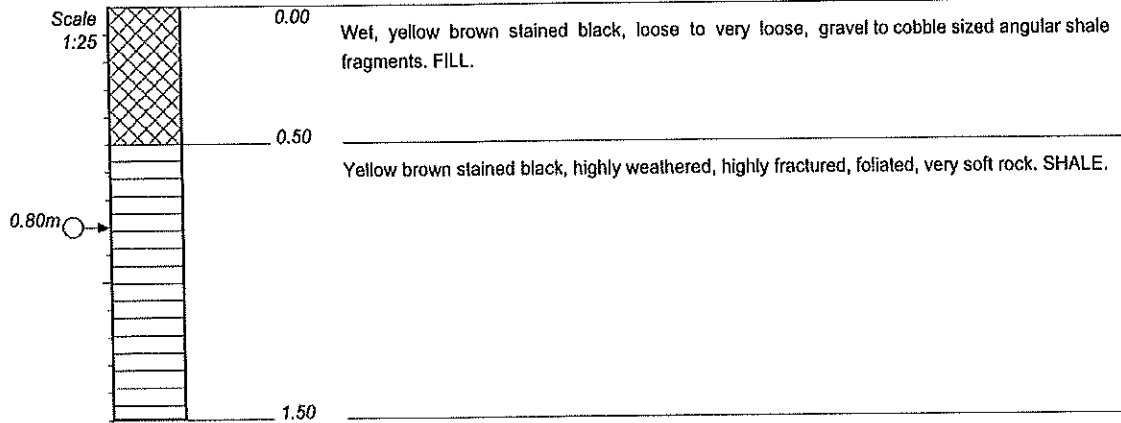
HOLE No: IP3

Ground water occurrence was noted in inspection pits IP 2 and IP 3 at depths of 0.50m and 0.80m respectively. Flow rate was strong due to the proximity of the inspection pits to the stream. It is recommended that allowance be made for dewatering during construction of foundations.

- 1) Ground water seepage observed from 0.80m.
- 2) Pit located in centre of stream bed.
- 3) Refusal depth on shale bedrock at 1,50m.
