**ANNUAL REPORT FOR THE TRONOX KZN SANDS  
(PTY) LTD FAIRBREEZE MINE**

**FOR TRONOX KZN SANDS  
DATE: 30 JANUARY 2019**

**Umlando: Archaeological Surveys and Heritage  
Management**

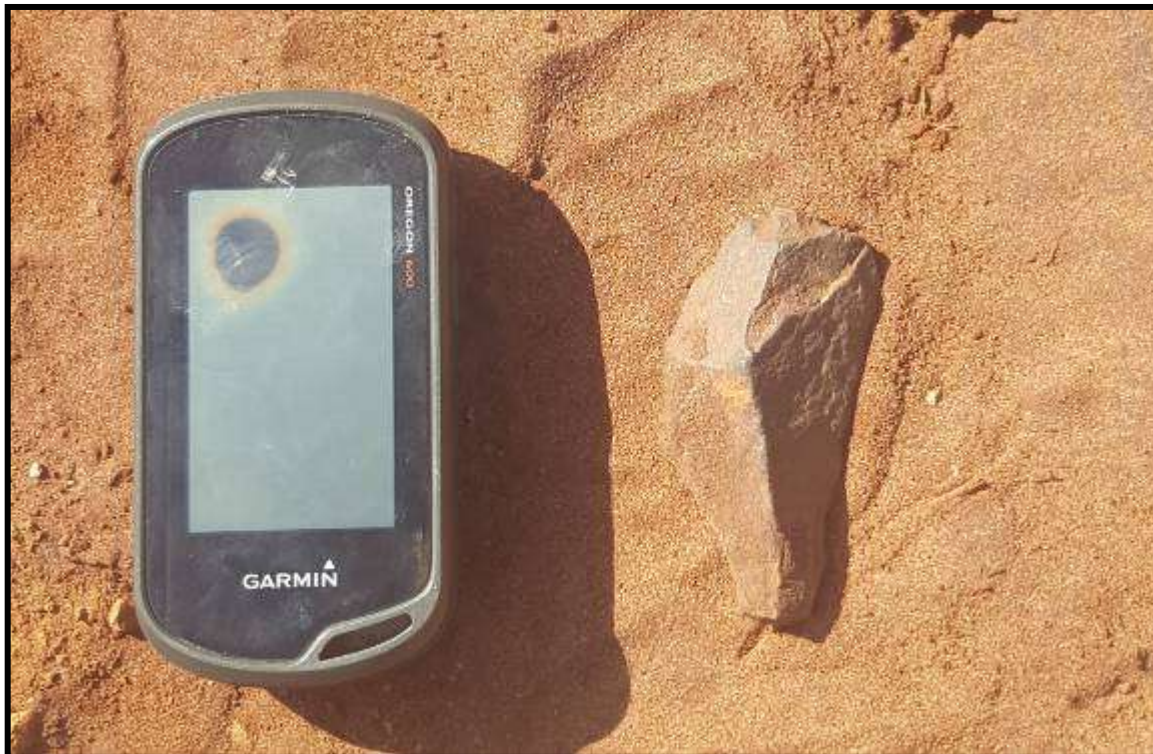
**FIG. 2: MSA TOOL AT FAIRBREEZE MINE<sup>1</sup>**

- A single dolerite Middle Stone Age stone tool was noted. The tool was a utilised flake (fig. 2).
- There was an erosion gully northwards and downhill from the MSA flake. In this gully were three Early or Middle Stone Age stone tools (fig. 3)
- A single Middle Stone Age flake was noted at the Siyaya River Bridge
- Two pottery shards and a small upper grinding stone were noted (fig. 4). The shard is undecorated but probably dates to at least the Late Iron Age. The artefacts are in a secondary context and have no significance. The artefacts are part of the general scatter of artefacts along this hill that was previously afforested
- Pottery around the site LH5 (fig. 5)
- The area near Siyaya farm building was noted for monitoring and the area was opened in December (fig. 6). Only a recent (1960s – 1970s) rubbish dump was noted.

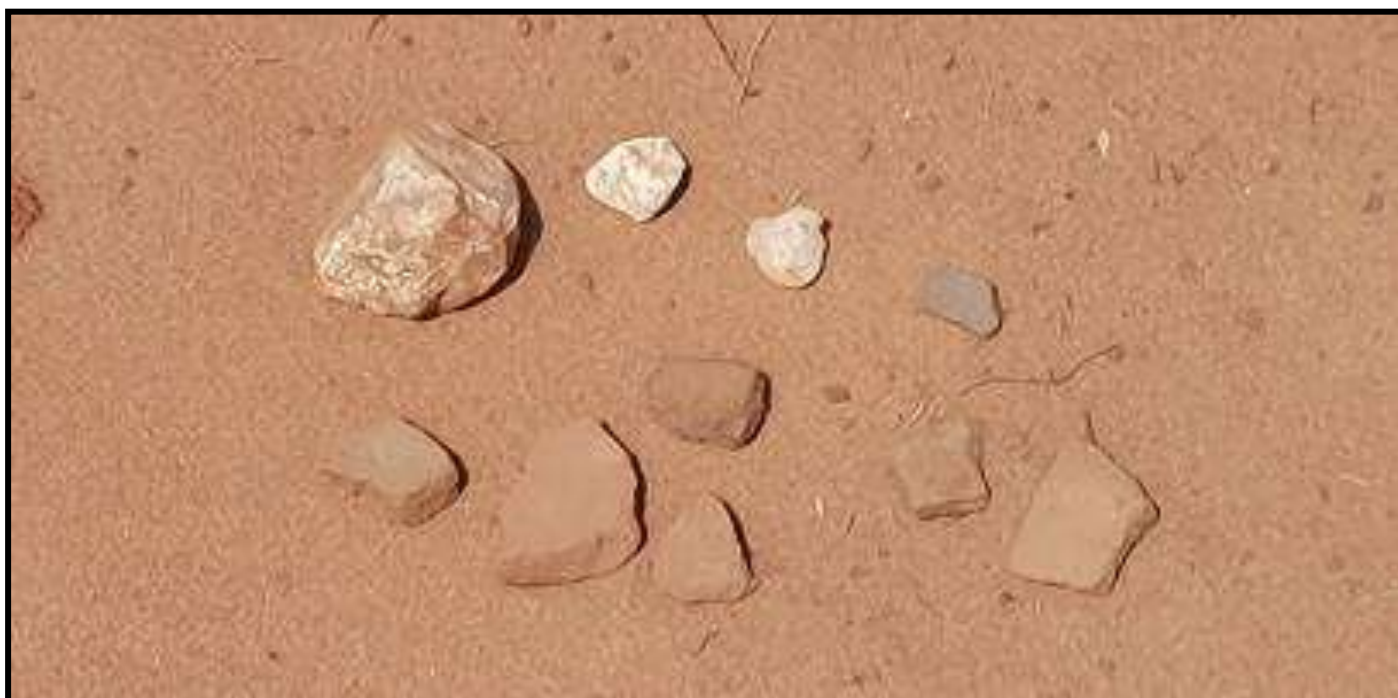
**FIG. 5: POTTERY AT LH5**

The monthly surveys did not yield any new sites or major finds. However the clearing of LH5 has highlighted a potential problem at the mine. While the maps indicating sensitive areas are available, they are not being consulted during the planning process. The point for LH5 has a 50m sensitivity radius and this should have alerted planning. To counter this I suggest that all heritage sites that require some form of mitigation are demarcated with painted poles and surveyed by the land surveyor. The paint must be unique for heritage sites and not conflict with other markers. The demarcation started in November and December and will continue in 2019. The demarcation of all heritage sites is apart of the RoD for the mine. This is important as staff change over time and new staff will not necessarily know about the location of sites. Demarcation is designed to be a permanent reminder of sites in the area. This can minimise accidental damage to sites, especially graves, that could result in mine closure if damaged.

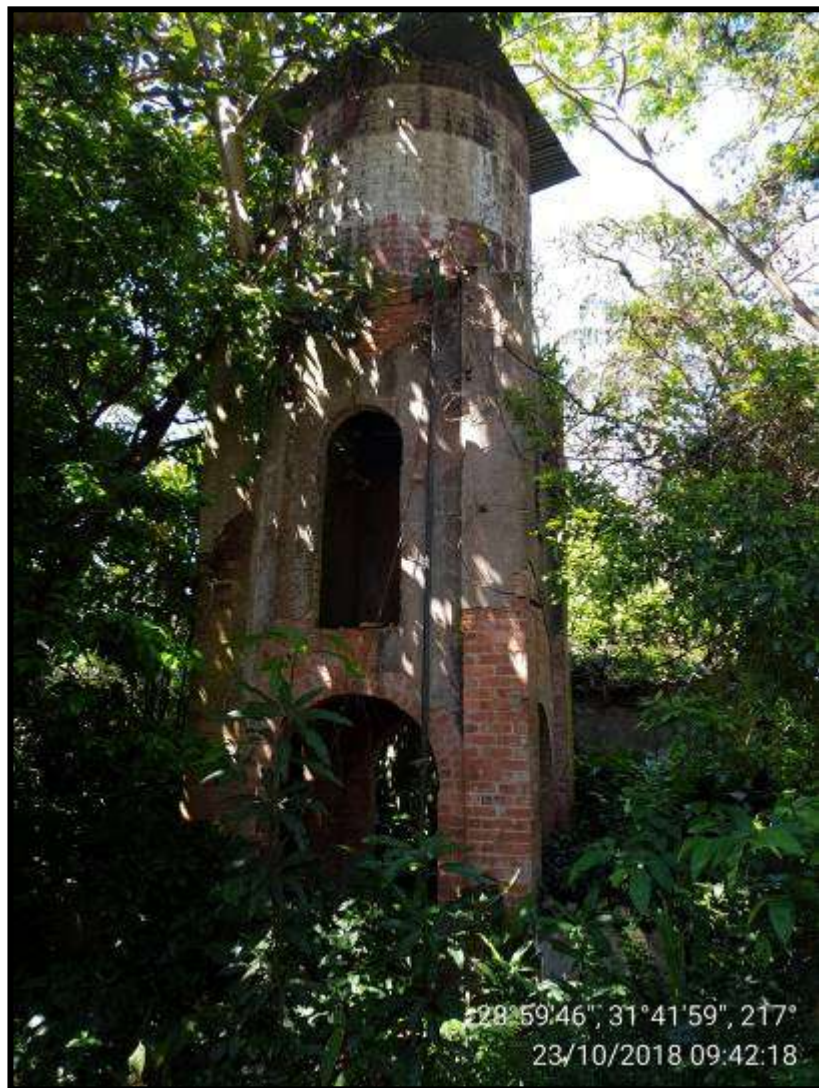
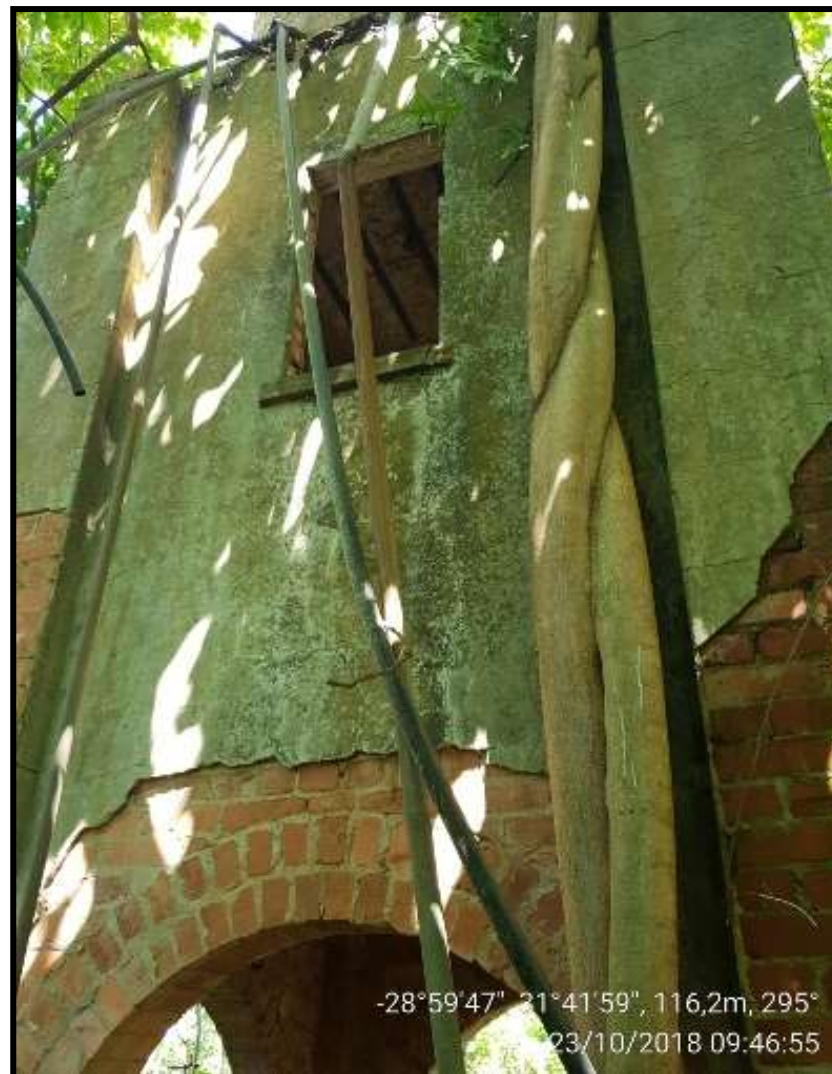
FIG. 7: WATER TOWER AT HIGHFIELDS HOUSE

The main office is situated at Highfields House. The house has been noted as having high significance and various restrictions have been placed on the estate. It has been noted by Tronox that some buildings pose a potential hazard and I was requested to enquire with Amafa KZN on possible remedial actions. I was informed by Amafa KZN Built environment that if any building on the estate needs to be removed, then Tronox must apply for a permit for that specific building whether it is for repair or demolition. The application will then be considered on merit. Tronox has the responsibility for the upkeep of all of the built features on the estate. Fig. 7 shows the water tower that is considered as a hazard.
