| <p>ARCHITECTS</p> | <b>ABLUTION BLOCK SOUTH WING</b><br>P.O.BOX 37188<br>OVERPORT<br>DURBAN<br>4067<br>TELE : 2097245/6<br>FAX : 2097247<br>E-MAIL :seedat@ion.co.za<br>AHMED.SEEDAT-ARCHITECT<br>REG no :3140(S.A.C.A.P) | <b>ROOM NAME -</b><br>PROJECT:<br>NATAL COMMAND -DILAPIDATION REPORT | <b>SCALE:</b><br>1/50 | <b>DRWG.No:</b><br>21126 |
| | <b>DRAWING TITLE:</b><br>ROOM AND OFFICE DATA SHEETS | <b>DATE:</b><br>DEC 2022 | <b>PAGE.No:</b><br>1 | |

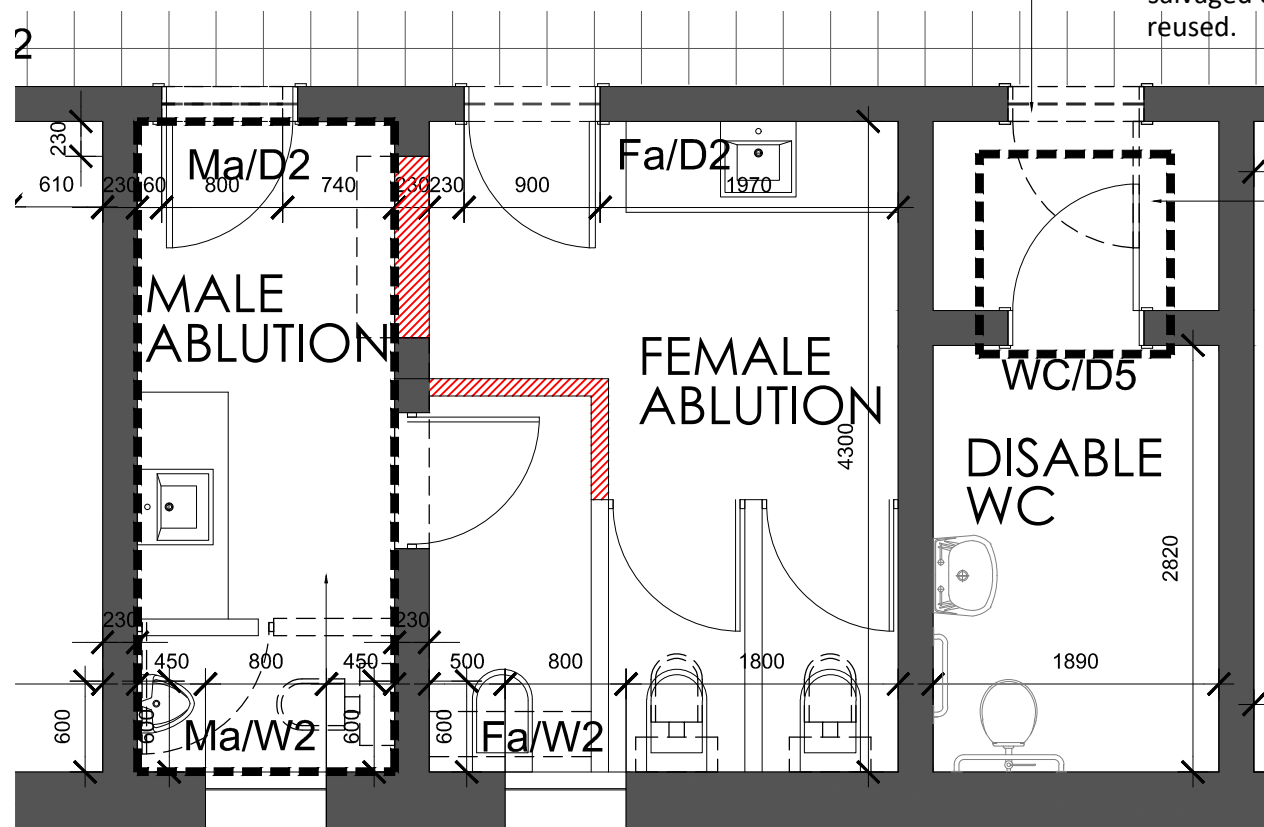
ex. door frame to be removed in its entire salvaged on site to be reused.
