HERITAGE STATEMENT ALPHA ONE AND PUMP HOUSE.

INTRODUCTION.

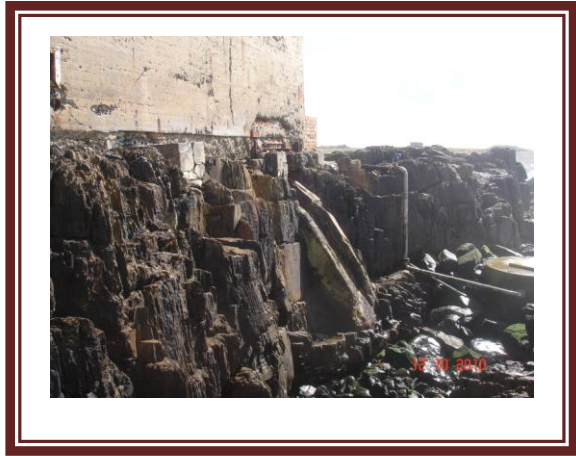
Shute on seaward side of Alpha One.

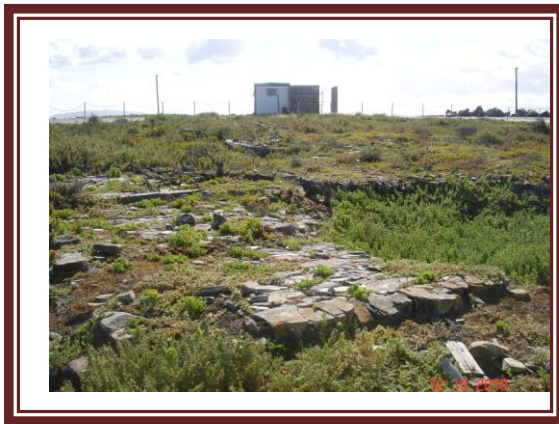
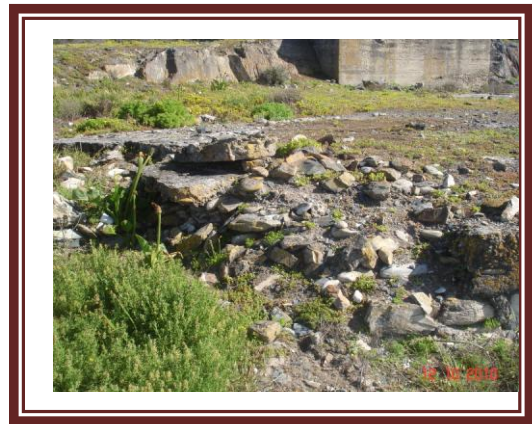
Structural remains requiring thorough archaeological assessment next to pump house and below the WWII gun emplacement.

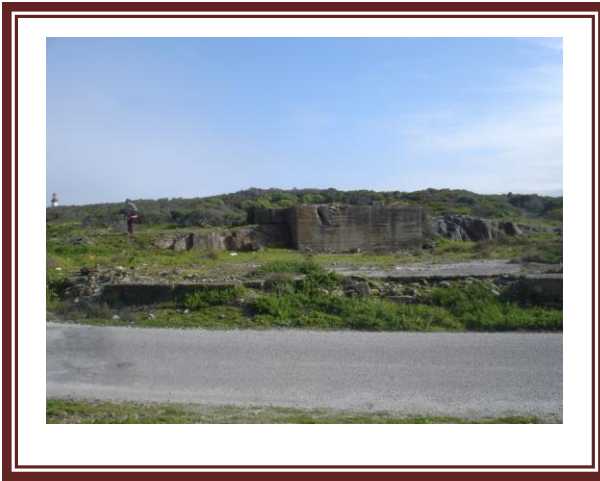
Anti-aircraft gun emplacement.
