Conservation document for house 38 Church Street

House 38 Integrated Conservation Management Plan

SITE NAME: House 38 Church Street and attached building

DATE: 14 April 2013

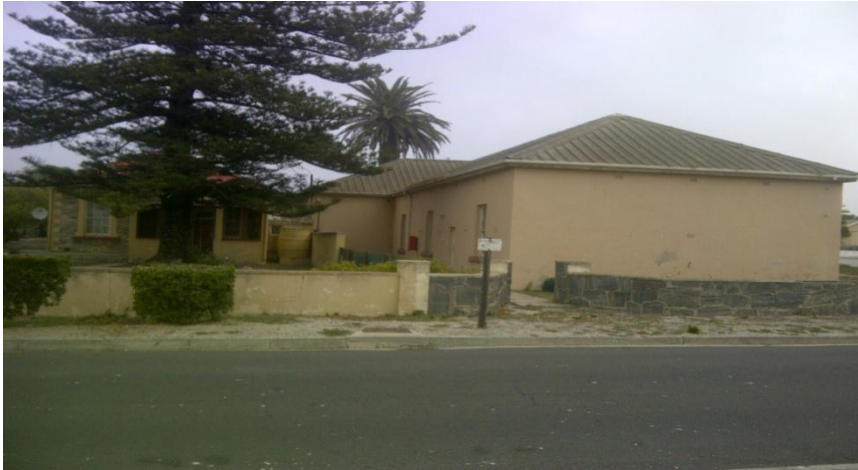
Figure 1 EAST ELEVATION OF HOUSE 38 & ATTACHED BUILDING

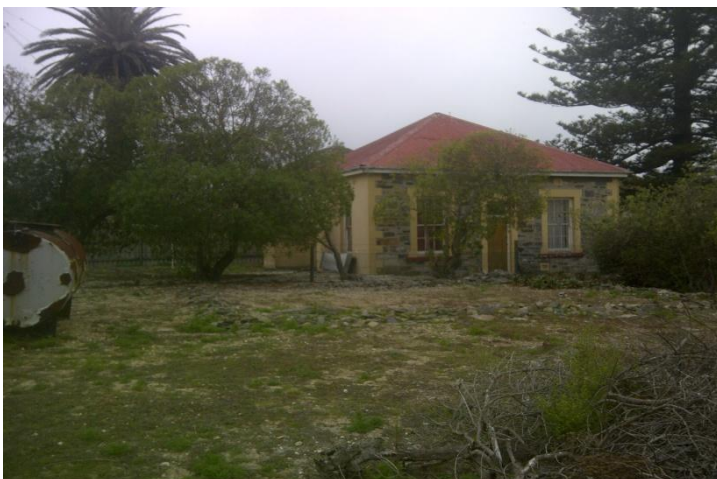
Figure 2 SOUTH ELEVATION OF HOUSE38

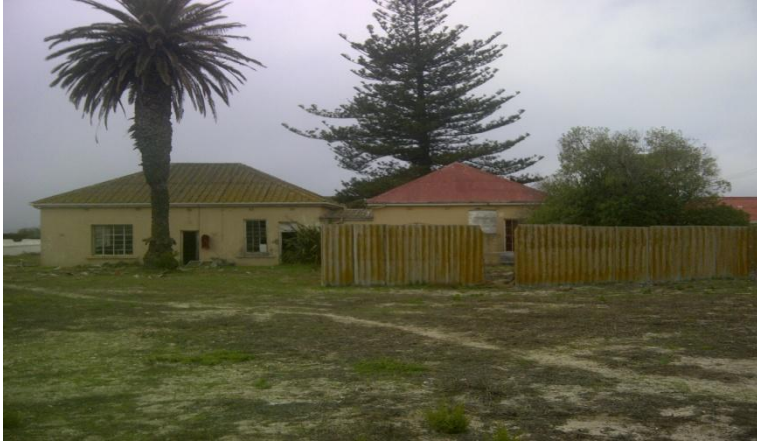
Figure 3 WEST ELEVATION OF HOUSE 38 & ATTACHED BUILDING

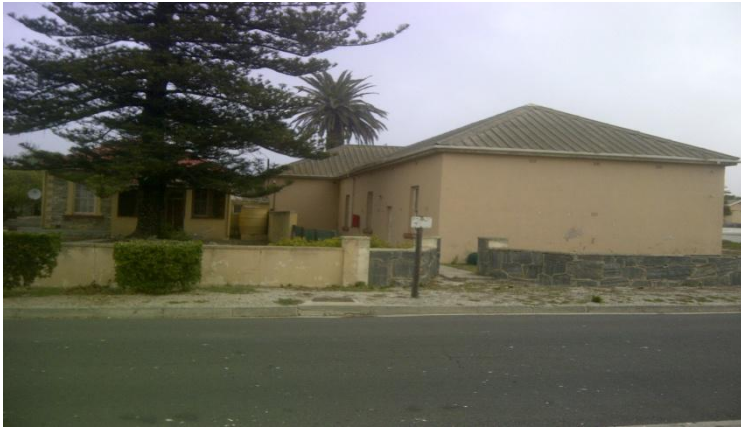
Figure 3 EAST ELEVATION OF BUILDING ATTACHED TO 38 CHURCH STREET

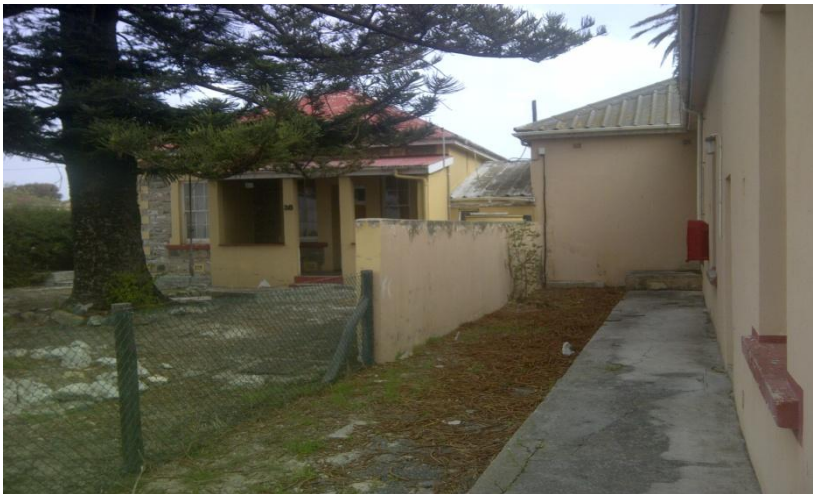
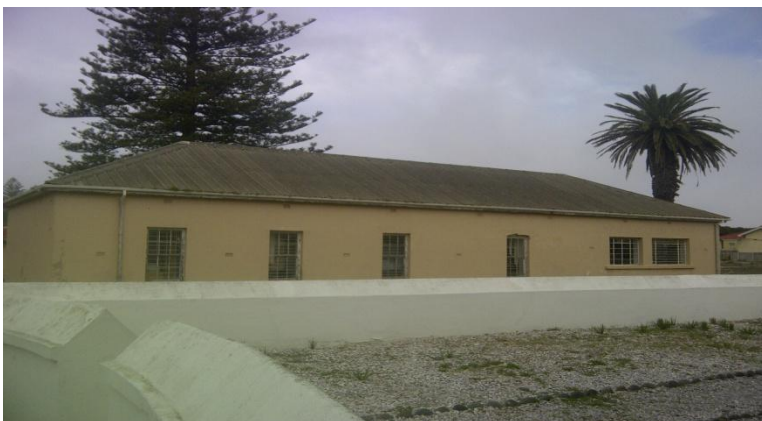
Figure 4 NORTH ELEVATION OF BUILDING ATTACHED TO HOUSE 38

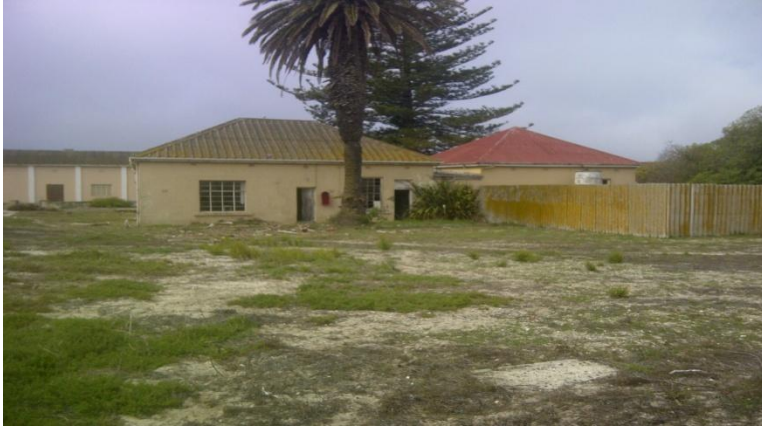
Figure 5 WEST ELEVATION OF BUILDING ATTACHED TO HOUSE 38 CHURCH STREET
