Biodiversity Management Plan

Jagersfontein Developments (Pty) Ltd

March 2013

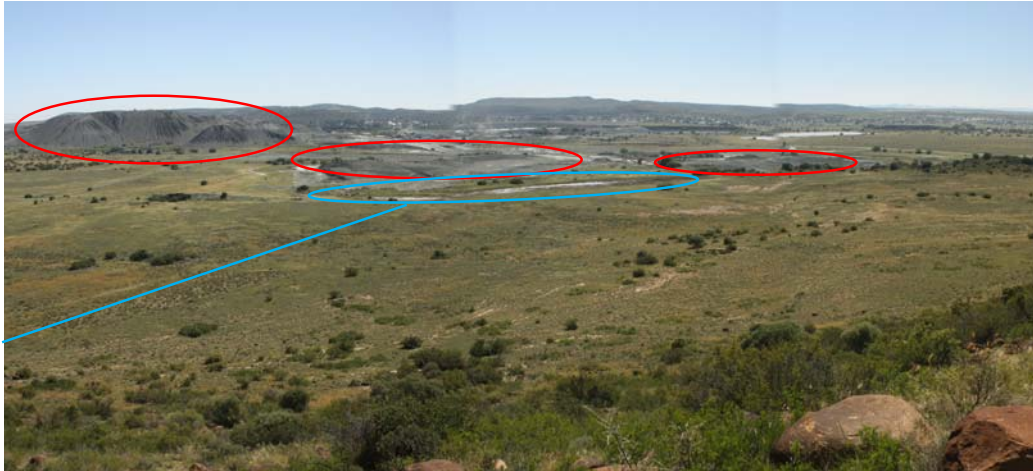
Figure 1: Panorama of mining activities on the site. Visible mine dumps are indicated (red circles). A drainage line flowing from south west has been obstructed by a mine dump and has consequently formed an artificial and degraded wetland. The drainage line and wetland is indicated in blue.

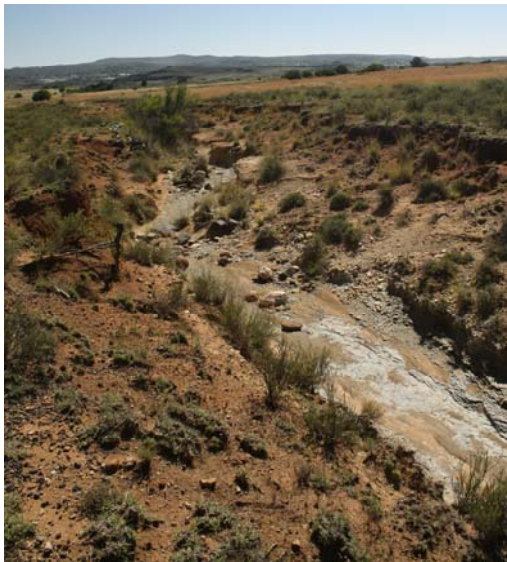
Figure 3: A close-up of the drainage line as depicted in Fig. 2. The erosion of this drainage line is unnatural and considered a large disturbance. The erosion is caused by increased runoff from a mine dump to the south of the drainage line.

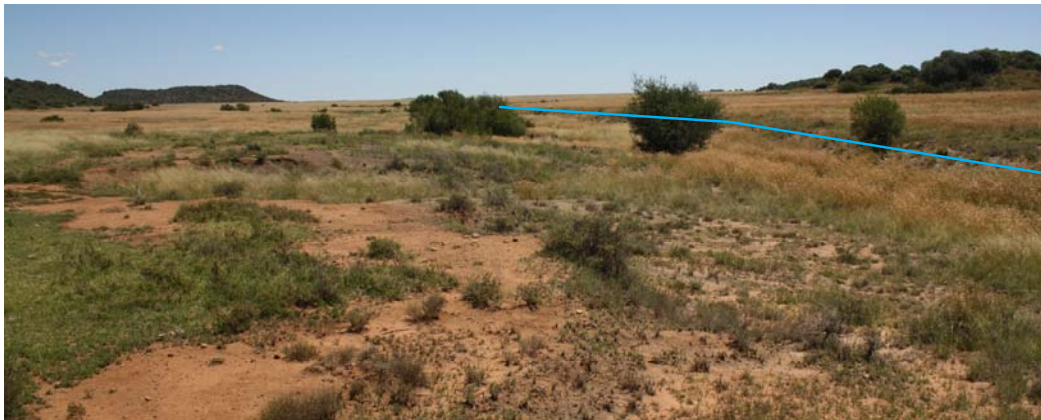
Figure 5: Close-up of the drainage line depicted in Fig. 4 (indicated by blue line). Note the sheet erosion. The drainage line itself also exhibits moderate gully erosion.

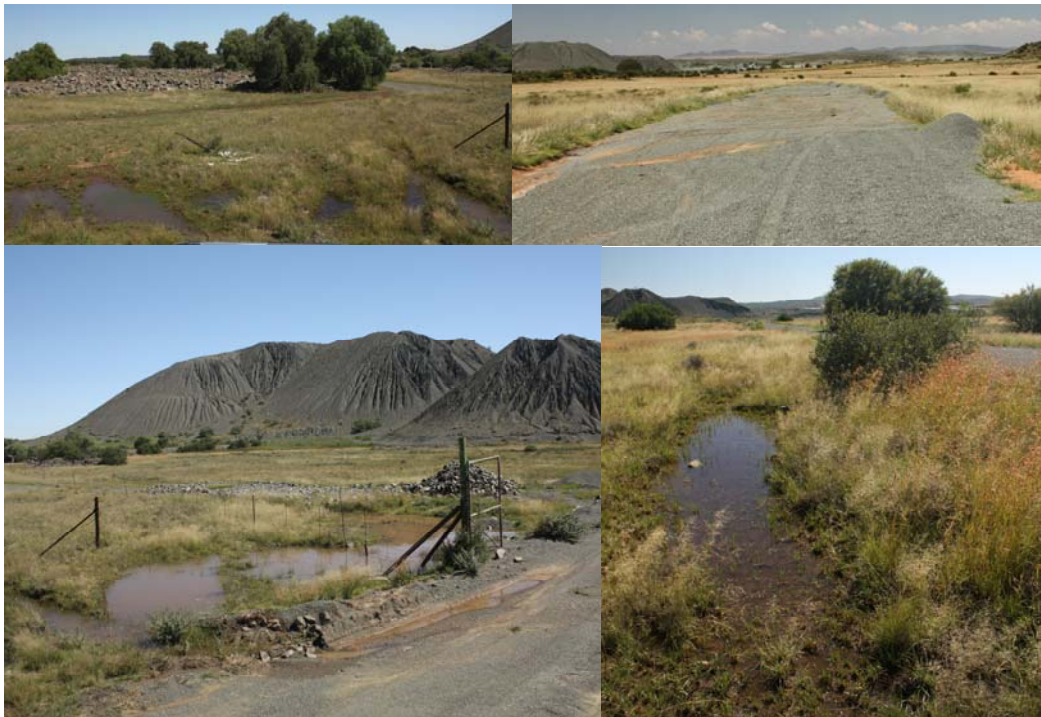
Figure 6: Selection of photographs illustrating areas where the internal road network causes ponding and erosion. This is due to the lack of culverts and the elevation of the roadways above the virgin soil level.

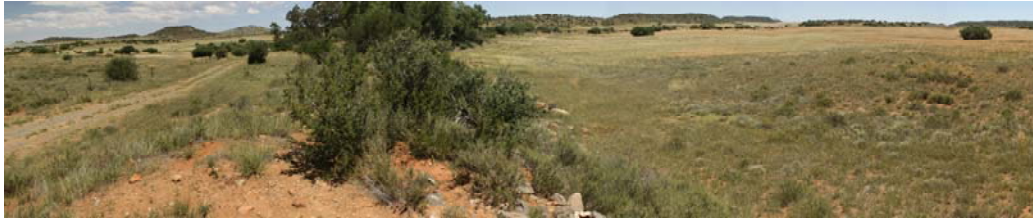
Figure 7: Panorama of the wall of a very old dam on the site. As can be seen the capacity of the dam has severely decreased due to sedimentation over the years.

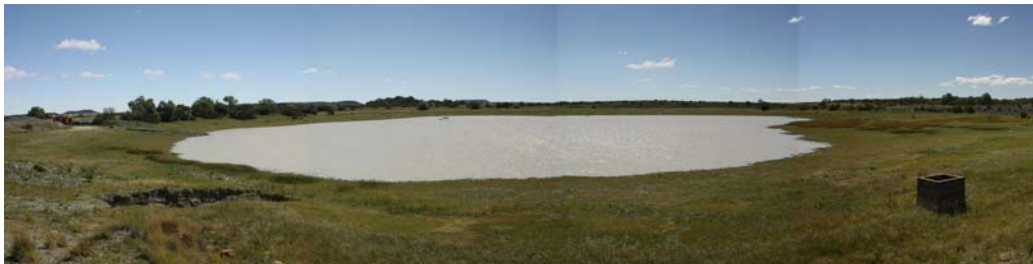
Figure 9: Panorama of the dam situated in the northern corner of the mining area. The dam is subjected to sedimentation by surrounding mine dumps and upon closer inspection a thick layer of mine dump sediment cover the soil layer.

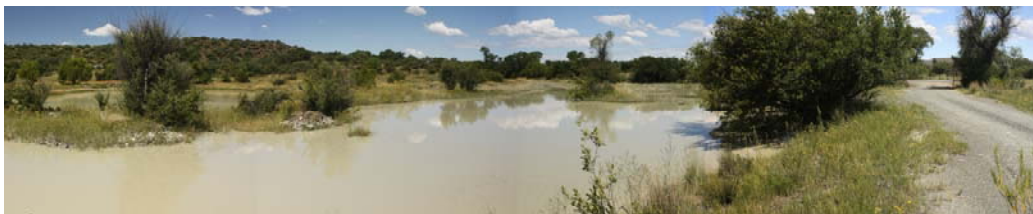
Figure 10: Panorama of an artificial pond adjacent to the dam depicted in Fig. 9. These ponds are a result of disturbance of the natural drainage pattern. This is primarily due to obstructions such as mine dumps, roadways and inadequate drainage in disturbed areas.

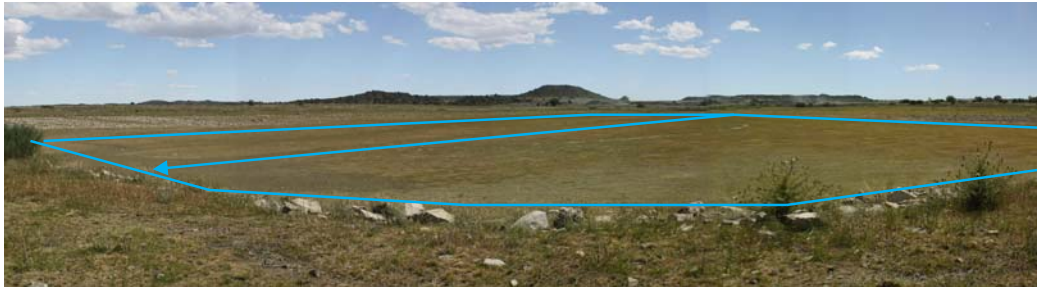
Figure 12: Panorama of the inflow of Dam 10. This area is periodically flooded and consists of an extensive wetland (blue figure). This wetland is a result of the dam and would, under natural conditions, be much smaller. The blue arrow indicates the main channel and inflow of the dam.

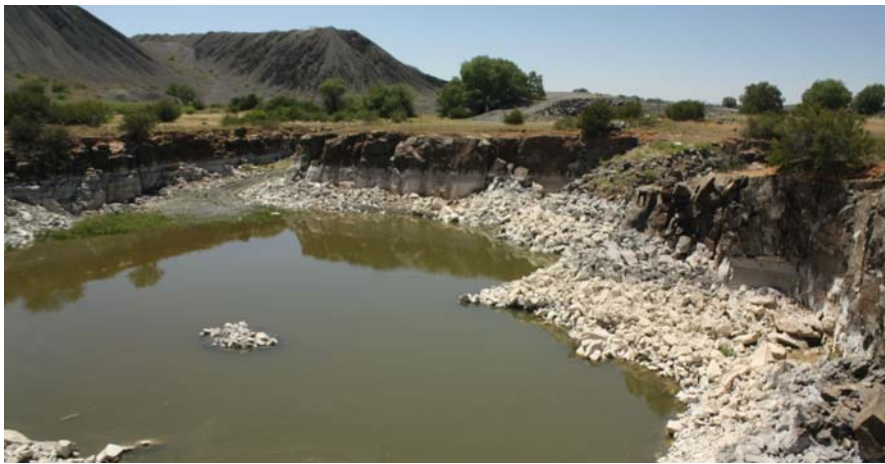
Figure 13: The large stone quarry situated in the centre of the mining area. The quarry acts as a surface water runoff trap. This is considered a degraded area.

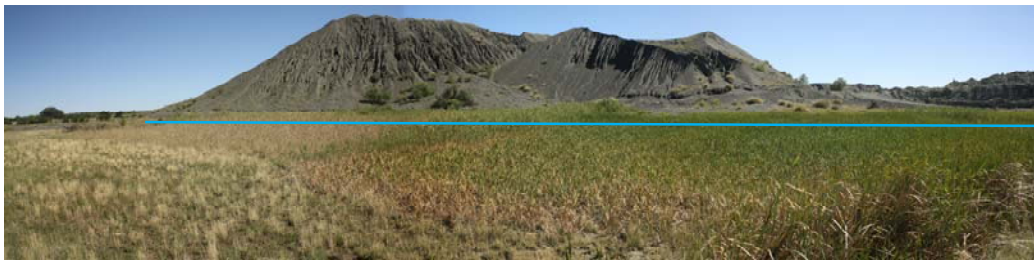
Figure 17: Panorama of the large, main mine dump as well as the seasonal stream (stream indicated by blue line). The dominance of Bulrush (*Typha capensis*) is not natural and is caused by retardation of water flow by road crossings, inadequate culverts, continuous sedimentation and increased runoff from the mine dump.

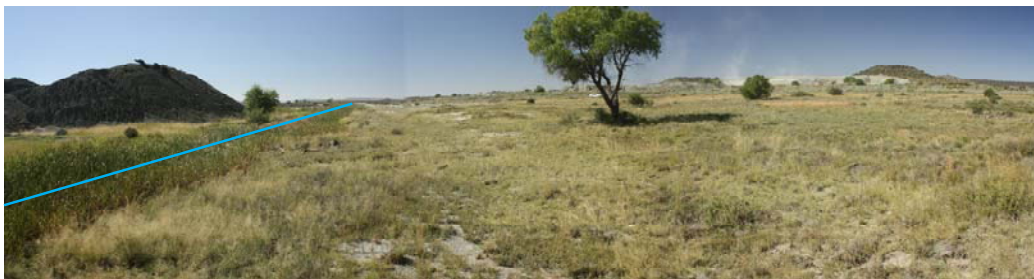
As the seasonal stream flows past the large mine dump the sediment load of the stream is increased drastically. As a consequence the stream is severely degraded in this portion. A small portion of the mine dump is also situated within the seasonal stream and this further transforms and degrades the stream. In this area the main channel of the stream is dominated by *Typha capensis* (Bulrush). The floodplain is dominated by several riparian grass and sedge species with a fair amount of dwarf karroid shrubs also present. Isolated trees are also present. The soil surface is covered by a thick layer of sediment and this causes suffocation of much of the vegetation and aquatic- and soil fauna. As a result the vegetation is in a severely degraded condition and the fauna in this area is very low in diversity.

Figure 18: Panorama of the seasonal stream (blue line). The large main, central dump is located to the left of the stream. Sedimentation of the stream is severe and leads to severe degradation of the stream.

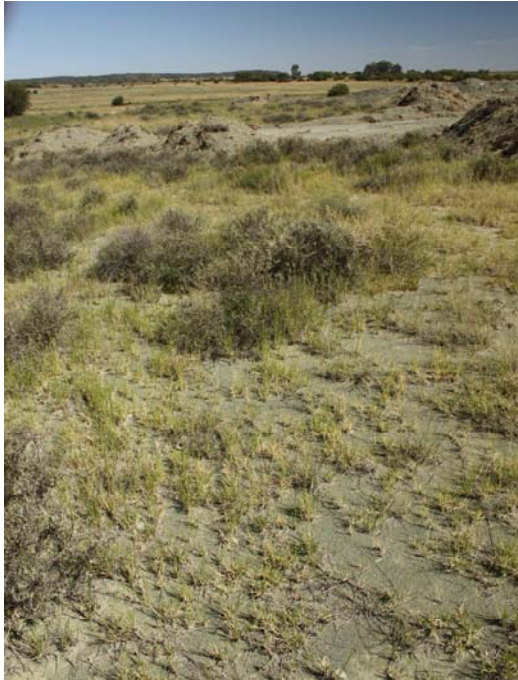
Figure 19: Portion of the floodplain of the seasonal stream. The sediment deposition is clearly visible in the foreground. This leads to severe disturbance including low percentage vegetation cover which is clearly visible.

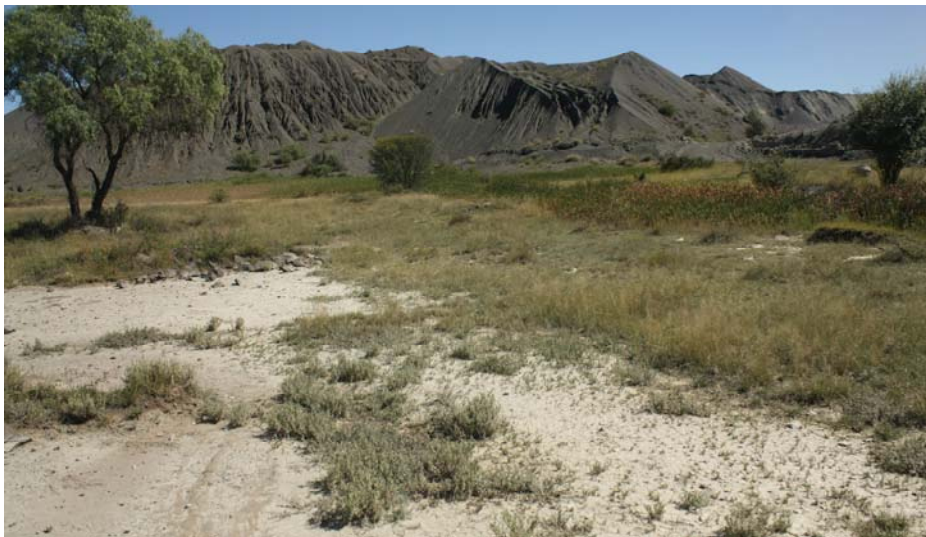
Figure 20: Another photograph adjacent to the seasonal stream. Sediment deposition is clearly visible. This causes a severe impact and leads to areas where vegetation is excluded as is the case in this picture.

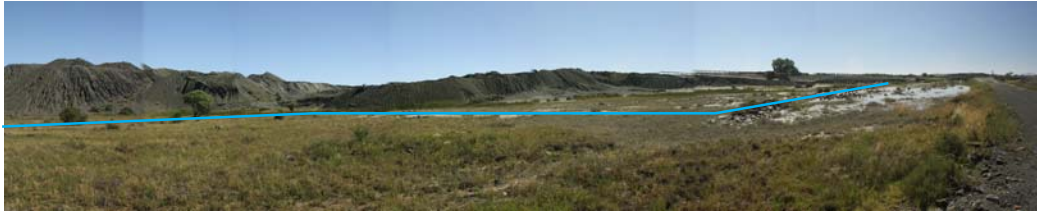
Figure 21: Panorama of a portion of the large main, central dump as well as the seasonal stream on the site (stream indicated in blue). As can be seen the roadways as well as the dumps has caused damming of the seasonal stream; this is unnatural and considered a large impact. Sedimentation of the seasonal stream in this area is also severe as caused by sediment runoff from the mine dump.

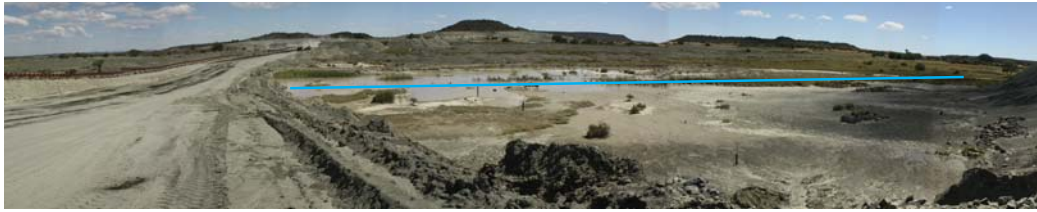
As the seasonal stream flows east a large dirt roadway crosses the stream. The culverts and drainage underneath this roadway is inadequate to allow drainage of the seasonal stream. In addition to the inadequate drainage the large amounts of sediment as mentioned above cause blocking of the culverts. The culmination of the above causes the water flow to dam up in this area. The condition of the seasonal stream is severely degraded in this area. The area contains only limited vegetation with most of the vegetation suffocated and the faunal component severely degraded.

Figure 22: Panorama of the area where the seasonal stream is crossed by a wide roadway (stream indicated in blue). The culverts are not adequate and together with sedimentation form the adjacent large main dump the stream is severely degrade in this area. Sedimentation and inadequate culverts have caused damming of the seasonal stream. The deposited sediment forms a thick covering layer and has essentially smothered all plant life.

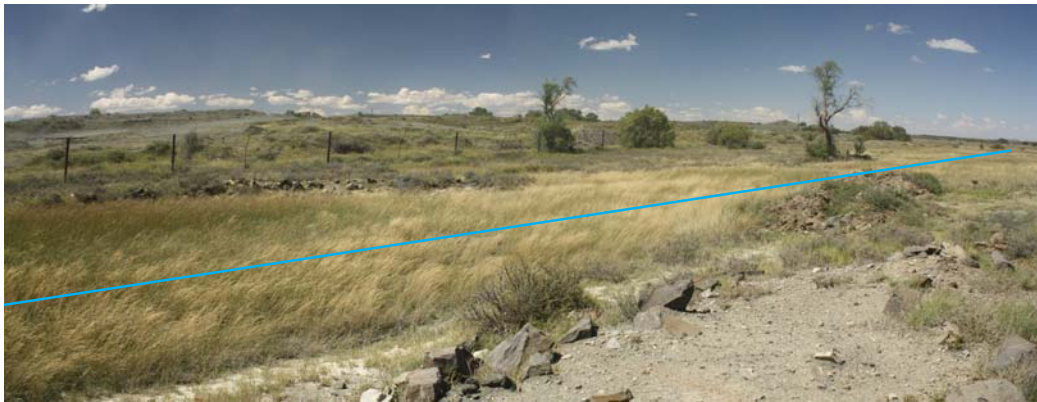
The stream is severely retarded at the above road crossing. Consequently on the eastern side of the road crossing the stream is starved of water flow and is consequently severely degraded. In addition, extensive areas of dumped screened sand occur in the floodplain of the stream. This also adds high volumes of sediment to the stream and further degrades its condition.

Figure 23: Panorama of the seasonal stream (blue line) downstream of the main road crossing. Due to flow retardation upstream of the roadway the stream is much smaller and severely degraded due to sedimentation and screened sand dumping.

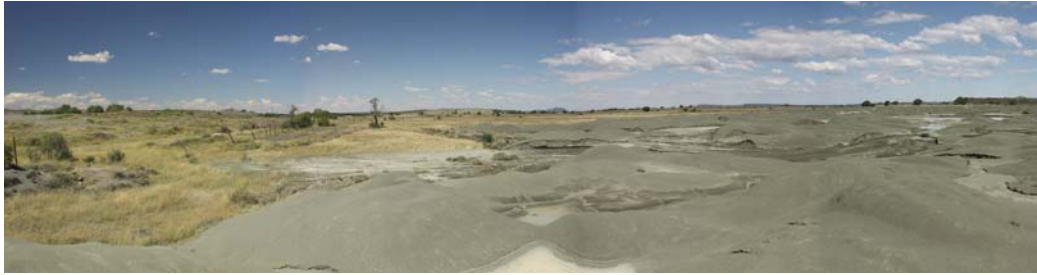
Figure 24: Extensive screened sand dumping south of the seasonal stream. These sand dumps cause severe disturbance of the adjacent seasonal stream. The sand dumps act as a surface runoff barrier and cause ponding of surface water. The sand dumps also cause severe sedimentation of this stream.

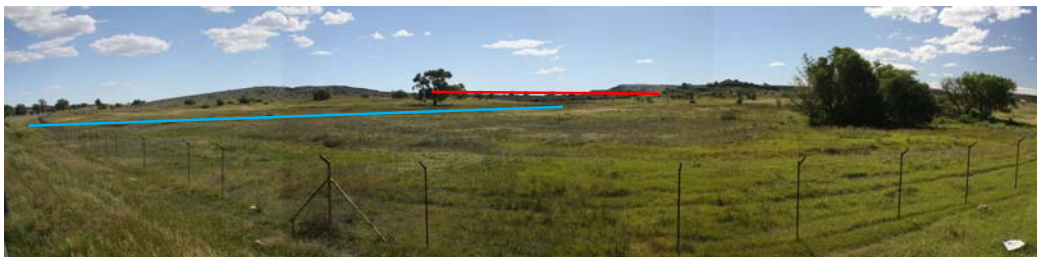
Figure 27: Panorama of the seasonal stream as it exits the mining area on the eastern border (blue line). The border of the mining area is visible as the fence line. The damwall of Dam 10 is indicated in red. This dam acts as a sediment trap and most of the suspended sediment is deposited in this dam. However, mine dumps outside the catchment of this dam releases sediment into the stream downstream of the dam.

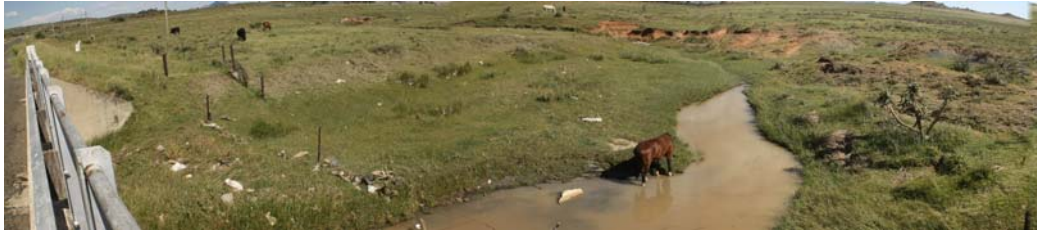
Figure 28: Panorama of the seasonal stream at the R704 road crossing approximately 1,5km east from the border of the mining area. The sediment resulting from the mine is still evident at this site. In addition disturbance caused by the Charlesville settlement adds to the degraded state of this stream.

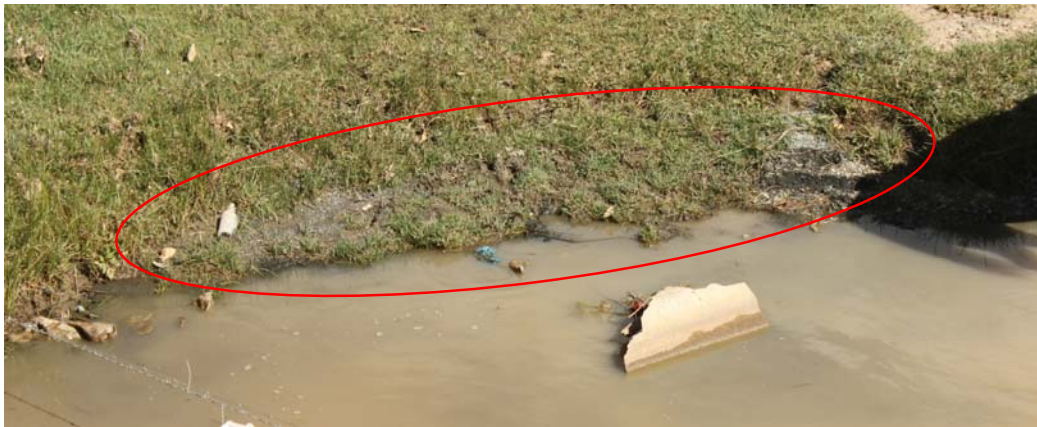
Figure 29: A close-up of this stream as depicted in Fig. 28. Note that suspended sediment increase turbidity of the water and sediment deposition occurs along the banks (red figure). This area is located approximately 1,5km from the boundary of the mine.

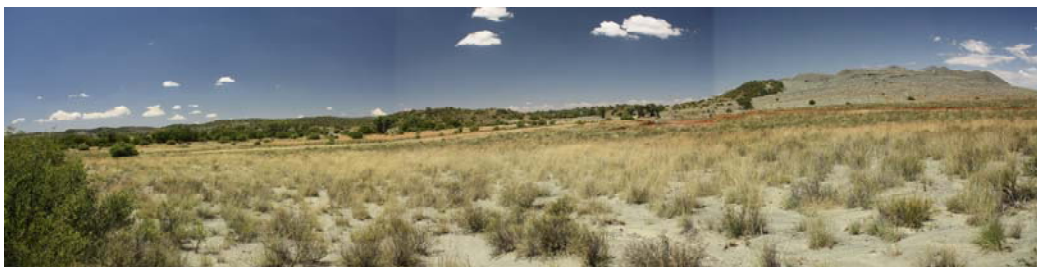
Figure 31: Panorama of the large main, central mine dump as seen from a north western perspective. Note the thick covering of sediment resulting from the runoff from the mine dumps. This sediment has caused degradation of the vegetation and soil surface. Note the low percentage vegetation cover and low species diversity.

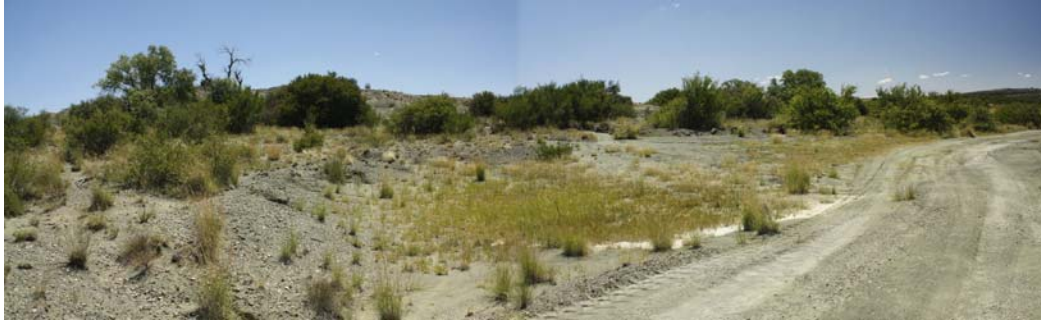
Figure 32: Panorama of a sediment plume of one of the mine dumps. The sediment is quite thick and causes substantial degradation of the natural vegetation.

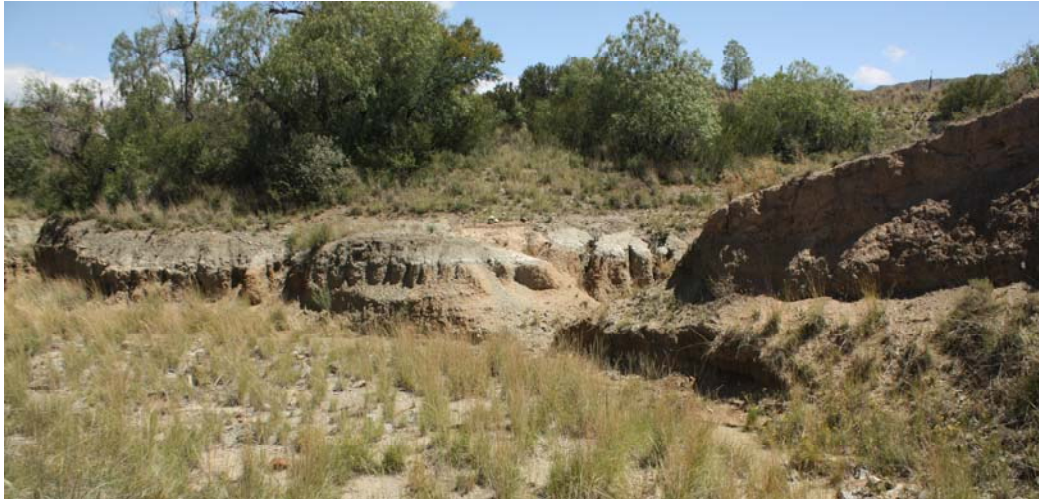
Figure 36: One of the drainage lines that flows into the Jagersfontein Pit. This drainage line has essentially been cut off from the drainage pattern on the site.

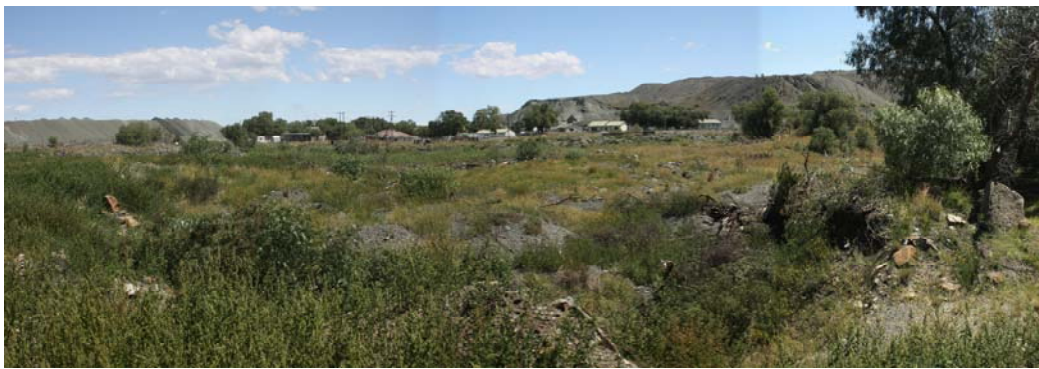
Figure 37: The area surrounding the Jagersfontein Kimberlite Pit as well as the processing plant is severely infested by exotic weeds. Disturbance of this area has occurred over an extended period during previous operation of the mine.

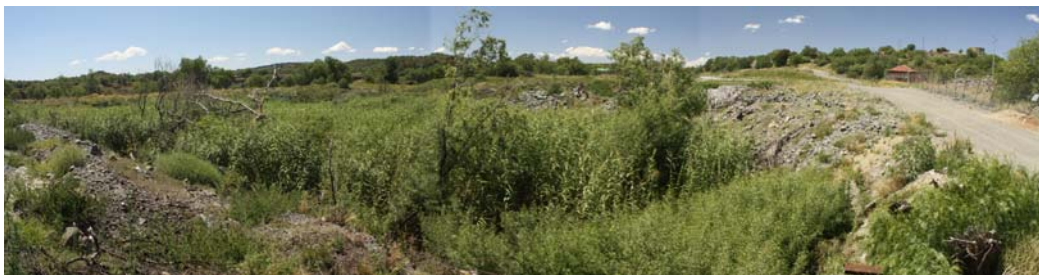
Figure 38: Drainage around the existing slimes dam and Jagersfontein Pit. The drainage pattern in this area has been altered and transformed. It is therefore in a highly degraded condition.

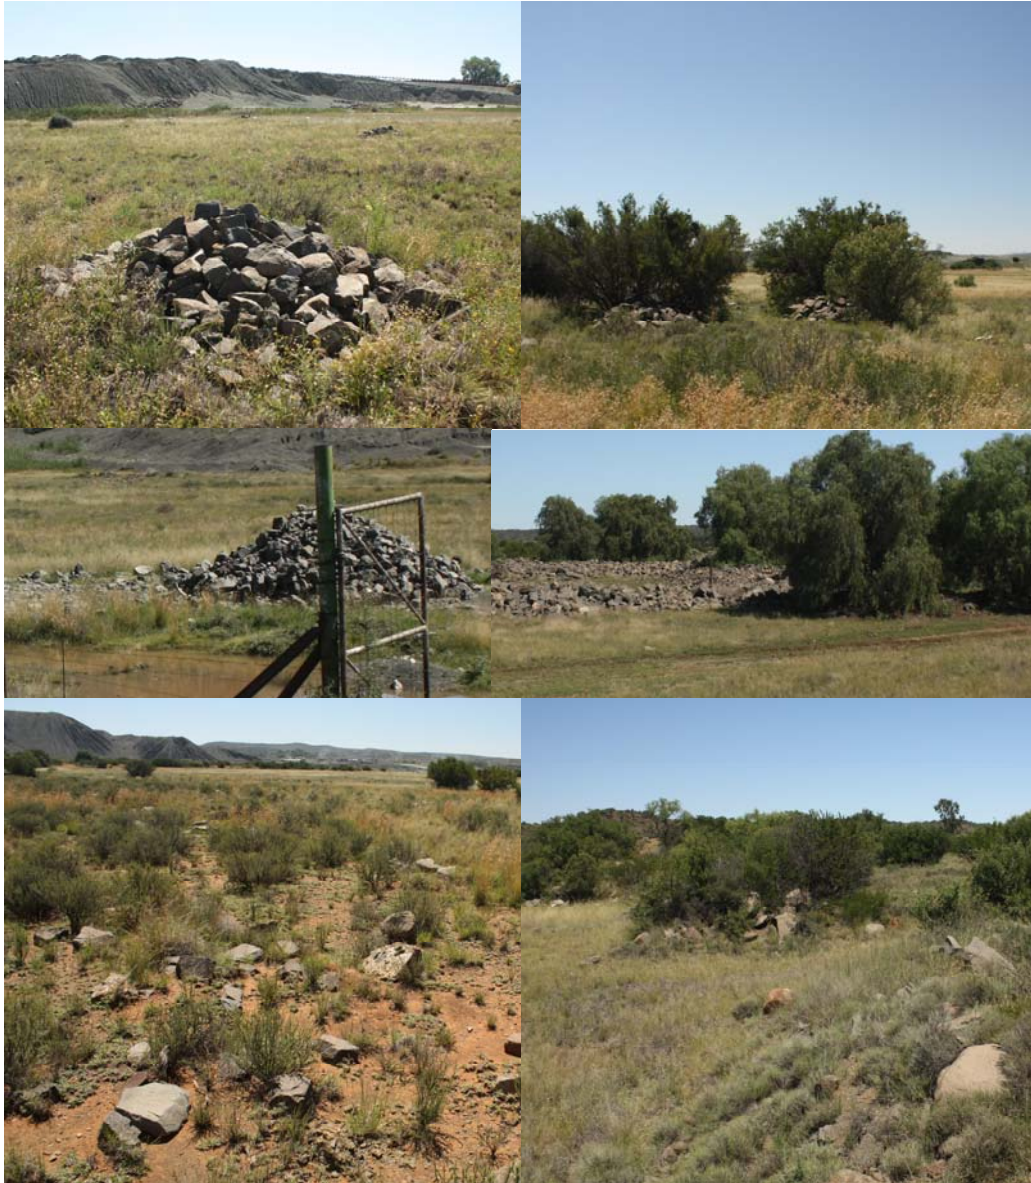
Figure 43: A selection of photographs illustrating the historical dumping of kimberlite boulders to weather. These heaps litter the plains and cause localised disturbance. The vegetation on and around these have been transformed and as is evident from most photographs trees establish on these heaps which is not natural to the plains environment.
