<u>Key features observed during the site inspection conducted on October 2022 for the proposed Lengana Solar Power Plant, near Excelsior, Free State province:</u>

Lengana Solar Power Plant (RF) (Pty) Ltd.

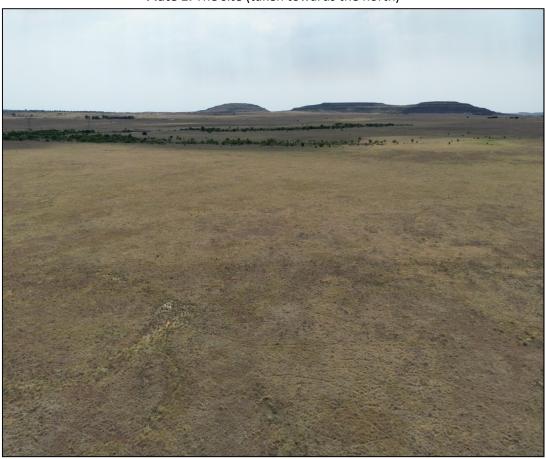
Plate 1: The site (taken towards the north)

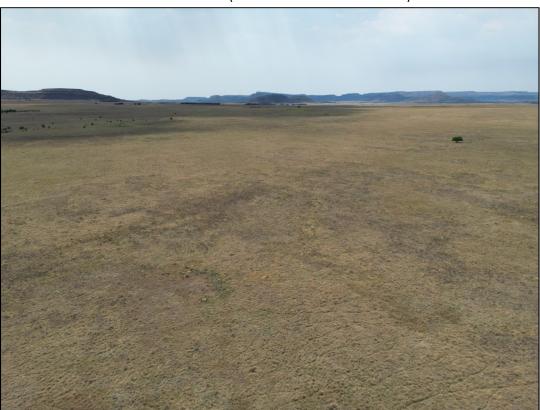
Plate 2: The site (taken towards the north east)

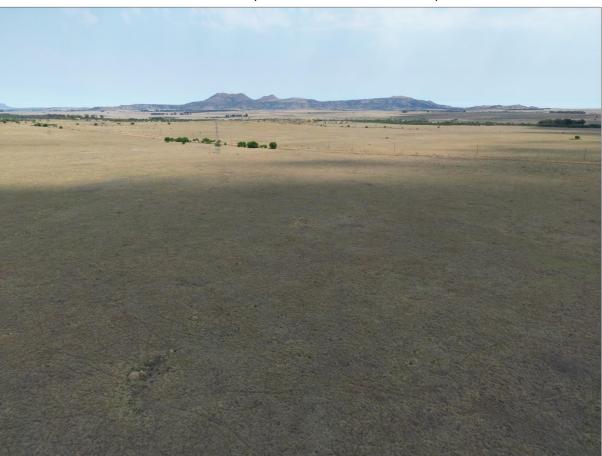
Plate 6: The site (taken towards the south west).

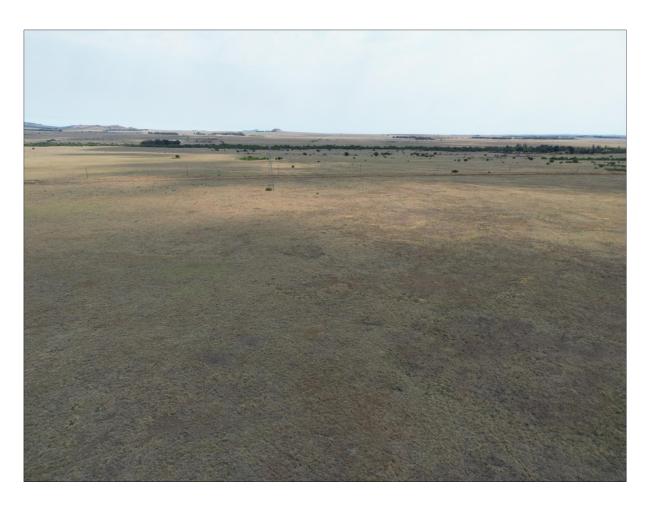
Plate 8: The site (taken towards the north west).

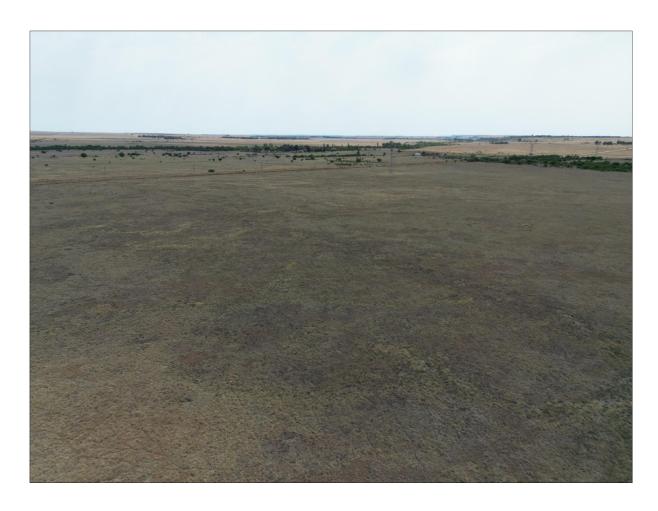
Plate 9: Significant portions of remaining natural grassland are dominated by a dense grass layer and though it only has a moderate diversity, is still in a relatively good condition.

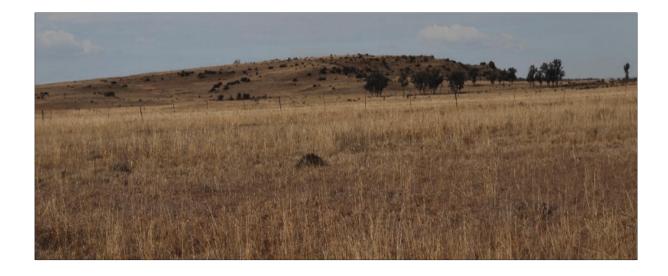
Plate 10: The low sandstone hill clearly differs from the surrounding habitats and will likely contain elements of high conservation value
