Distribution environmental screening document (DESD)
Reticulation Powerlines and Ancillary Services

Project name/Survey

Project number NW-STM-1209-1876-00005 File number

Rural scheme/
Feeder Lindley Munic-Vooros Voltage 22kV

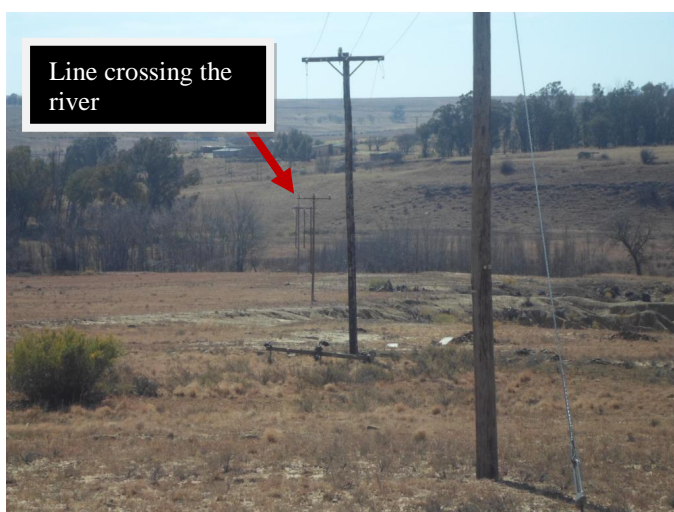
Present condition: The line is crossing the perennial Valsriver on farm Brandhoek 20 and Lloyd George 750 (See image 1). The line is connecting to pole mounted transformer (E 27° 56' 43.8", S -27° 52' 57.5") close to the Valsriver on farm Williesdeel 974. There is a perennial stream with eroded banks where the proposed line is crossing farm Jacobasrust 692 and Maresrust 515 (See image 2). The proposed line will be crossing a non-perennial stream twice on farm Onverwag 1013. The line crosses another part of the Herbstspruit on farm Driekant 835, Vlakspruit 423, Franshoek 842, Herbstspruit 346 and Babsie 497. There is a cemented farm dam present on farm Triangle 598 where the line is going to stand (See image 3). Farm Groenvallei 54 has non perennial streams on it where the proposed line is crossing. A non-perennial pan is present on farm Stonehenge 264. Farm Bulthoek 950 has a high underground water table with a water well present (See image 4).

Image 1: River crossing at farms Loyd and George

Comments/ mitigating measures: Do not construct or plant poles within a distance of 100m from the edge of river bank or any water body. No poles should be planted within the 100 year flood line of a river or stream. No excavations should be made within a water body. Refrain from any sort of littering in and around the water bodies. No driving in or through water bodies must take place and construction vehicles should be serviced regularly. Do not let oil spill in or close to water bodies and any oil spilling incident must be reported immediately to the environmental management section: Mahlatse Moeng 051 404 2287/ Andrea van Gensen 051 404 2040.

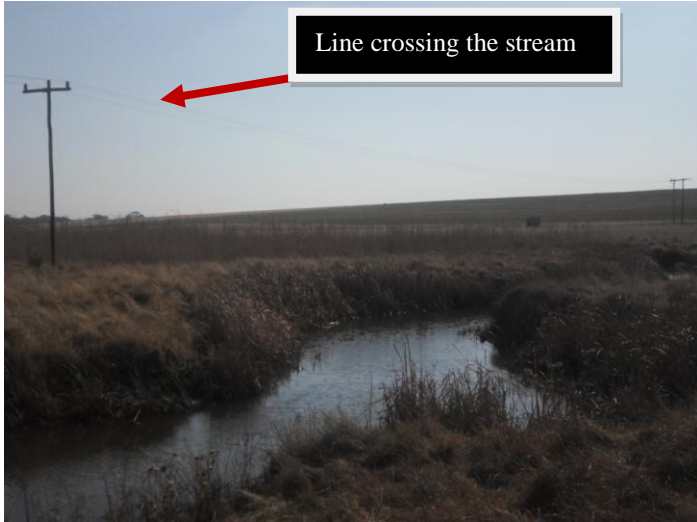
Image 2: Line crossing at farm Maresrust 515

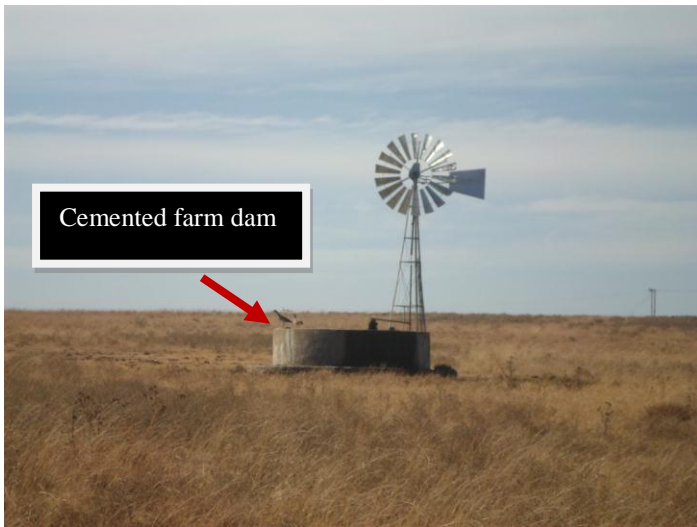
Image 3: Cemented farm dam on farm Triangle 598

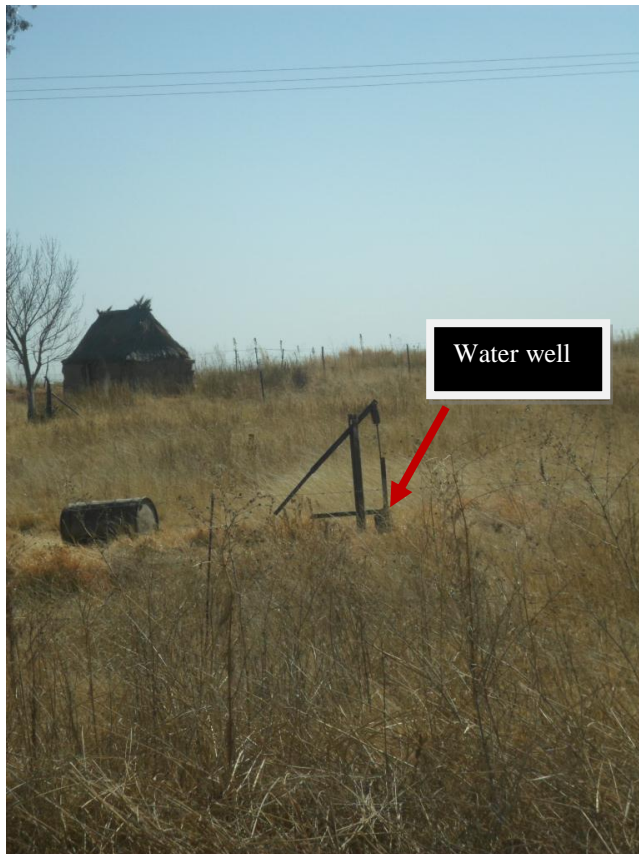
Image 4: High water table with water well present on farm Bulthoek 950

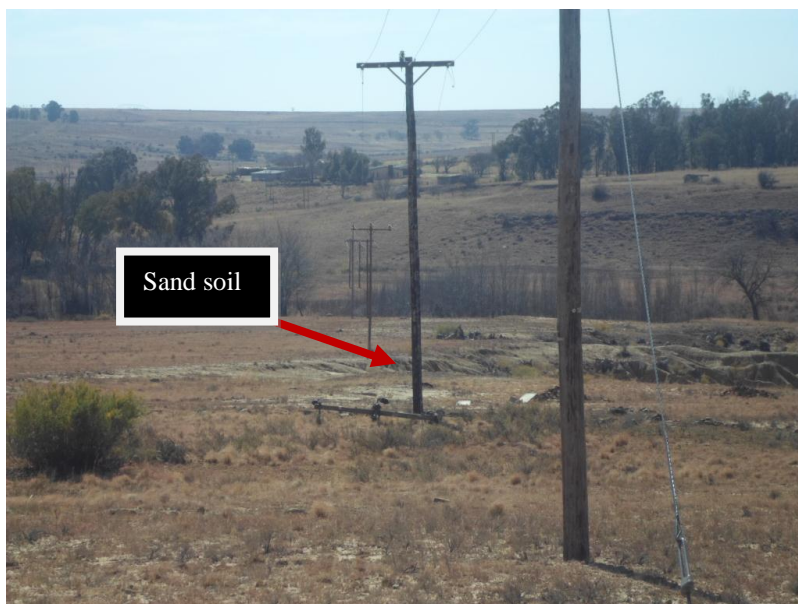
Present condition: Mainly loam soil was observed along the route of the proposed line. Mainly sandy soil was observed at eroded river and stream banks on farms Loyd and George (See image 5), Maresrus515 and Jacobasrust 692, Driekant 835, Vlakspruit 423, Franshoek 842, Herbstspruit 346 and Babsie 497.

Potential Impact: There is a potential of erosion of soil along the route of the line with all construction traffic involved. The riverbanks that are sandy and already eroded have a potential to experience loss of top soil through wind, water erosion processes and during construction. A potential risk of falling poles where it is planted in eroded sand soil might have an impact on the electrical supply in the area. Land pollution and the pollution of soil through littering and the spilling of chemicals might have an impact on the fertility of soil for agricultural activities i.e. land cultivation and the crops.

Image 5: Sand soil on eroded river bank

Comments/ mitigating measures: Do not plant poles in or close to highly eroded areas. Construction vehicles and other oil containing equipment should be serviced regularly. No vehicle movement should be conducted through eroded areas and one access route should be utilized to the construction sites. Do not litter in and around the area.

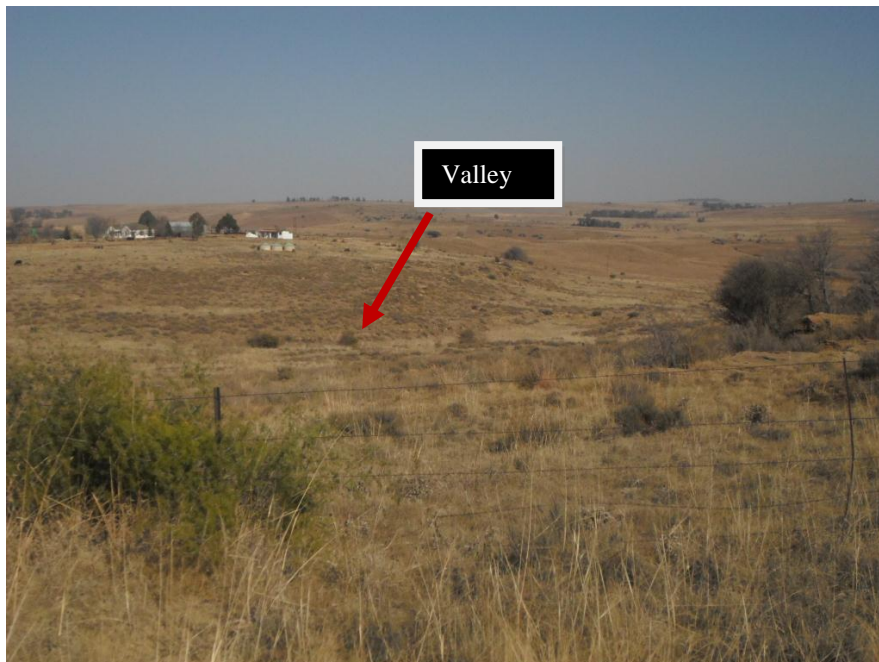
Present condition: The plain along the route of the line is mainly deeply undulating with hills present and valleys where the river crossings are found. There is a deep valley and a hill present on farm Tygerkloof 415 portion 1 (See image 6). A high hill present on farm Dorethea 819. There are deep dongas present close to the river-crossing on farm Loyd and George.

Potential impact (e.g. of erosion): The loosening of top soil through driving and constructing on slopes might result into soil erosion. Construction activities might lead to the transformation of landforms. Construction and vehicle movement on ploughed slopes might increase erosion and impact on the output of crops.

Image 6: Valley and hills

Comments/mitigating measures: Minimize vehicle movement and excavation on hill slopes. Existing access roads should be utilized throughout the lifespan of the line. No excessive movement on the cultivated sloping areas.

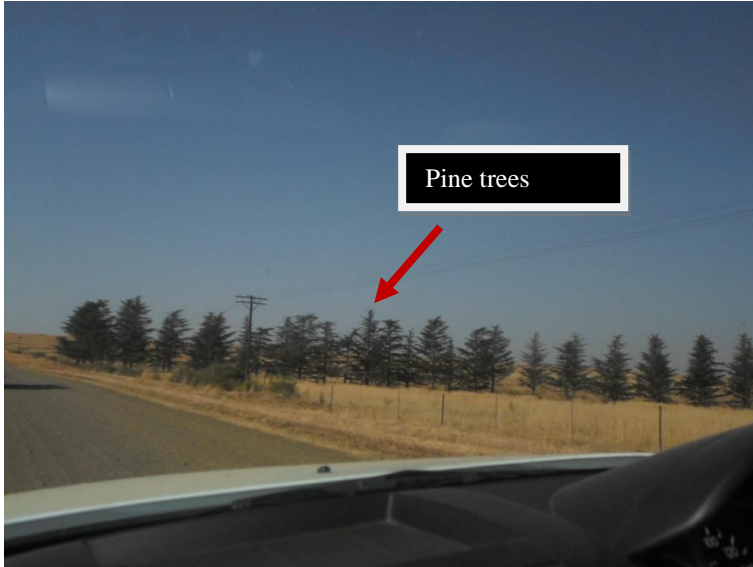
Brief description and conservation status (e.g. rare, etc., mention trees/bush/grass): There are some pine trees located along the route of the line in farms Holpan 475 and Charnwood (Erf 824) (See image 7). There are also more pine trees located next to the road where the line passes through the farm Tygerkloof (Erf415) between the gravel road and VKF141-246-28. There is some weeping willow trees located between the t-off and pole mounted transformer LMM3-9-4 (See image 8), these trees are also found between the main road and customer supply pole LMM3-5-23-1. There are bluegum and poplar trees that were observed next to the pole mounted transformer LMM3-12-2-1 that supplies to a house in the vicinity, between pole number BVS 68 and BVS 81 on farm Elizabeth 479 (See image 9), on farm Beersheba 13 portion 1 between pole BVS 66-41-14 and BVS 66-41-17, farm Middelbult (Erf476) and next to pole number BVS66-65-6

Potential impact (e.g. permit applications): The excessive removal of trees can result in an increase in soil erosion. The loss of habitat for nesting birds. The trees might encroach on safety clearance of conductors. The removal of poplar trees can cause soil around it to become toxic. The loss of shelter for small mammals can occur due to the removal of trees. The removal of trees can lead to birds nesting on the pole structures.

Image 7: Pine trees on farm Holpan 475

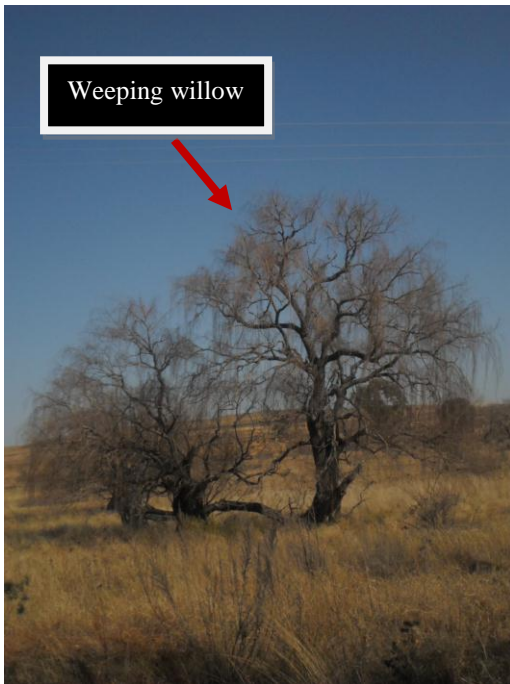
Image 8: Weeping willow at vlei

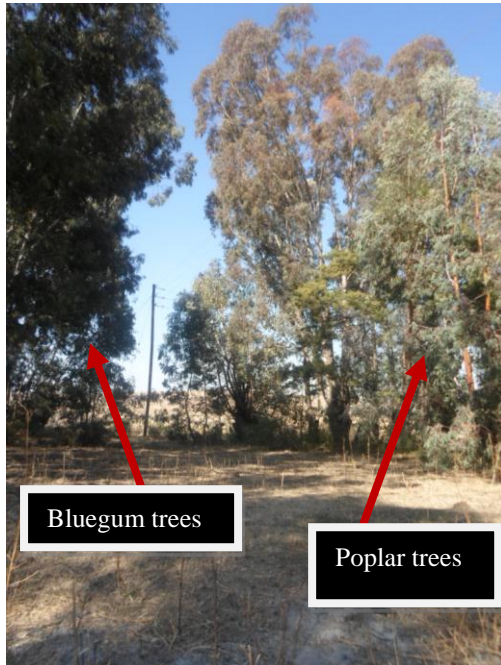
Image 9: Poplar - and Blue gumtrees

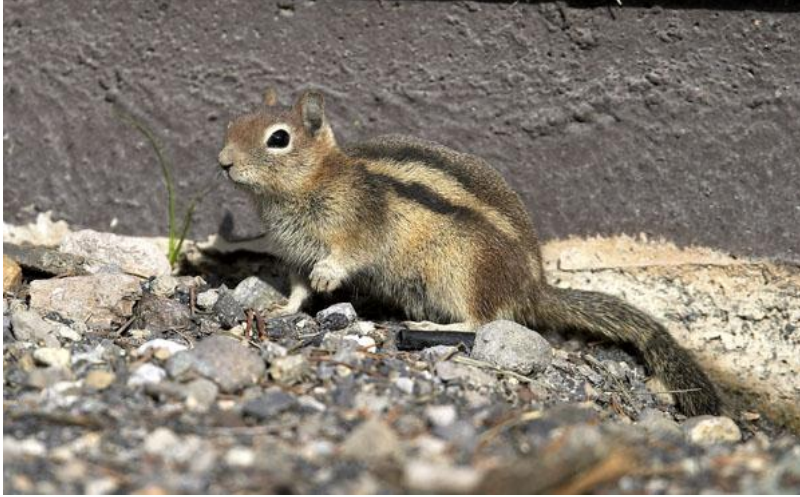
There are ground squirrels that were observed between LMM3-5-7 and LMM3-5-10 (See image 10). Most of the area that the proposed route passes through farms where there is grazing land and there are cattle that were observed in these areas. Sheep grazing on farms Monika 797, Herbstspruit 346. Bird nests were observed next to pole number LMM3-5-10. Kiewit birds were observed numerous times along the route of the line and more of these birds were observed between poles BVS66-85-2 and BVS66-8 (See image 11), farm Beersheba 13, where they are attracted by the stream crossing and vleis. Guinea fowls were observed along the route of the proposed line on farm Dorothea 819 (See image 12). The Eupodotis caffra (Natalse Korhaan) was observed in the grassland on farm Tygerkloof 415 portion 1 (See image 13). Lewerik birds and geelborskoesters were observed on farm Elizabeth 479 in the grasslands with red grass.

Image 10: Ground squirrel

Comments/mitigating measures: Landowners should be informed regarding the commencement of construction so that they can relocate their livestock from the construction sites. Bird flappers should be installed at wet areas i.e. streams, river crossings, vleis and marshlands. Vegetation clearance should be kept to a minimum at dense grasslands. The Guinea fowls and other birds should not be disturbed. Vehicular movement through the grasslands should be prevented as far as possible.

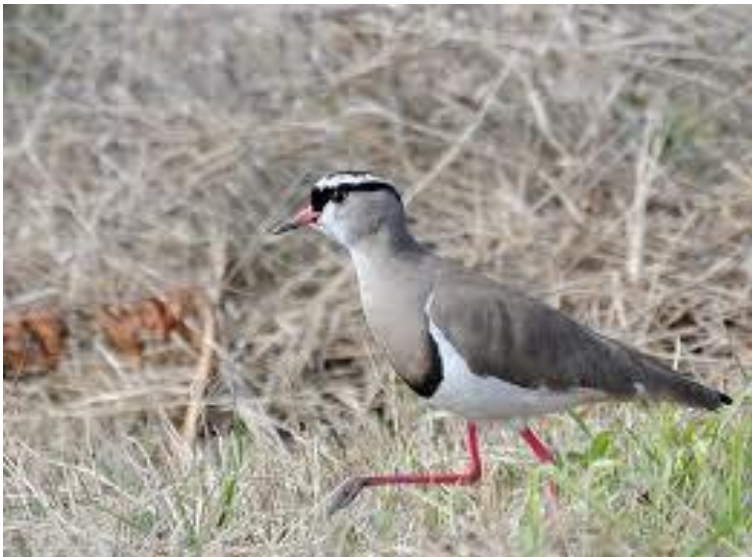
Image 11: Kiewit bird

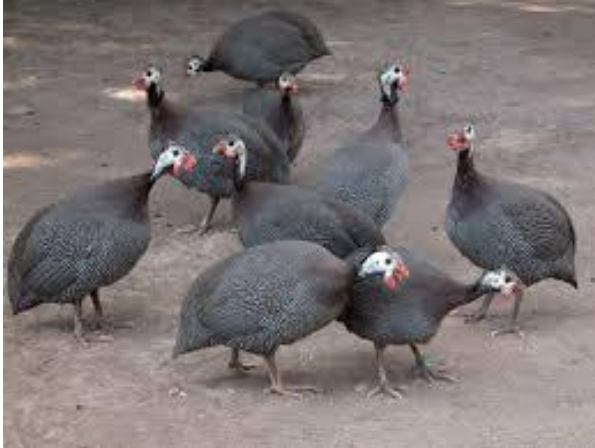
Image 12: Guinea fowls

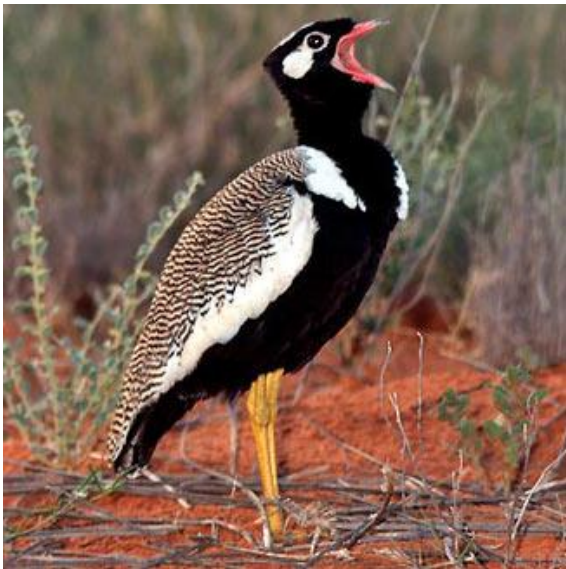
Image 13: Naltese Korhaan

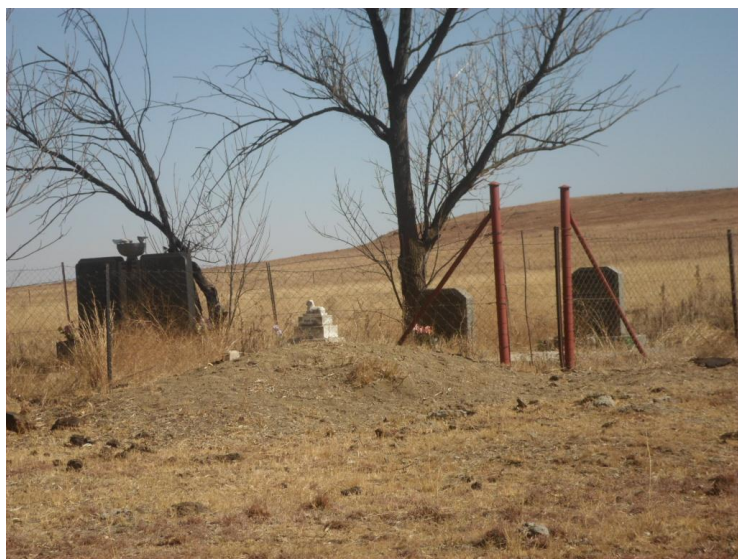
Graves observed on farm Tygerkloof 415 portion 1 and on farm Groenvallei 54 in a small graveyard close to the yellow container at the main road (See image 14). Another graveyard was observed on Tygerkloof 415 portion 3 at the side of the main road (See image 15). Stones that were packed in a circular formation (old cattle kraal) were observed in the veld of farm Groenvallei 54 where the line crosses (See image 16)

Image 14: Small graveyard

Notify SAHRA before any commencement on the project takes place. Do not proceed with any activities if a grave or any heritage feature is disturbed. Excavation or any construction activity must be at least 50meters away from the graves and as far as possible from the identified stone kraals.

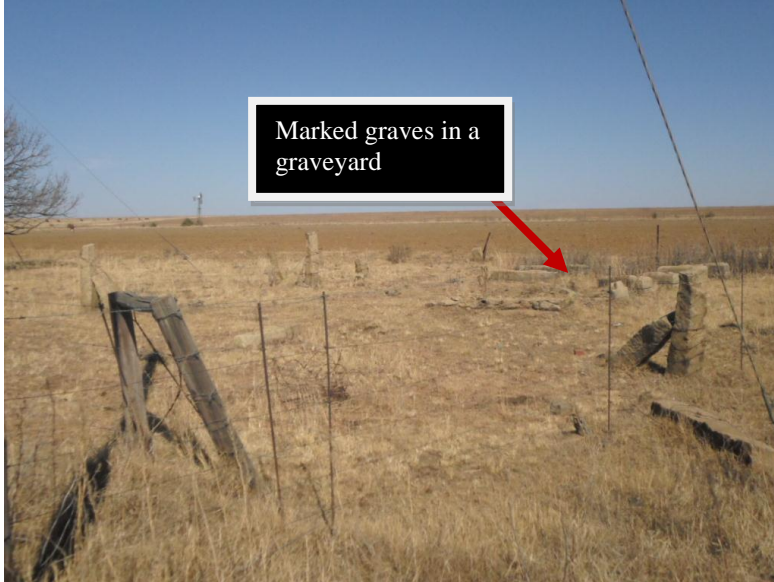
Image 15: Marked graves on border of farms Tygerkloof 415 and Herbstspruit 348

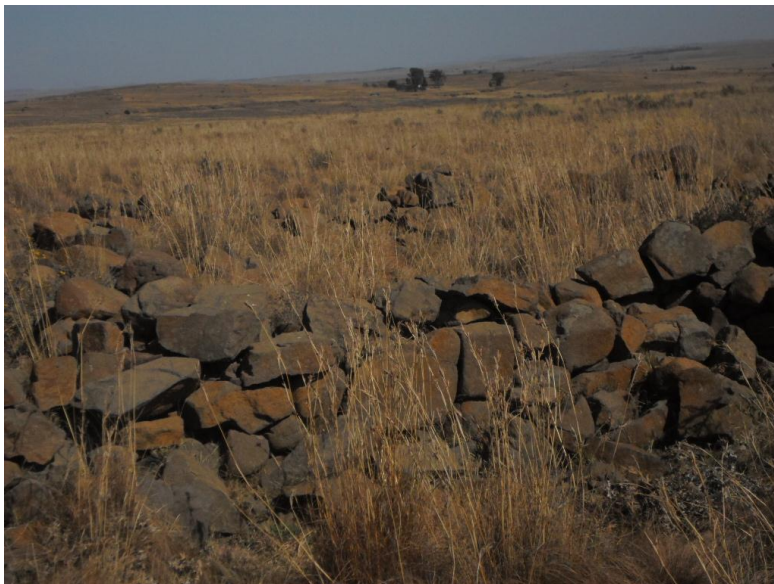
Image 16: Old stone cattle kraal on farm Groenvallei 54

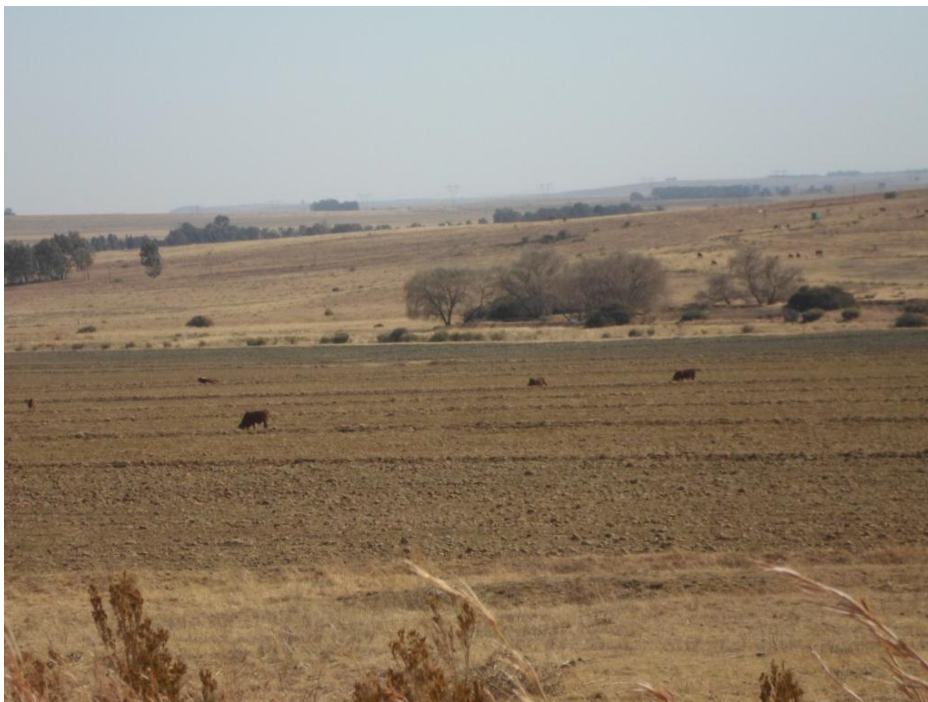
Brief description: There are maize fields present along the proposed route. There are land ploughed for future cultivation on farm Vlakspruit 423, Holpan 475, Bastiaan 478 (See image 17). Most areas along the proposed route are being used for grazing land for livestock

Image 17: Land ploughed for future cultivation
