Report on the floristic and ecological assessment of the proposed borrow pit on the farm Sydenham 445, Bloemfontein District.

December 2012

South African National Roads Agency Ltd (SANRAL)

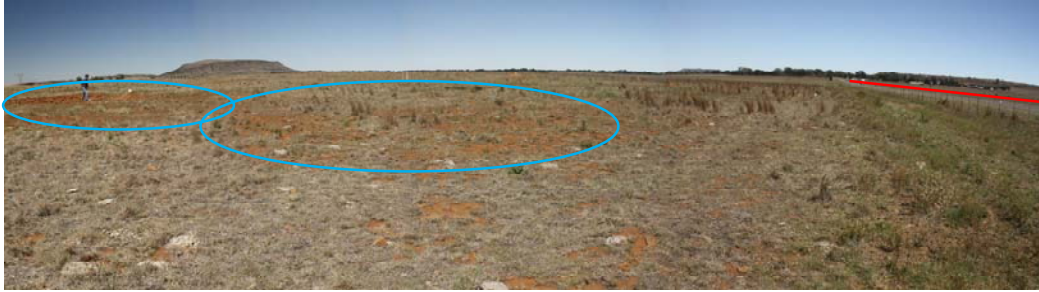
Figure 1: Panorama of the site as seen from the east toward the west. The adjacent public tarred road is indicated (Red line). Note the bare soil caused by overgrazing (Blue circles).

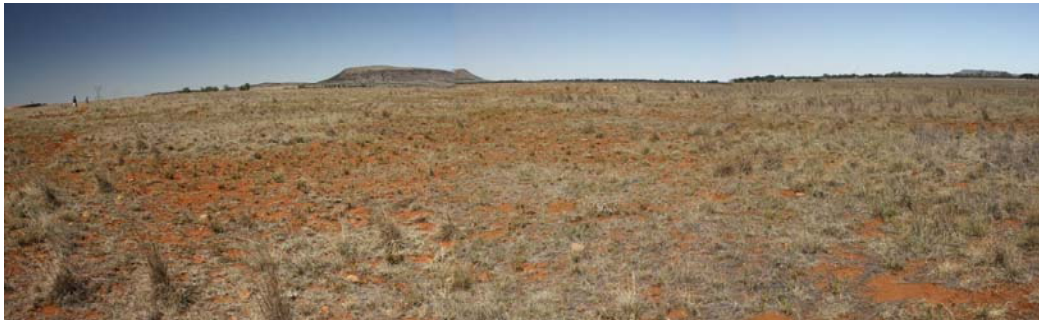
Figure 2: Panorama of the site as seen from the north of the site towards the south west. Leeuberg Hill is visible in the background. Note the large amount of bare areas where overgrazing has destroyed the grass layer.

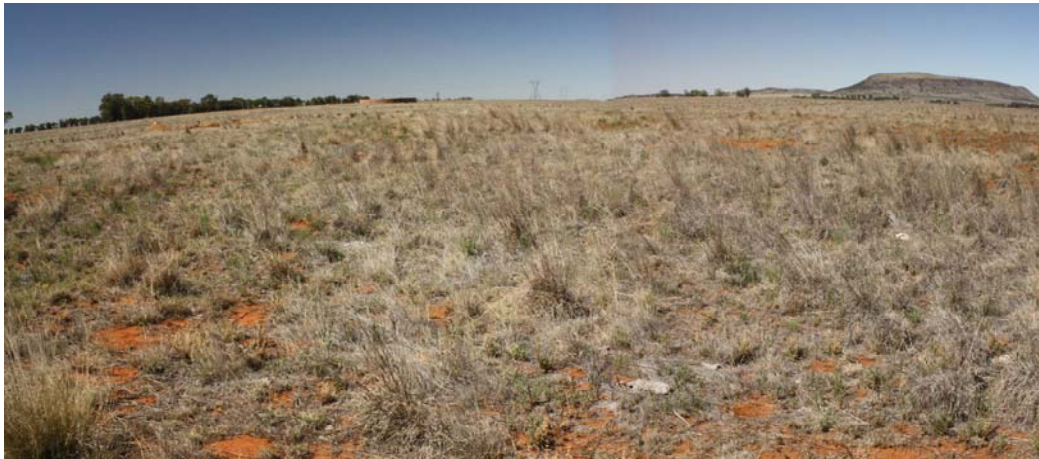
Figure 3: Panorama of the site as seen from the west toward the east. Percentage grass cover is higher in this area, but bare areas are still evident.

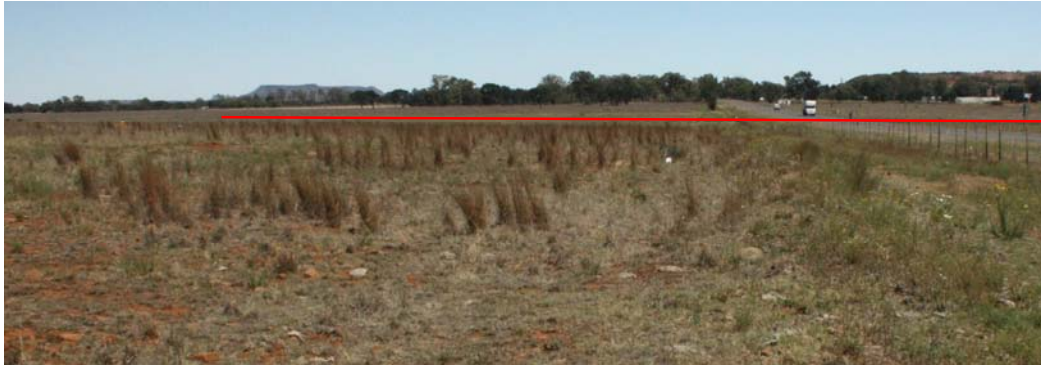
A wetland with a small associated annual stream is located approximately 300m west of the proposed borrow pit. This wetland and seasonal stream has its origins in the high density residential settlements to the north east of the site. As a result this wetland as well as the annual stream is severely degraded. The runoff from this high density residential area is highly polluted. The amount of runoff is also increased due to the lack of vegetation cover and tarred roads. Other factors that impact on the wetland include intensive and sustained grazing pressures by domestic stock, illegal dumping and littering near the wetland and the damming of the annual stream by dirt walled dams. Consequently this wetland and seasonal stream is severely degraded and transformed. However, the wetland and seasonal stream system remains sensitive environments with regard to water transporting and –regulating processes.

Figure 4: The wetland and seasonal stream to the west of the site as viewed from the site (Red line). This wetland is located approximately 300m from the site and it is not anticipated that the development would have any significant impacts on this system.

wetland. Alternatively stormwater may also be directed around the borrow pit. This will also prevent sediment runoff from entering the wetland.

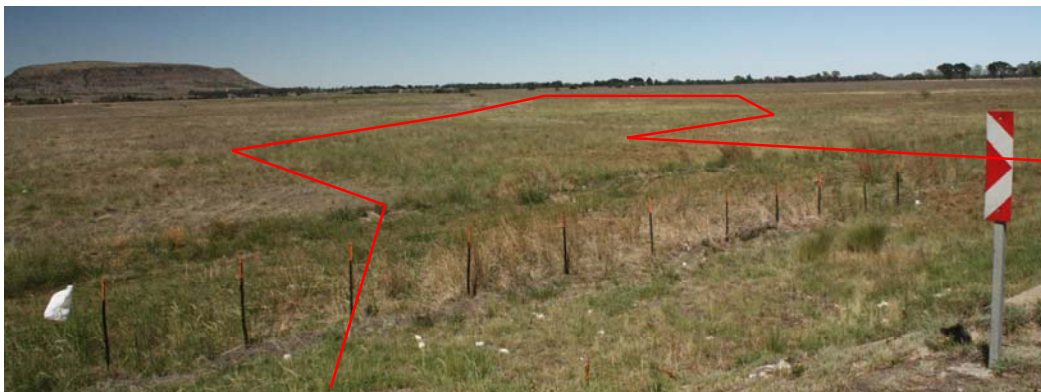
Figure 5: Close-up view of the wetland. The area has not received rain yet and consequently the wetland is dry and not clearly visible. The wetland is visible as the light green areas (Red figure).

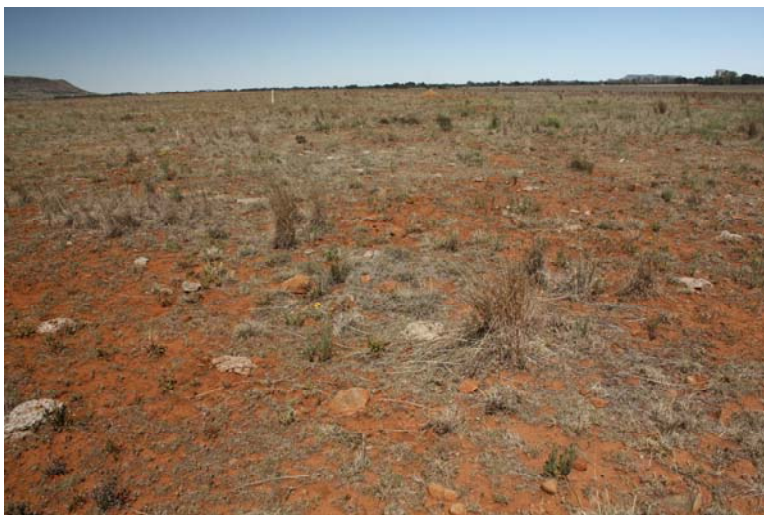
Percentage ground cover is low. This is due to heavy and sustained overgrazing. As a result the site contains large bare patches where limited vegetation occurs and is dominated by weeds and pioneer species.

Figure 6: View of the site. Note the large bare areas where the grass layer has been destroyed by overgrazing.

- Topsoil should be removed and stockpiled. The topsoil stockpile should be kept free of weeds and erosion.
- Topsoil should be replaced in bare areas after cessation of excavation activities.

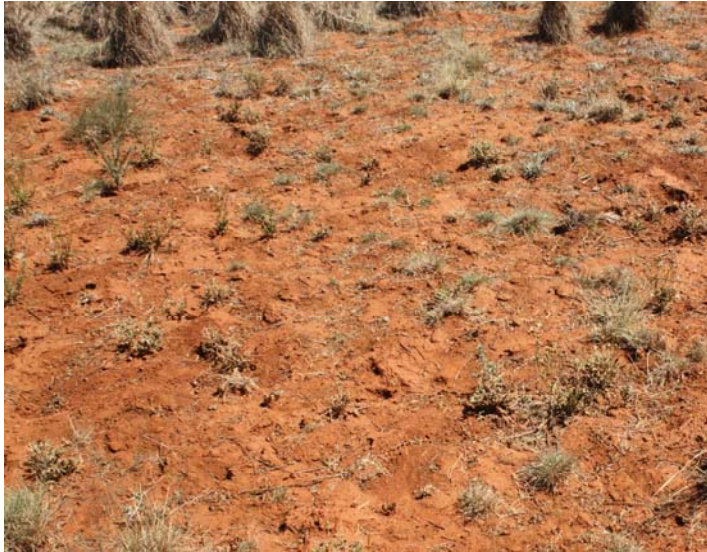
Due to the heavy overgrazing the area has been degraded and bare patches are common on the site. These bare areas in conjunction with the slight slope of the site lead to sheet erosion of the site. Erosion is therefore considered to be moderate.

Figure 7: Close-up view of the soil surface on the site. Note the absence of vegetation, this is caused by overgrazing.

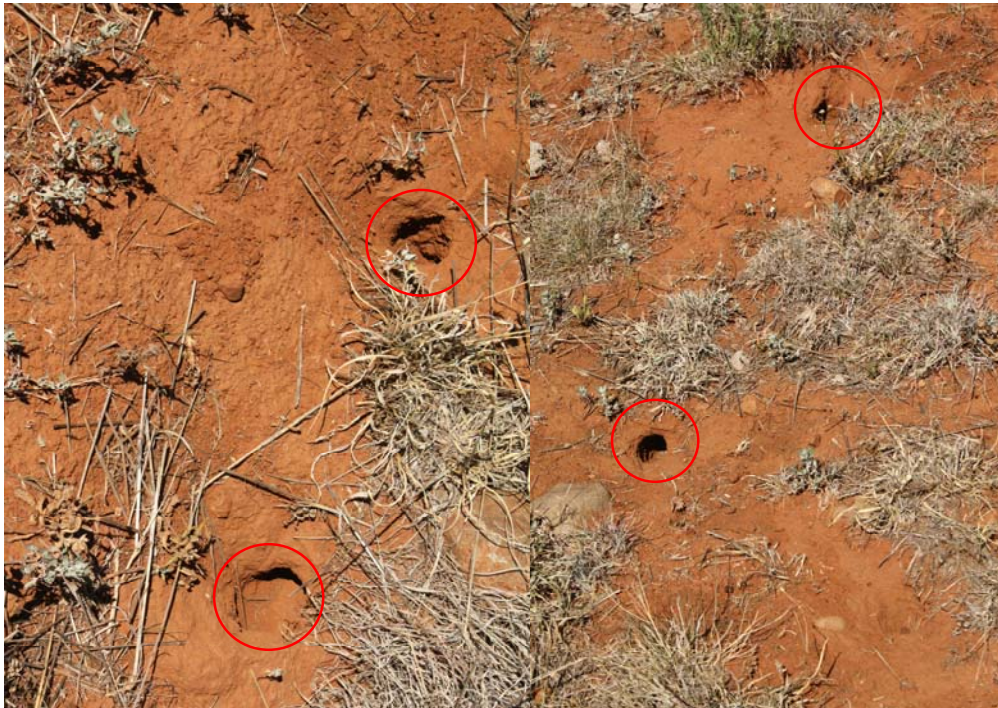
The site is riddled with the burrows of rodents. These burrows are most likely those of the Multimammate Mouse (*Mastomys coucha*) and the Striped Mouse (*Rhabdomys pumilio*). According to Avenant (2000) where extensive disturbance of grassland occur these species dominate. It has also been shown that these rodent species can be used as indicators of grassland degradation (Avenant & Cavallini 2007, MacFadyen *et al.* 2012).

The dominance of these rodents on the site substantiates the degraded condition of the vegetation. The species are not of concern to the proposed development.

Figure 8: Photographs illustrating some of the rodent burrows on the site (Red circles). The site is riddled with these burrows, it is considered to be an indicator of disturbance.
