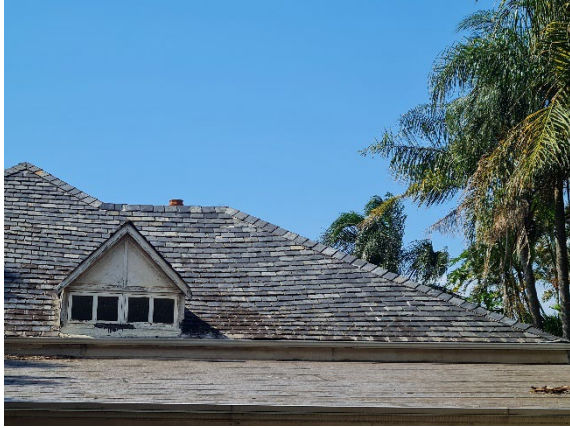
DAMAGED ROOF
