WIRELINE WORKSHOP

ATV STRUCTURE LOG

WELL ID: **ZND05**

COMPANY: NORTHAM PLATINUM LIMITED

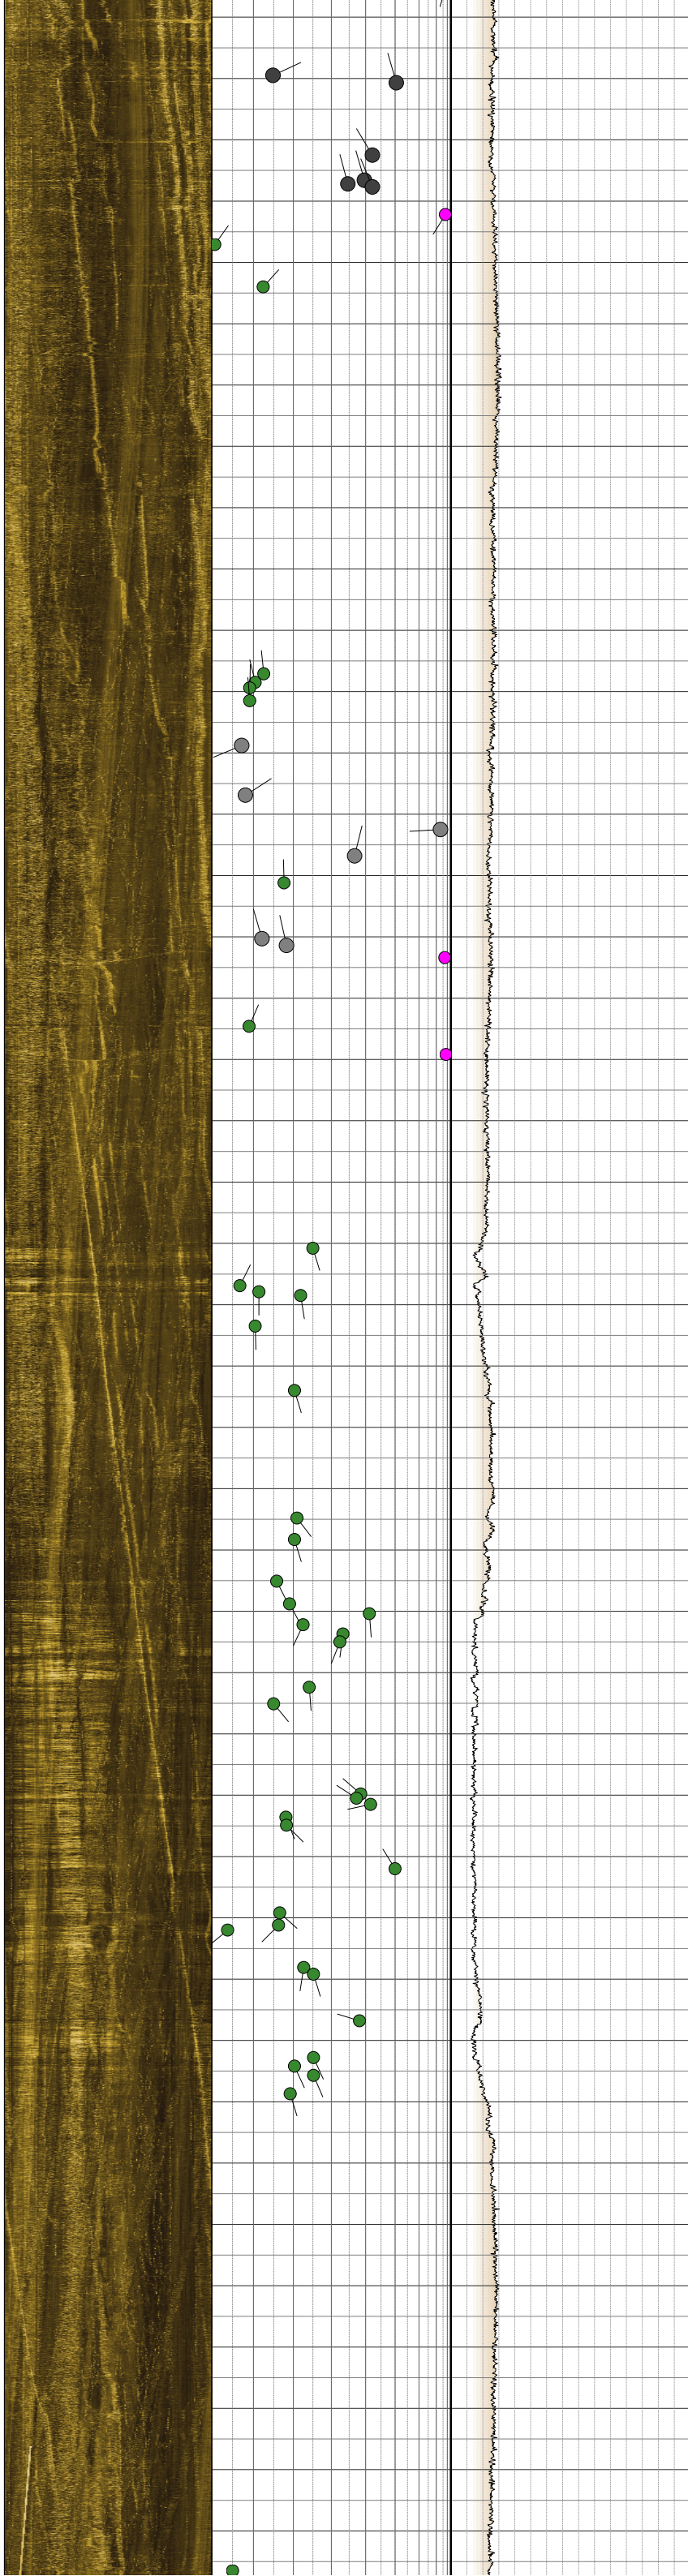
Layering visible on OTV image (not on ATV).

OTV image smeared by grease on borehole wall.

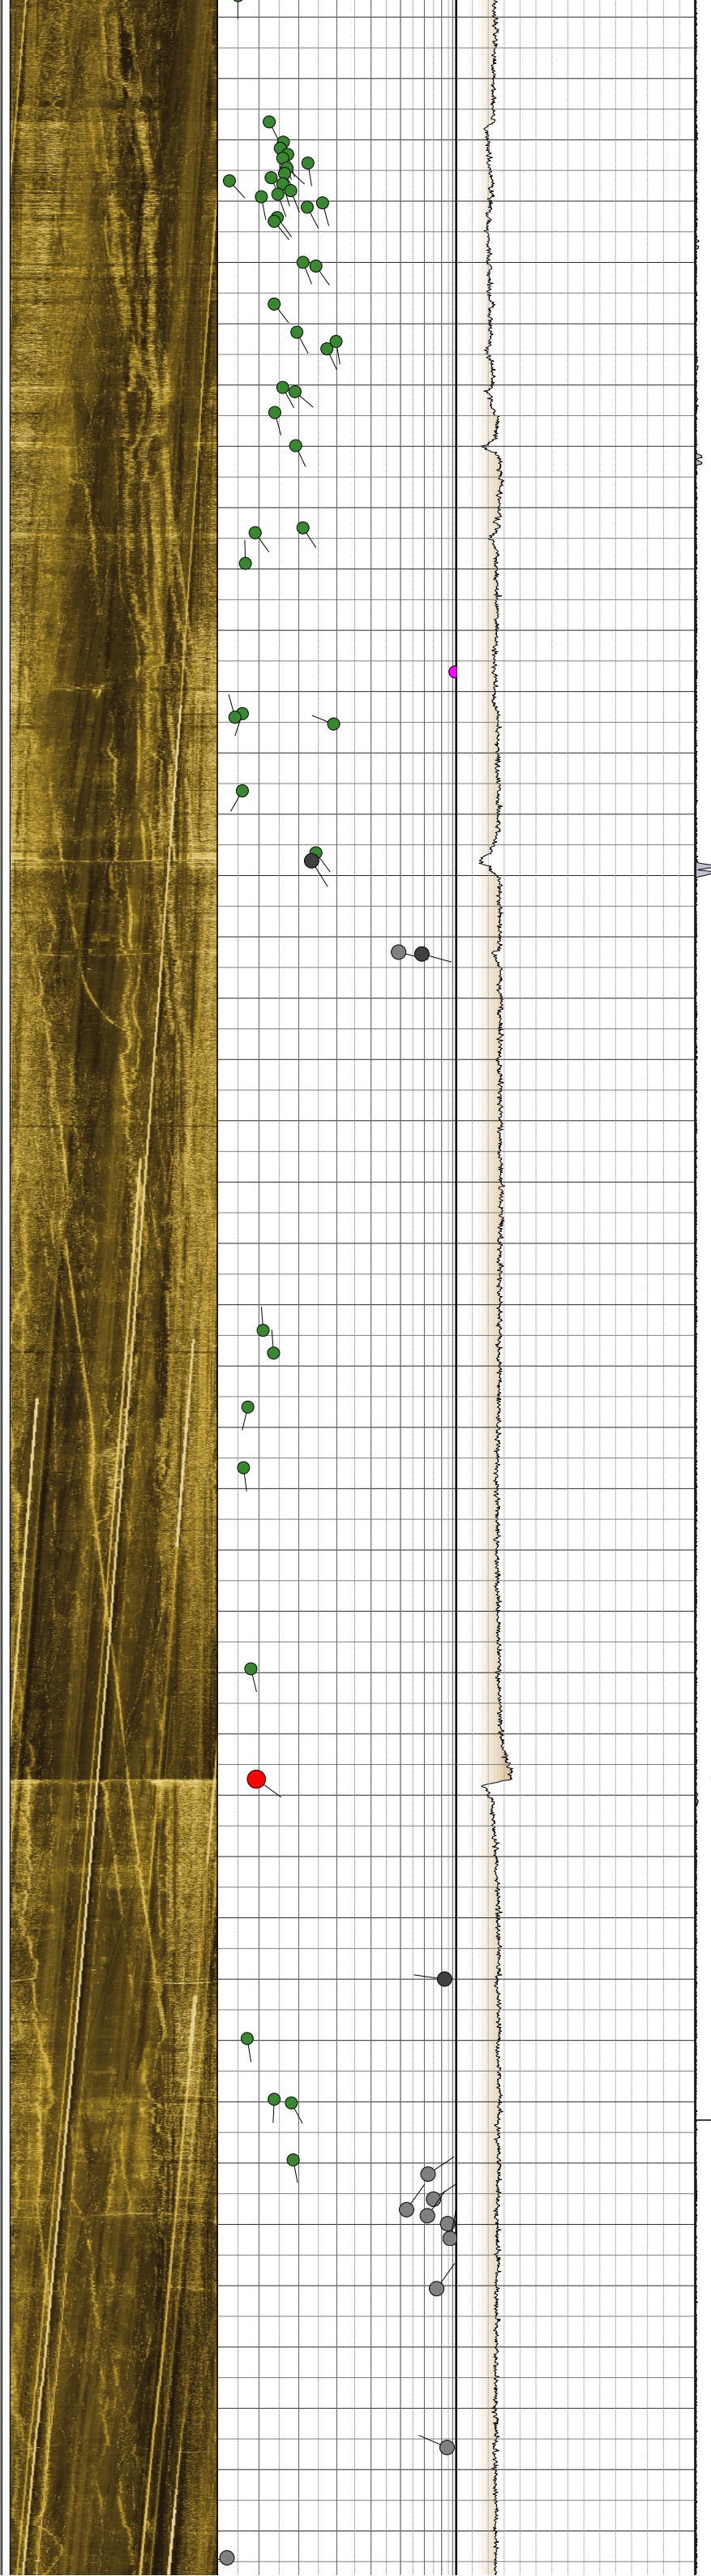
Water entering borehole column.

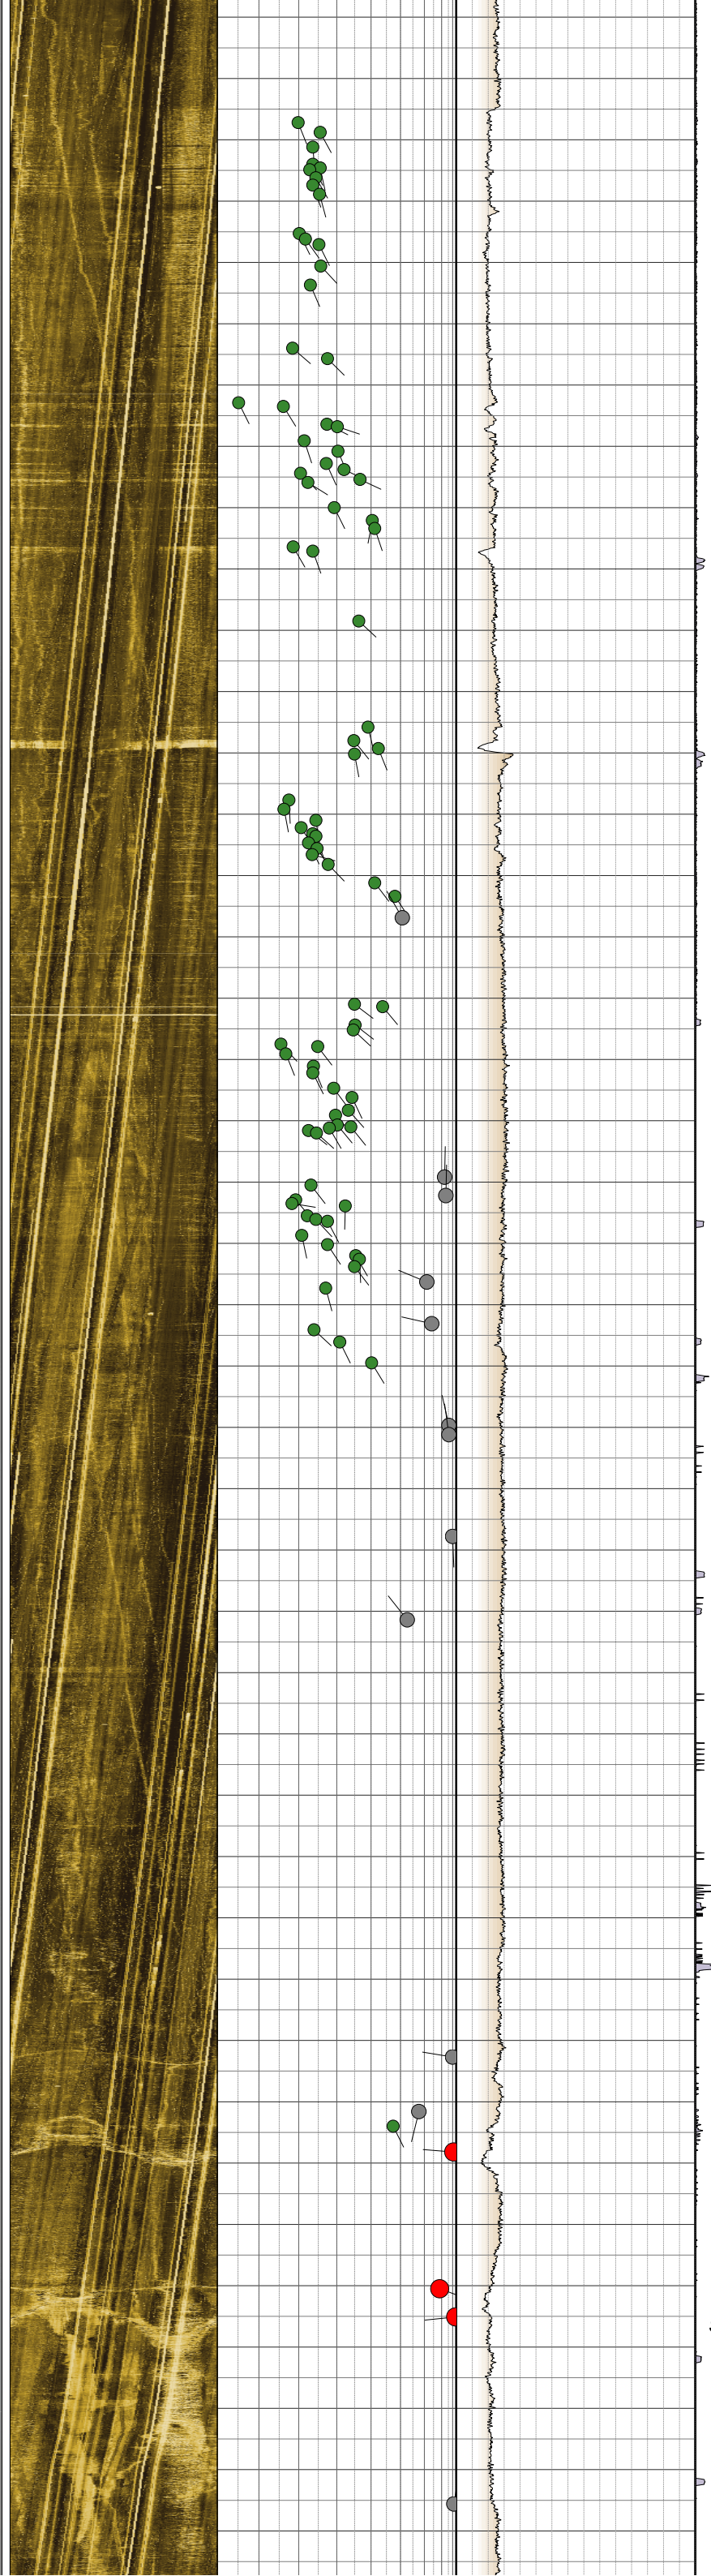
Steeply dipping open fracture.

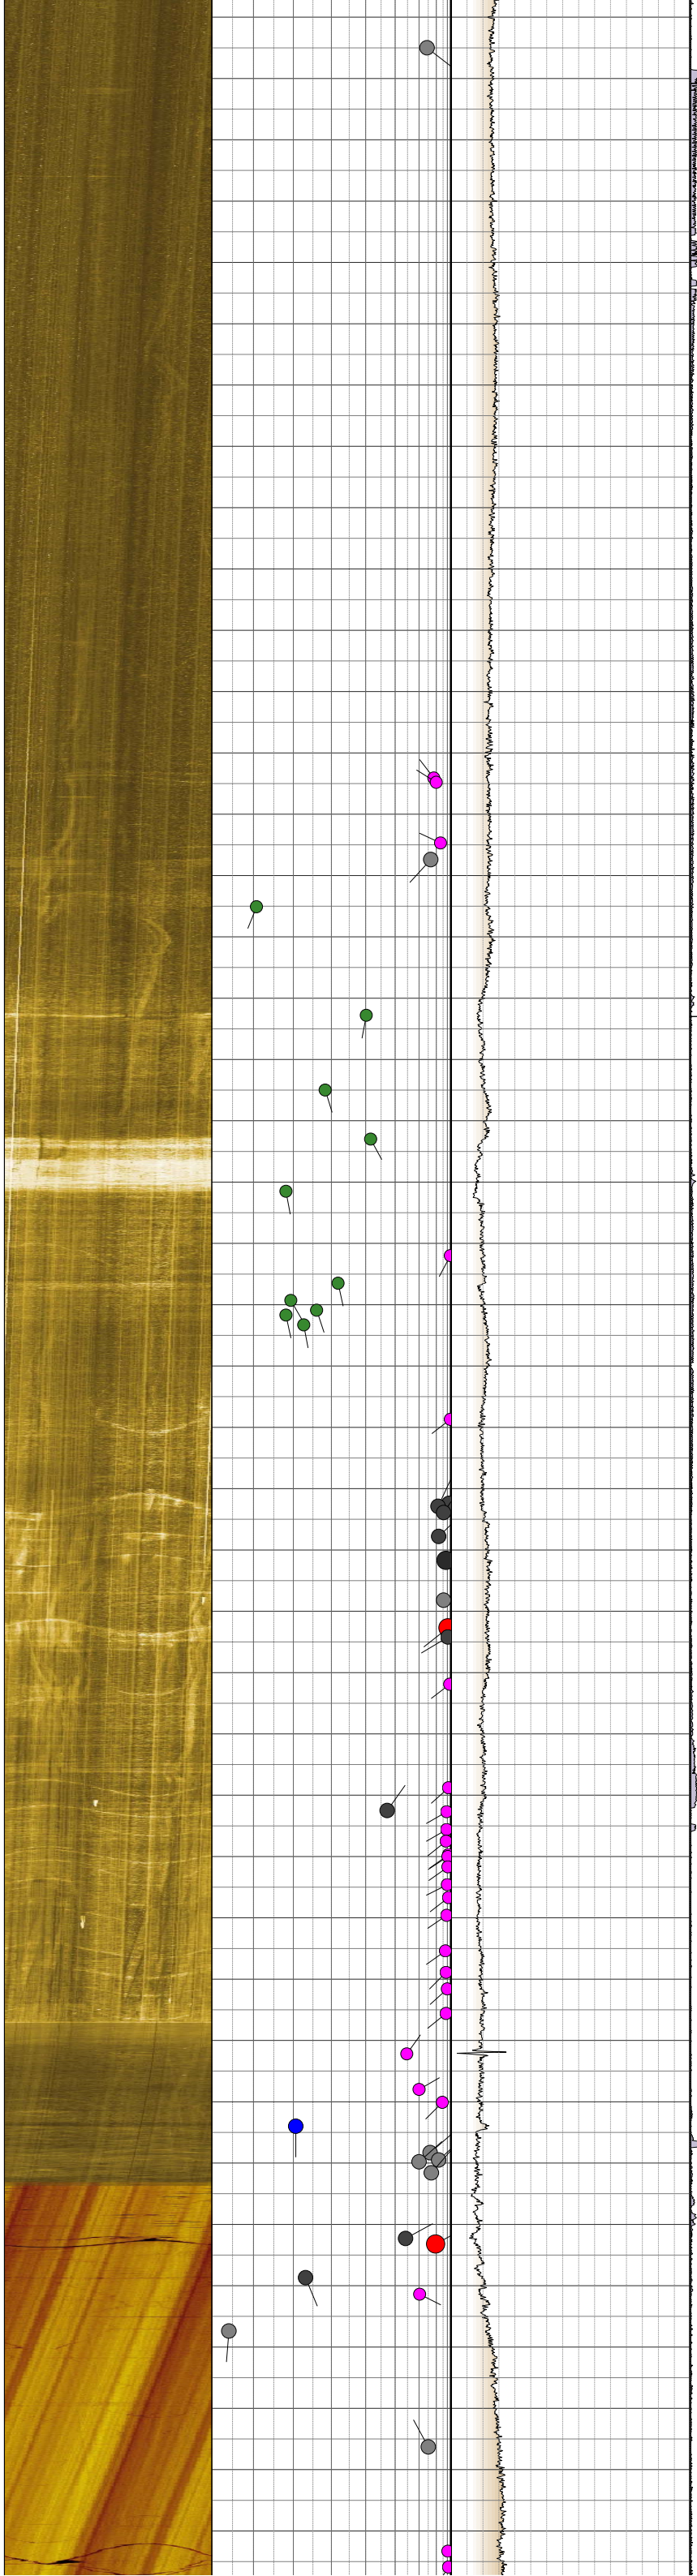
*Fluid level.
Image in clean water (introduced) is of better
quality.*

ATV below, OTV above.

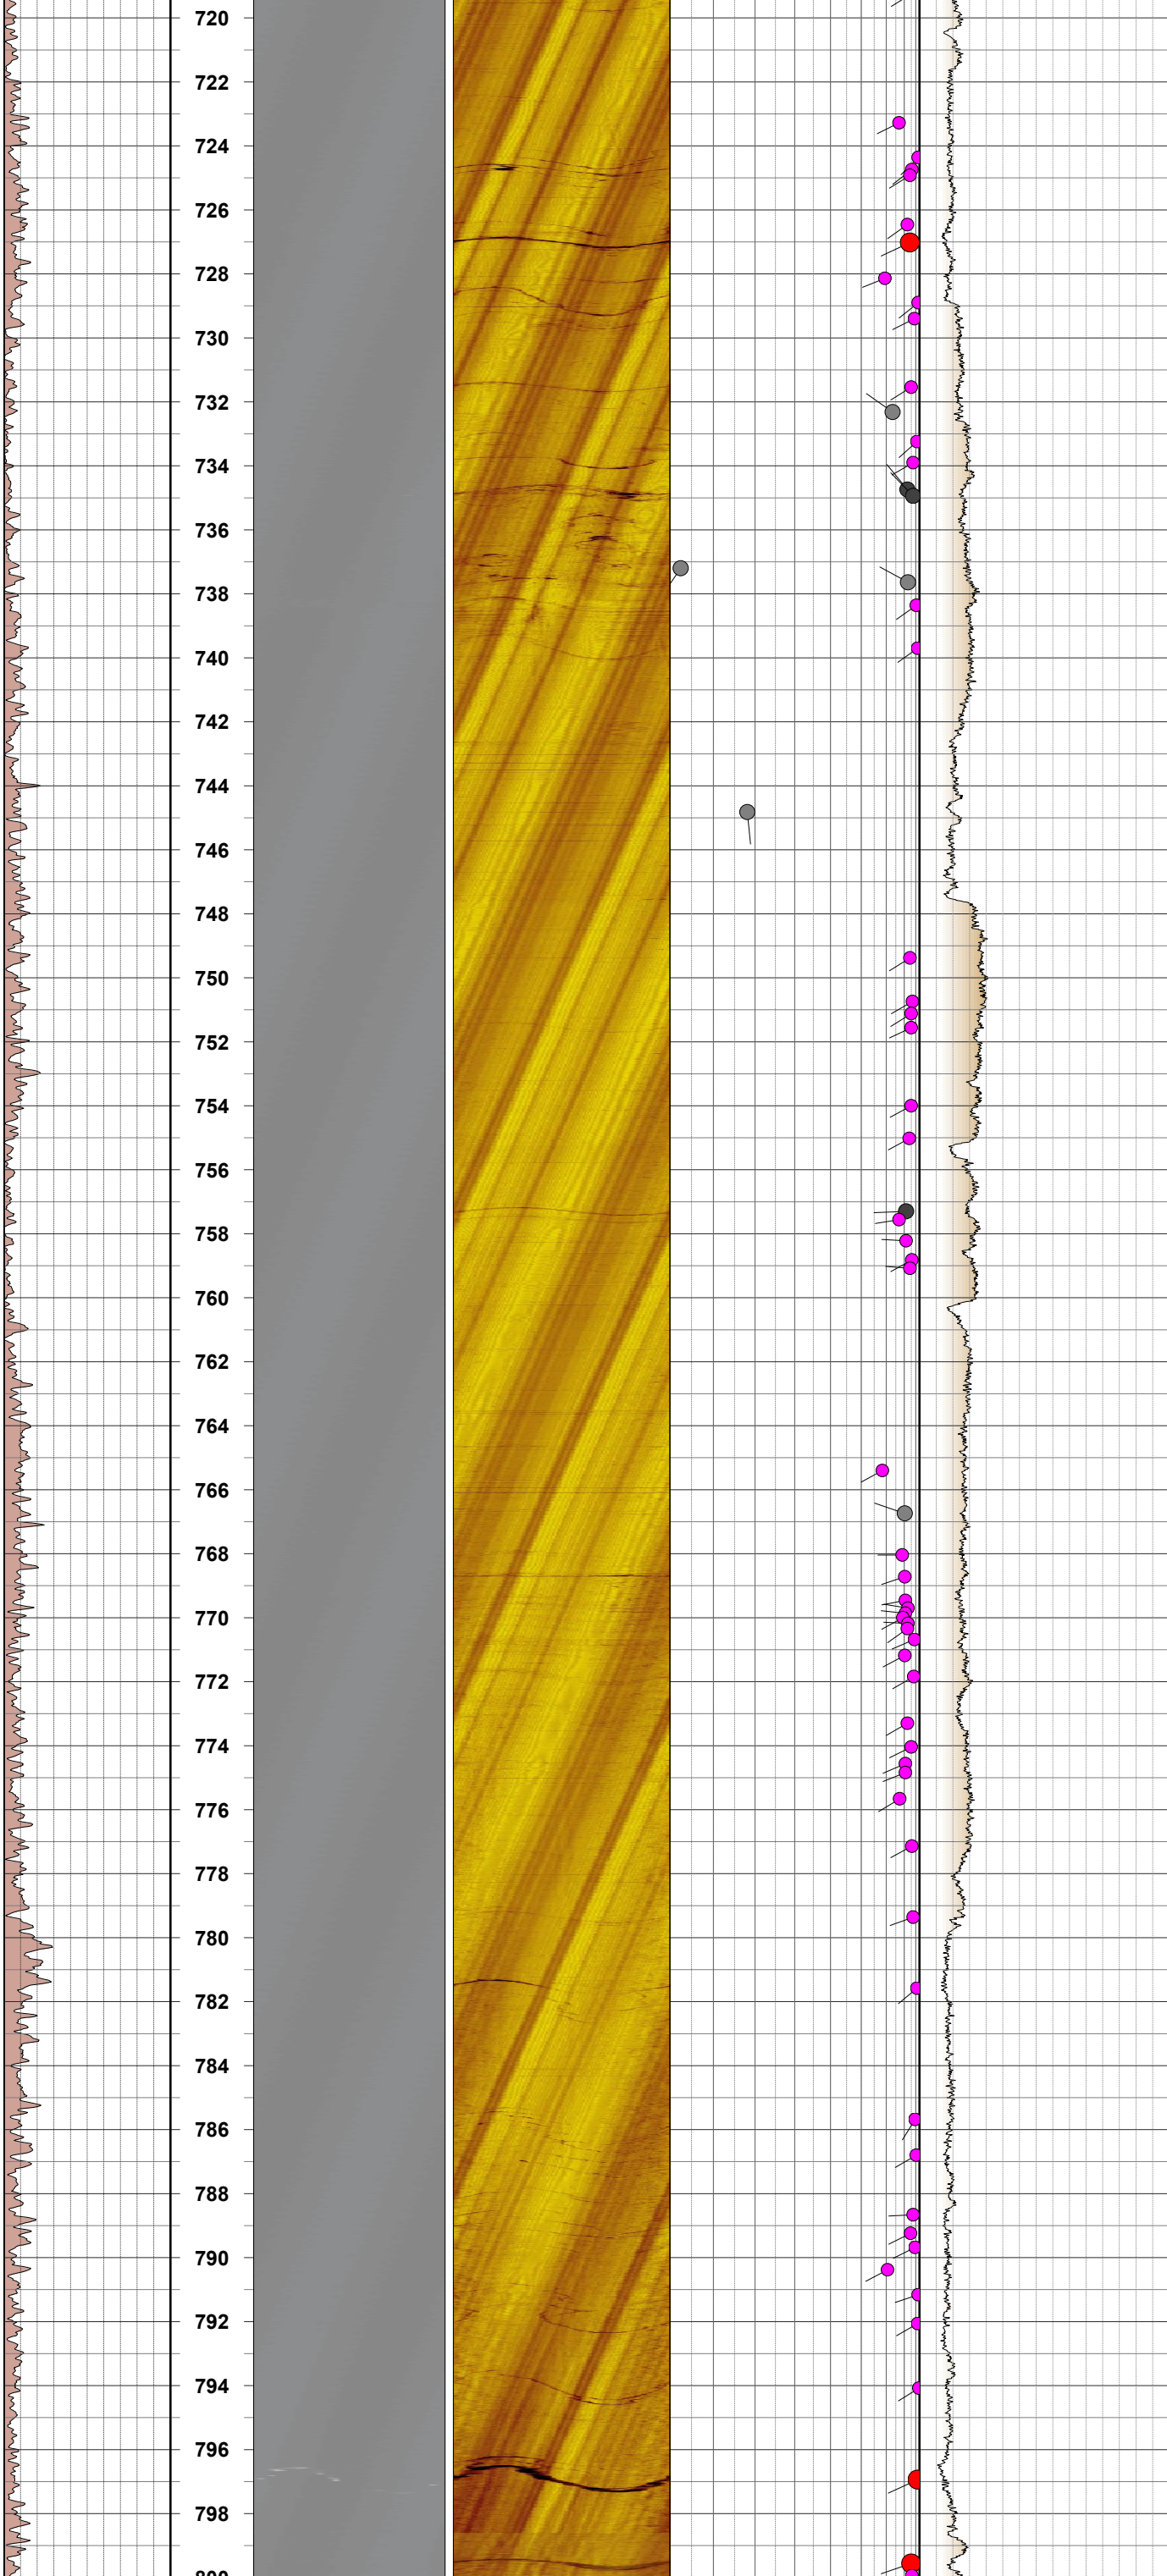
Major open fracture, aligned with current stress tensor.

Steeply dipping open fracture.

Major geotechnical event.
