Distribution environmental screening document (DESD)
Reticulation Powerlines and Ancillary Services

Project name/Survey **PETRUSBURG STEUNMEKAAR 22KV LINE REFURBISHMENT-MAIN LINE AND T-OFF'S**.....

Project number BP2008164574944..... File number

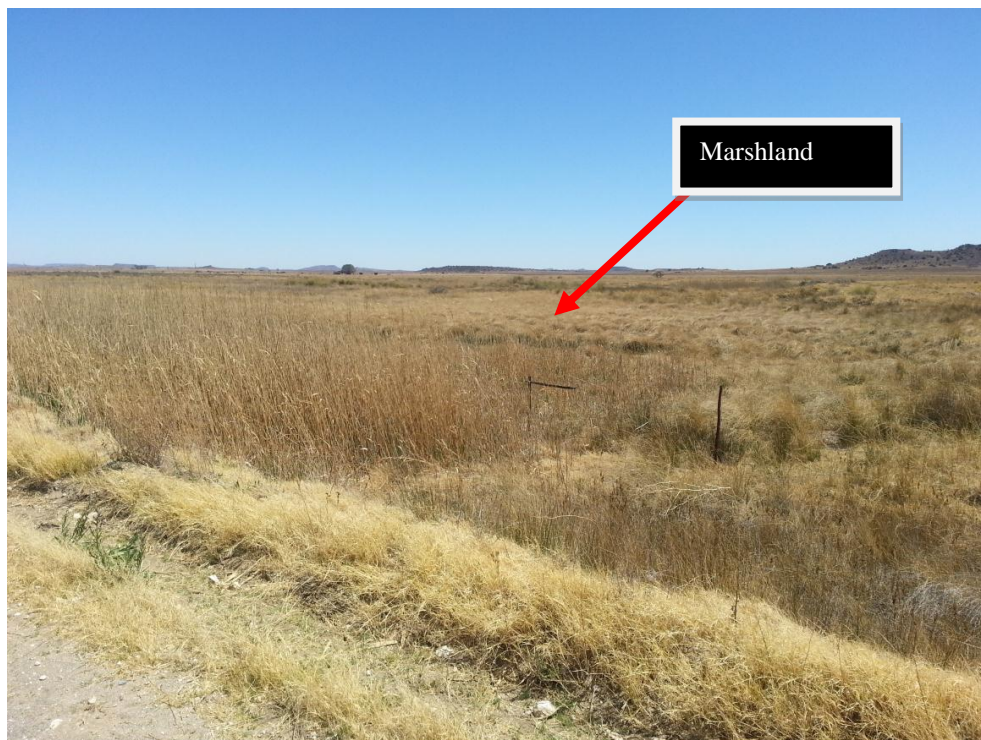
Present condition: There is a **marsh** with water and aquatic grasses, rushes, reeds and low-growing shrubs in it present where the line is crossing farm Brakput 886 (See image 1). **Dry pans** were observed on farms Biesiebult 372, Populierdam 1123, Bathseba 1183, Welkom 360, King Heath 154, Reddersfontein 410, Avenbury 734, Legkraal 65 (See image 2). A **water reservoir** is present on farm Geluk (See image 3). **Farm dams** were also observed along the route of the proposed line on farms Mooivlakte 571, Geluk (See image 4).

Potential impact (e.g. threat of pollution): Water contamination might occur from oil leaking vehicles and equipment during site preparation and construction activities. Contravention of the National water act 36 of 1998 section 21 on water uses if the banks or beds of the waterbodies are altered.

Image 1: Marsh on farm Brakput 886

Comments/ mitigation measures: Do not plant poles in the marsh. Use higher structures in order to build long spans over the pans and marshland. Plant poles at least 100m away from the waterbodies. Do not damage or pollute water in farm dams and reservoirs. Refrain from driving through pans and marshland.

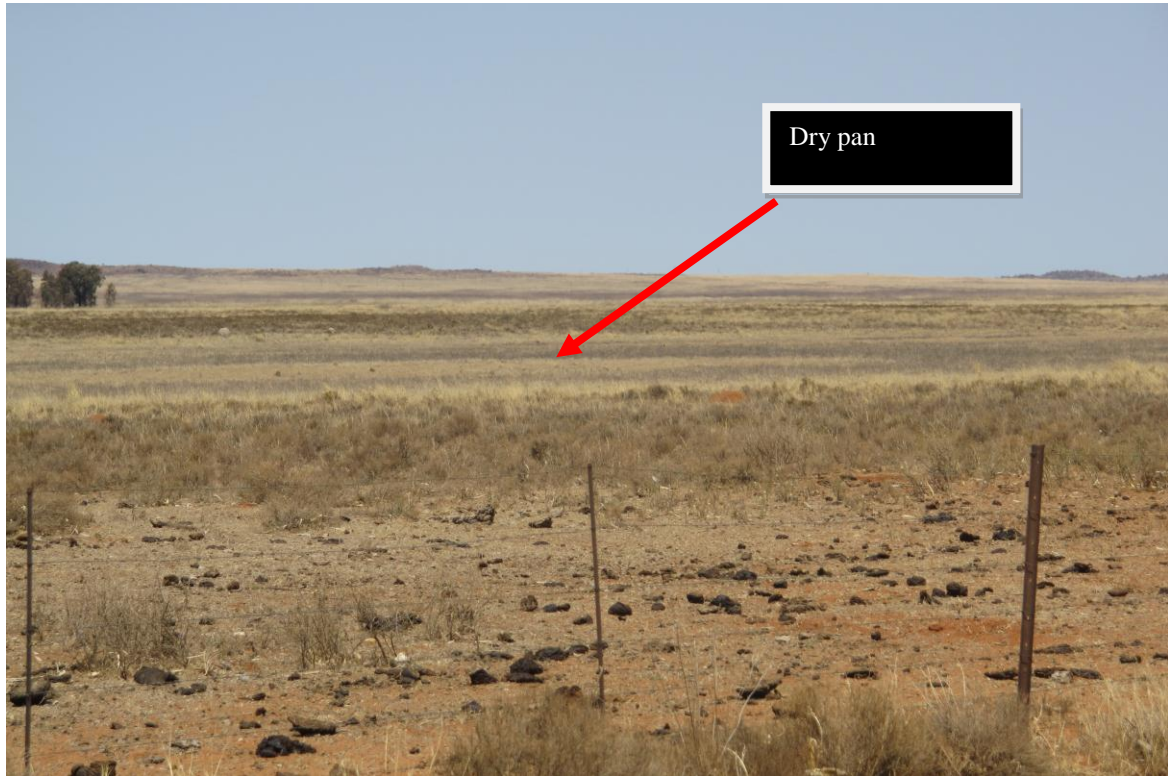
Image 2: Dry pan on farm Legkraal 65

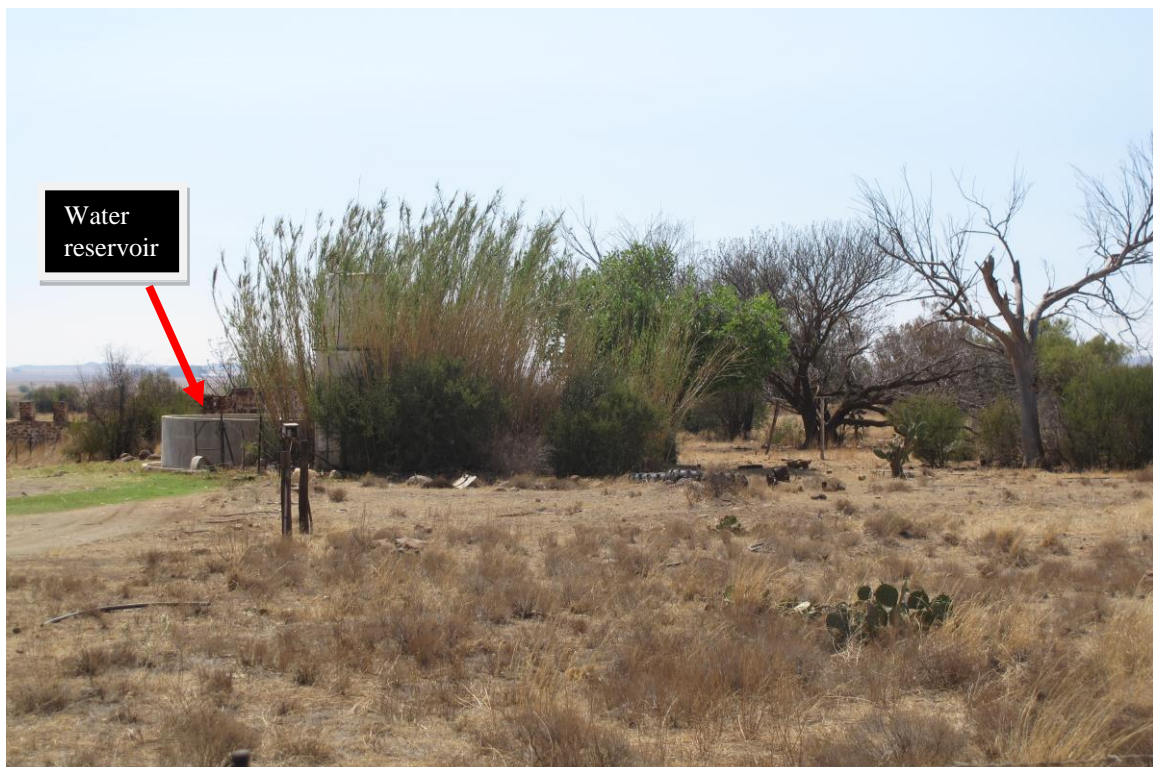
Image 3: Water reservoir on farm Geluk

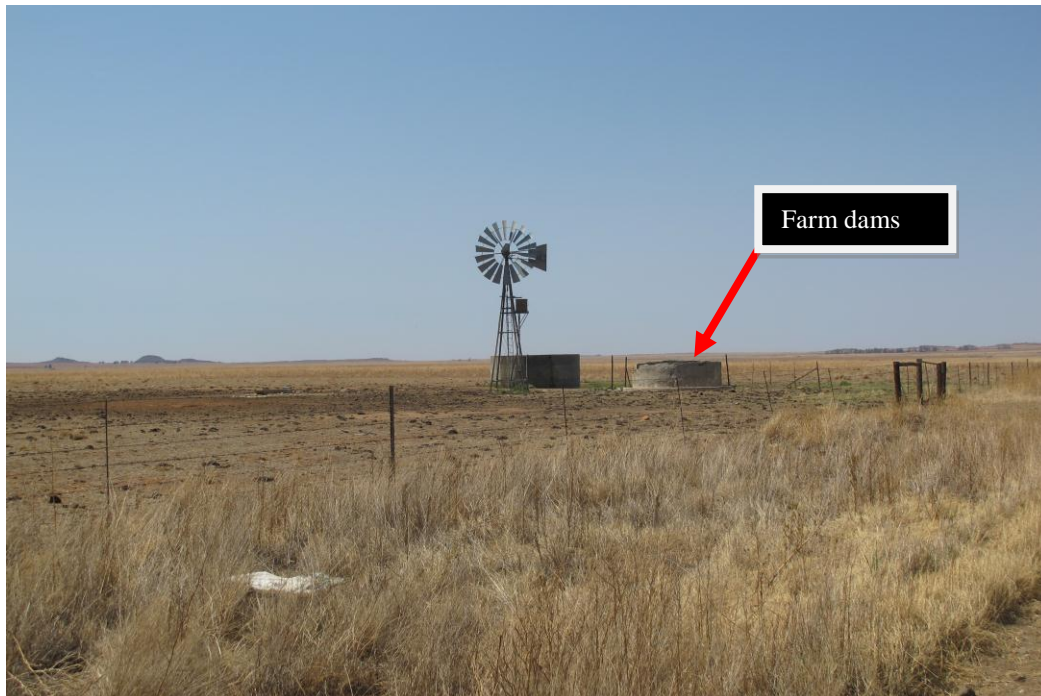
Image 4: Farm dam on farm Mooivlakte 571

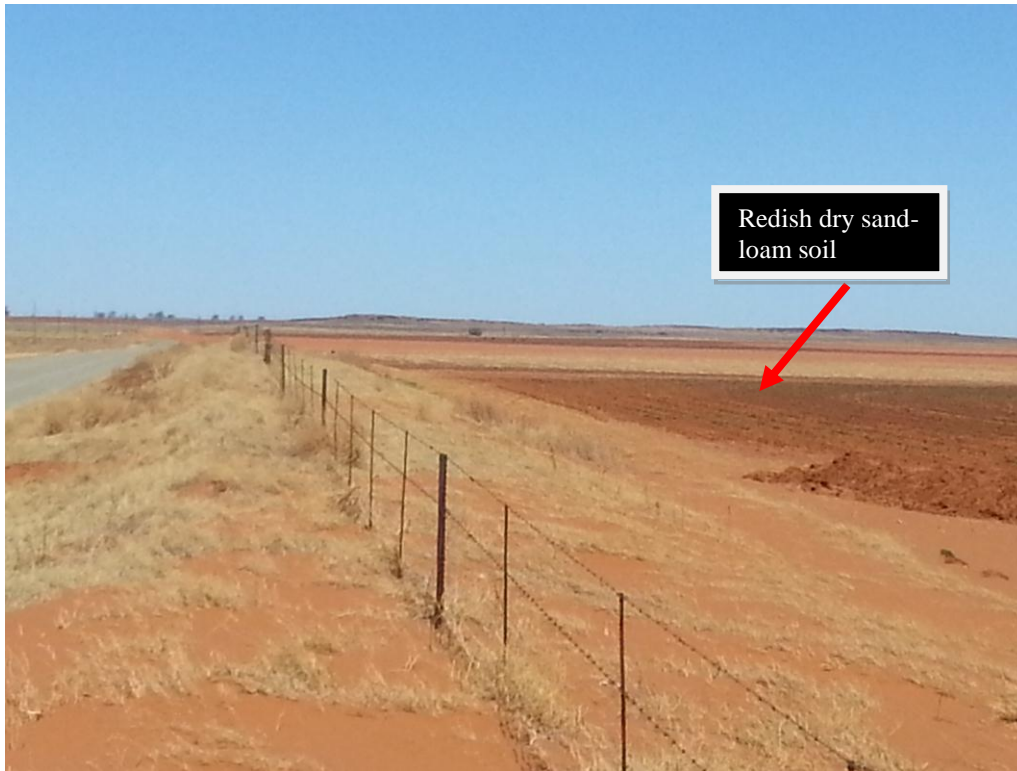
Present condition: Sandstone, shale and siltstone covered with **light to dark red loam sandy soil**. Soil is mainly dry, but wetter at irrigation points which result in it to be clayish (See image 5)

Potential impact (e.g. of erosion): The area can suffer loss of topsoil through soil erosion by wind, water or other causes of erosion. Land pollution can impair on the fertility and composition of soil. The sandiness of soil might cause poles to be unstable frequently which can make maintenance to be costly for Eskom. Vehicular movement and excessive activity on the soil can also accelerate soil erosion.

Image 5: Sand-loam soil at irrigation point on farm Eben Haezer 1040

Comments/ mitigation measures: Drive vehicles at a moderate speed in the area. Refrain from commencing construction activities on highly sandy plains and sand dunes. Do not drive vehicles and trucks through cultivation land in order to minimize loss of top soil. Extract soil in layers when excavating, in order to deposit the soil back into its original layers to keep maximum top soil. Do not litter anywhere.

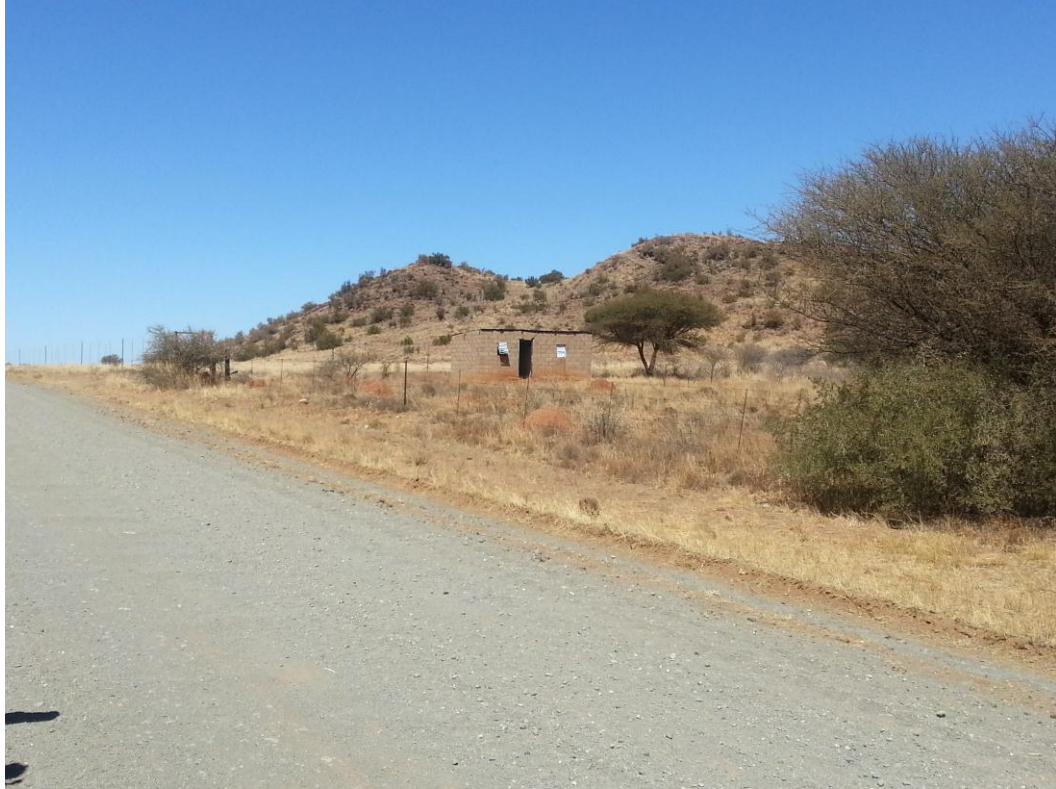
Present condition: There are hills present on farms Boesman’s put152 (See image 6) and Spitzkop 398. A quarry also occurs along the route of the proposed line on farm Boesmans put 152 (See image 7). An erosion gully is present on the route of the proposed line on farms Rustplaats 240, Vrede 1052, Leeuwberg 465 and Mooivlakte 571 (See image 8)

Potential impact (e.g. of erosion): The presence of hills can accelerate soil erosion. The quarry might erode deeper if vehicular movement or construction takes place inside of it. Erosion gullies might broaden if poles are planted in close range or inside its edges. Eskom structures might be unstable or standing skew as erosion at the gullies proceeds in the direction of the poles.

Image 6: Hills on farm Boesmans put 152

Comments/mitigating measures: Refrain from commencing with activities or driving vehicles in the quarry. Do not plant poles in close proximity of the erosion gullies. Use long spans with higher structures when crossing the eroded areas with poles far from the edges. Build the proposed line on the other side of the road where erosion gullies cannot be avoided.

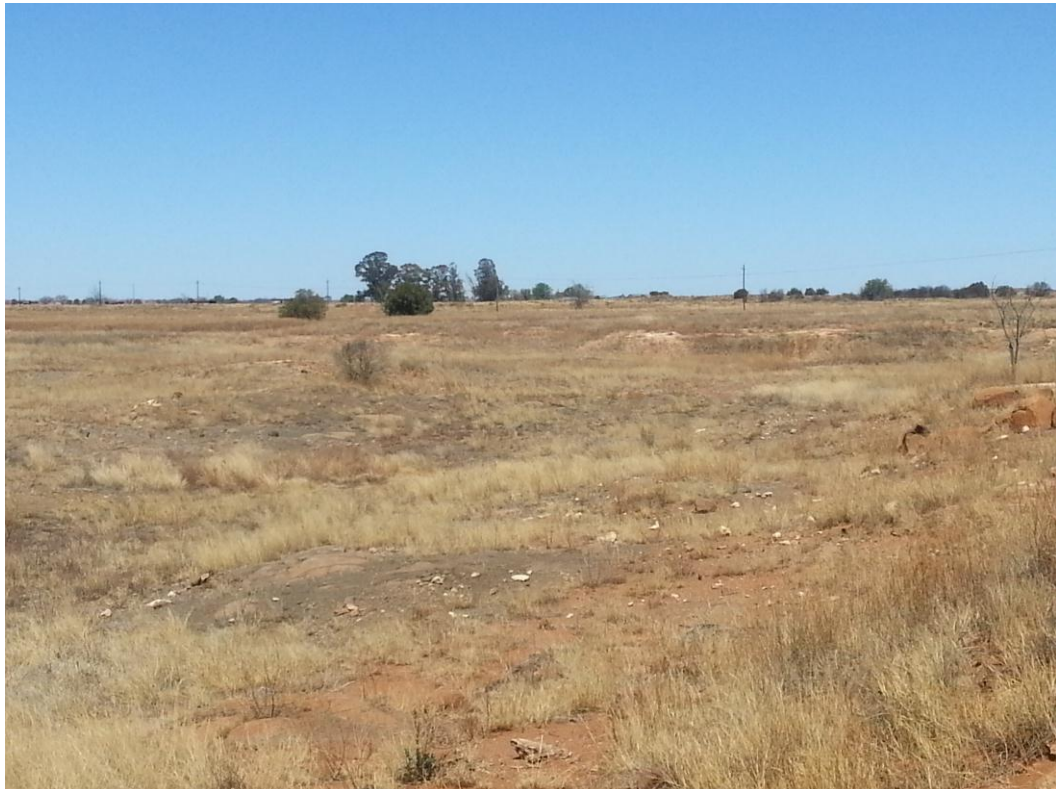
Image 7: Deep quarry on farm Boesmans put 152

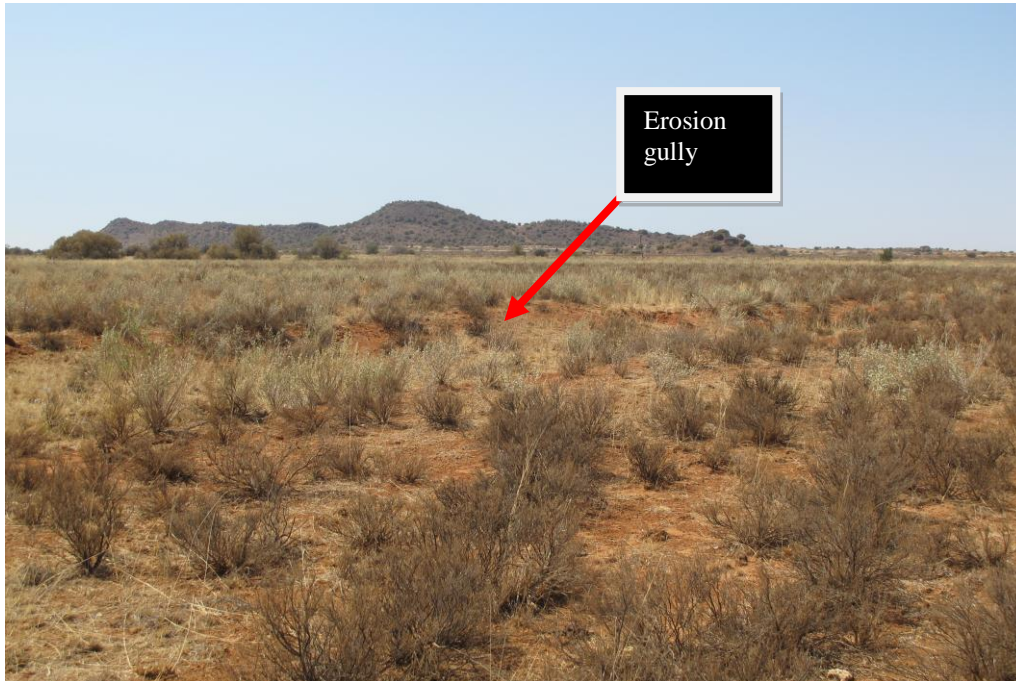
Image 8: Erosion gully next to the road on farm Rustplaats 240

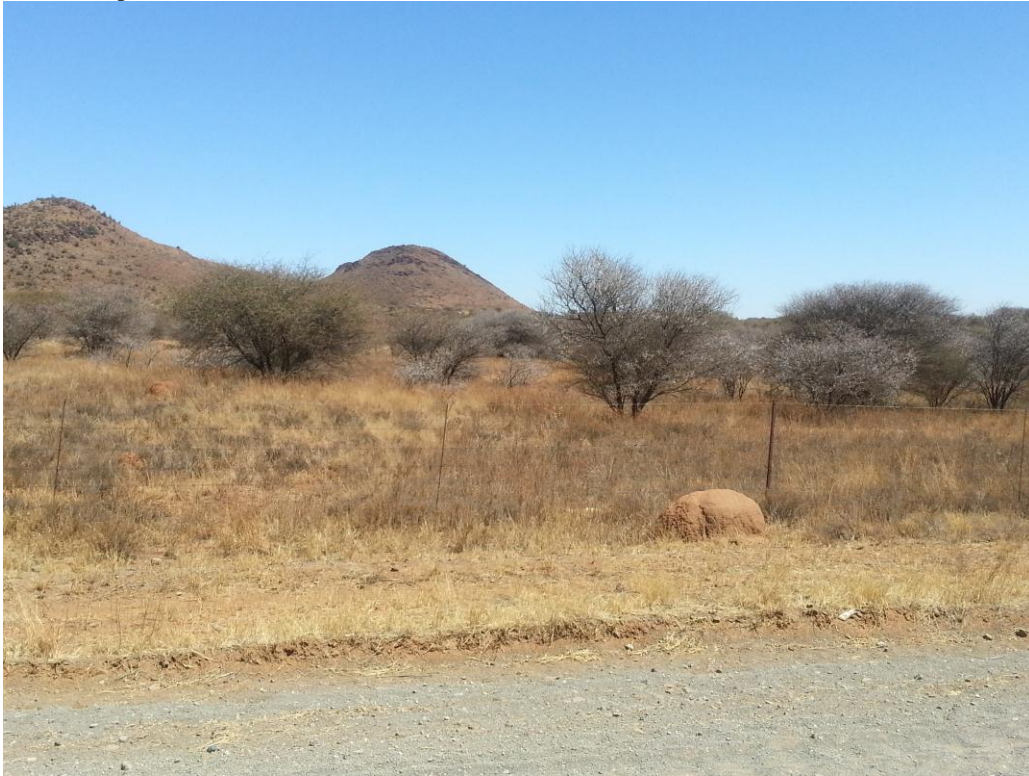
The Dry highveld temperate **grassland** vegetation is present. This is a grassland with a few **Sweet Thorn Acacia karroo trees** occurring only occasionally along water courses (See image 9). Diagnostic grasses include the grasses Lehmann's Lovegrass *Eragrostis lehmanniana*, *E. obtusa*, Small Buffalograss *Panicum coloratum* and *Stipagrostis uniplumis*, and the karroid dwarf shrub, Bitterkaroo *Pentzia globosa*. Other prominent grass species include **Redgrass *Themeda triandra***, Weeping Lovegrass *Eragrostis curvula*, Hairy Lovegrass *E. trichophora*, *Anthephora pubescens*, *Aristida congesta*, *Digitaria eriantha* and *Cynodon dactylon*. A large variety of dicotyledonous forbs are also present, including *Chamaecrista mimosoides*, Poison Apple *Solanum panduriforme*, Tummy Bitterroot *Dicoma anomala*, *Helichrysum callicomum*, *H. cerastioides*, *Kyphocarpa angustifolia*, *Leucas capensis*, *Gnidia capitata*, *Blepharis angusta*, *Anthospermum hispidulum* and *Acalypha angustata*. West of Bloemfontein, affinity to Karoo vegetation can be seen in plant communities dominated by **dwarf shrubs** (See image 10), including Fringed Karee *Rhus ciliata*, Anchorkaroo *Pentzia incana*, Bitterbush *Chrysocoma ciliata*, *Helichrysum pentzioides*, *Salsola kali*, *Felicia muricata*, *Walafrida densiflora*, *W saxatilis* and *Nenax microphylla* (Bredenkamp, G., Granger, J.E. & van Rooyen, N. 1996. Moist Sandy Highveld Grassland. In: Low, A.B. & Robelo, A.G. (eds) *Vegetation of South Africa, Lesotho and Swaziland*. Department of Environmental Affairs and Tourism, Pretoria.)

Potential impact (e.g. permit applications): The removal of vegetation cover can lead to loss of top soil and the acceleration of soil erosion. The debris that result from vegetation clearance, cut and trimmed trees can pose as a fire risk on the property of landowners. The loss of grazing land and natural habitat of small mammals and birds living in grassland. Veld fires can also pose danger to Eskom equipment and infrastructure where grasses are long. The legal contravention of cutting or removing protected trees without a permit from the department of environmental affairs

Image 9: Sweet Thorn Acacia karroo trees

Comments/ mitigation measures: Minimise the removal of vegetation cover during site preparation and construction. Drive with moderate speed in the veldt. Inform the land owner about debris and wood to be

removed after cutting or trimming trees on the property. Do not cut protected trees if it's found along the route of the proposed line, contact the Eskom FSOU environmental section on (051) 404 2287 to obtain a tree cutting permit from the Department of Environmental affairs.

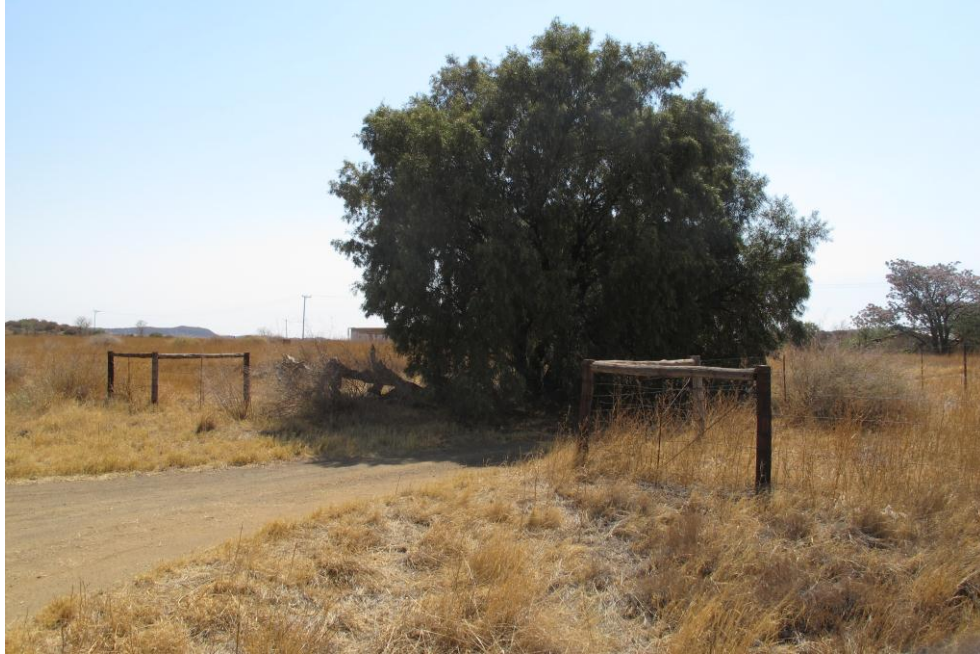
There are also **bluegum, beefwood, pepper trees** (See image 11) and **poplar trees** observed along the route on farms Eden 893, Helderwater 1145, Transportdam 363, Ebenhaezer 1040 (See image12).

Image 11: Pepper tree on farm Katdoornpan 367

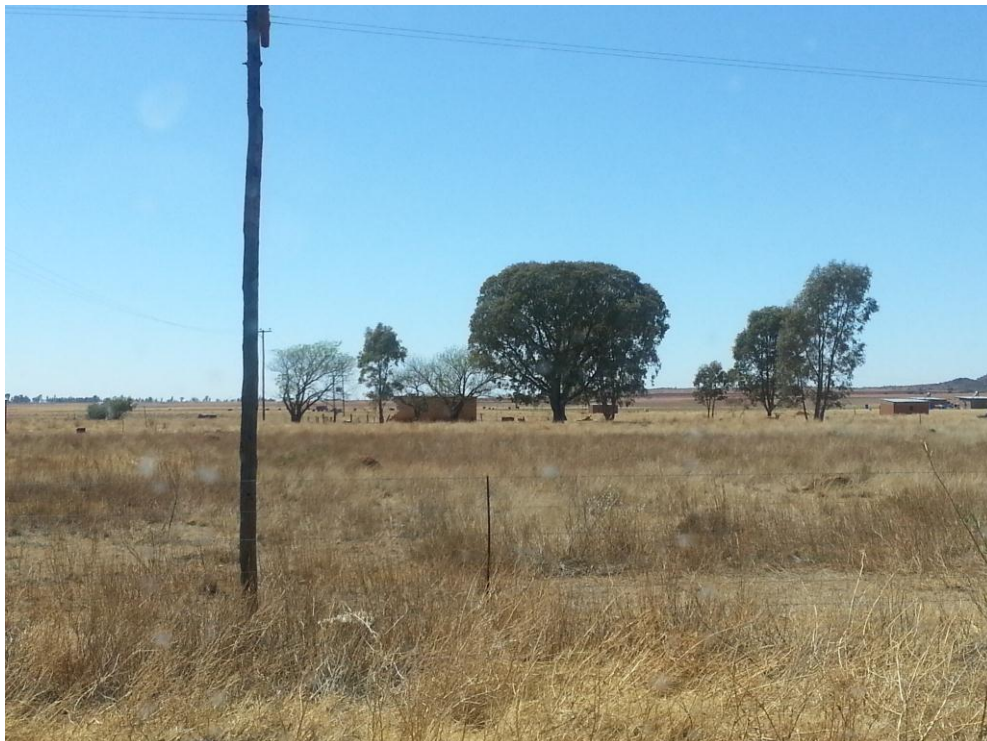
Image 12: Blue gum and poplar trees on farm Transportdam 363

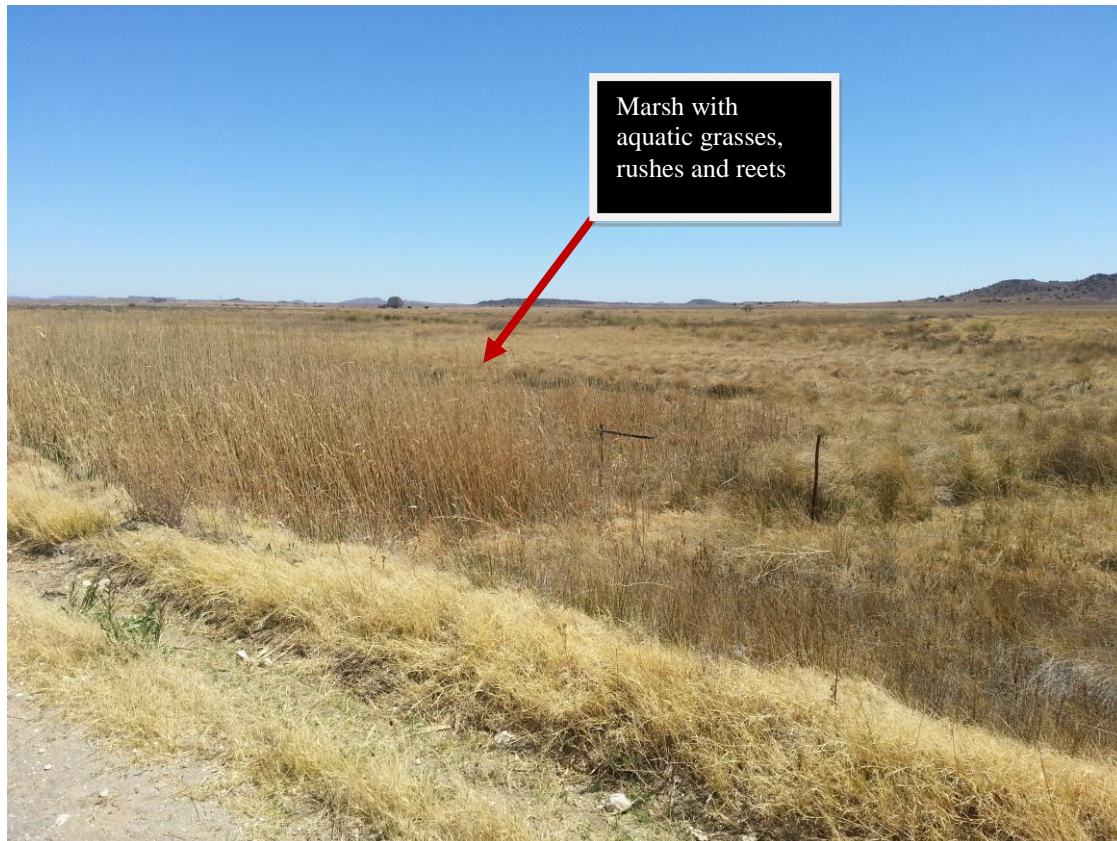
There are also **aquatic grasses, rushes, reeds** present at the marsh at farm Brakput 886 (See image13).

Image 13: Aquatic grasses, rushes and reets at marsh on farm Brakput 886

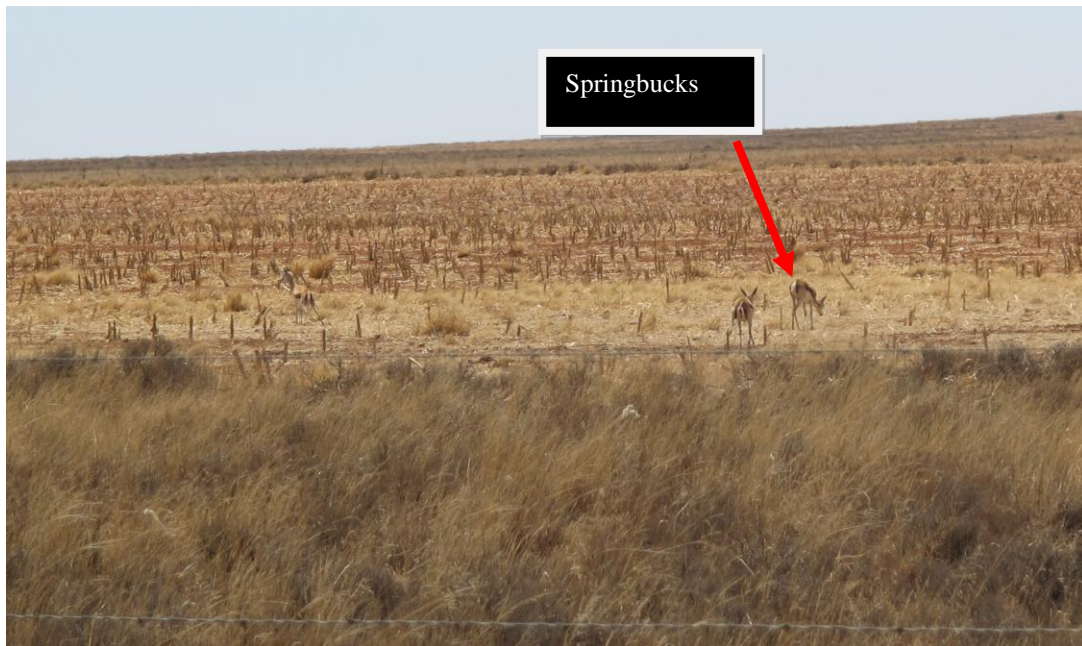
There are **wildcamps** present on the route of the line on farms Boesmansput 152, Ebenhaezer 1040, Hartebeesplaat 1142, Legkraal 65, Reddersfontein 410. There were also **springbucks** observed on farm Whitbourne 730 and Waterbron 68 (See image 14). **Cattle and sheep** were seen grazing on farms Helderwater 1145, Transportdam 363, Katdoornpan 367, King’s Heath 154, Legkraal 65, Reddersfontein 410, Whitbourne 730, Waterbron 68, Leeuwberg 465, Witfontein 652, Mooivlakte 571 (See image 15). **Guinea fowls** on most of the farms along the route. **Wild peacock** and a **secretary bird** were observed on farm Katdoornpan 362. **Vultures and eagles** were observed on farm Kranshoek 1089. Herons were observed along the route on farm Mooivlakte 571

Potential impact (e.g. threat of electrocution, collision, etc): Bird collisions at inland water pans where birds associated with these pans migrate to water and back to their habitats. The electrocution of guinea fowls as they sit on conductors. The electrocution of vultures and eagles as they sit on Eskom’s structures. The streaming of birds on Eskom conductors causes pollution of structures and current faults. Pouching of guineafowls and springbucks by contract workers. The disturbance of wild animals, cattle and livestock. Animals escaping from the property due to the damaging of fences and gates being left open by contractors.

Image 14: Springbucks on farm Whitbourne 730

Comments/mitigating measures: Use bird friendly structures. Install bird flappers on the line where inland water pans are present close to the line. Pouching of any bird or animal should not take place. Workers should inform land owner when activities will commence so that landowners can relocate their animals. No form of fire should be started on any property. Animals and birds should not be disturbed in any way. Keep construction activities during normal working hours. Do not damage any farm fence or violate the landowner’s rules on the opening and closing of gates. Refrain from driving through grazing land of animals as far as possible. Keep the driving of vehicles close to the farm fences. Install bird flappers where the line is going to cross near or over inland water bodies. Make use of rapture protectors on the Eskom infrastructure, call the EWT toll free number: 0860 111 535 or Rudi Kruger 053 830 5771 for information on suppliers of rapture protectors.

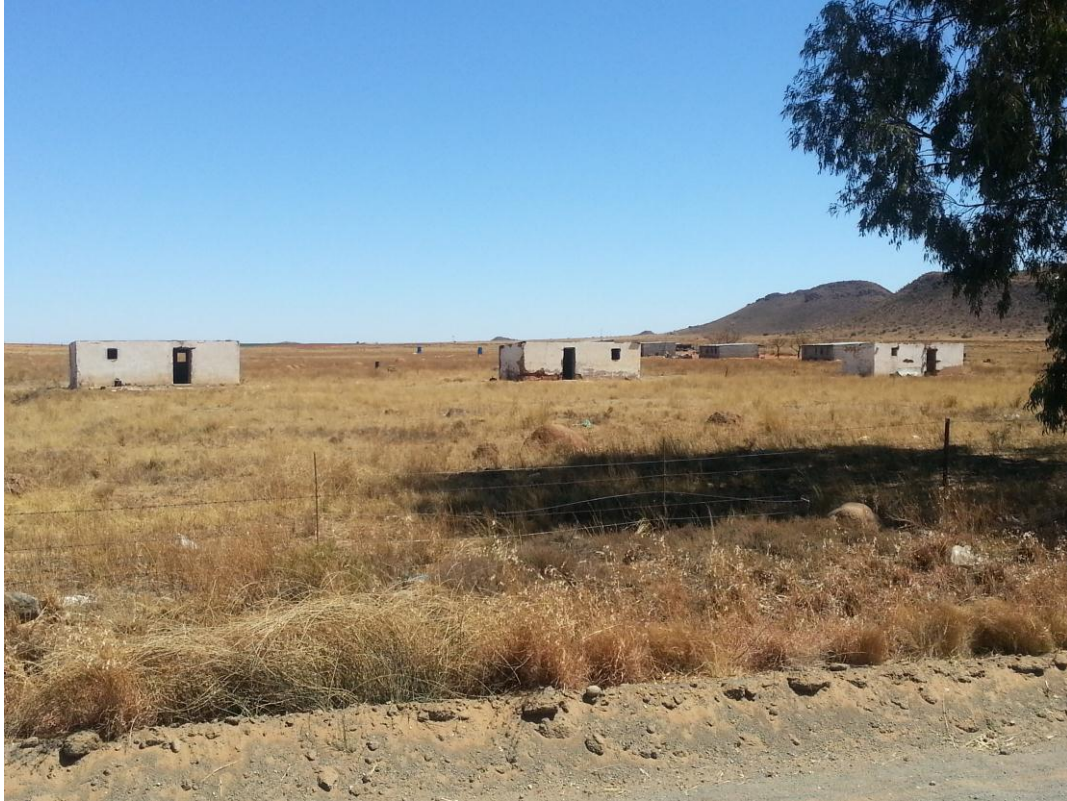
Brief description: Occupied farm houses and **farm workers houses** (See image 16) were observed along the route of the line on the farms where take-off lines are going to be rebuilt to transformer poles to supply electricity to **farm houses**(See image 17).

Potential impact (threat of encroachment, etc.): Noise, dust and land pollution. The construction activities might pose a safety hazard to occupants. Electrocutation due to low hanging conductors or conductors lying on the ground. The encroachment of safety clearances from houses.

Image 16: Farm workers house on farm Eben Haezer 1040

Comments/ Mitigating measures: Keep safe clearances from houses and other structures that are on the farms. Barricade construction site and put signs of construction up in the vicinity. Inform landowners when construction are going to take place. Do not litter, remove waste and surplus materials from the landowners property after construction.

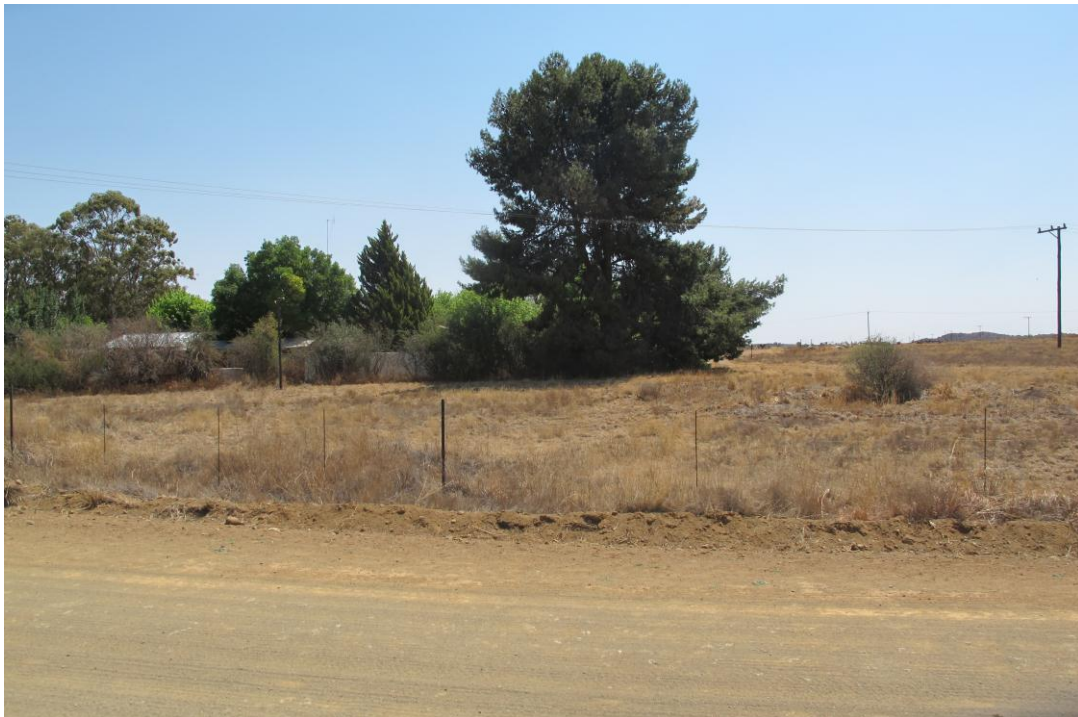
Image 17: Farm house on farm Leeuwberg 882

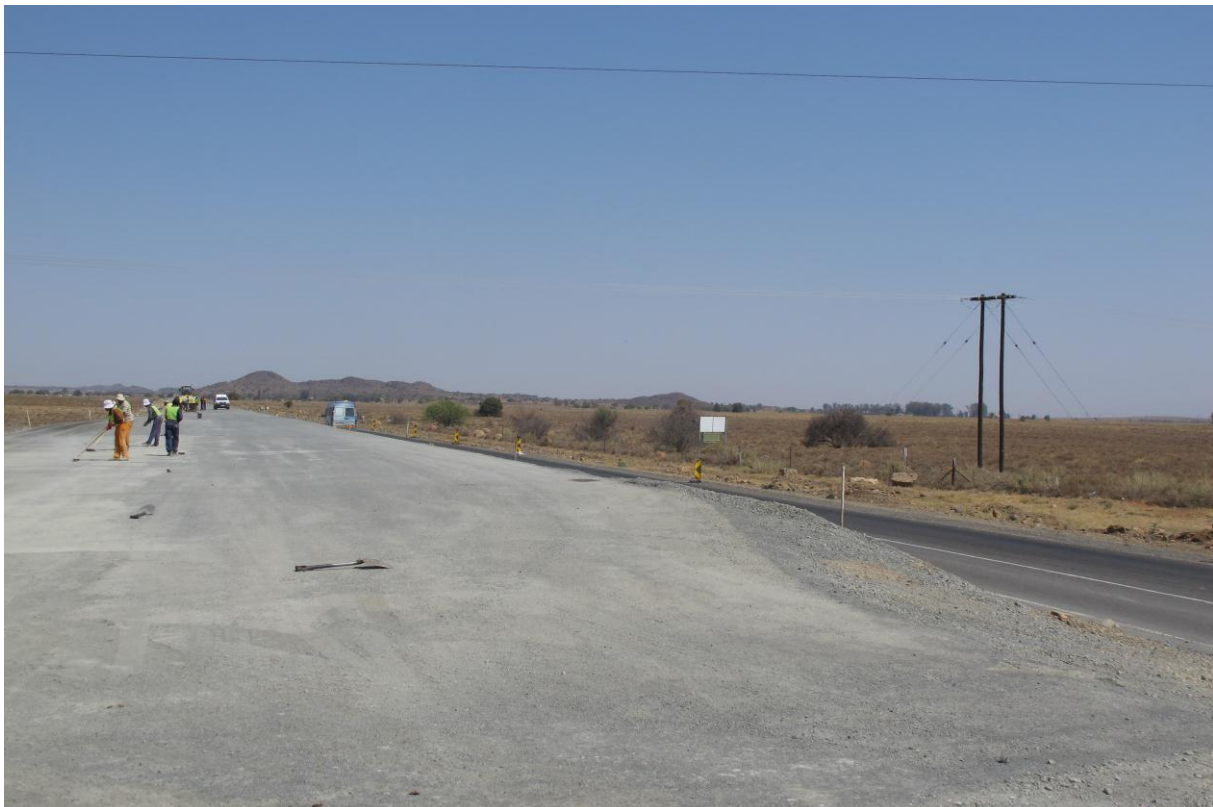
Potential impact: The encroachment of road clearances might take place due to the elevation of the N8 national road (See image 20). Road crossing permits obtained from the Department of Transport, roads and public works being outdated. Safety clearances of Telkom communication infrastructure might be encroached.

Image 20: N8 national road construction

Comments/ Mitigation measures: Before constructing the line, verify the road clearances for powerline crossings on the newly constructed N8 national road at the point where the proposed line is going to cross the road. Obtain permission from Telkom to cross their communication infrastructure. Be alert for loose structures and hanging conductors. Remove old conductors and structures from the proposed route.
