HERITAGE IMPACT ASSESSMENT FOR PROPOSED HYDRO-ELECTRIC FACILITIES NEAR RIEMVASMAAK, NORTHERN CAPE

(Assessment conducted under Section 38 (8) of the
National Heritage Resources Act (No. 25 of 1999) as part of an EIA)

07 December 2012

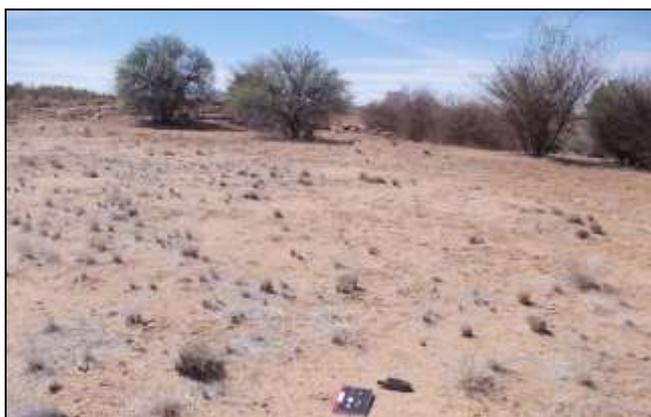
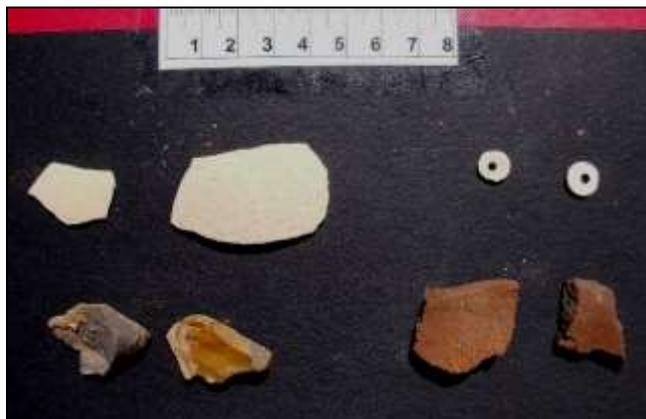
Figure 15: View of the area close to the riverine bush where site RVM2012/038 (point L029) was found. The river is out of picture to the right.

Figure 16: Artefacts from RVM2012/038 (point L029). OES (upper left), flaked stone (lower left), OES beads (upper right) and pottery (lower right).

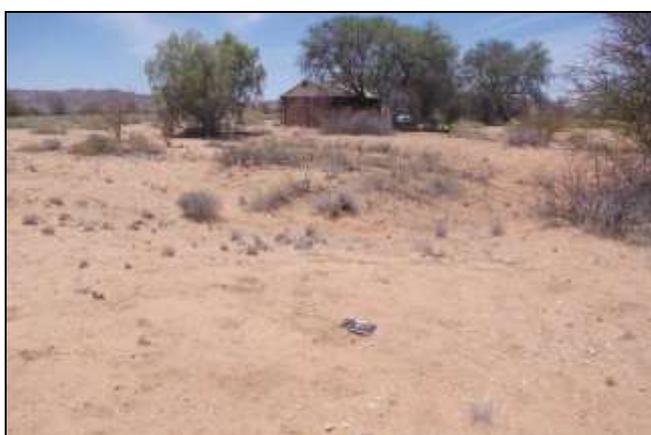
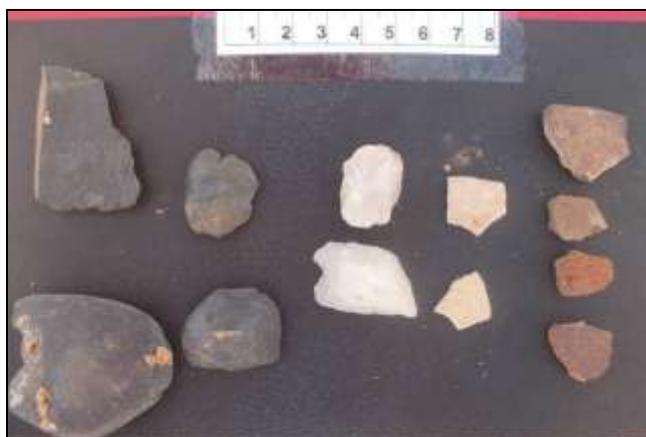
Figure 17: View of the area close to the riverine bush where site WV2012/033 (point L038) was found. The river is to the right and the building in the background is part of a disused SANParks bushcamp.

Figure 18: Artefacts from WV2012/033 (point L038). They include flaked fine-grained black rock, quartz, OES fragments and pottery fragments.

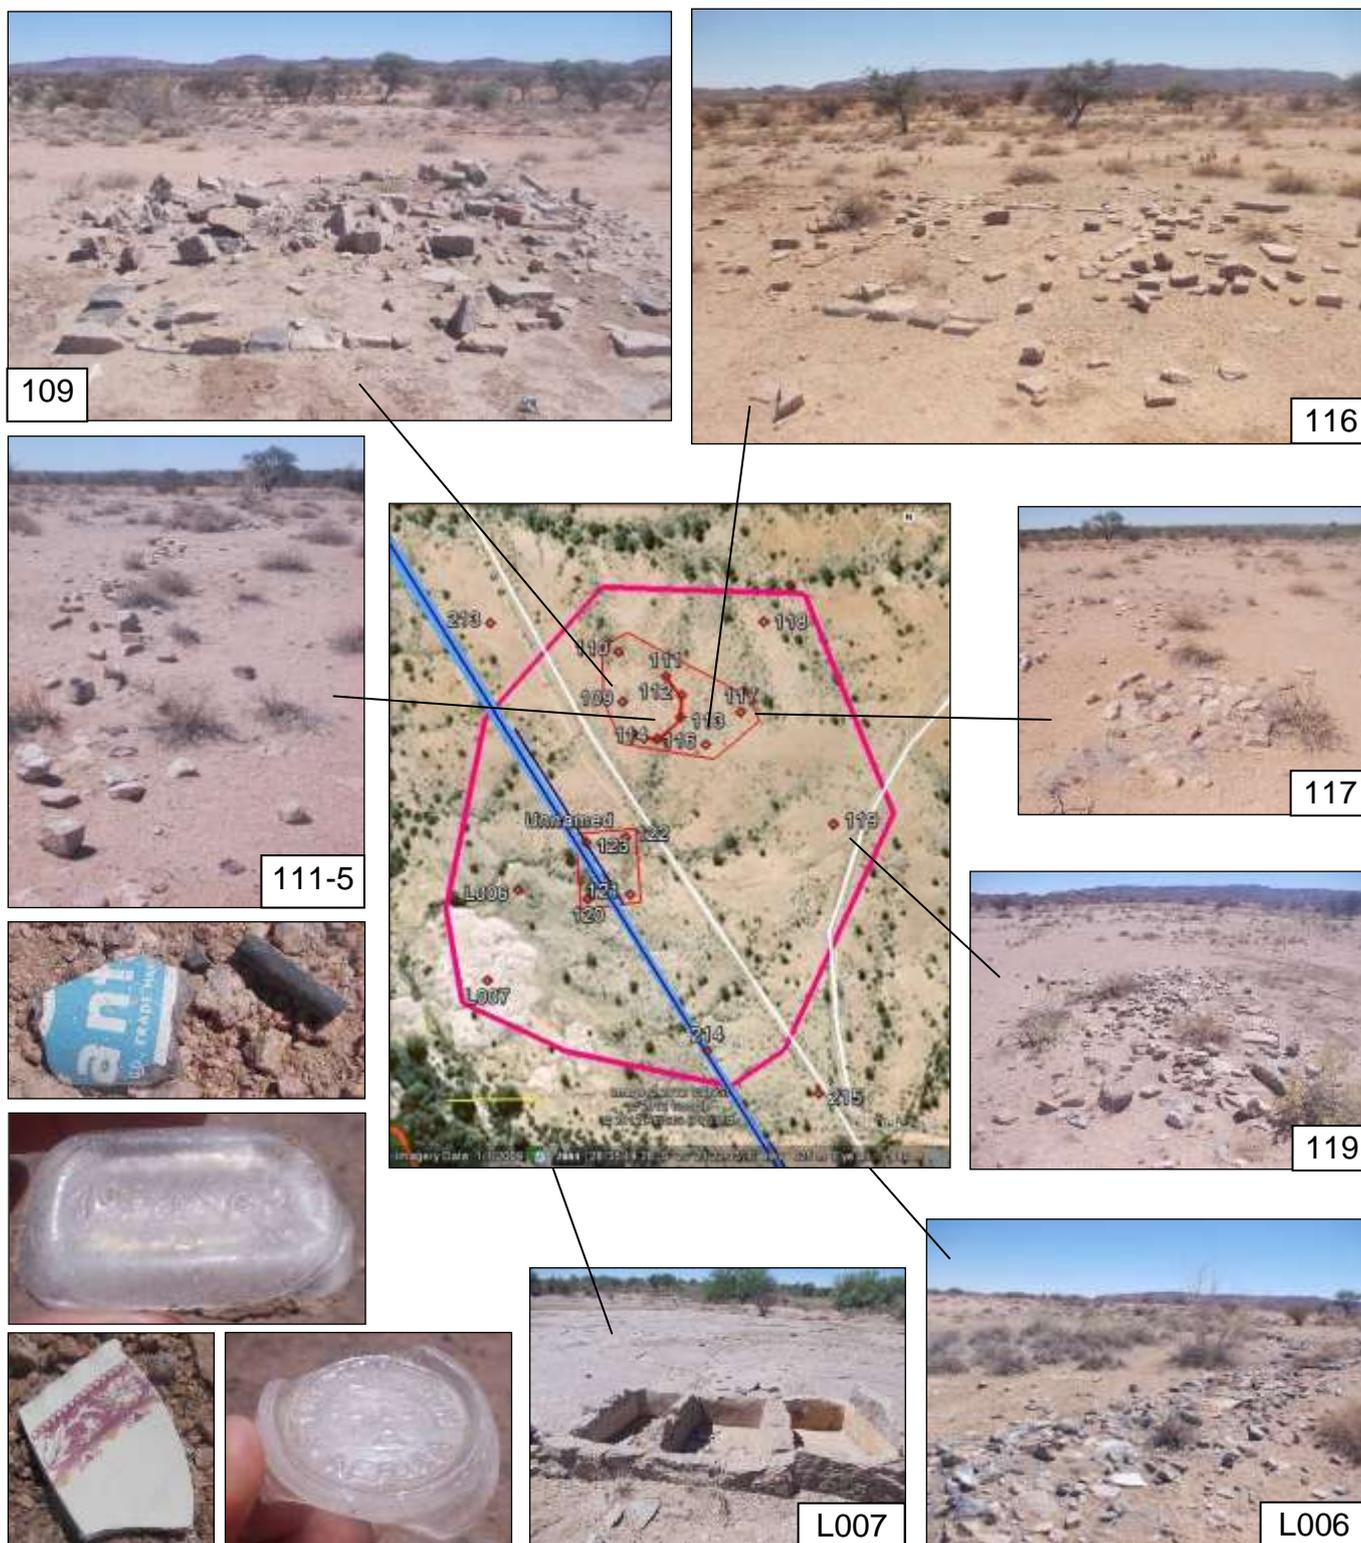
Figure 31: Photographs of finds at the unnamed settlement (WV2001/002) in the south-eastern part of the study area. 109, 116 and 119 are building foundations, 111-5 is a semi-circular feature, presumably the base of a fence, 117 is a stone feature of unknown function, L006 is a large collapsed kraal and L007 is set of what may be animal feeding/watering troughs close to the river. A few isolated artefacts found close to the kraal are also found. The Fanta bottle fragment is clearly not very recent but it is essentially modern rubbish. The yellow bar for scale at lower left in the aerial photograph is 50 m long.

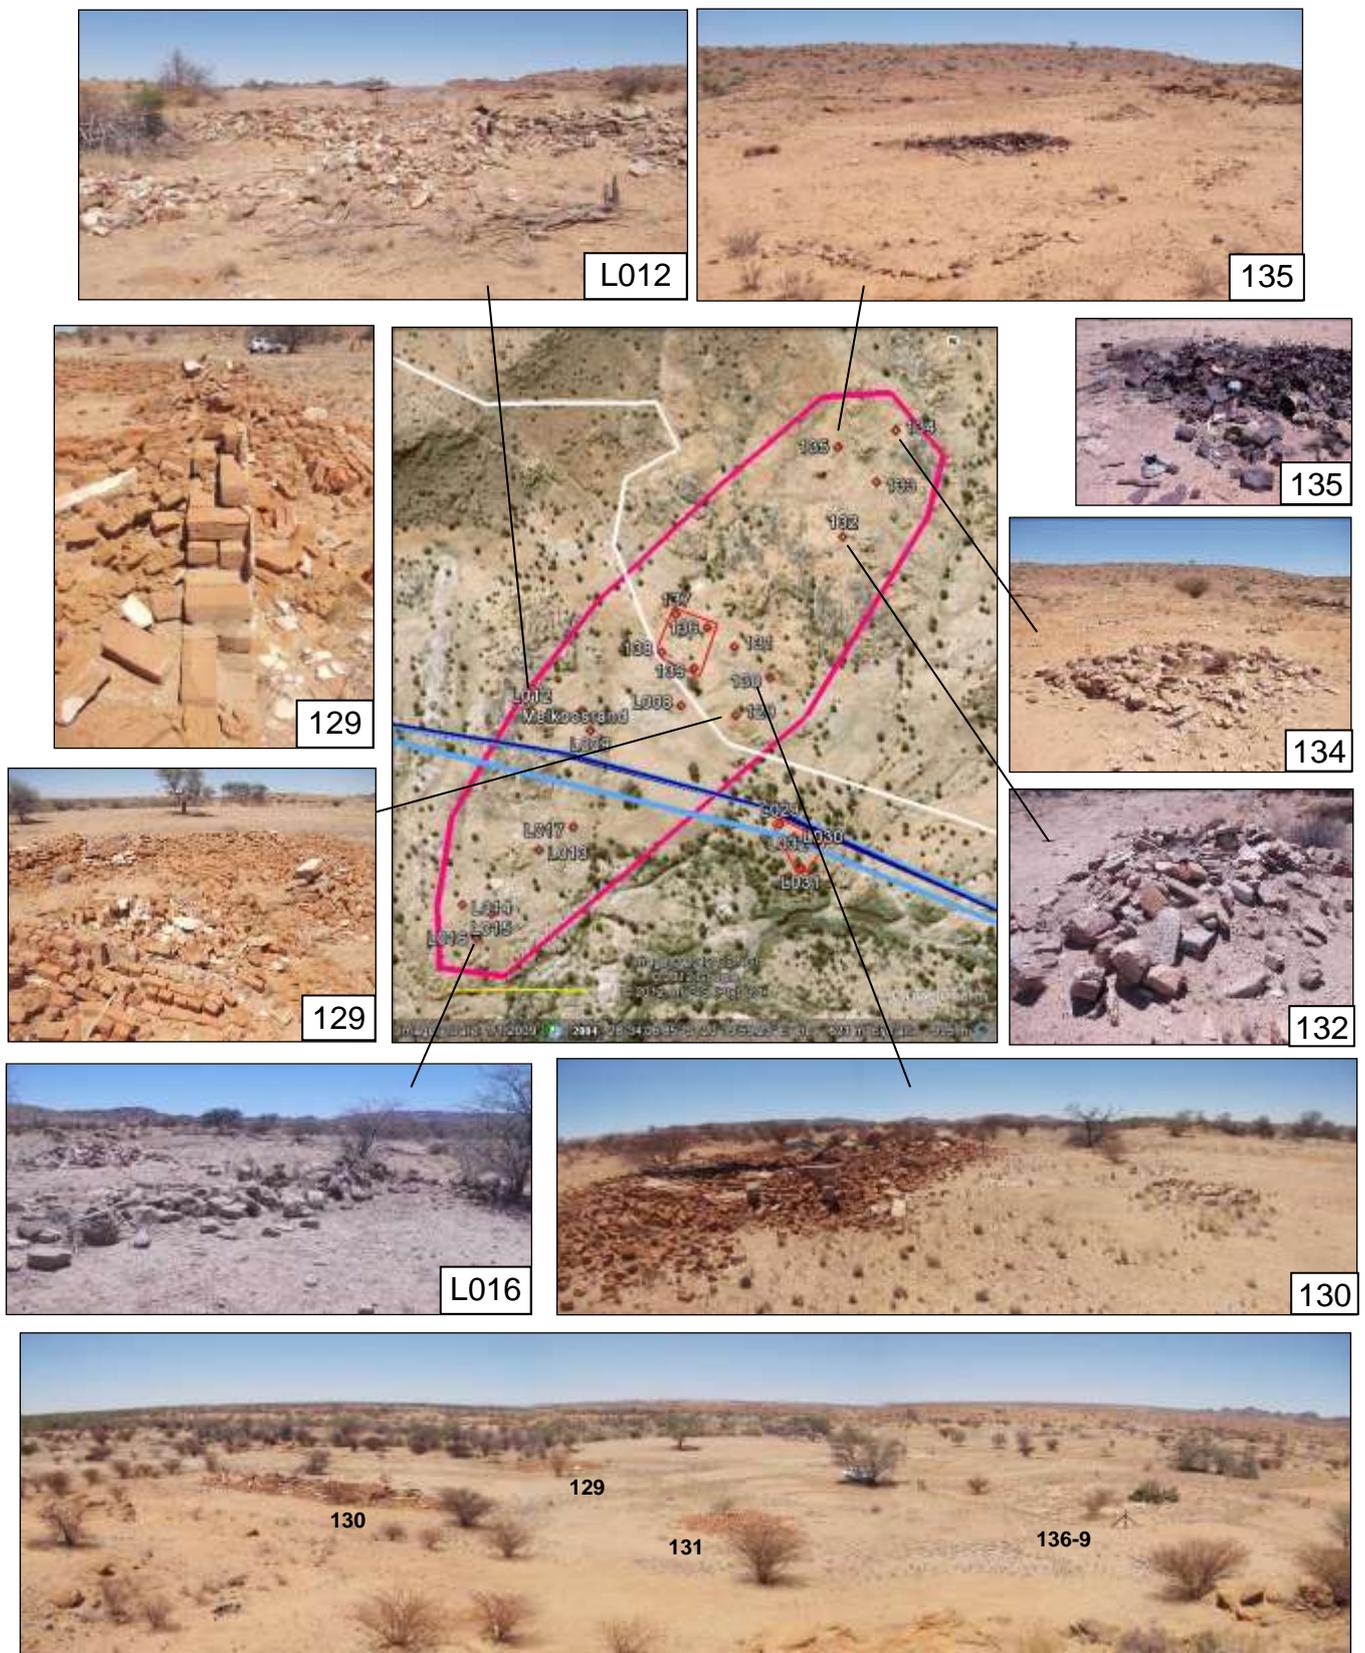
Figure 32: Photographs of finds at the Melkbosrand settlement (MB2001/010) in the central part of the study area. 129 and 130 are demolished houses, 132 and 134 are stone features, the latter may have been a small structure, 135 is probably the base of a fenced stock enclosure with a dump of tins inside it and L016 is two sides of a collapsed stone kraal.

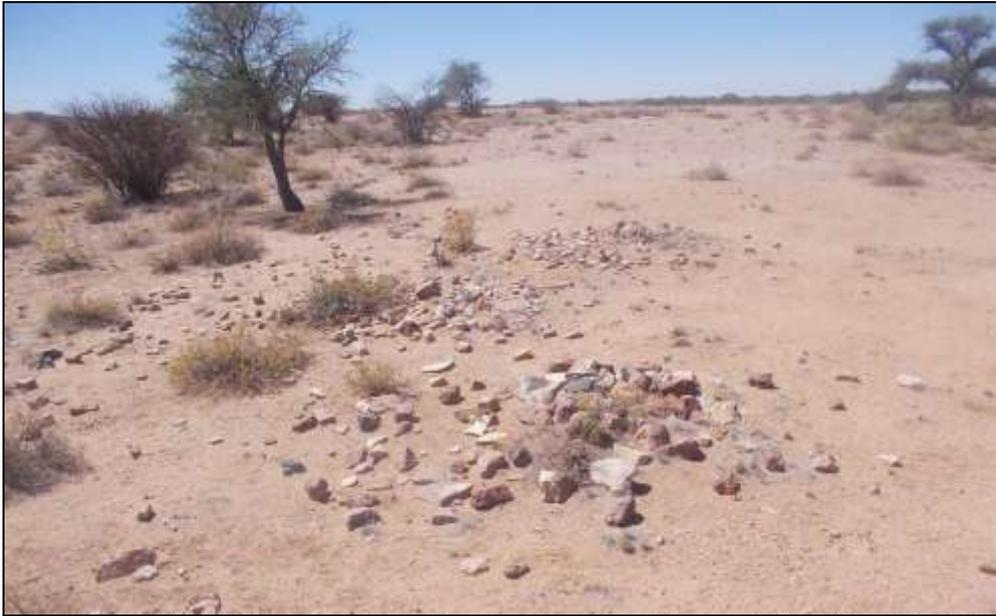
Figure 43: Graves at WV2001/002 (point 118). These three stone mounds occur side by side to the north of the unnamed settlement in the south-eastern part of the study area.

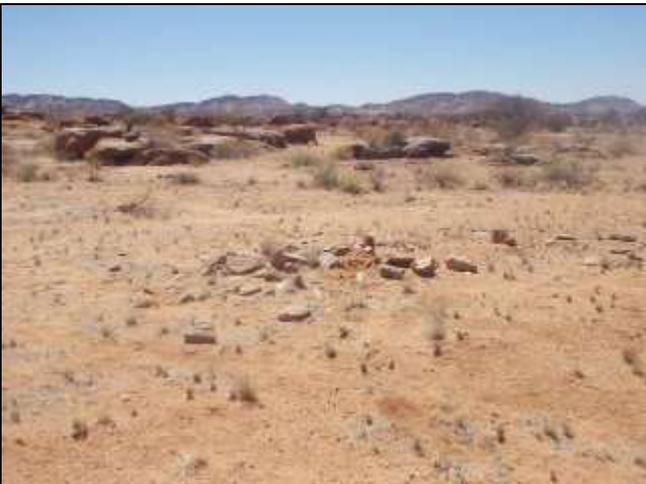
Figure 44: Possible grave at WV2012/002 (point 125).

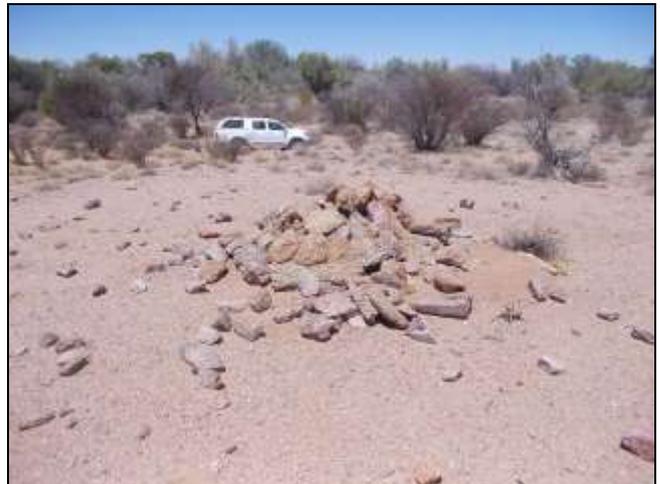
Figure 45: Possible grave at WV2001/030 (point 127).

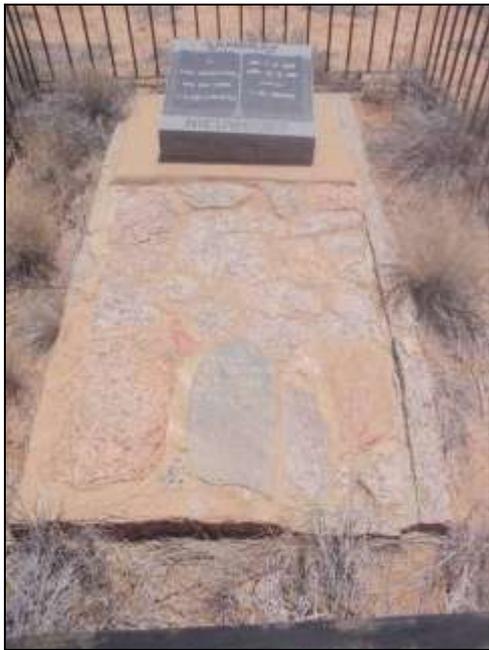
Figure 46: Grave at WV2001/018 (point 201). The person died in 1921.

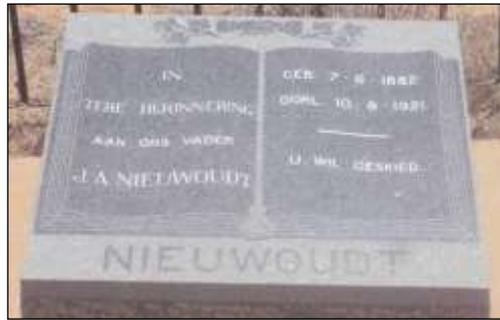
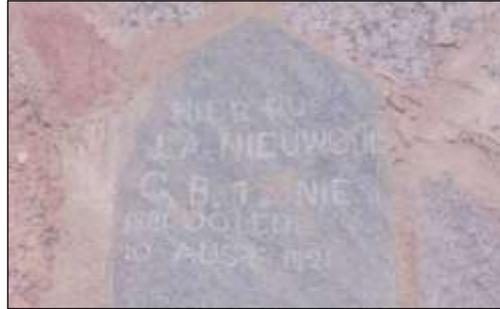
Figure 47 & 48: New and original headstones on the t grave at WV2001/018 (point 201).

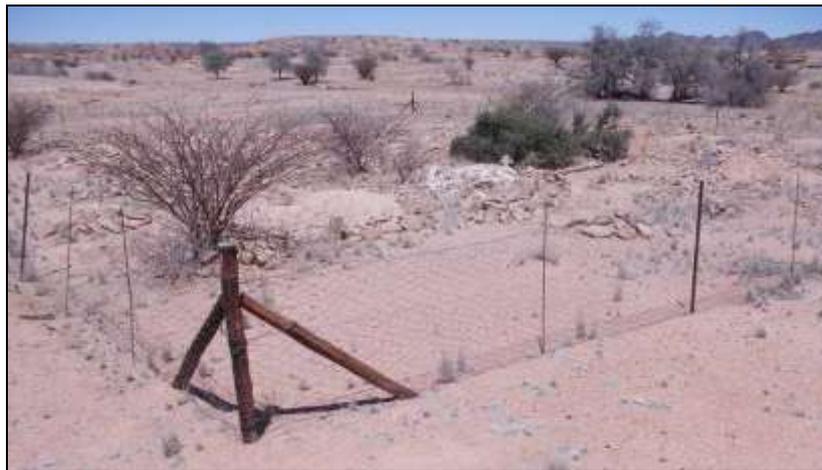
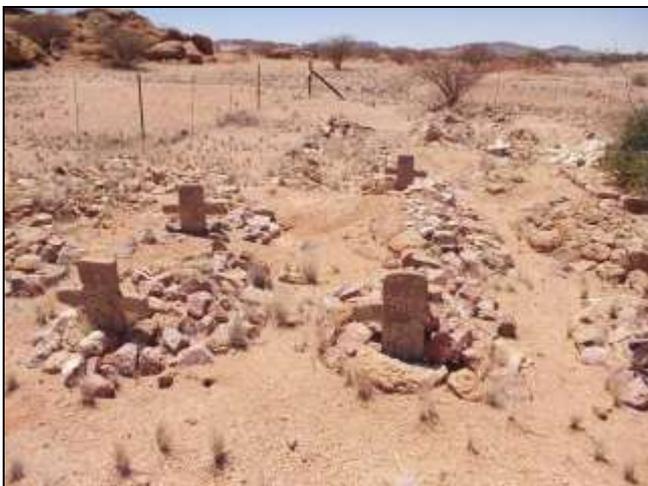
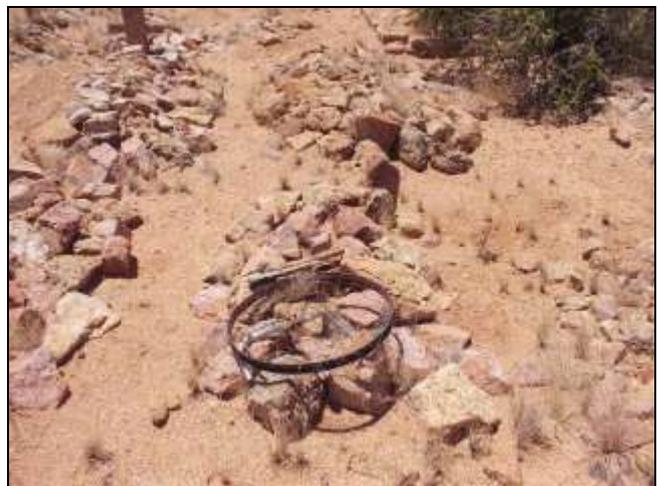
Figure 49: View of the graveyard at MB2001/010 (points 136-139).

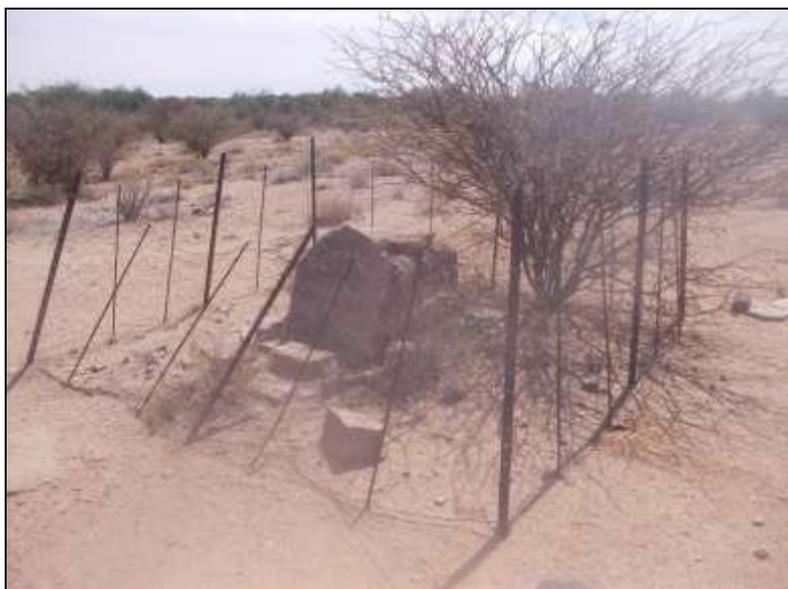
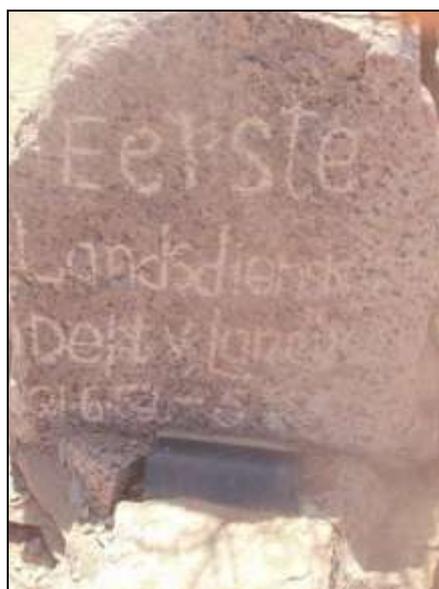
A memorial stone was found at WV2001/014 (point 215; Figures 52 and 53). It has an inscription reading: “Eerste Landsdienskom Dept v Landbou 21.6.52 – 5.?.52”.

Figure 53: The inscribed memorial stone at WV2001/014 (point 215).
