## Design motivation for conversion of the Educational Resources Centre into a new Visitor Centre for the SAAO.

### Preamble and analysis

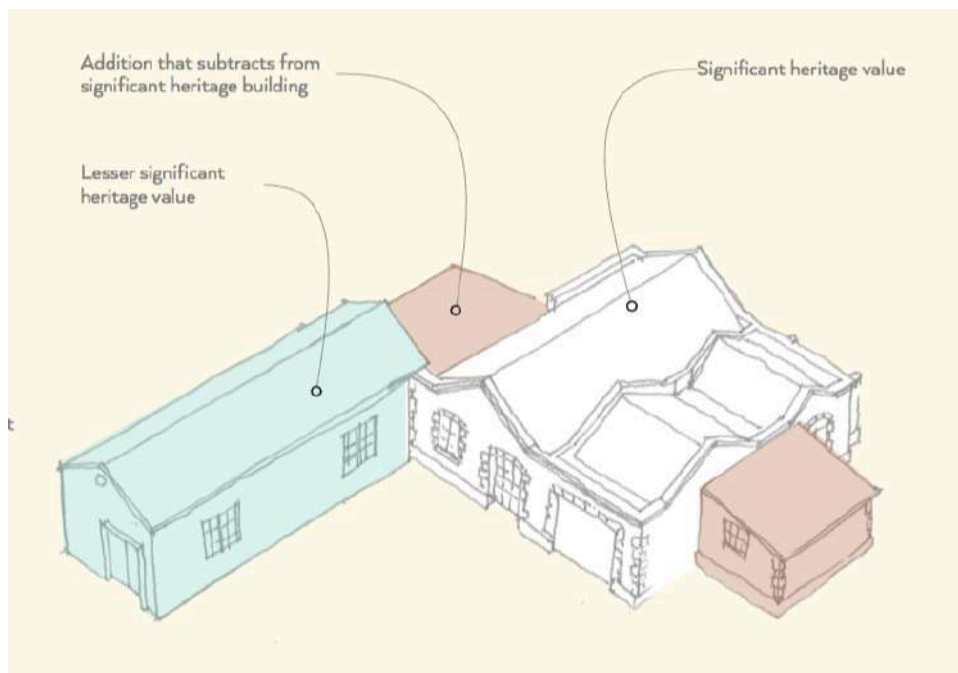
- The building portion that is indicated in white has been identified as clearly being the original building.
- The portions in red indicating later additions that was added later. These two portions also have substantial waterproofing issues that need to be addressed. If possible, these should be altered to not detract from the original building
- The portion indicated in blue is the most recent addition clearly evident in the difference in detailing

Fig. 1 - Existing building analysis

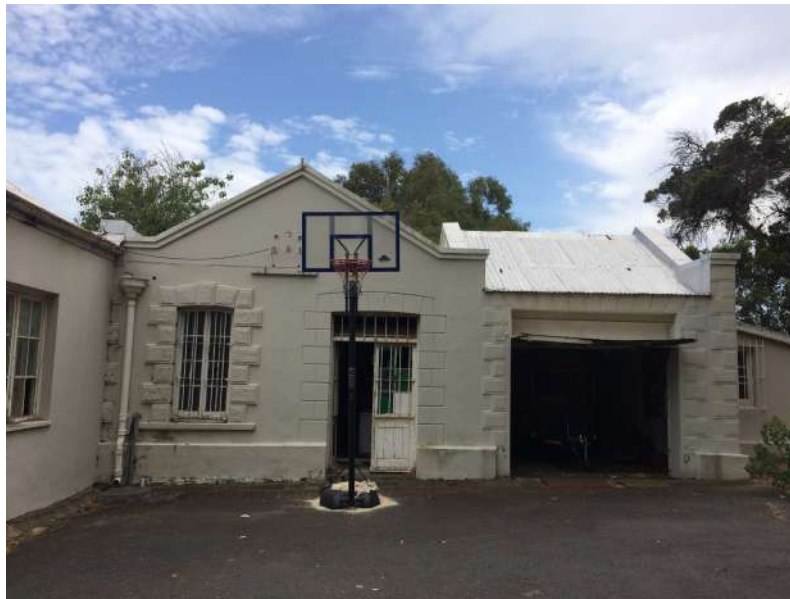
Some alterations have been made to this portion of the building, most prominently being the conversion of the street facing room to a garage – see *fig. 2*

*Fig. 2 - Existing building front façade, with garage alteration*

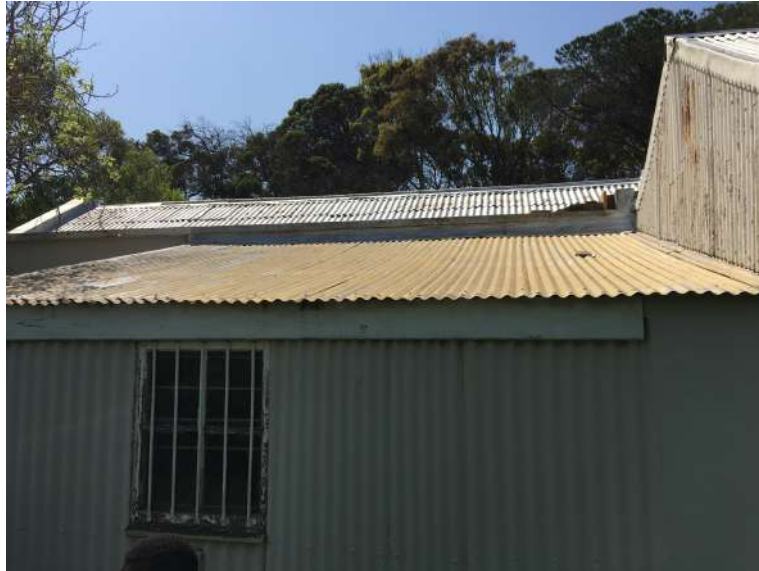
- The roof and general construction of the addition on the western side is problematic. Both the roof and walls are constructed of a timber frame clad with corrugated sheeting. The roof structure seems to be sagging, and may need replacement. This will only become evident upon removal of the ceiling. Refer to *fig 3*.

*Fig. 3 - Sagging of roof on corrugate clad addition on north-western corner.*

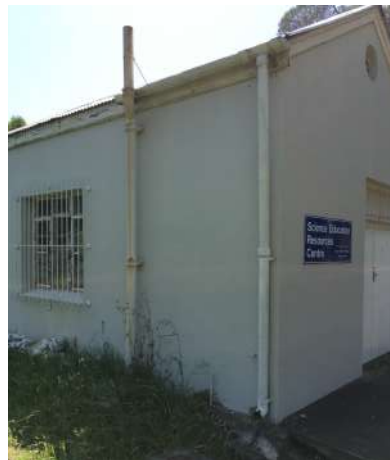
The most recent addition is indicated in blue. This portion is functionally in the best condition. Some general maintenance is required with gutters and downpipes missing. Roof sheeting needs replacement. It is suspected that the purlins to the roof sheeting are still in fair condition. Gutters and downpipes need to be re-instated and replaced. Refer to *fig 4*.

*Fig. 4 - Most recent addition to the Educational Resources Centre*

Most windows in this portion only needs maintenance and replacement of glass and putty. Details are indicated in the *window and door schedule* in *Annexure A*.

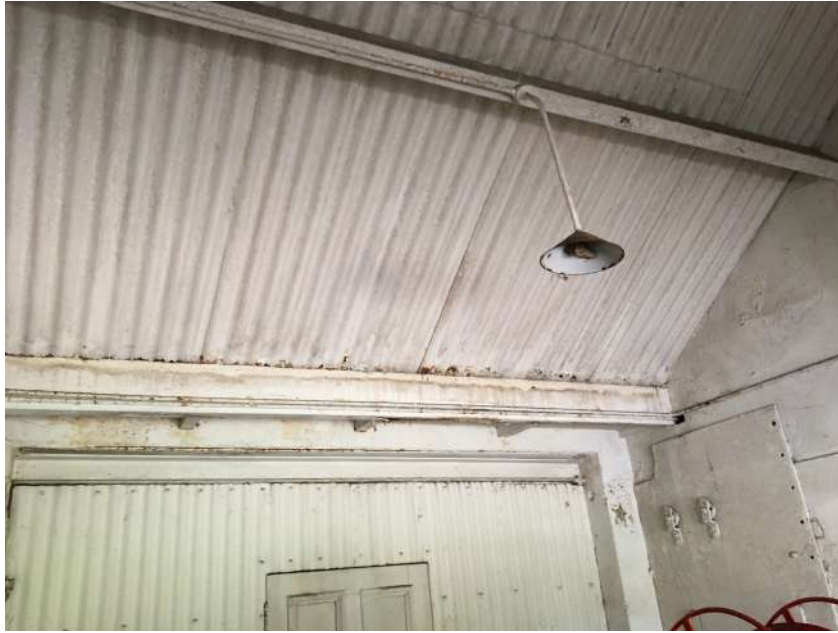
*Fig. 5 – exposed roof in the existing “garage” area*

An important part of the proposed design is not to only maintain, but improve where a real need is presented. Water drainage from the roofscape is clearly a problem currently. A solution is proposed where the two pitched roofs over the current garage and newly proposed WC's are removed, and replaced with a single pitch roof draining onto a new single internal gutter. This removes three other internal gutters out of the equation, and reduces the risk for water leakage into the building significantly. These two roofs are internally also not of great significance, and currently the roof sheeting is completely exposed from the inside. See *fig 5*.
