**Aquatics Assessment**  
**(Vlakkeland, Paarl, Western Province)**

**DHEC Report 622/2013**

## **AMENDMENT NOTE TO REPORT DHEC 622 (2013): VLAKKELAND (PAARL)**

### **Vlakkeland Soil investigation**

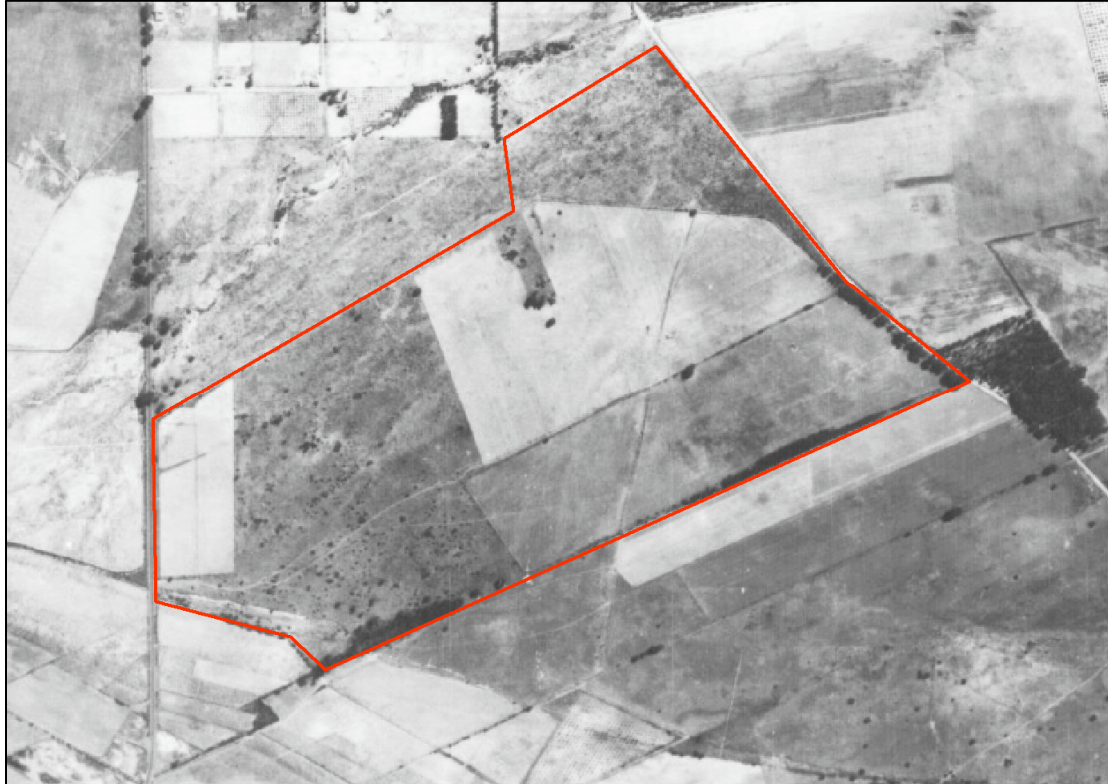
**Figure 3:** The Vlakkeland site (approximate outline in red) as in 1938. The streamline, entering the site towards the south-western corner, appears as little more than a field (tile) drain.

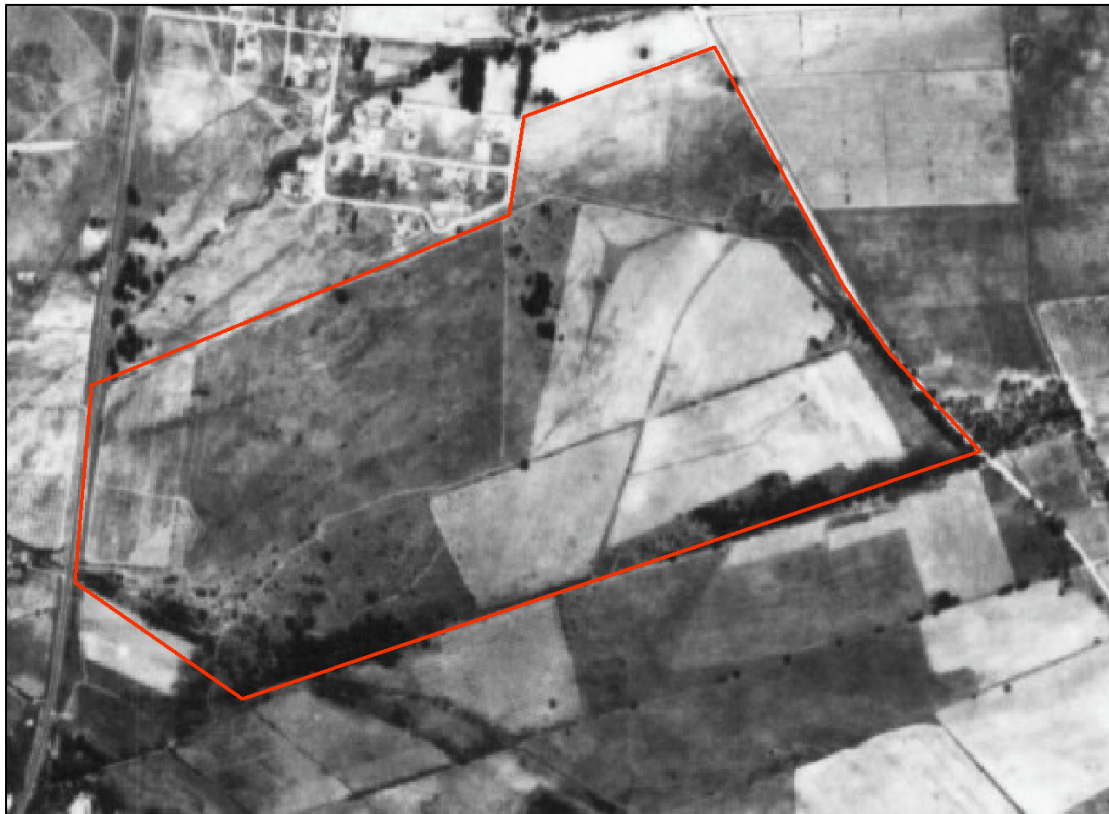
**Figure 4:** The Vlakkeland site (approximate outline in red) as in 1966. The streamline is now more obvious as a result of upstream development.

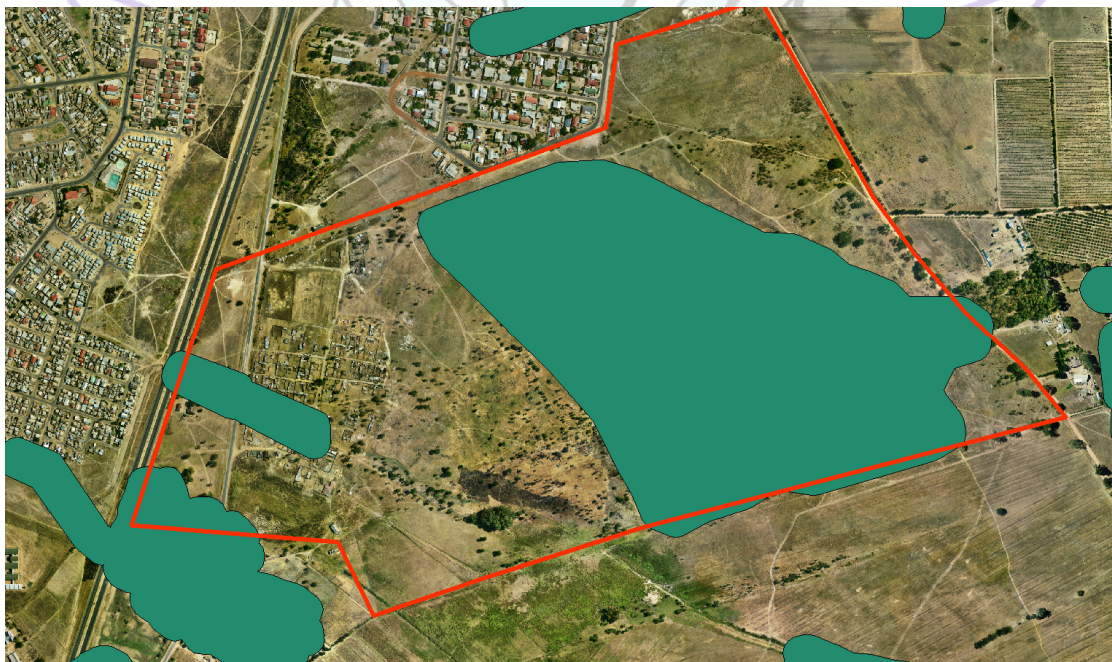
**Figure 5:** Extract from Drakenstein EMF GIS wetlands layer showing the areas deemed by the DEMF to be wetlands. The wetland areas are completely artificial and dysfunctional as aquatic environments.

Per the Drakenstein Environmental Management Framework (DEMF), the pans and the disused dam to the south-west (Klein Vlakkeland) have been mapped as wetlands (see **Figure 5**). This classification is clearly incorrect and is not considered further in this report. The DEMF further maps the western end of the streamline where it passes through the informal settlement. A possible option for the streamline is provided hereunder.

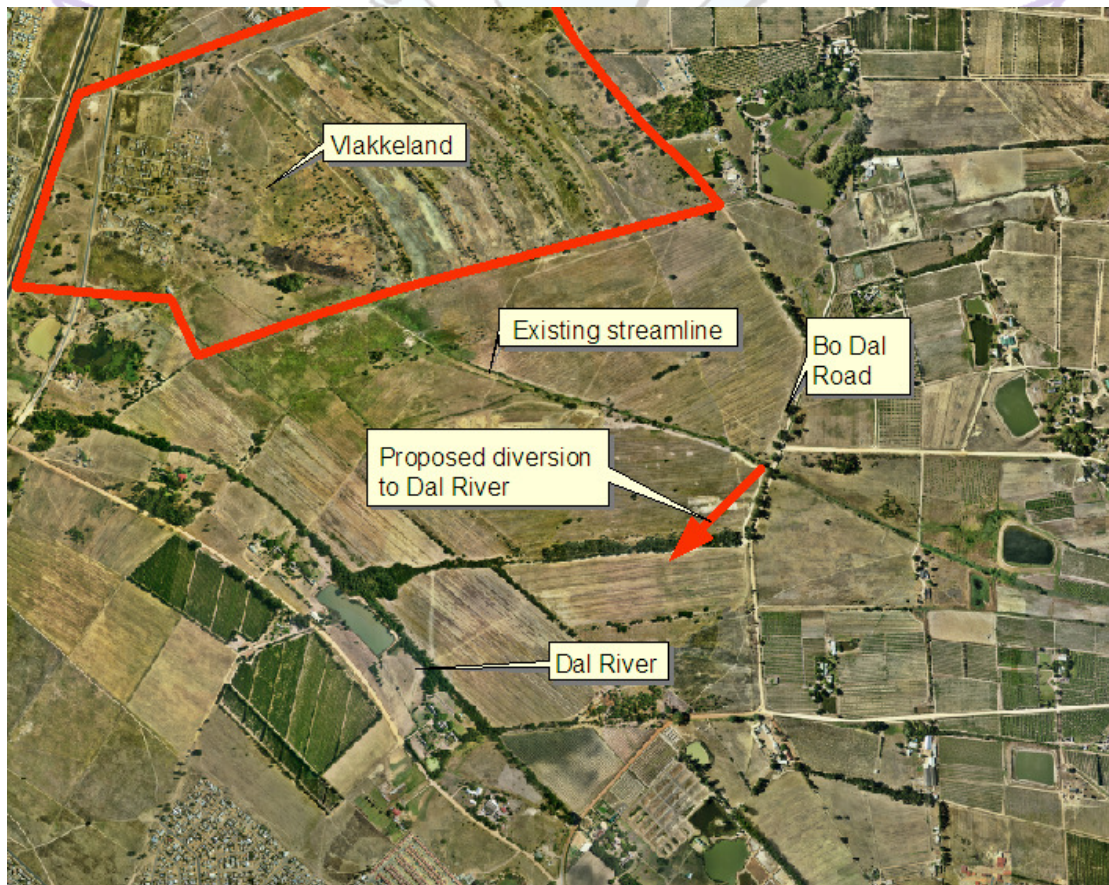
**Figure 6:** Proposed diversion option for the Kleinbosch Stream (Red Arrow), southwest to an adjacent, good condition drainage line flowing to the Dal River.

An alternative, and in my opinion superior option, would be to divert the streamline towards the southwest as soon as possible after it crosses the Bo Dal Road and allow it to confluence with the immediately adjacent stream that ultimately confluences with the Dal River flowing along the northern side of the Dal Road (see **Figure 6**). This would allow the stream to connect with a watercourse of good condition, rather than allowing it to simply discharge into the degraded environments alongside the R303.

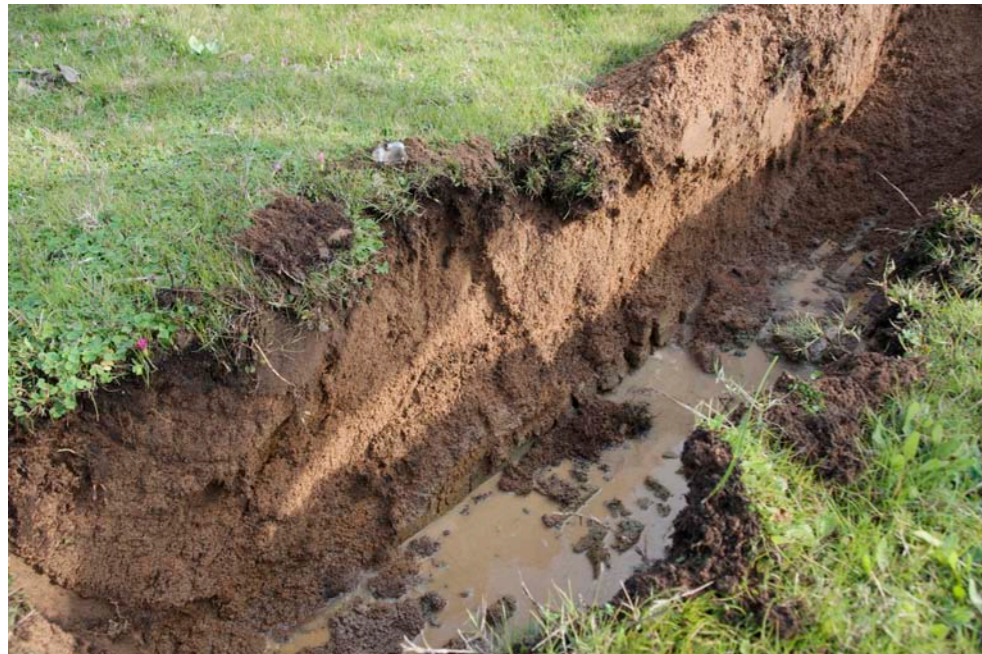
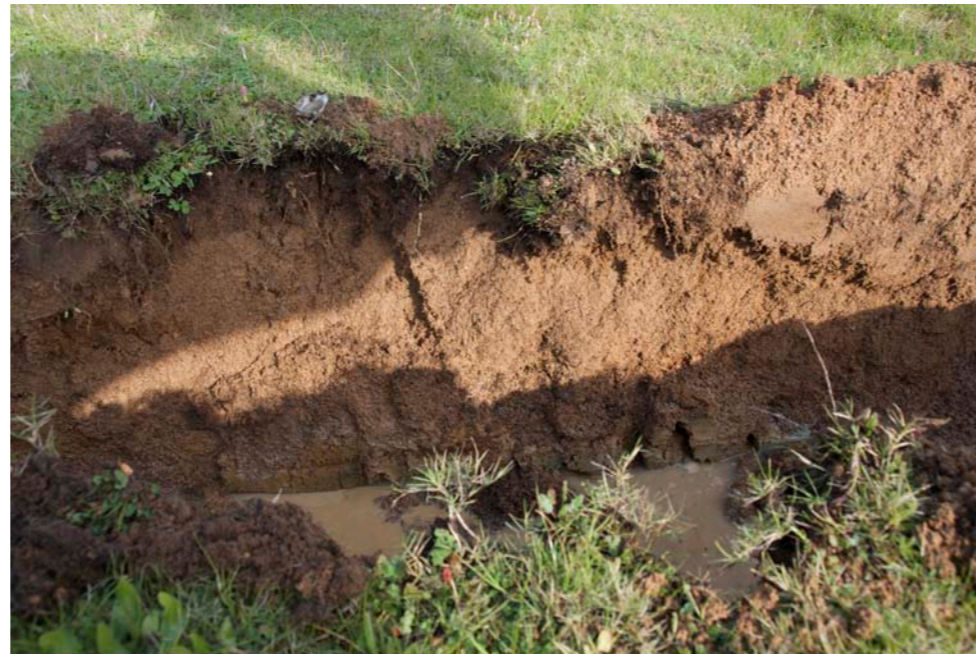
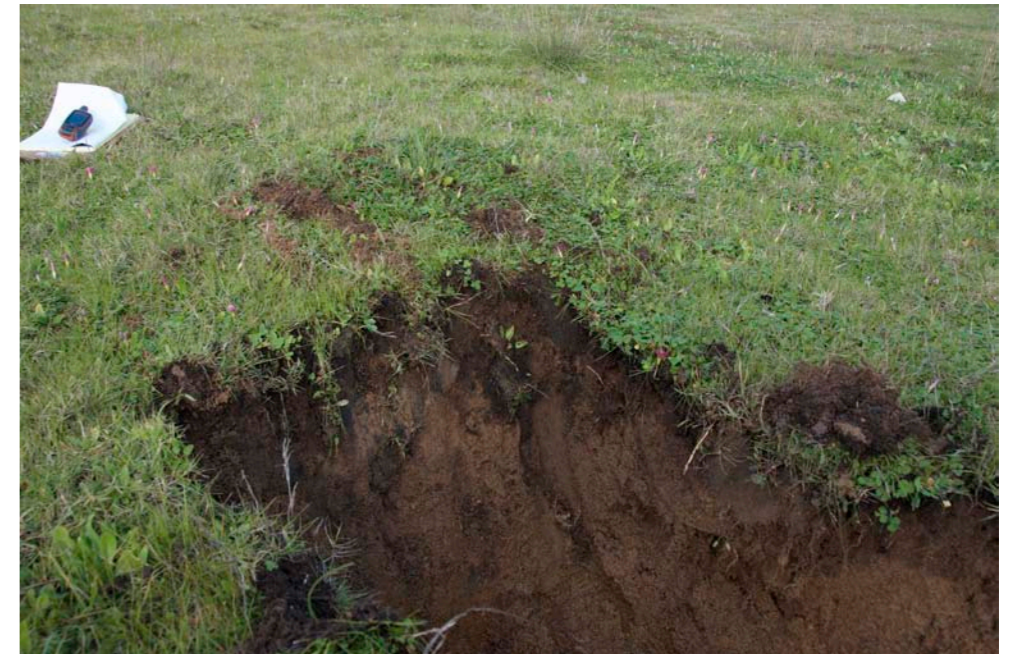
TP33 (Hole 002)

TRIAL PIT NO: TP33

METHOD OF INVESTIGATION : Digger/loader  
COORDINATES: X: 3728350  
Y: -200

o : o :	GRAVELLY SILTY SAND Slightly moist, brownish grey, very loose, slightly pinholed, slightly clayey and fine silty gravelly medium to coarse sand. Coarser grained towards basal contact. Alluvial wash. Fine roots to 0.1m.
: : o :	
o : o :	
: : o :	
o : o :	
: : o :	
o : o :	
: : o :	
o : o :	
: : o :	
o / b / o	0.70 GRAVELLY CLAYEY SILT Moist, light khaki, blotched light brown, stiff to very stiff, fissured clayey silt with fine and scattered medium gravel. Alluvial wash.
/ o / o /	
o / b / o	
/ o / o /	
o / b / o	1.40 GREYWACKE Light khaki, stained and mottled red brown, highly weathered, very fine grained, very closely to closely jointed (sub vertical foliation and joints), very soft rock to generally soft rock greywacke, and very soft rock to very stiff soil.
/ o / o /	
o / b / o	
/ o / o /	
o / b / o	
/ o / o /	
o / b / o	
/ o / o /	
o / b / o	
/ o / o /	
o / b / o	3.05

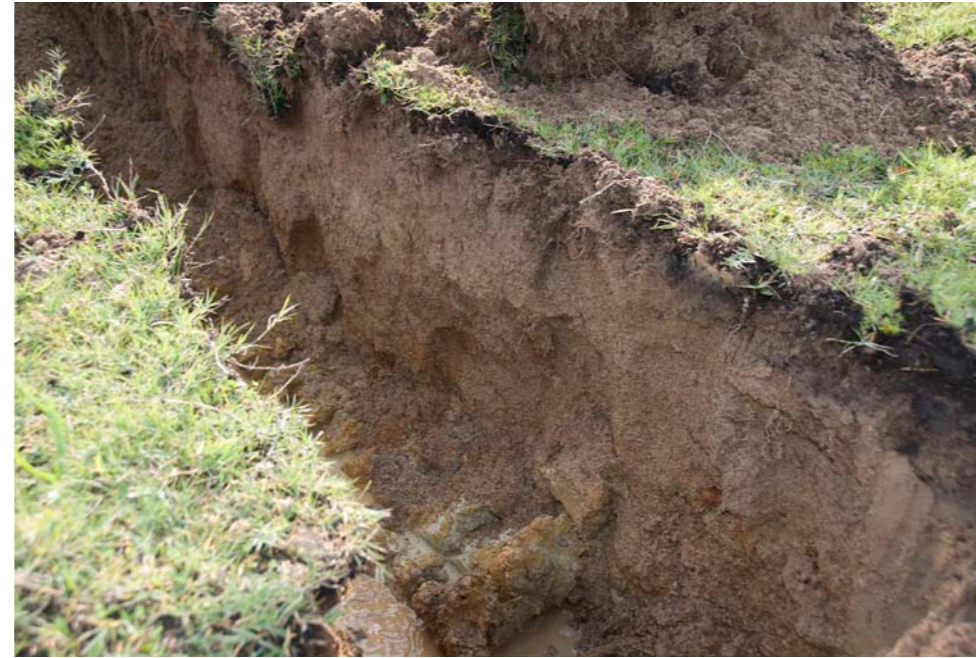
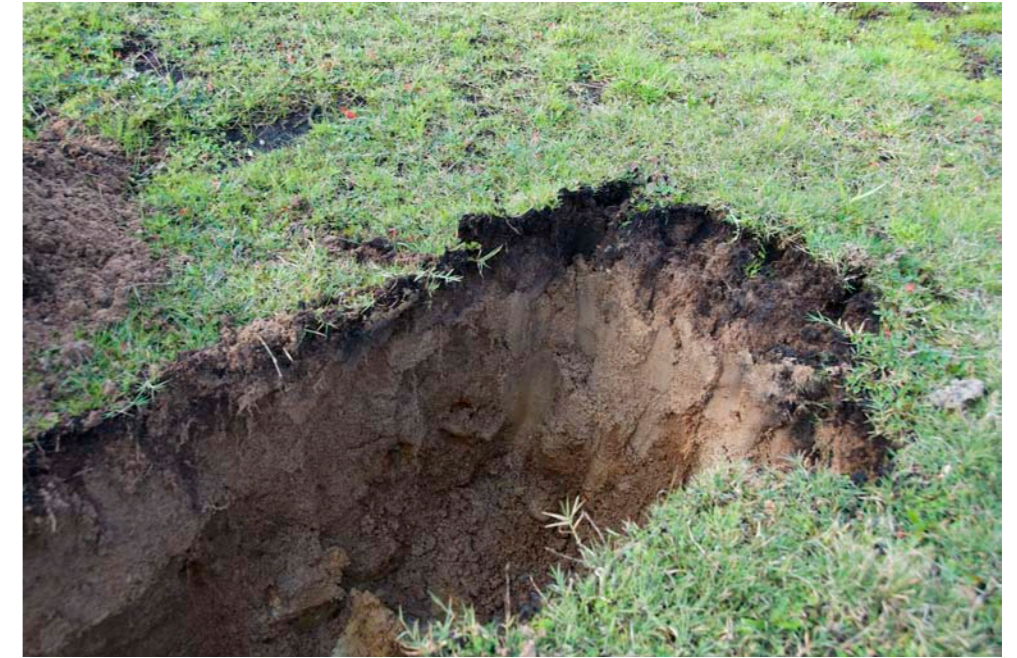
TP34 (Hole 003)

TRIAL PIT NO: TP34

METHOD OF INVESTIGATION : Digger/loader  
COORDINATES: X: 3728450  
Y: -300

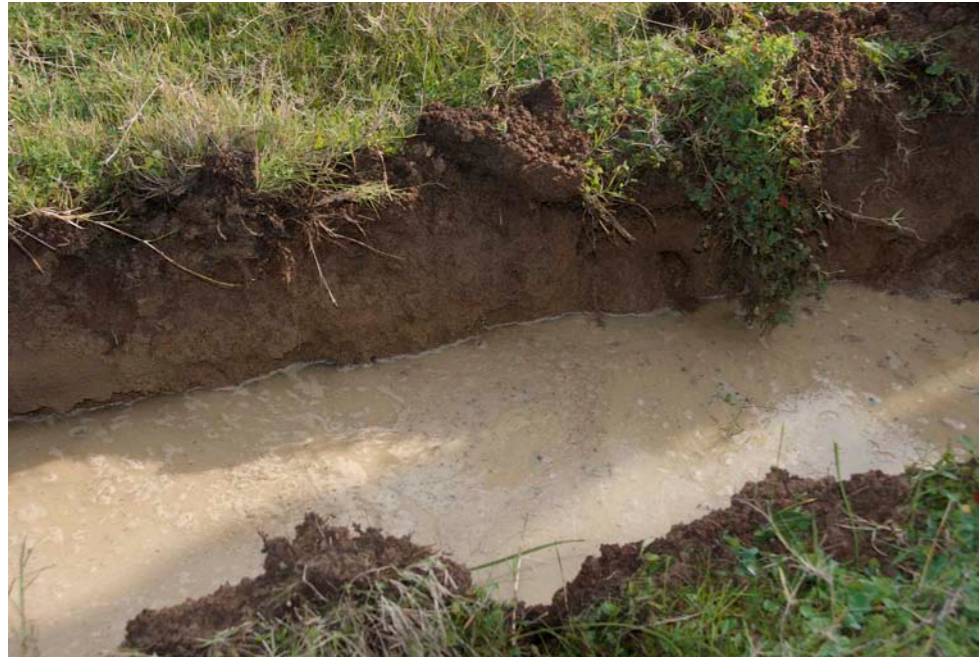
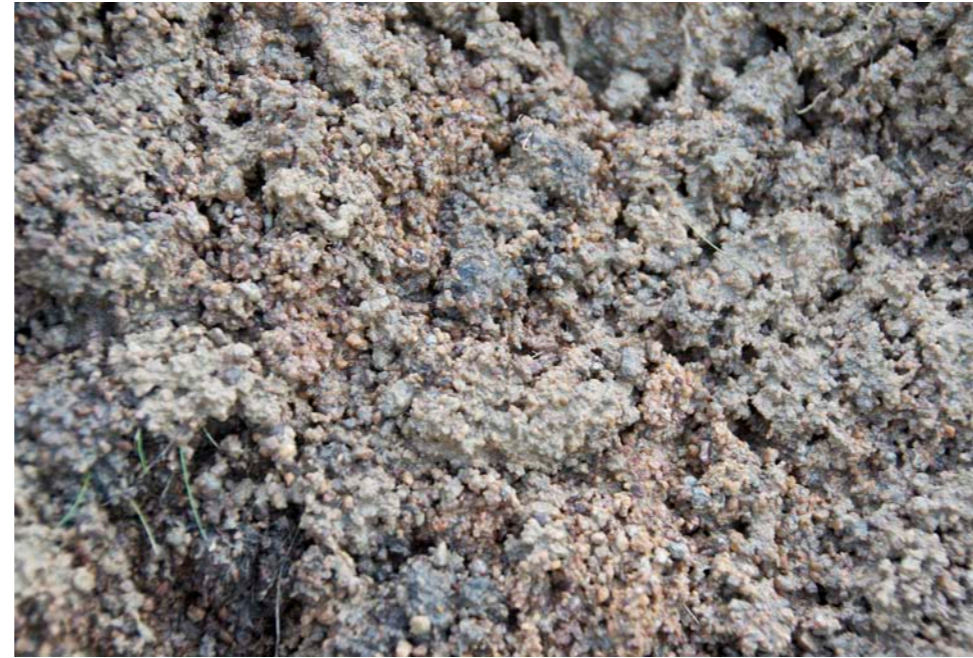
TP35 (Hole 004)

<b>TRIAL PIT NO:</b> TP35		<b>METHOD OF INVESTIGATION :</b> Digger/loader	
		<b>COORDINATES: X:</b> 3728546	
		<b>Y:</b> -387	
: o : : o :		GRAVELLY SILTY SAND Dry, greyish brown, dense, layered and	
: : : o : : :	0.15	locally slightly pinholed, slightly clayey medium to coarse sand	
: o : : o :		with a fine gravel component. Numerous fine roots to 0.1m.	
/ : o : : :		GRAVELLY CLAYEY SILTY SAND Dry, orange brown, very dense,	
: o : : o :		layered, clayey silty fine to coarse sand with a very minor fine	
/ : o : : :		gravel component. Alluvium.	
: o : : o :	0.65		
O : O : O		SILTY SANDY GRAVEL Dry, brownish grey, very dense/hard (weakly	
: O   O :		cemented), intact, sandy fine gravel with a minor slightly clayey and	
O : O : O	1.00	silty coarse sandy matrix. Alluvium/pedogenic.	
NOTE: Machine refused at 1m depth.
