**Underwater Heritage Impact Assessment  
for the Proposed Offshore Sandwinning for Developments  
within the Port of Durban, KwaZulu-Natal**

**UNDERWATER HERITAGE IMPACT ASSESSMENT FOR THE PROPOSED OFFSHORE SANDWINNING FOR DEVELOPMENTS WITHIN THE PORT OF DURBAN, KWAZULU-NATAL, SOUTH AFRICA**

**Report #:** 2016/DBN/005  
**Status:** Final  
**Revision #:** 2  
**Date:** December 2016

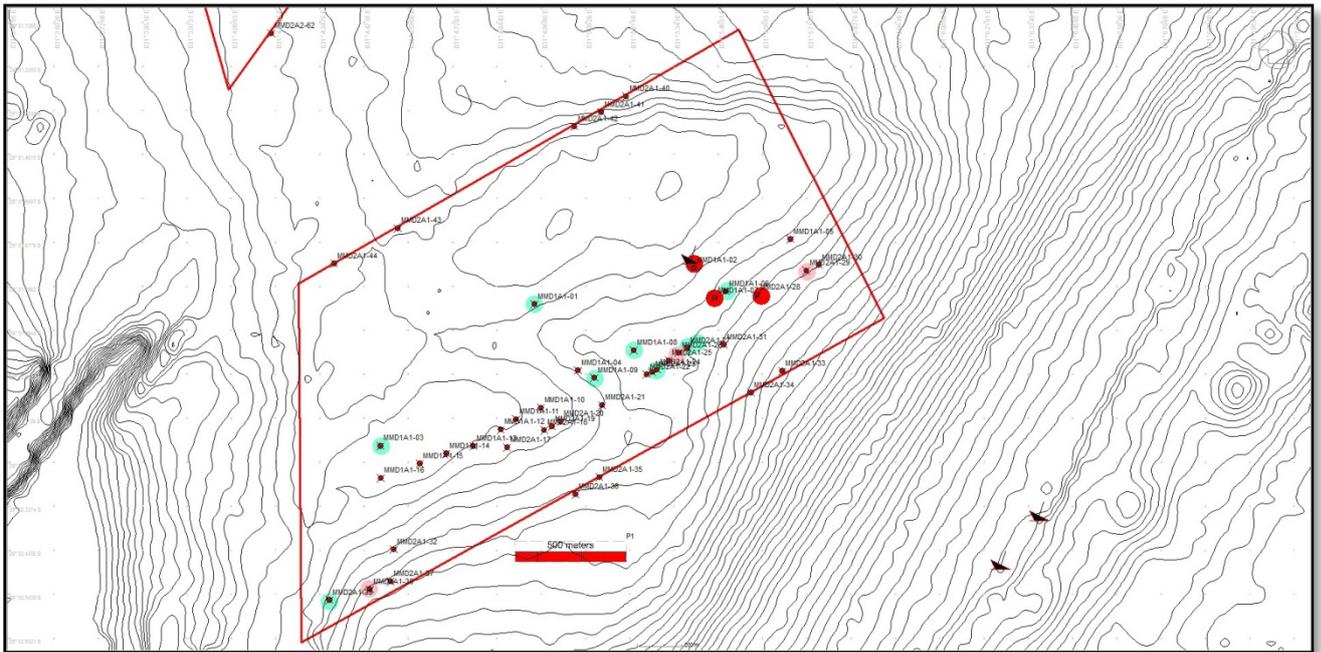
Figure 8: Alternative 1 and 2 – Field Data Magnetic Anomalies showing diver search results (Adapted from Council for Geoscience map: 2001)

The mark – MMD1A1-02 – is a 30m long metal trawler known to local divers as “Stuart’s Wreck”. The actual identity of the wreck has not been established to date. All of these strong hits were in the general area of “Stuart’s Wreck”, that is the south-eastern corner of Alternative 2.

All the relevant magnetic anomalies occurred within Alternative Area 2. Diver searches were conducted on 34% of these hits, of these only two had visible metal objects which may be MUCH sites. All of these were in the general area of “Stuart’s Wreck”, that is the south-eastern corner of Alternative 2. For full details of the

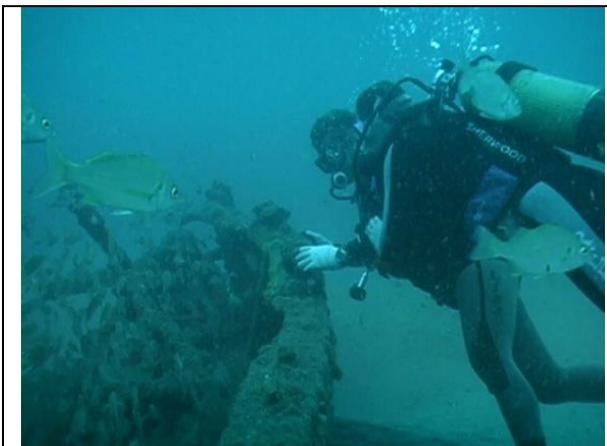
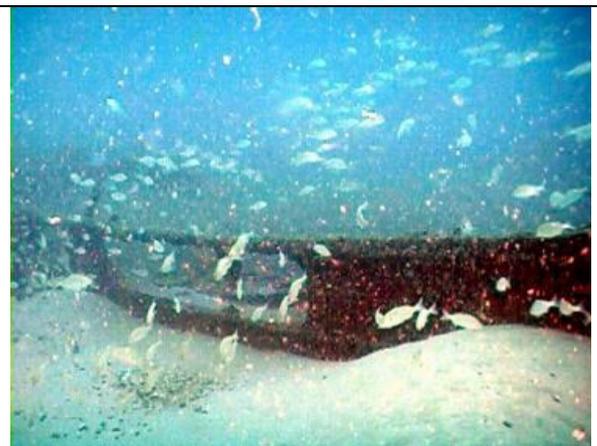
Figure 9: Sports divers on the bow of ‘Stuart’s Wreck’ (Image: Naude: 2009)

Figure 10: The Gunnel of ‘Stuart’s Wreck’ (Image: Naude: 2009)

Therefore, I would recommend dredging in Alternative 1. However, the dredgers should be aware of their work environment and follow the recommended management measures should they uncover any potential MUCH sites during the work.

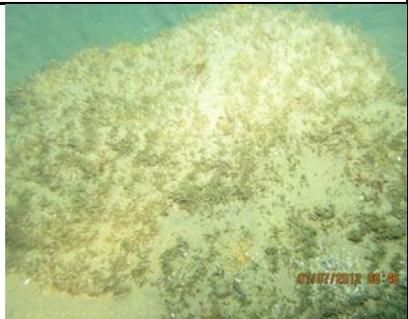
12	29 051.839' S	31 05.560' E	300	21	MMD2A1-28	07-07-2012	G. King A. Booysen	25 m	7 min	15 m	Slight current	Flat sand. Lots of bait fish. Protruding metal block. 10mm diameter cable.

Figure II – 1: Protruding metal object (King: 2012)

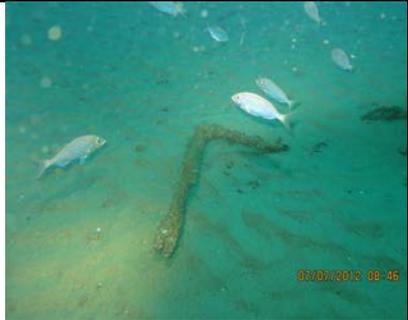
Figure II – 2: Cable (King: 2012)
13	29 051.780' S	31 05.700' E	30	9	MMD2A1-29	07-07-2012	D. Robinson T. de Sousa	26.3 m	8 min	15 m	Slight current	Sand. No fish life. Protruding wedge shaped metal object, 50 x 30 x 20 cm. Covered in marine growth.

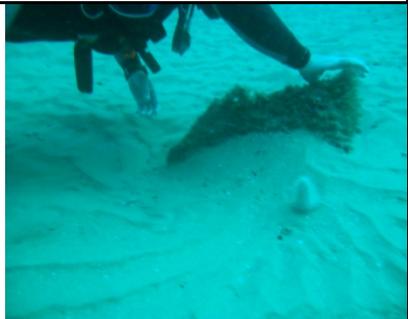
Figure II – 3: Wedge-shaped object (de Sousa: 2012)
14	29 051.766' S	31 05.735' E	25	9	MMD2A1-30								
15	29 051.959' S	31 05.465' E	120	9	MMD2A1-31								
16	29 052.449' S	31 04.529' E	120	9	MMD2A1-32								
17	29 052.026' S	31 05.628' E	60	9	MMD2A1-33								
18	29 052.078' S	31 05.539' E	70	15	MMD2A1-34								
19	29 052.280' S	31 05.110' E	70	9	MMD2A1-35								
20	29 052.321' S	31 05.042' E	45	9	MMD2A1-36								
21	29 052.528' S	31 04.519' E	15	6	MMD2A1-37								
22	29 052.546' S	31 04.461' E	130	9	MMD2A1-38	14-07-2012	D. Moldenhauer L. Ehlers	26 m	4 min	7 m	Slight current	Sand. Some bait fish. Sheet of wood.

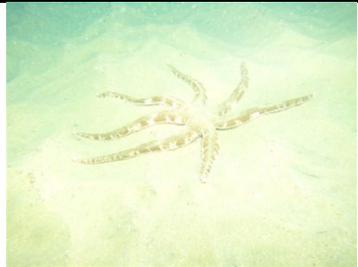
7	29 049.834' S	31 04.459' E	600	18	MMD4A2-94	05-08-2012	S. Donkin B. Karlsen	22 m	6 min	6 m		Sand. 20 m scatter of coal. Rusted cable, 52.5cm x 5 m. Modern wine bottle.	Figure II – 5: Starfish (King: 2012)
8	29 049.777' S	31 04.434' E	20		MMD4A2-95	05-08-2012	M. Zunckel R. Zunckel	22.5 m	9 min	6 m		Fine sand with decayed organic matter. Some bait fish. Sea pens. Sea grass.	
9	29 049.737' S	31 04.419' E	15		MMD4A2-96								
10	29 049.500' S	31 04.351' E	425		MMD4A2-97	05-08-2012	G. King	21.5 m	4 min	6 m		Fine sand. Some bait fish. Sea pens.
