Heritage Application – Vista High School

2. SECTION 27/ SECTION 29/ SECTION 31/SECTION 34 - APPLICATION FOR A PERMIT, MINOR WORKS:

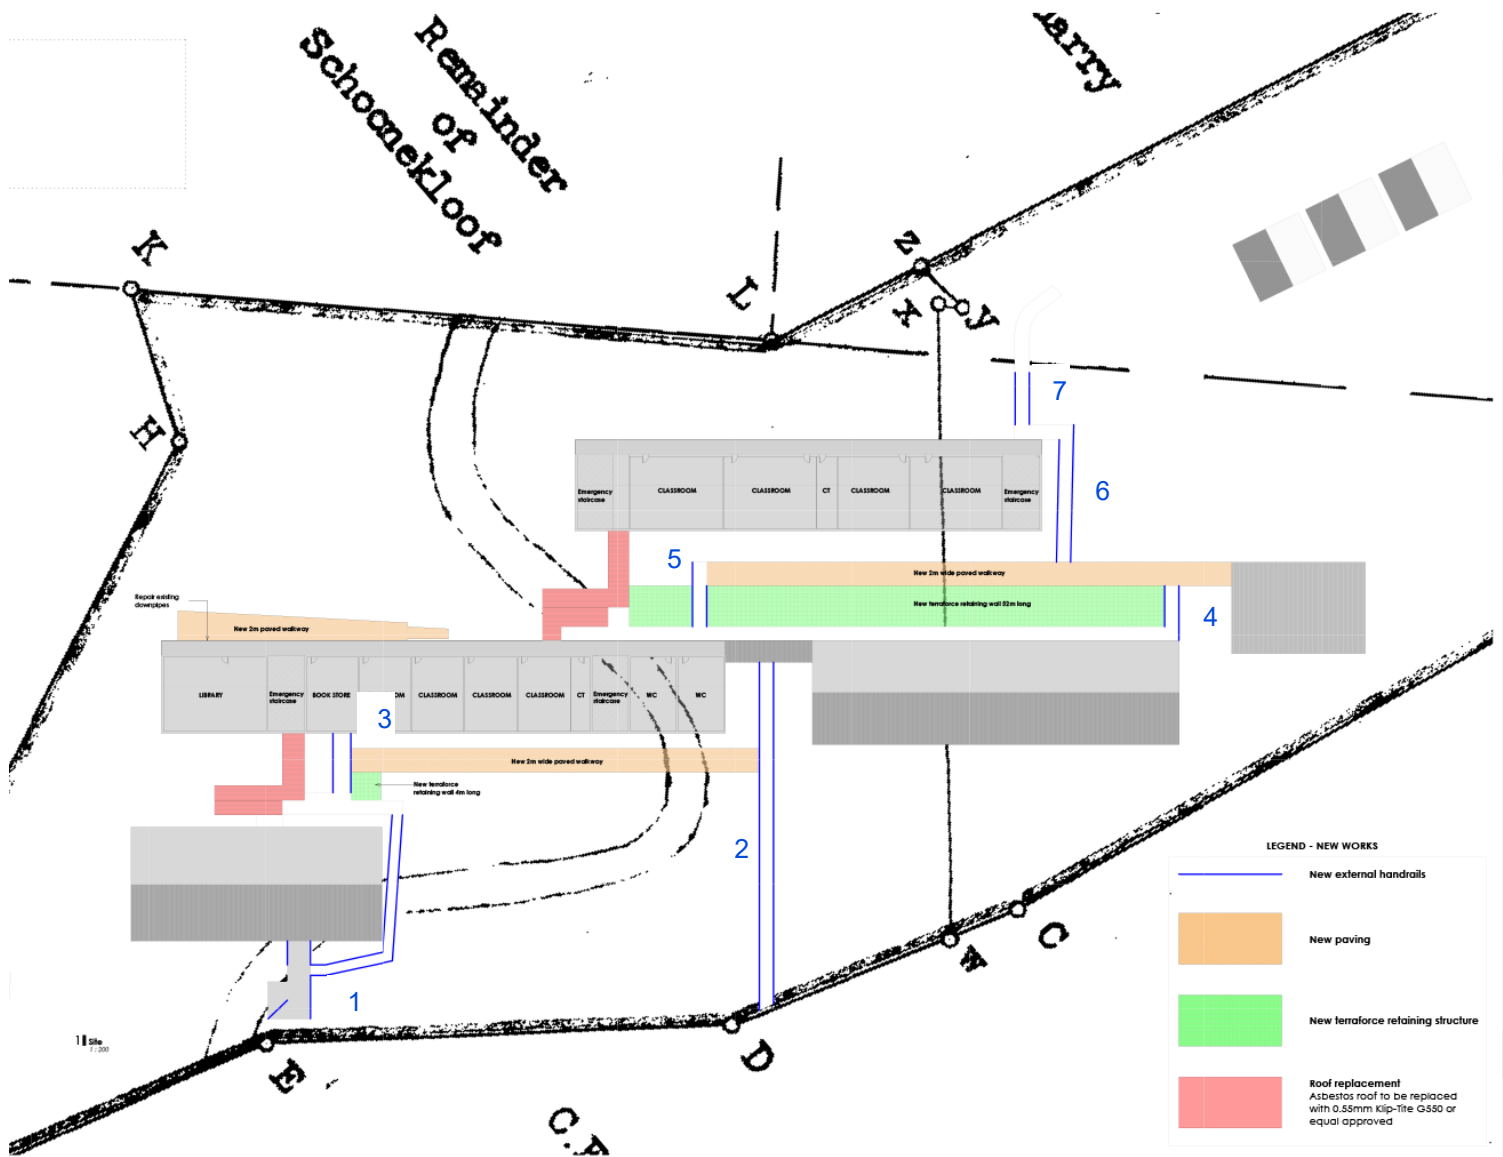
1. SITE PLAN – PROPOSED SCOPE OF WORKS

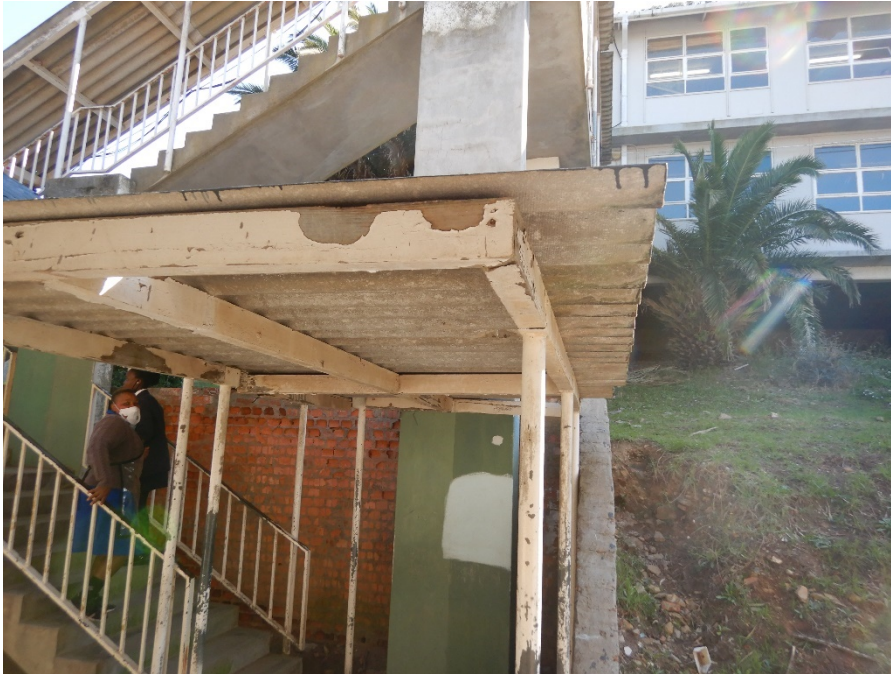
Figure 4: Condition of roof canopy – asbestos sheeting to be replaced.

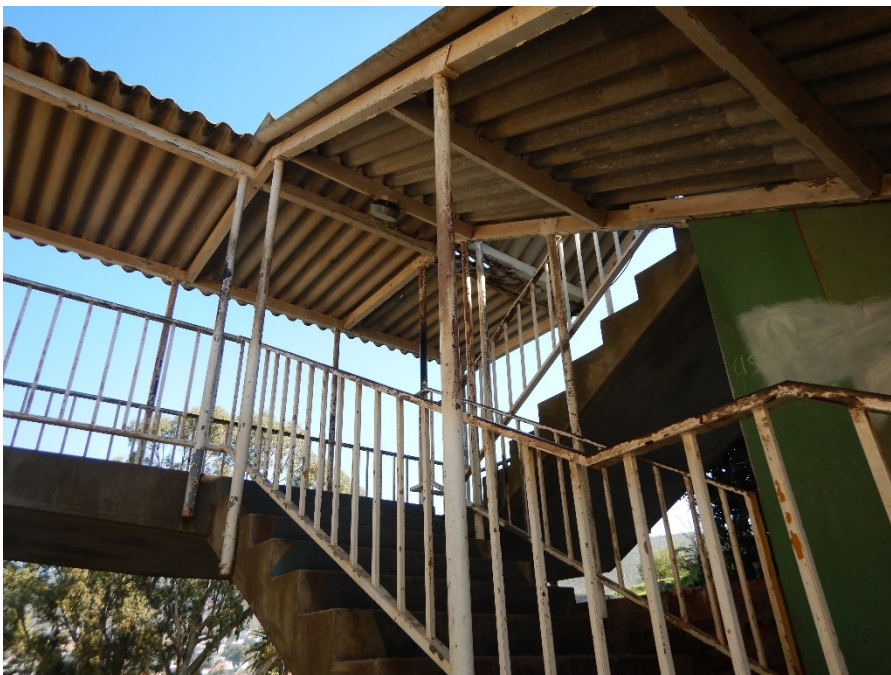
Figure 4.1: Condition of roof canopy – steel posts weathered and corroded.

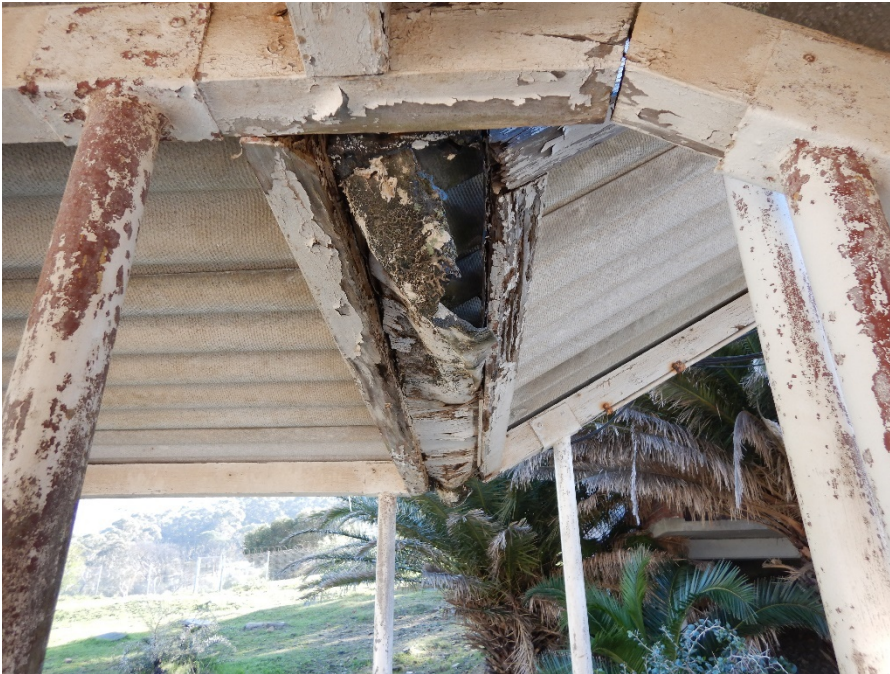
Figure 4.4: Condition of roof canopy – rotting of timber members impacting structural integrity.

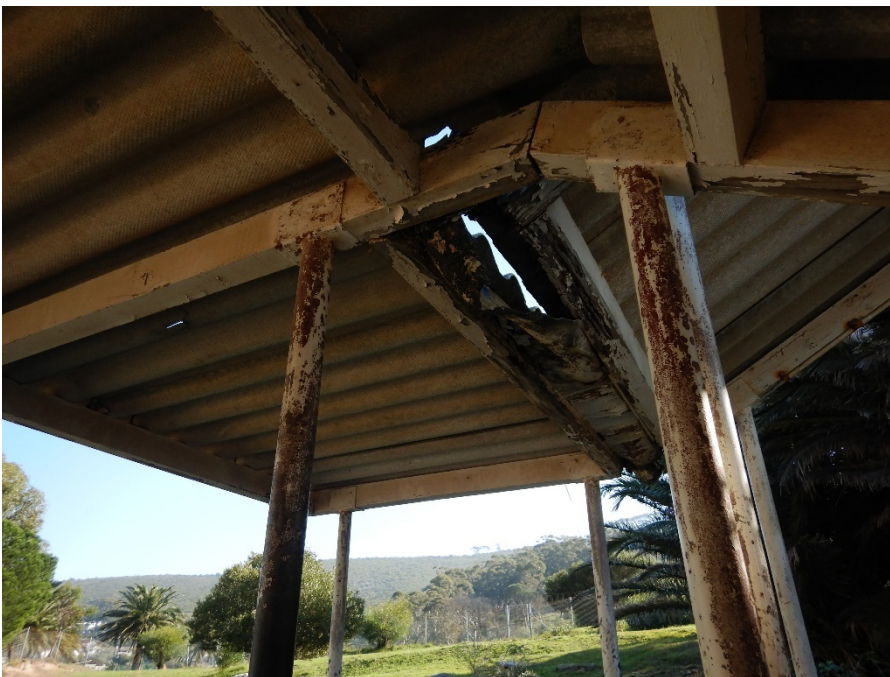
Figure 4.5: Condition of roof canopy – exposed rusted fixing members hazardous for learners.

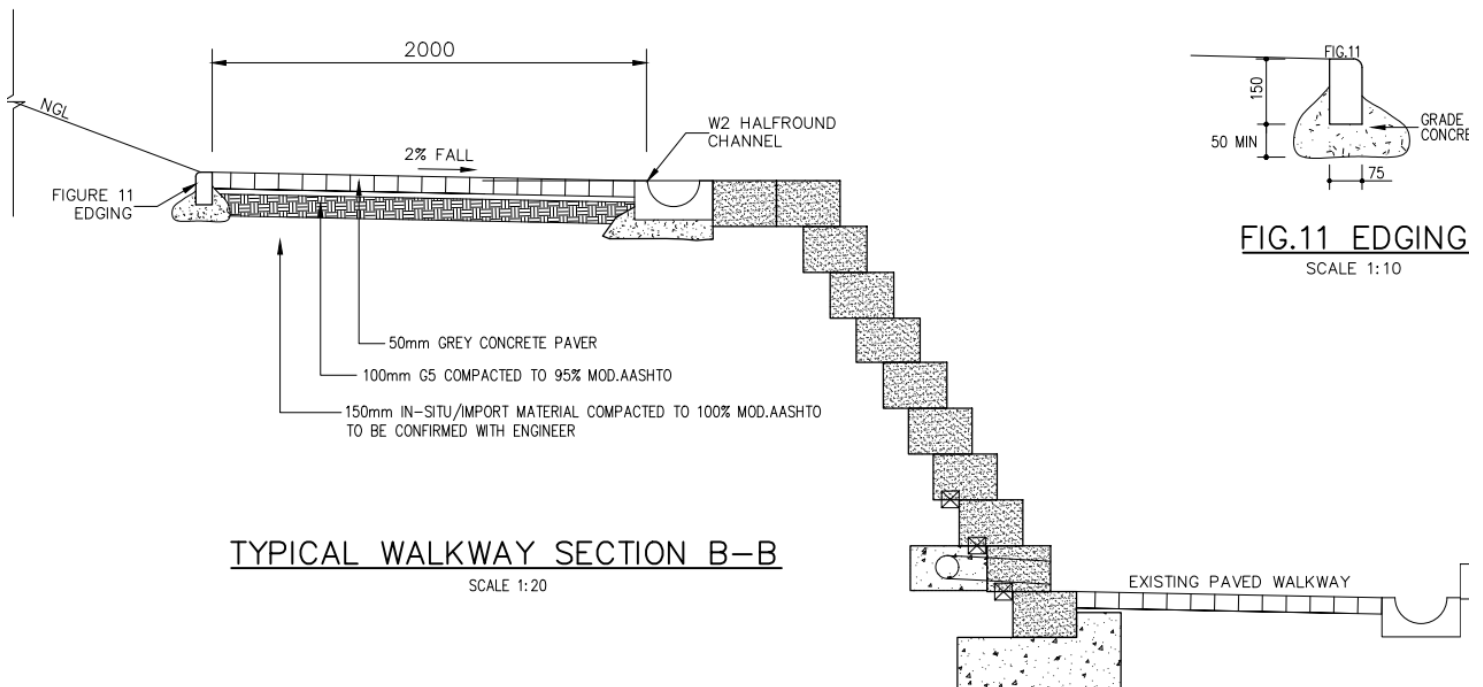
Figure 4.15: paving and retaining structure detail.

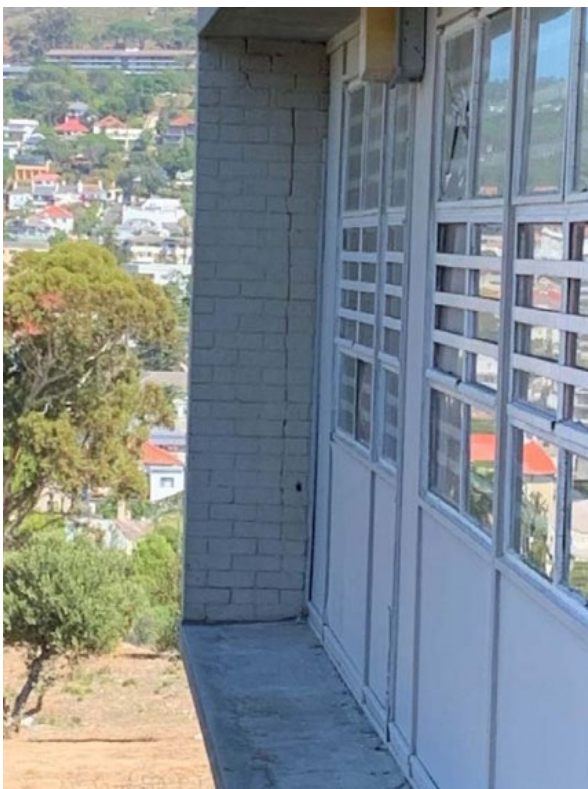
Figure 4.17: cracking in structural brickwork.

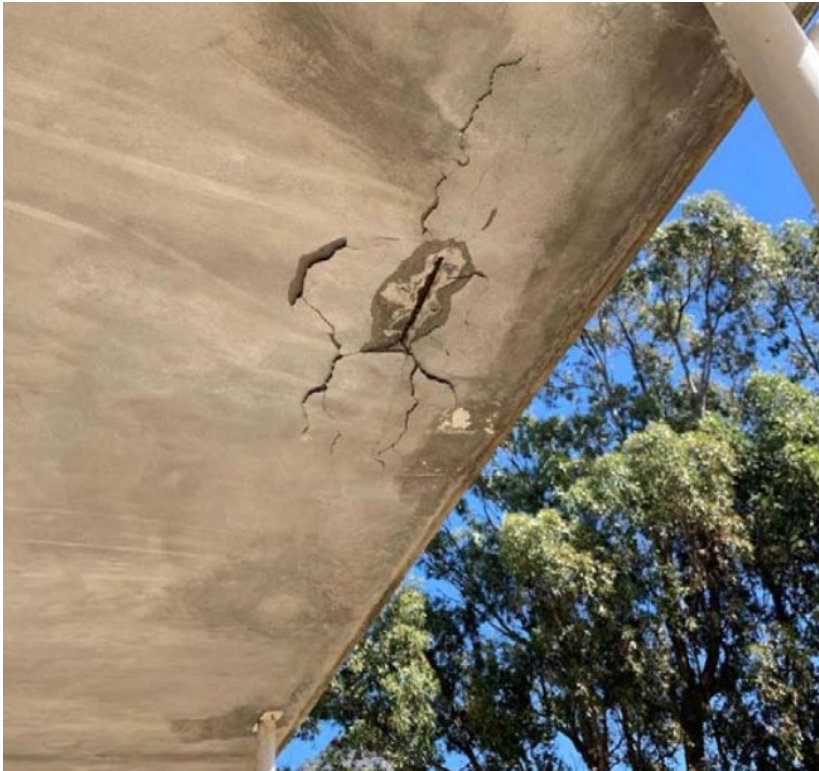
Figure 4.18: concrete spalling and cracking.
