**WETLAND DELINEATION IN THE RUSTENBURG
PLATINUM MINE PROJECT AREA AND A HIGH
LEVEL ASSESSMENT OF SELECTED RIVER
CROSSINGS, NORTH-WEST PROVINCE**

Prepared for

SRK Consulting (Pty) Ltd

May 2015

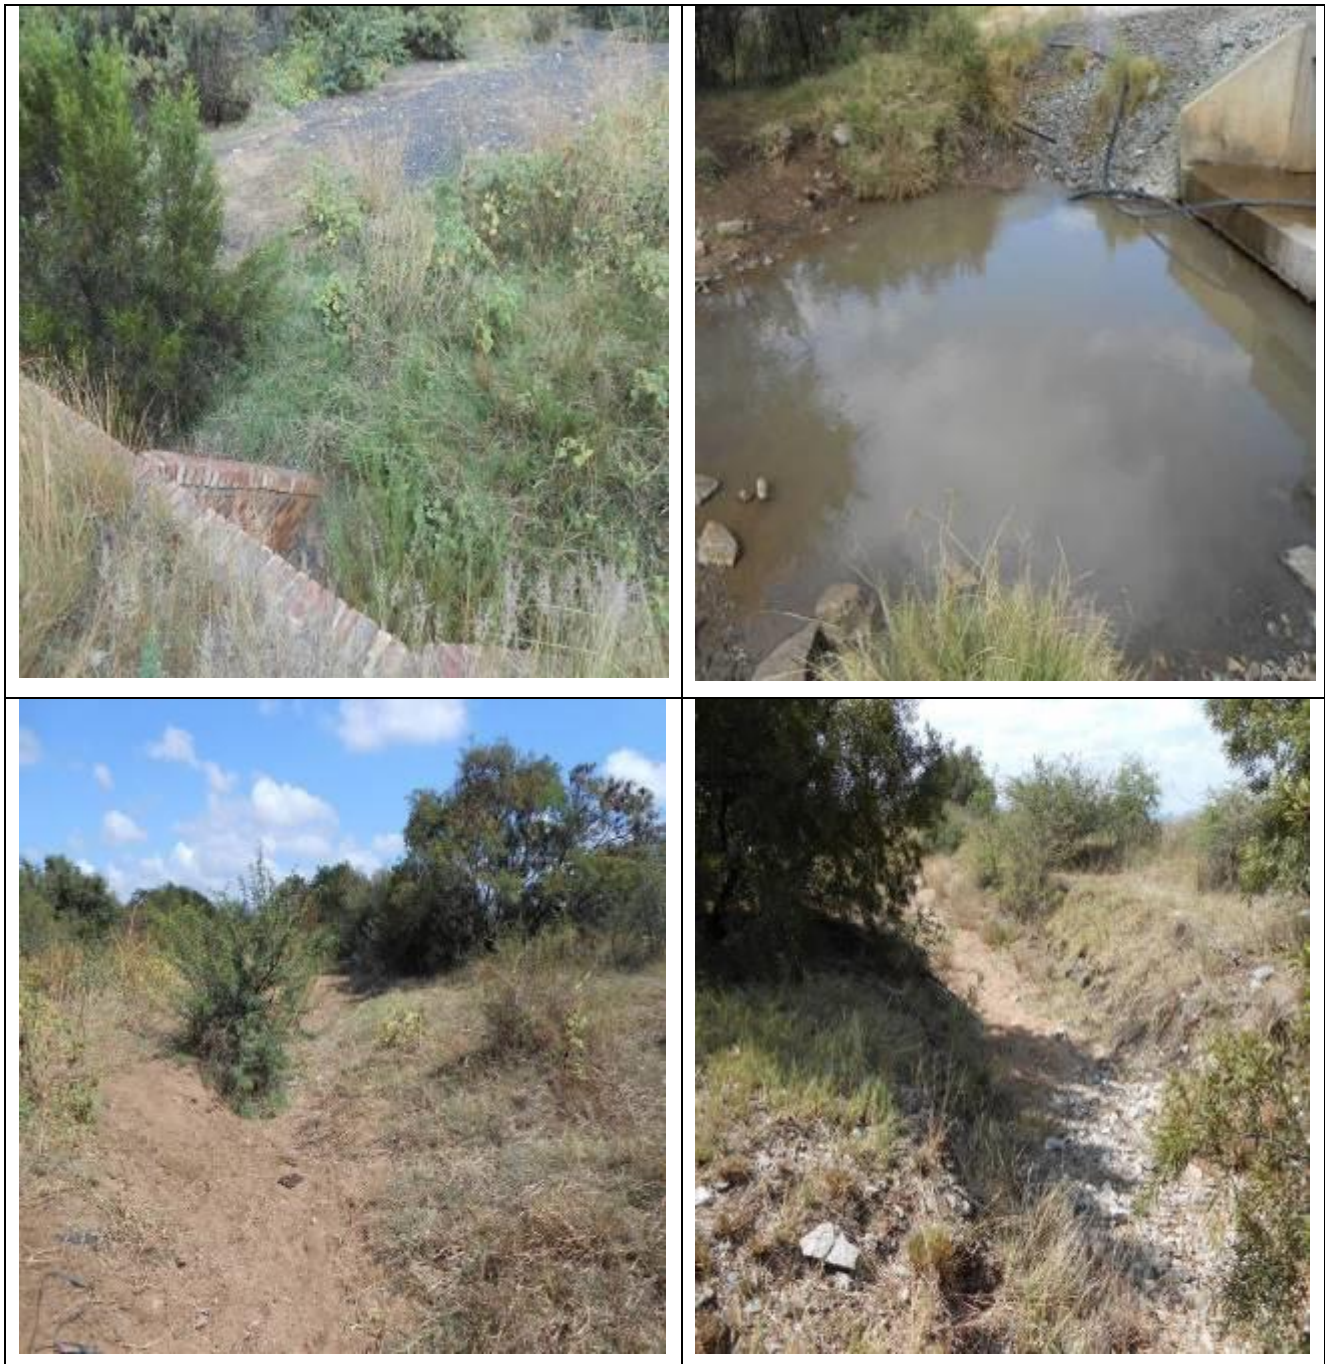
The hydrology of the system has been moderately modified by the construction of the bridges/road crossings which increases the width and in some portions the depth of the channel. There were water abstraction activities observed on site which might be used by the community for crop irrigation. This activity contributes to the modification of the hydrology of the system. Potential influences on water quality are sedimentation and runoff from the neighbouring communities as well as waste dumping. Furthermore, livestock grazing and trampling as well as increased runoff have resulted in the formation of erosion gullies within the system. The vegetation component of the system has been moderately disturbed, by the construction of the bridges as well as the effects of erosion. Alien vegetation such as *Xanthium strumarium*, *Asclepias fruticosa* and *Tagetes minuta* were observed on site. Due to the presence of the culverts and road crossings as well as sediment deposition, the geomorphology of the system has been moderately modified. The figure below represents the disturbances within the Wilbeesfontein system.

Figure 11: Representative photographs of the Wildebeesfonteinspruit (South of Khuseleka 2).

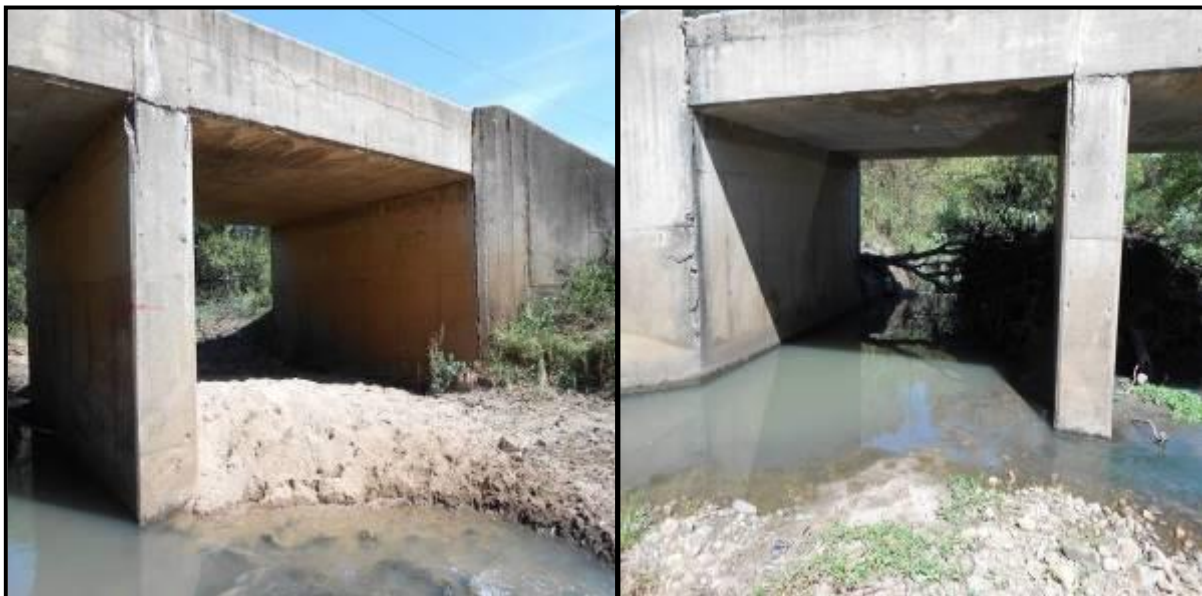
Figure 16: Sediment deposition and debris within the stream.

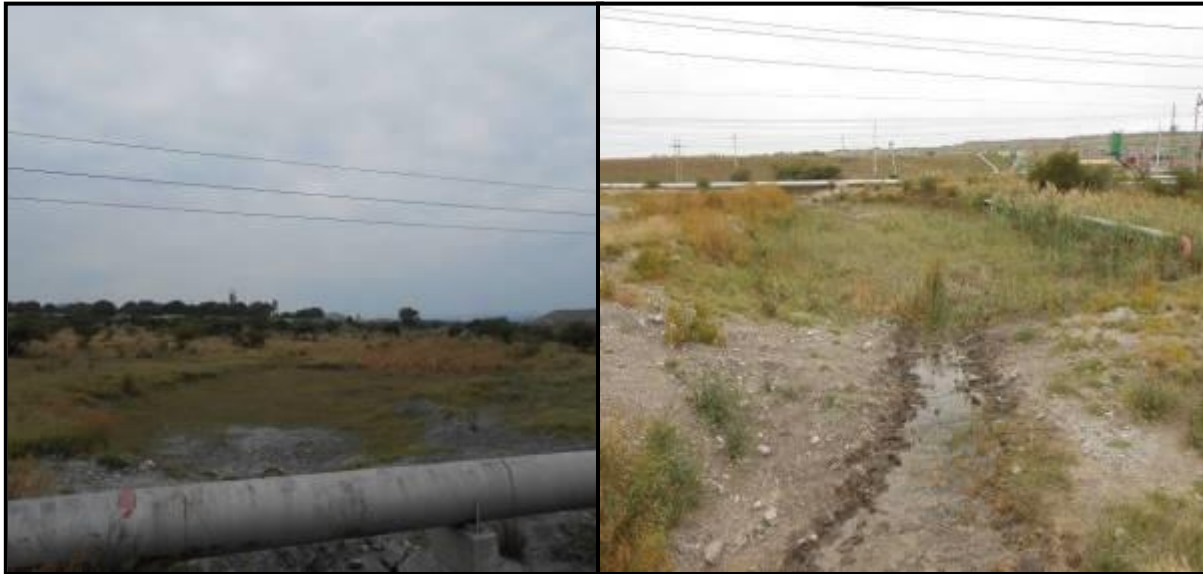
Figure 19: Erosion observed along the pipeline crossing within Klipgatspruit.

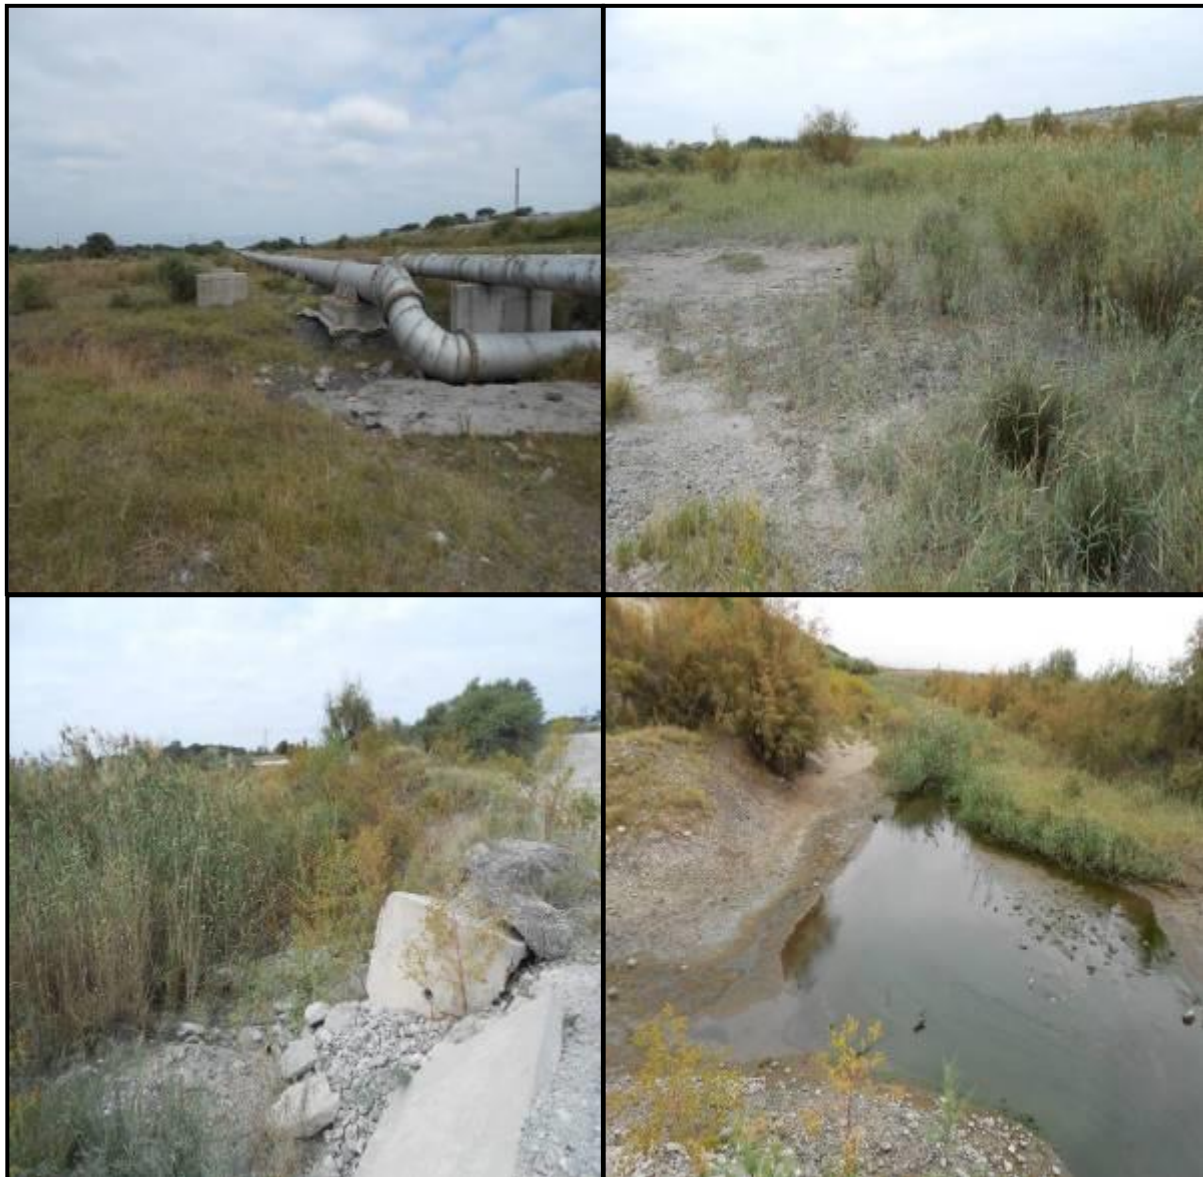
Figure 20: Disturbances within Klipgatspruit.

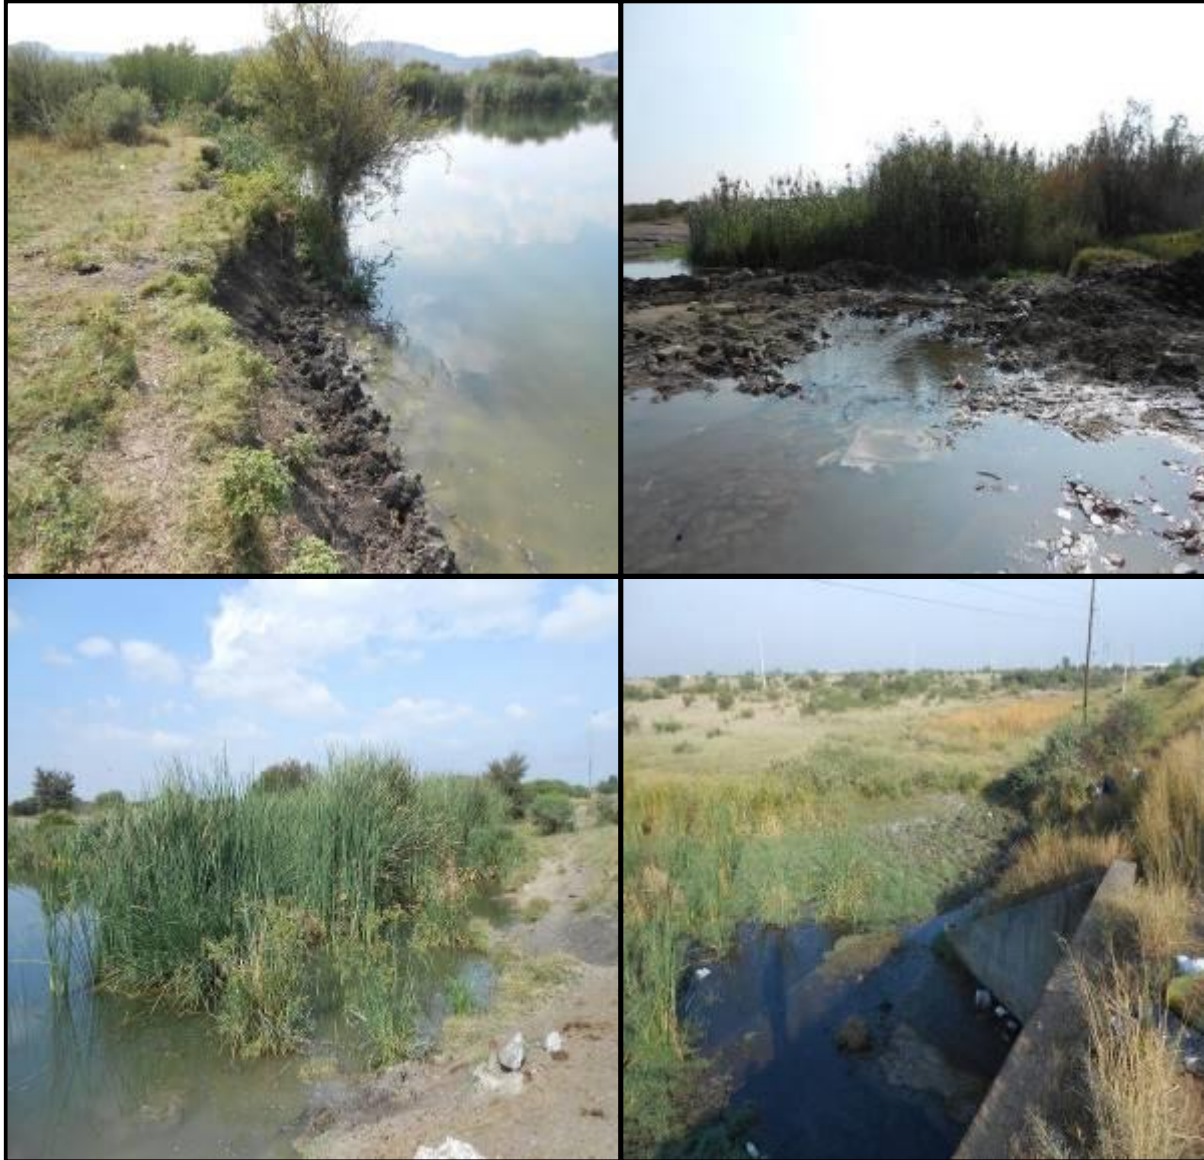
Figure 24: Representation of disturbances observed within Paardekraalspruit.

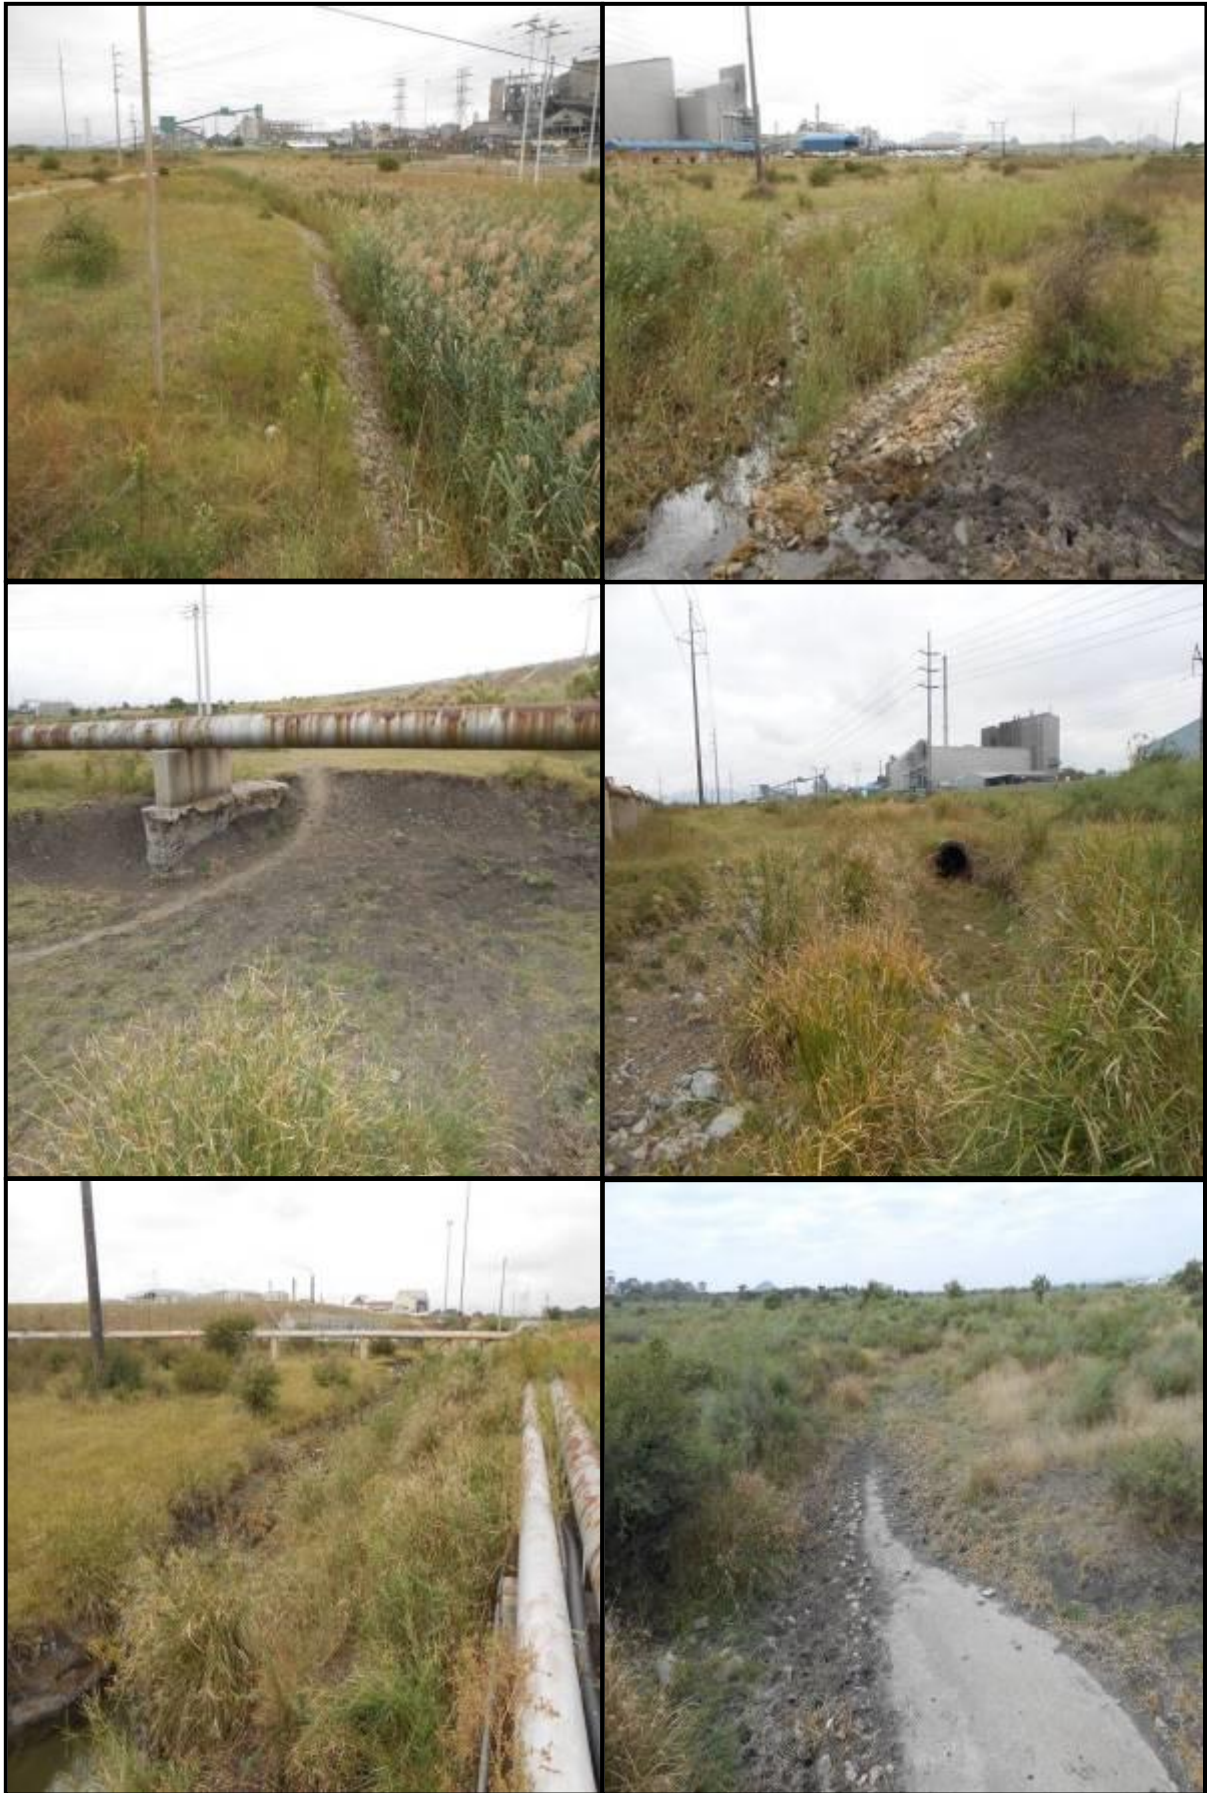
Figure 27: Disturbances within Klipfonteinspruit.

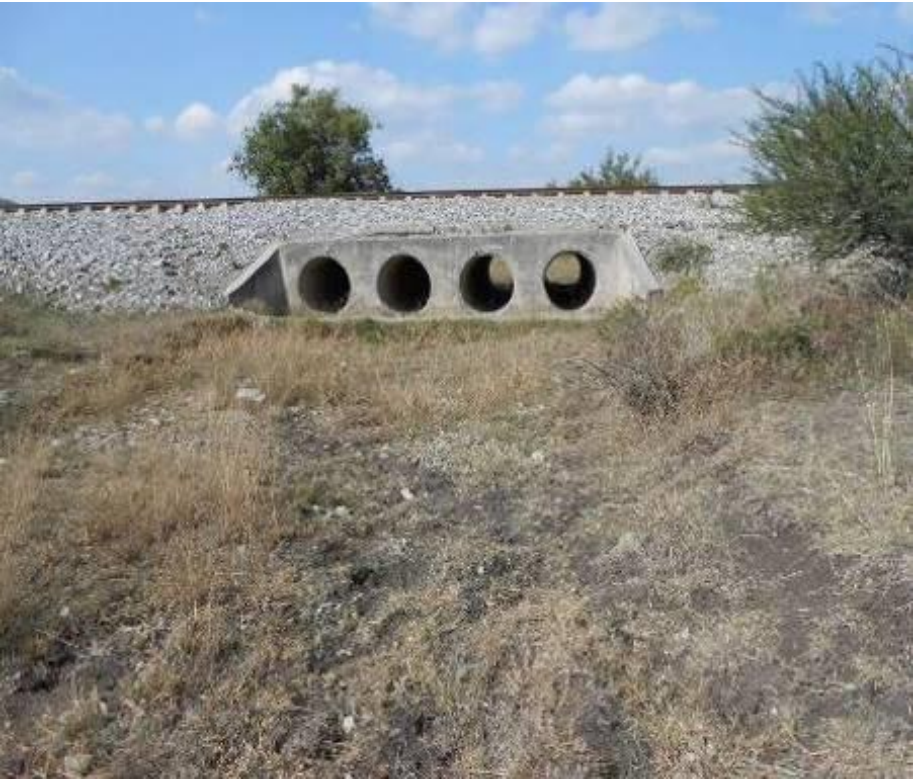
Site number: 02	Coordinates: 25°41'49.41"S 27°22'25.60"E
Crossing Type: Railway/Culvert	
Site Photo:

Present Ecological State	C
Wetland type	River
Morphology	Wide, shallow banks, ephemeral river. Culvert/bridge well-constructed; however the area adjacent to the culvert has been eroded due to the inherent vulnerability of the soils to erosion.
Riparian and in Stream Habitat	Acacia spp dominated bushveld vegetation; Instream ecology: well vegetated.
Vegetation	Alien species such as <i>Bonariensis verbena</i> and <i>Asparagus laricinus</i> have invaded the area, with <i>Acacia</i> tree species observed along the banks along the erosion gullies.
System Modifiers	Erosion, trampling and grazing by livestock.
Potential impacts of water use on environment	The culvert/bridge will not significantly negatively impact on any water users.
Socio-economic impacts of water use	The culvert/bridge will not significantly negatively impact on any water users.

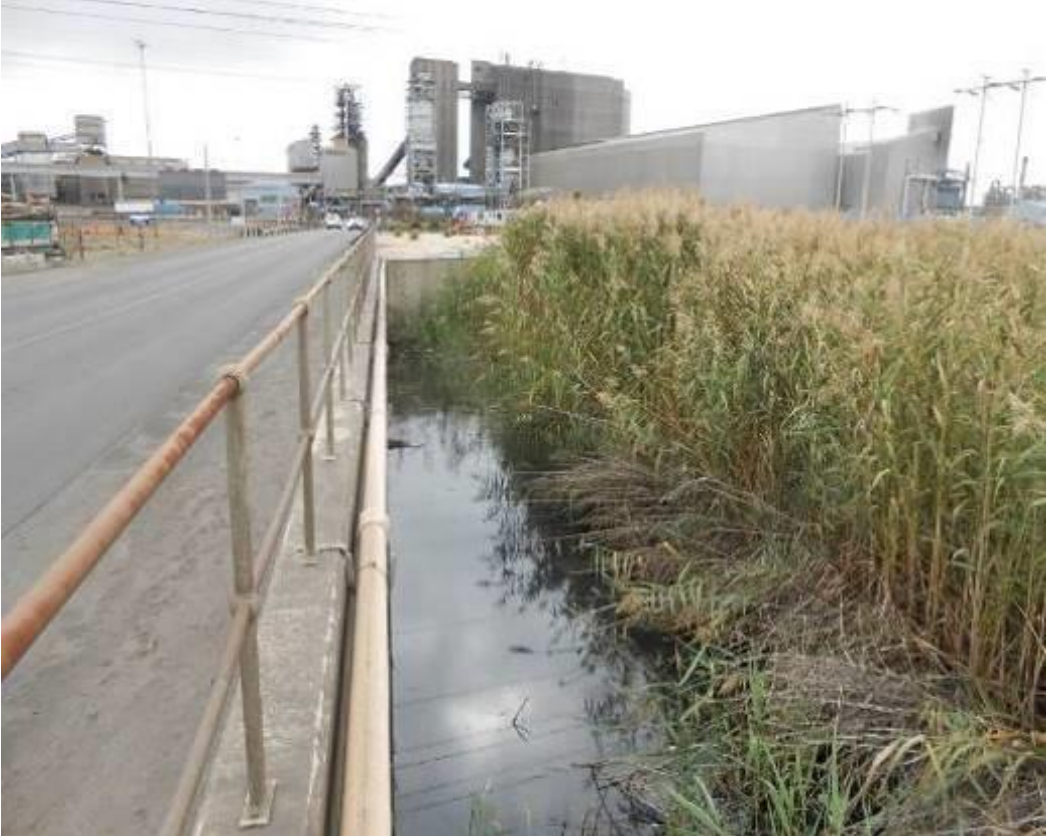
Present Ecological State	C
Wetland type	River
Morphology	The channel is mostly eroded on the area just below the bridge.
Riparian and in Stream Habitat	Primarily herbaceous and graminoid floral species, little to no overhanging vegetation. Instream ecology: inundation below the bridge
Vegetation	<i>Phragmites australis</i> , <i>Cyperus sexangularis</i> , <i>Asclepias fruiticosa</i> , <i>Tagetes minuta</i> .
System Modifiers	The feature is augmented due to discharge from the mining area. Bridge crossing increasing water input within the river.
Potential impacts of water use on environment	The road crossing will not significantly negatively impact on any water users.
Socio-economic impacts of water use	The road crossing will not significantly negatively impact on any water users.

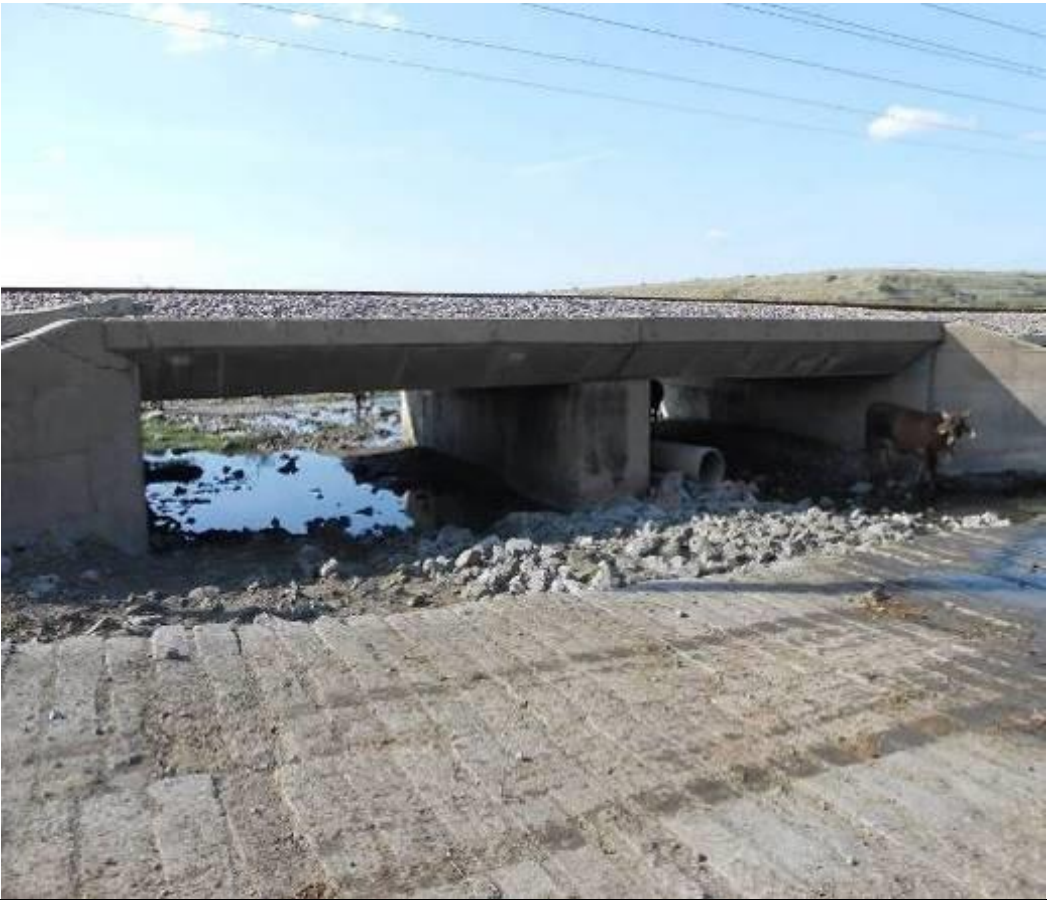
Present Ecological State	D
Wetland type	River
Morphology	The channel is not deep and it is more tramped below the crossing.
Riparian and in Stream Habitat	Acacia species dominated bushveld vegetation. Instream ecology:
Vegetation	<i>Cyperus sexangularis</i> , <i>Cynodon dactylon</i> , <i>Typha capensis</i> , <i>Acacia</i> spp.
System Modifiers	Infiltration due to paved surface which further increases runoff. Erosion. Livestock grazing and trampling.
Potential impacts of water use on environment	The railway crossing will not significantly negatively impact on any water users.
Socio-economic impacts of water use	The railway will not significantly negatively impact on any water users.
Socio-economic advantages of water use	The railway line is utilised for the mining operations.
Potential impacts of water use on water resource	The railway is not considered likely to have a significant impact on the resource; however the culvert will alter water flow patterns and there will be reduced infiltration since the area is cemented just below the culvert.

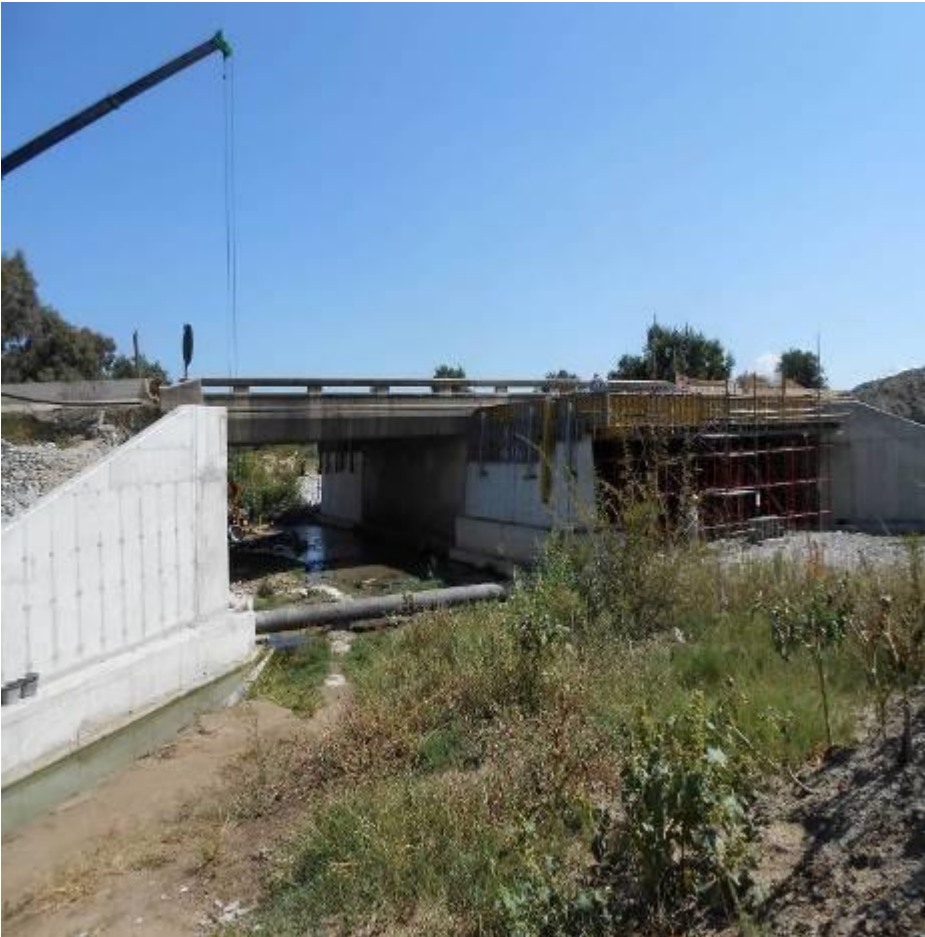
Present Ecological State	D
Wetland type	River
Morphology	Wide, relatively shallow channel.
Riparian and in Stream Habitat	Water flow ceased due to construction.
Vegetation	<i>Xanthium stramonium</i> , <i>Flaveria bidentis</i> , <i>Erqagrostis gummiflua</i> , <i>Sporobolus africanus</i>
System Modifiers	Road bridge construction. Erosion. Stockpiling.
Potential impacts of water use on environment	The road crossing will not significantly negatively impact on the environment.
Socio-economic impacts of water use	The road crossing will not significantly negatively impact on any water users.
Socio-economic advantages of water use	The road crossing plays an important role in providing connectivity in the area, particularly to the local community, thereby allowing economic activity in the area.

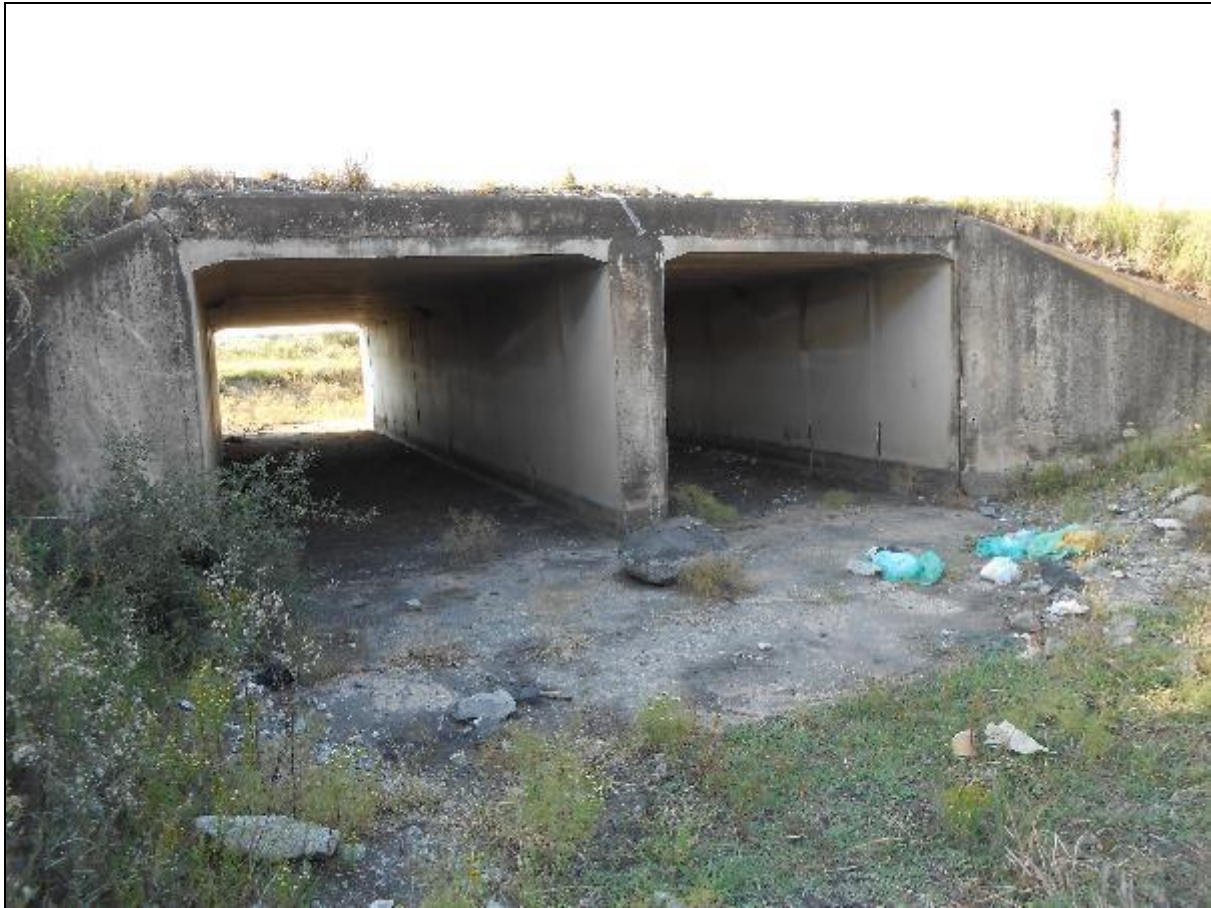
Figure 67: Culvert Bridge indicating the artificial habitat within the structure.

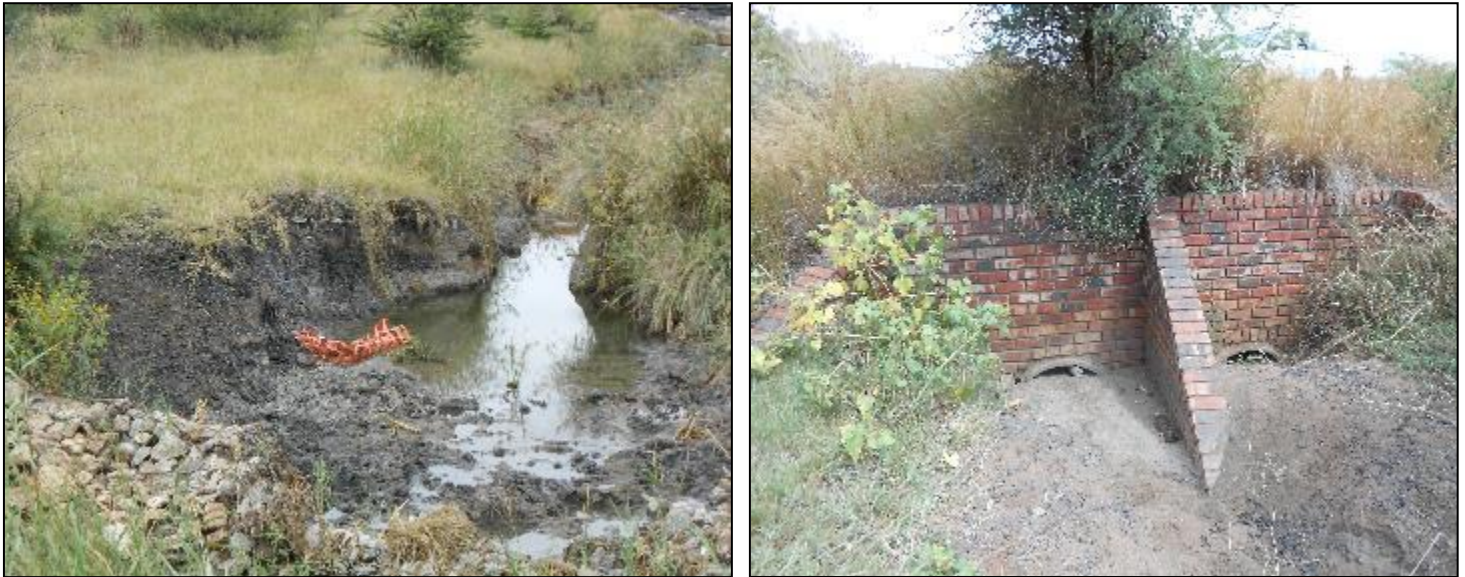
Figure 68: Erosion and Sedimentation evident at crossings within the RPM boundary.

- Any areas where bank failure is observed, due to the effects of bridge crossings, should be immediately repaired by reducing the gradient of the banks to a 1:3 slope and where deemed necessary, installing support structures;

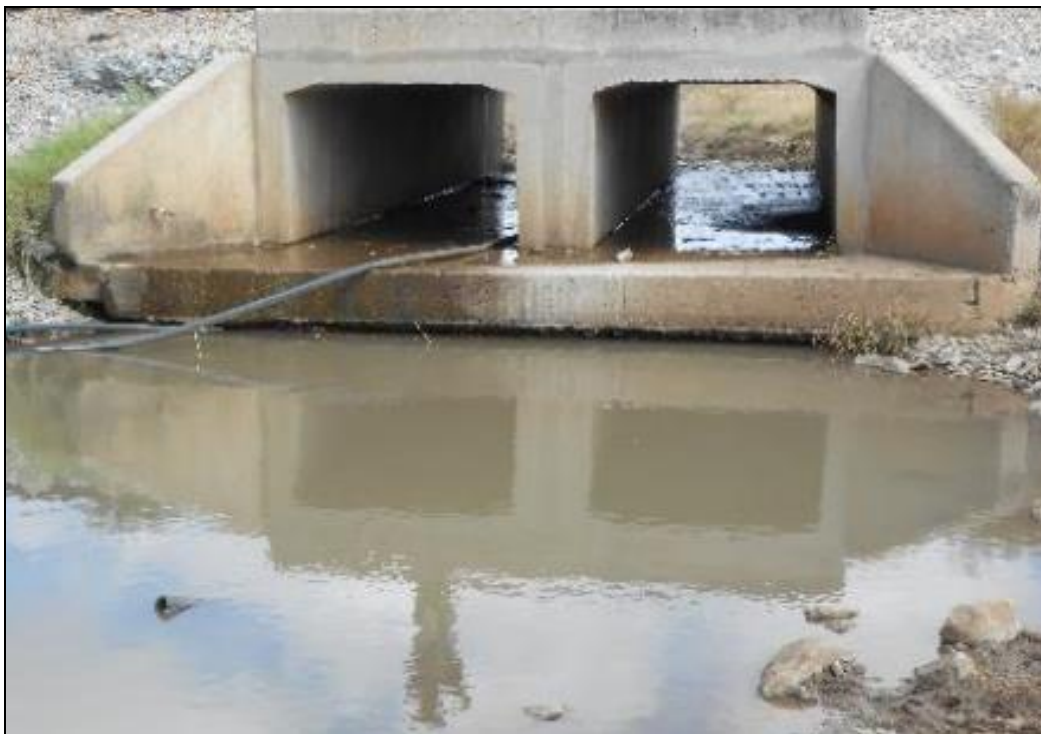
Figure 69: Culvert Bridge indicating the scouring and undermining of the Culvert structure resulting in altered stream hydrology.

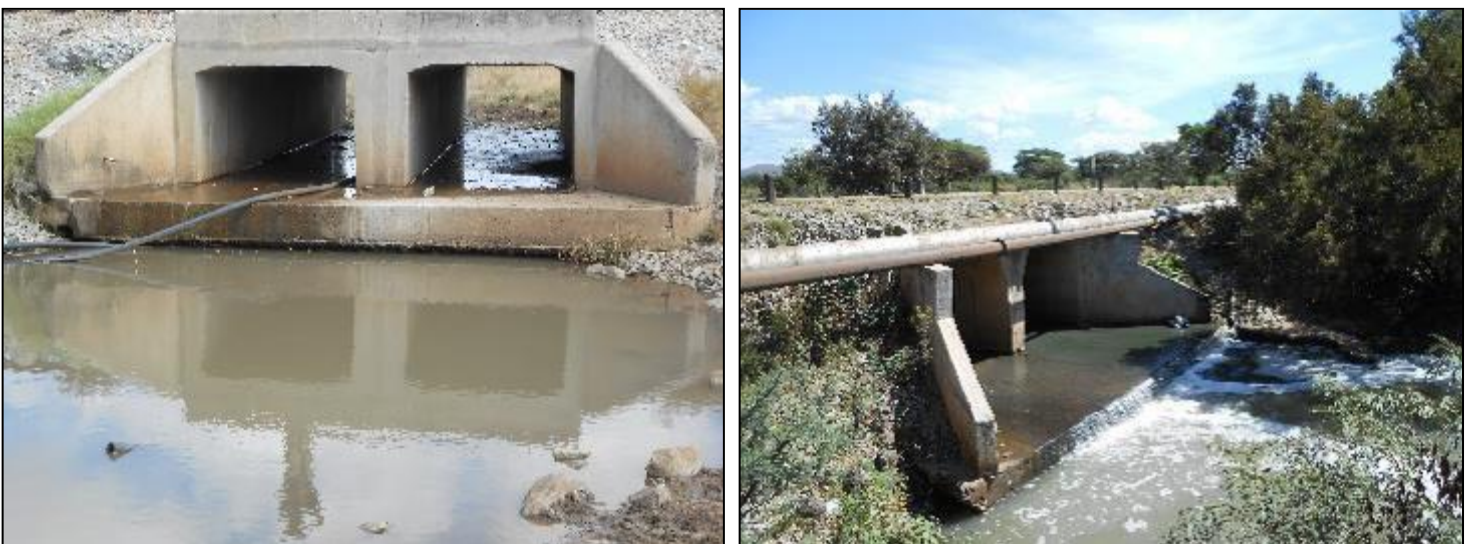
Figure 71: Culvert Bridge indicating elevation drops at biomonitoring sites.

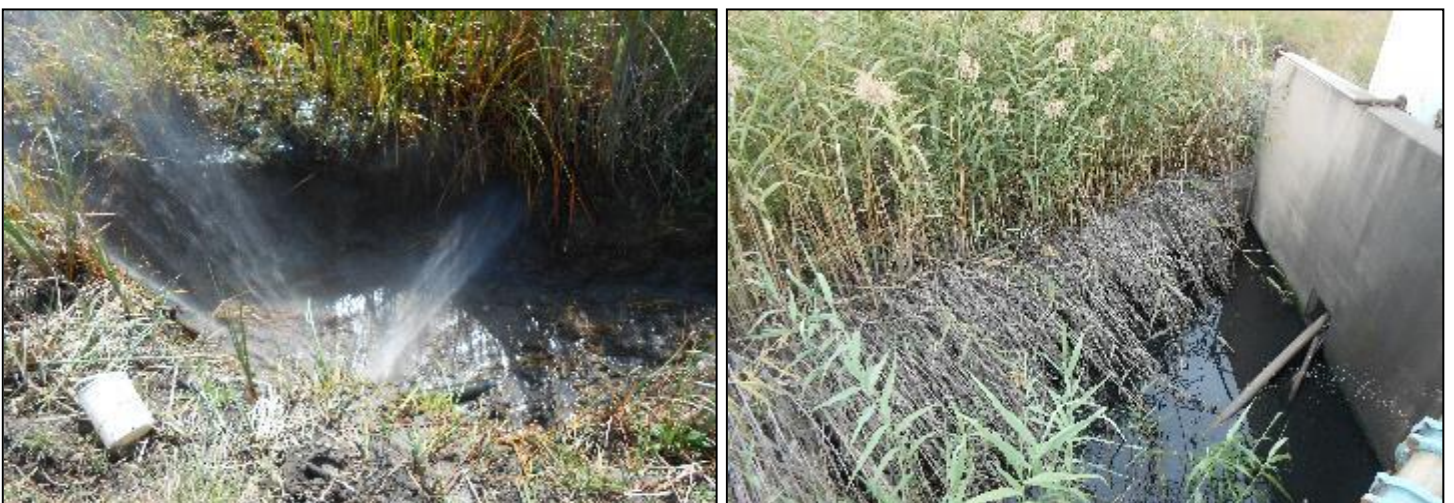
Figure 73: Leaking pipes within the RPM operations boundary.

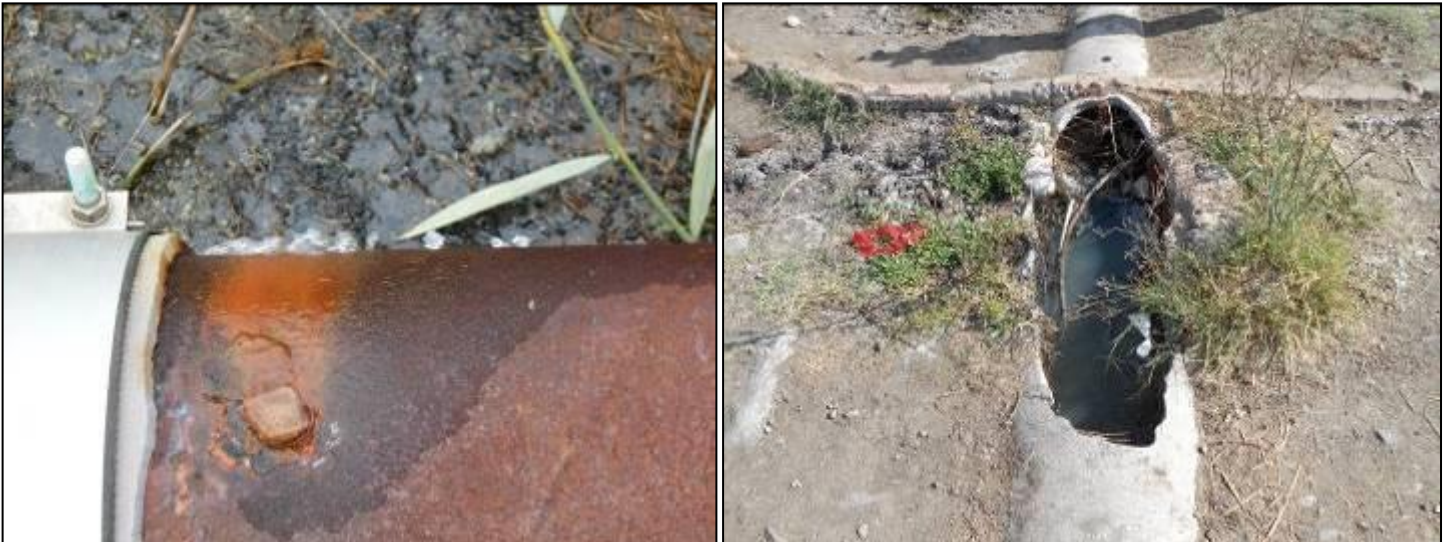
Figure 74: Leaking pipes within the RPM operations boundary and broken pipes within the rural residential area.
