5 FIELDWORK AND FINDINGS

A controlled surface survey was conducted on foot and by a vehicle by an archaeologist from PGS. The fieldwork was conducted 24 September 2020. The tracklogs (in yellow) for the survey are indicated in **Figure 19**.

The study area is a proposed powerline situated about 5 km north of Aliwal-North running from the N6 highway in a south-westerly direction through a valley towards the Orange River. The eastern part of the proposed line runs west from the edge of the N6 over a large open field that is predominantly used as grazing for cattle. A disused railway line runs across this landscape from south to north.

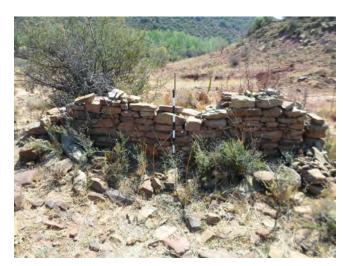
Waypoints 514, 515 and 517 marks a Historical homestead that is situated on the end where the valley opens up again into a large open field that is being used to grow crops and graze livestock. The homestead consists of multiple packed stone features/buildings (515) with some red brick elements present, as well as a large rectangular packed stone enclosure or kraal (514). The small homestead is built on the shoulder inline of the small hill which forms part of the valley through which the proposed line runs. Another small structure (517) is situated further up the hill. This structure is also a small packed stone feature; however, this site is extremely overgrown, making it difficult to assess the extent of the feature.

Figure 16 – Remainder of stone wall at 515

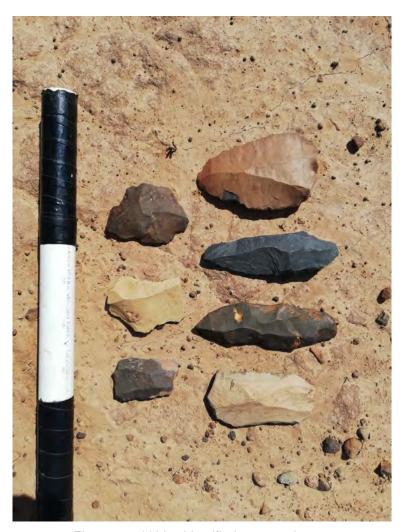
Figure 18 - Lithics identified at waypoint 507
