**PHASE 1 ARCHAEOLOGICAL IMPACT ASSESSMENT FOR ELEPANT
CREEK RESORT CC., CLANWILLIAM DISTRICT, WESTERN CAPE**

13 February 2007

*Proactive Archaeology
Renée Rust & Sarah Wurz
PO Box 71, Grabouw, 7160
Cell: 082 394 5588*

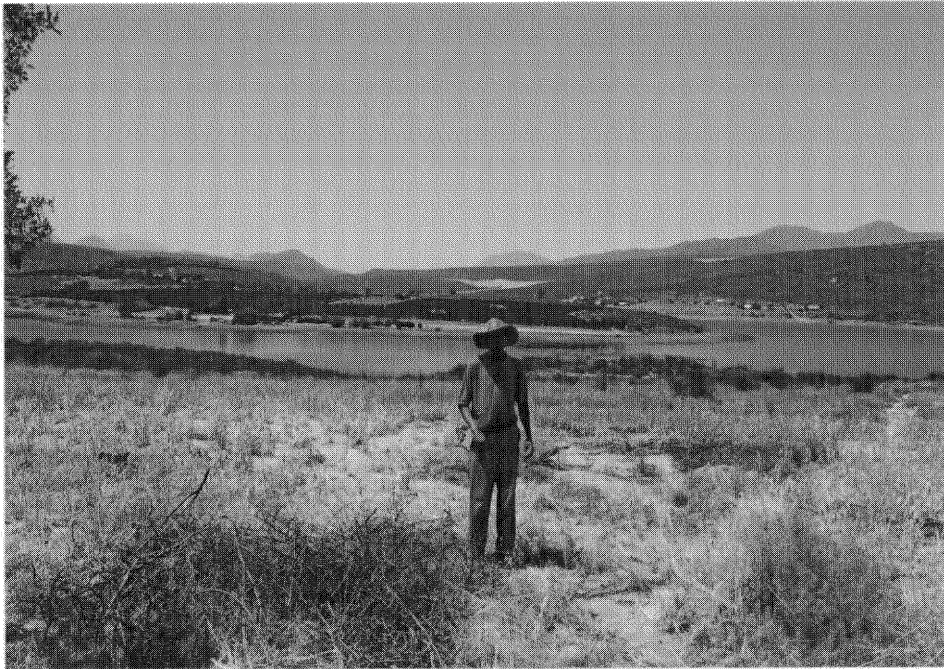
Fig. 2. View of the Clanwilliam Dam and area of the proposed development stretching further down (250m) from where Petrus Dirks is standing in the foreground of the photograph. The disturbed nature of the soil is evident.

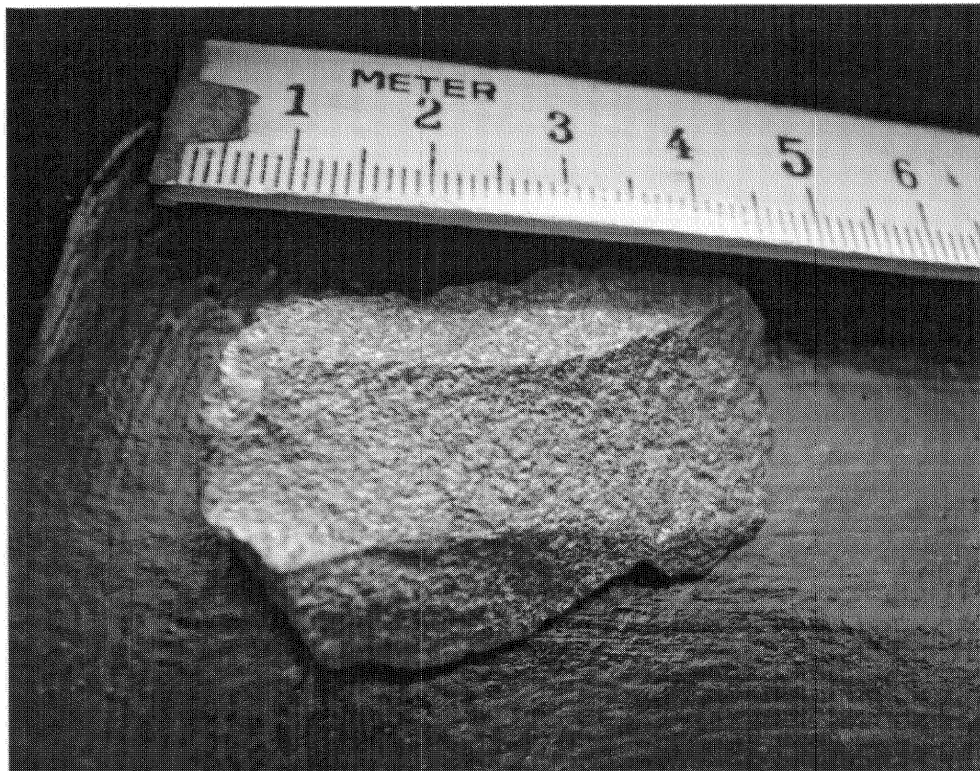
Evidence of prehistoric occupation of the land earmarked for the proposed development was negligible. A few silcrete flakes (3) of average 20mm size and larger quartzite flakes (2), 50mm to 70mm in length (Figure 3) scattered near the fence on the eroded surface were observed. The artefacts are not *in situ*.

Fig. 3. A quartzite blade-like flake.

1. The stone tools require no further documentation.
2. The rock art site should be protected as a heritage site. The impact of the development, foreseen tourism activities and agricultural practices near the rock art site will be high if protection of the site is not guaranteed. Further action is required from the developer(s) and landowner(s) to set in place effective and protective measures. Paintings at a rock art site known as Swartklip, five kilometers from the site described in this report, south of Rondegat, located in proximity to the RD 2183, are defaced and destroyed in places by graffiti. This is an example of the poor protection afforded heritage sites in the area. Charcoal graffiti is present at the site described in this report. Thus a process of damaging and destroying the rock paintings is a reality and a probability in the future of these sites.

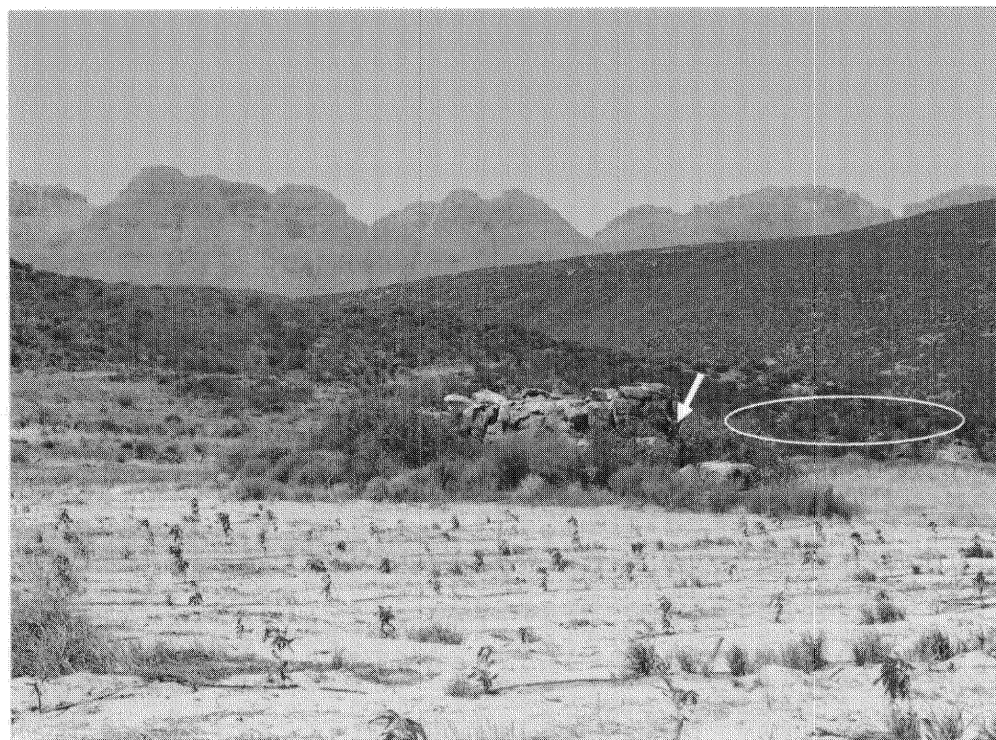
A rock art site was found (Figures 4 & 5) at 32°15.53' S 18°55.02' E, approximately 300m from the proposed development area on the waterfront of the dam. Although the site is not situated in the area to be developed, farming and tourism activities will have an impact on the rock art. The ground surface surrounding the rock art site has been bulldozed and prepared for planting of mango trees. A road servicing an adjacent recently planted mango plantation leads past the site and terminates lower down.

Fig. 4. The inserted white arrow points to the position of the rock art site. The gravel road is visible in the background of the photograph and the white inserted oval shape indicates the south eastern boundary area of the proposed development. From there it extends southward towards the waterfront of the Clanwilliam Dam. The surrounding area of the rock art site is disturbed by prior agricultural activities. Mango trees grow in the foreground.

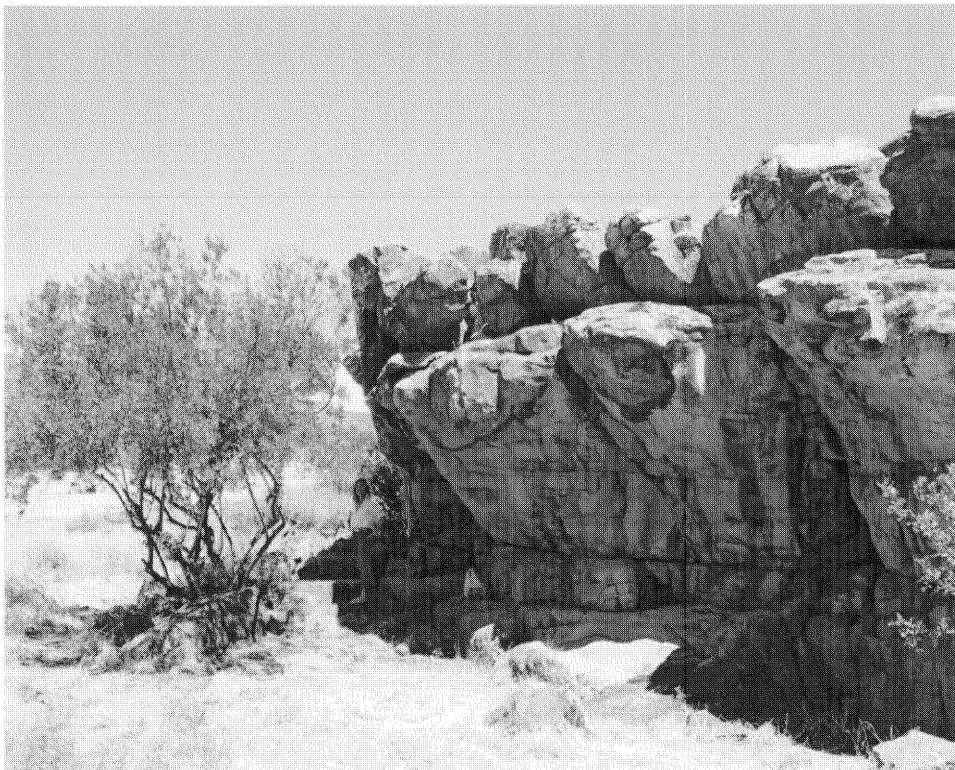
Fig. 5. View of rock art site with paintings facing southwest toward the proposed development.

•	% OF SEEPAGE / DRIP / LICHEN / MOSS AND VEGETATION ON PAINTINGS	: 30%
•	ARE PAINTINGS IN DANGER OF DISAPPEARING?	: Yes
•	VANDALISM / GRAFFITI PRESENT ON THE PAINTINGS	: <i>Paint chipped off</i> – none <i>Charcoal</i> – graffiti present <i>Paint</i> – none <i>Scratches</i> – none <i>Smoke</i> – none <i>Other</i> – exfoliation

The guidelines and minimum standards for the protection of rock art sites (National Heritage Resources Act No. 25 of 1999, sections 32 & 35) should be followed in future management of the rock art site. If the rock art site is included in any visitation activities planned for the development, Elephant Creek Resort, further documentation of the rock imagery is needed. A management plan for the protection of the rock art site must be drawn up and should include the following aspects:

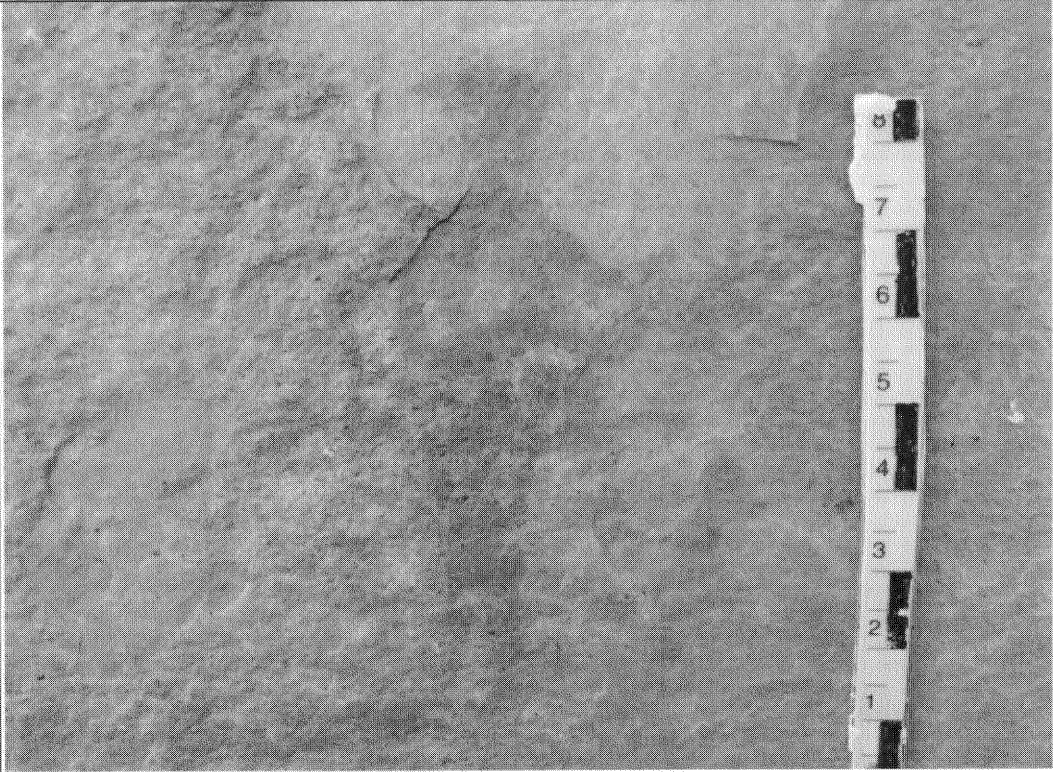
Location	Description of the images(s)
To the left side of rock face

<p data-bbox="374 1115 1365 1178">Fig. 6. A red human figure (80mm in height) with grid-like torso. There are more figures but preservation is poor and the images are indistinct.</p> <p data-bbox="374 1285 1448 1653">The rock paintings at this site are in keeping with the rock art tradition of the Cederberg area. The paintings are mostly monochromes, painted in a single colour. However there are hook head human figures present in the sample on the rock face and these show the use of another colour, white in this case, to indicate the fill-in of the face. There are more human figures than animal. The human figures are grouped and arranged in a procession. Some wear karosses and are outlined in black.</p>

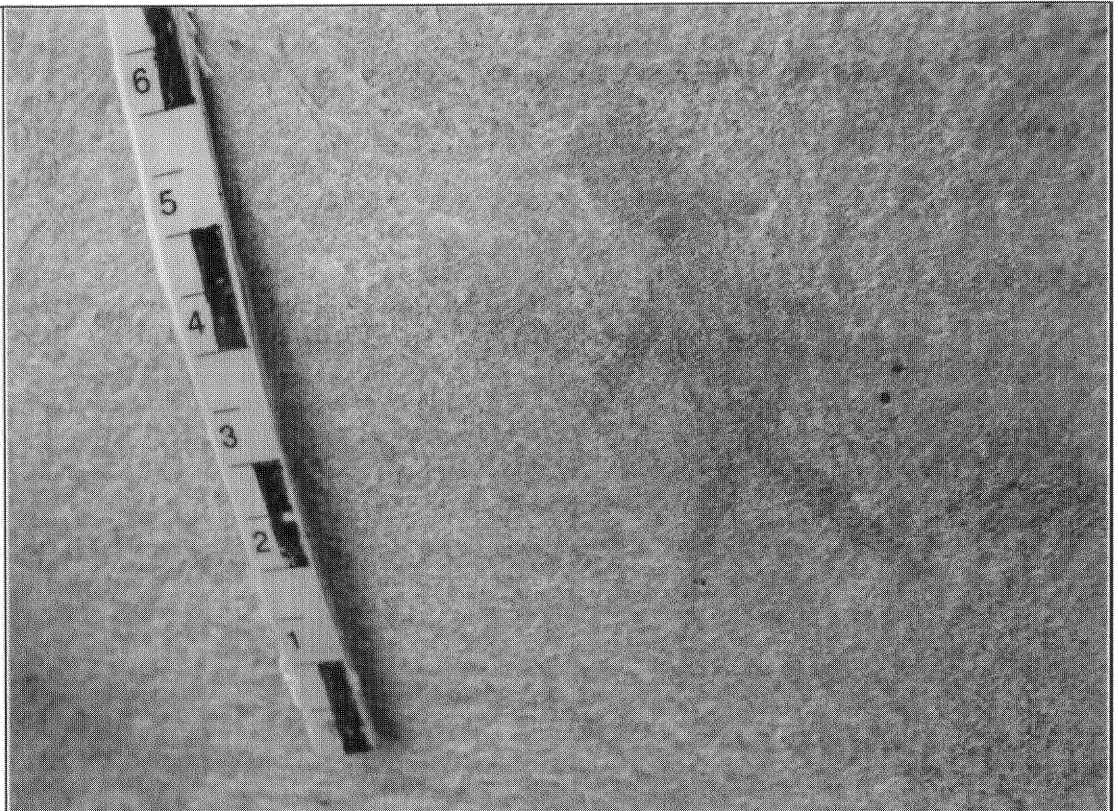
Fig. 7. This human figure appears to be striding. It is immediately below the figure in Figure 6. It has a headdress or a protuberance from the head.

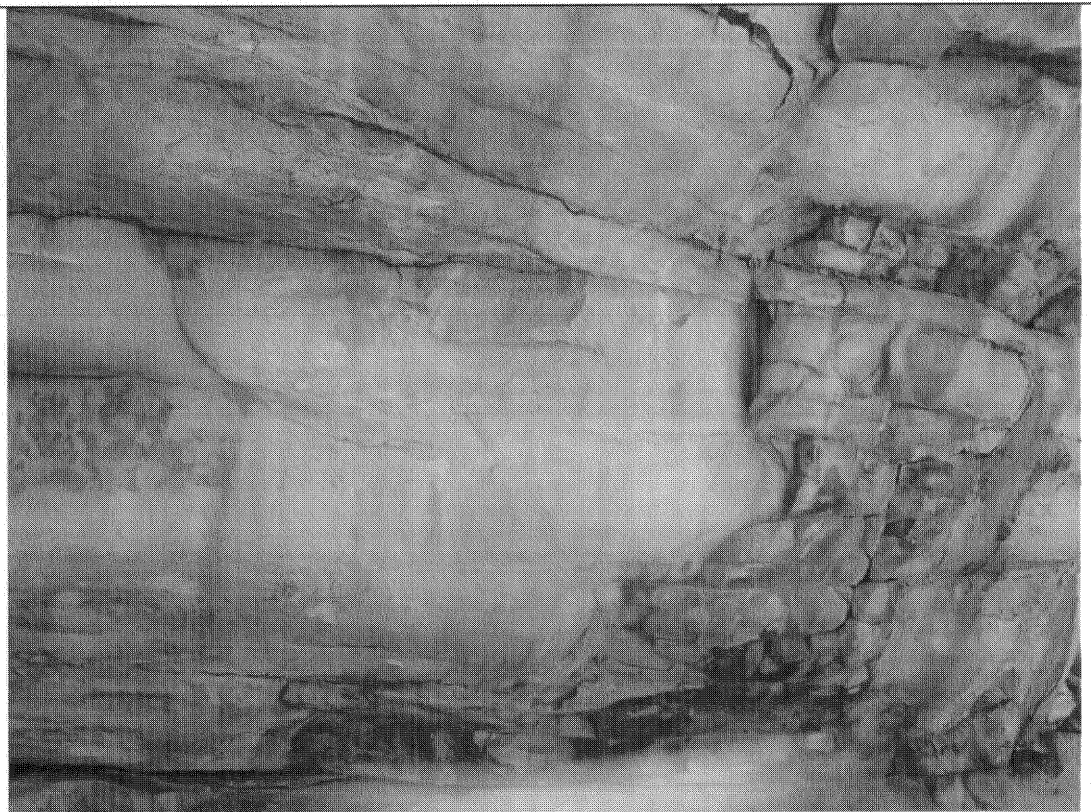
Fig. 8. The frieze of paintings is in the centre of the site and shows hook head figures in procession. A palette is present to the right of the frieze of paintings.

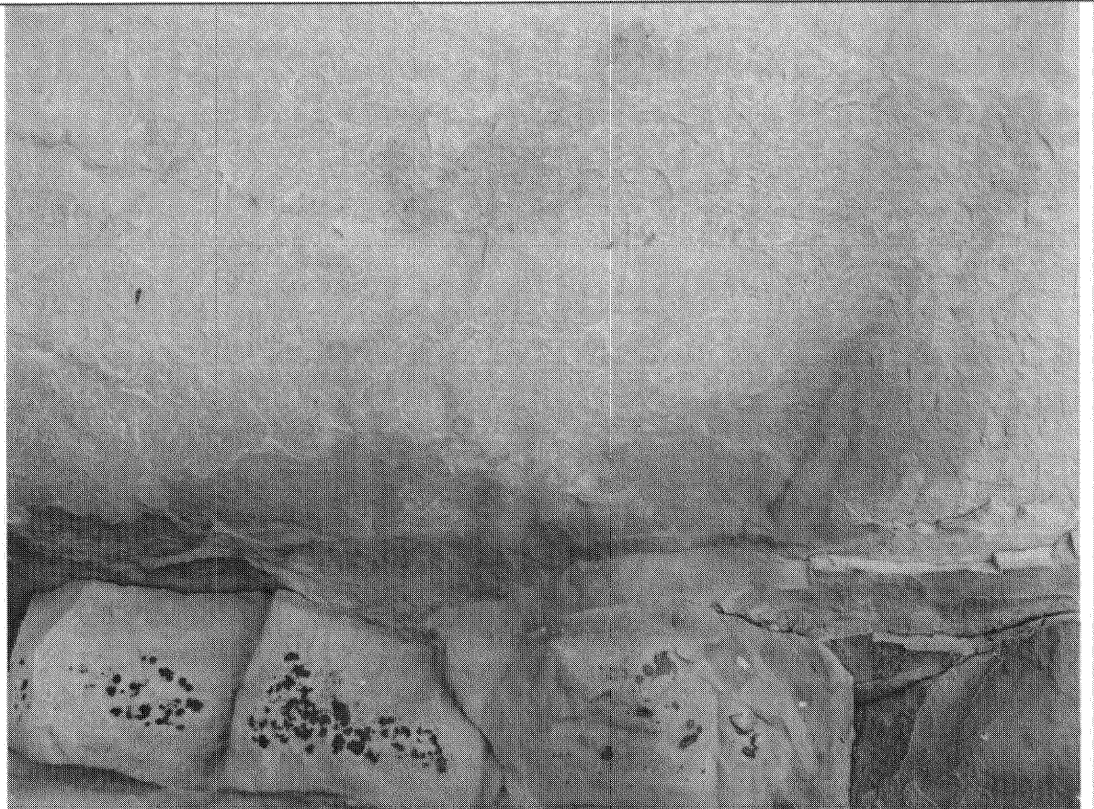
Fig. 9. These human figures, partially preserved, appear to have multiple legs and lean forward. The images are located high up to the right of the frieze in Figure 8.

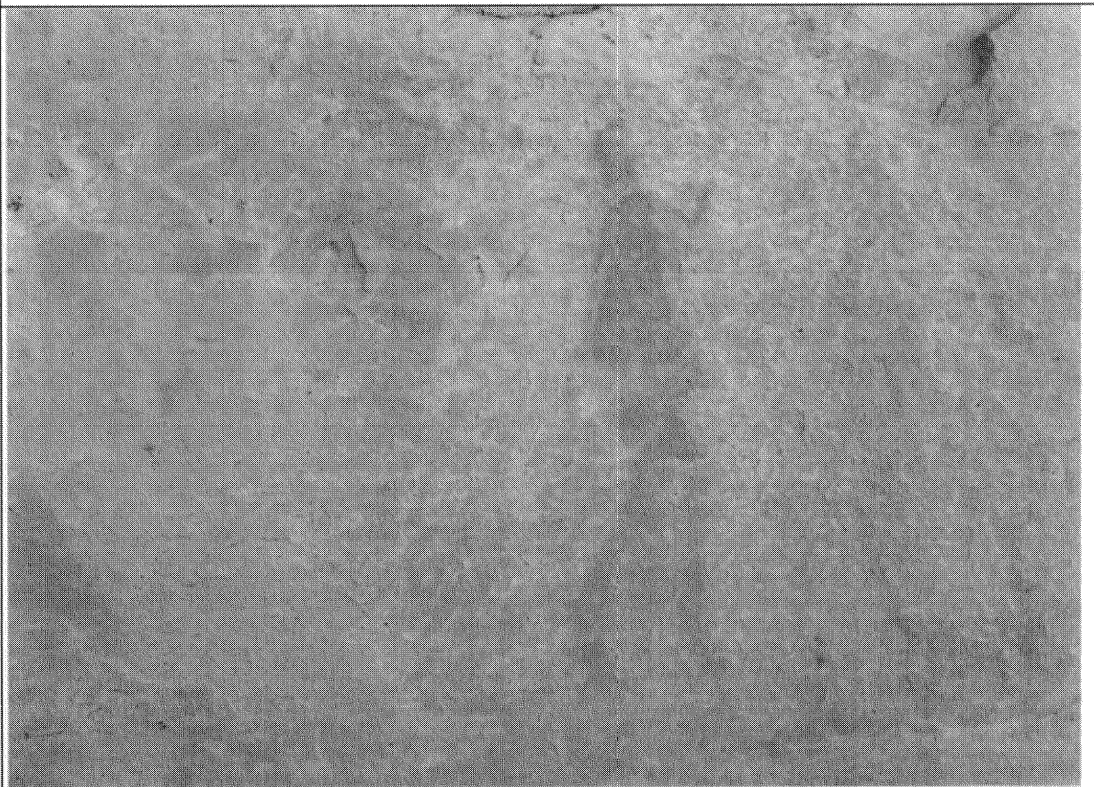
Fig. 10. The hook head figures in the procession in the middle of the frieze as shown in Figure 8.

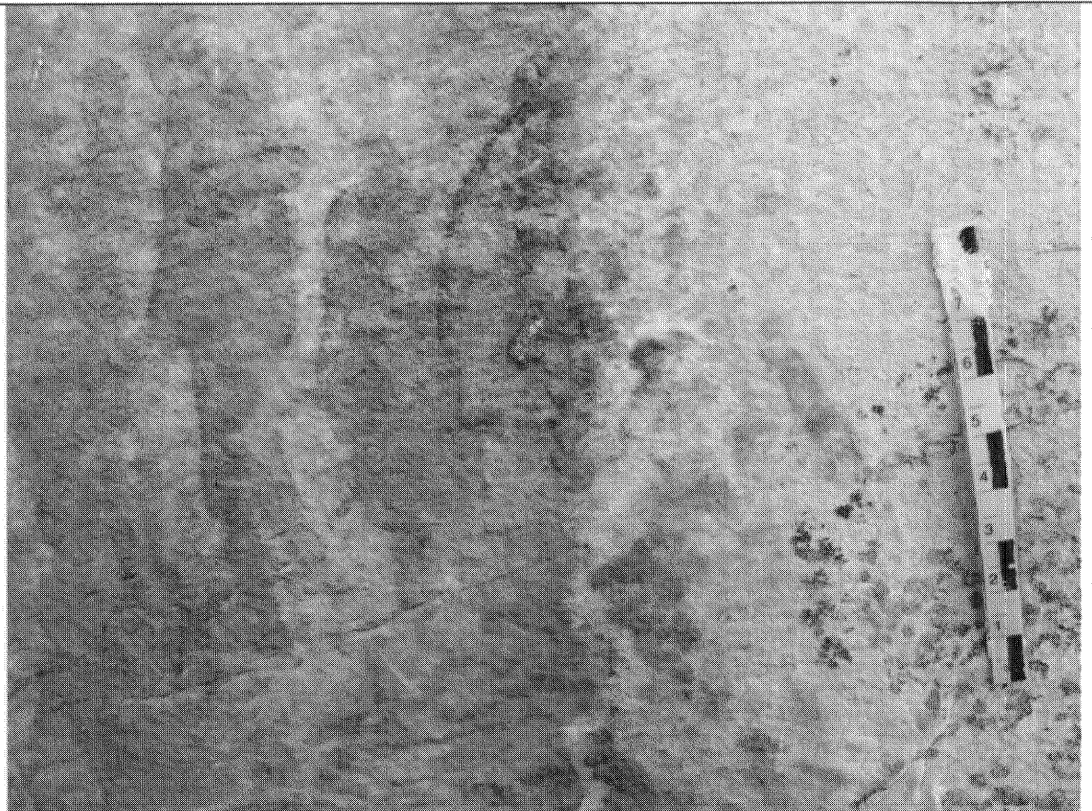
Fig. 11. These human figures wear karosses and are outlined in black. The figures are located to the right of the frieze in Figure 8.

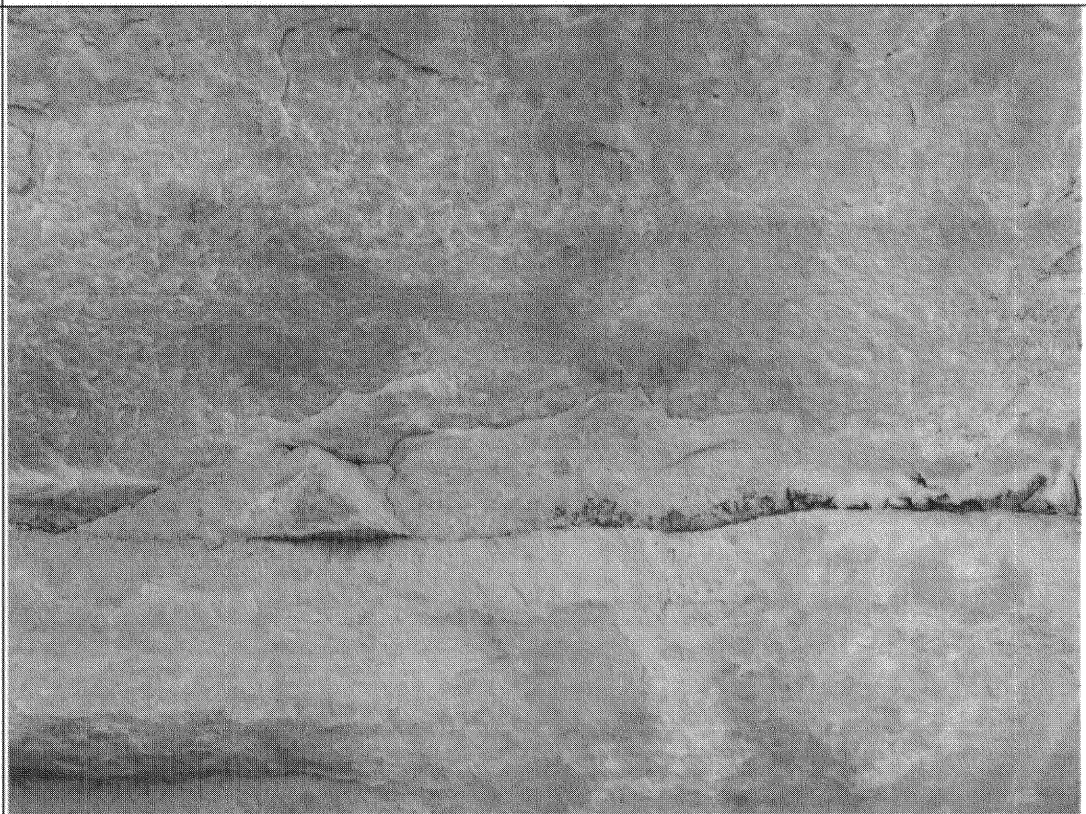
This snake figure is low down to the right of the site

Fig. 12. A snake-like figure appears to emerge from a crack in the rock face.

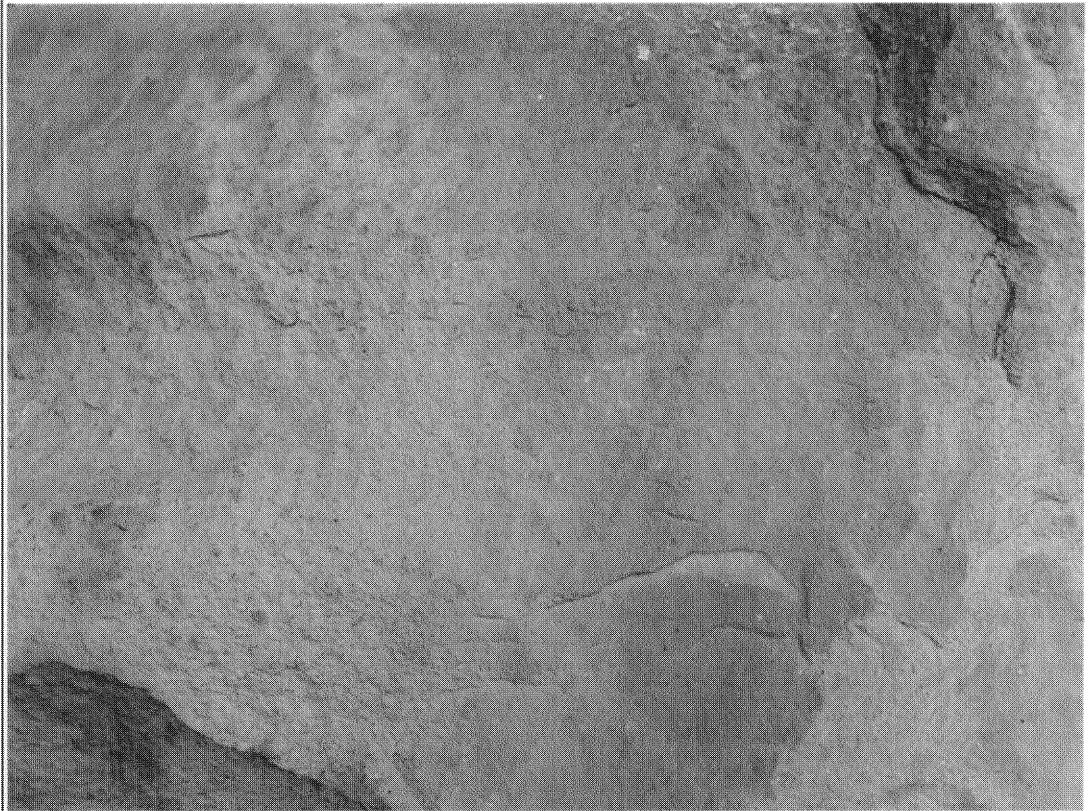
To the right of the site near the snake image in Figure 12

Fig. 13. A beautifully executed small antelope type (70mm in height from toe to head) with his head turned facing over his haunches and back. This figure is low down to the right of the rock face at the site.

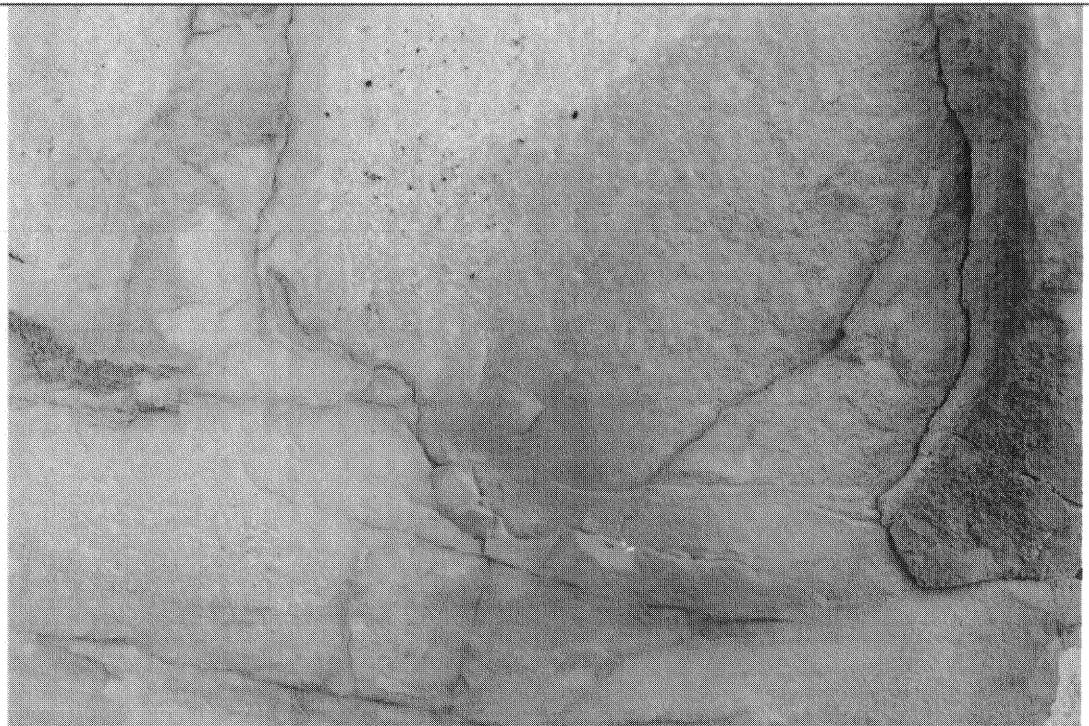
Fig. 14. These human figures are to the right of the frieze in Figure 8. More than one human figure is bending forward; one has his arms held outward. The extremities, fingers, are shown.

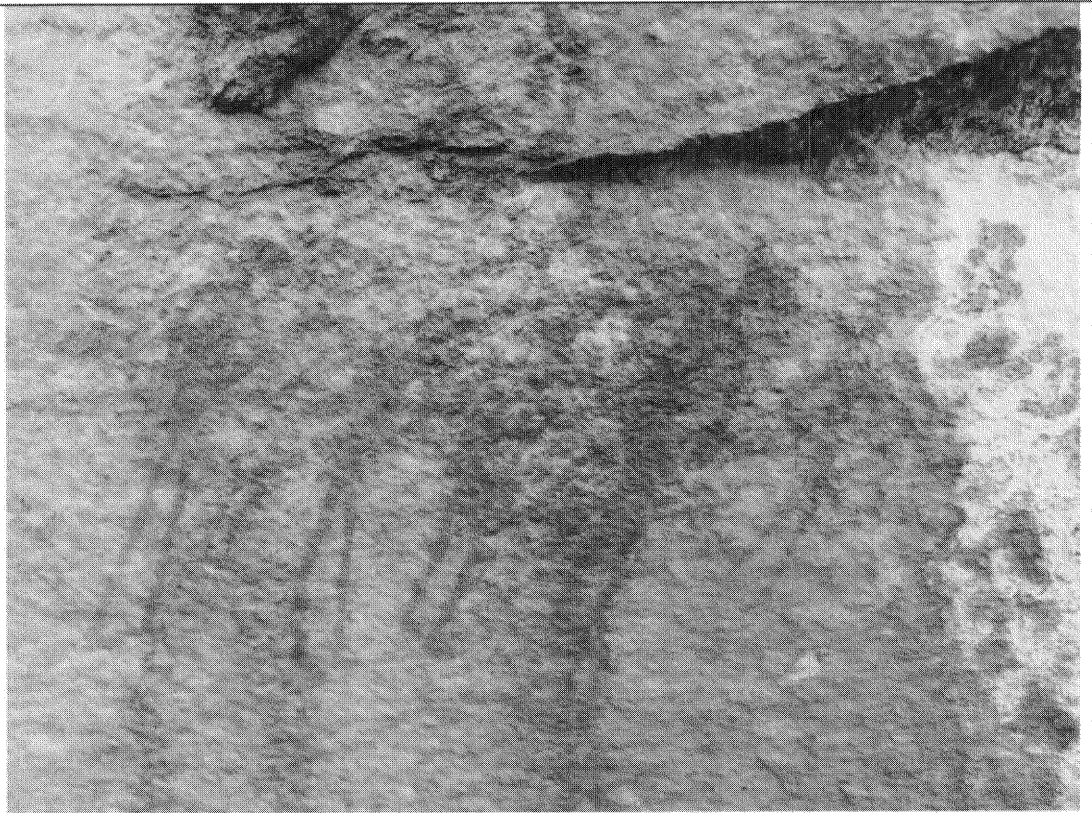
Fig. 15. Five human figures (80mm in height) in a procession below the figures with karosses in Figure 11.

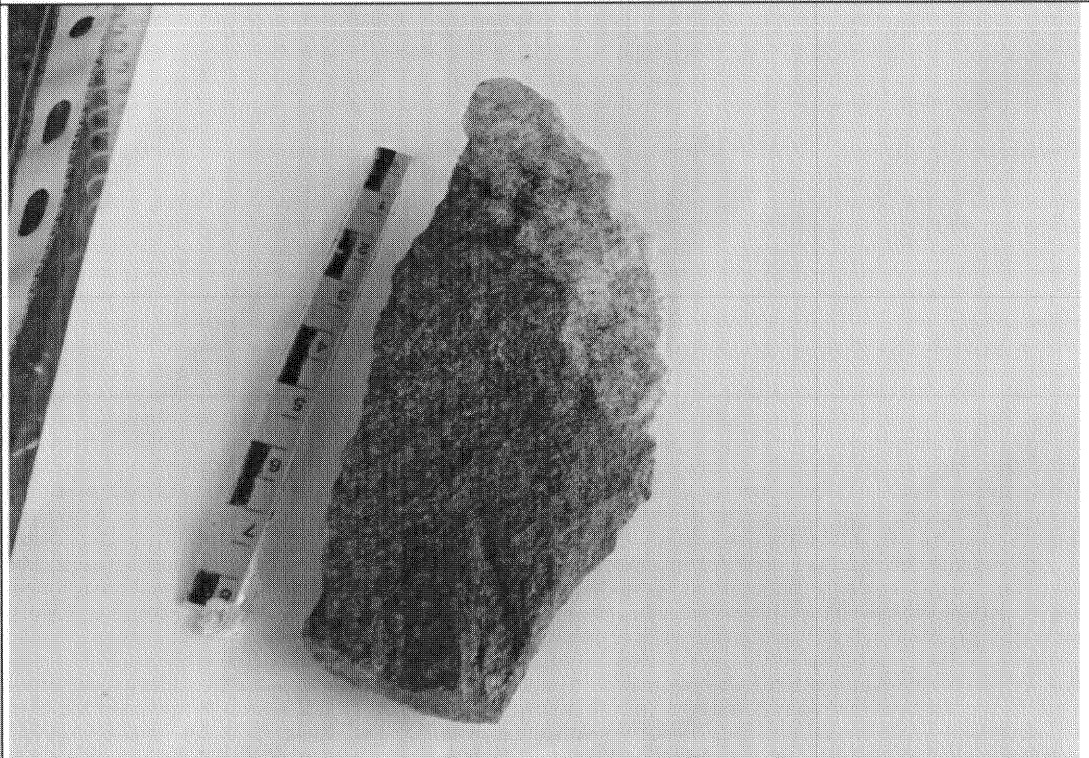
Fig. 16. Quartzite blade.
